**ARCHITECTURAL COLLECTION
OF
HARVIE P. JONES, F.A.I.A.**

BOOK 42

1840's - 50's
Solomon DeBow
Log Hse, Madison Co., Al.

Photos April 1993
Harrie P. Jones, FAIA
Huntsville

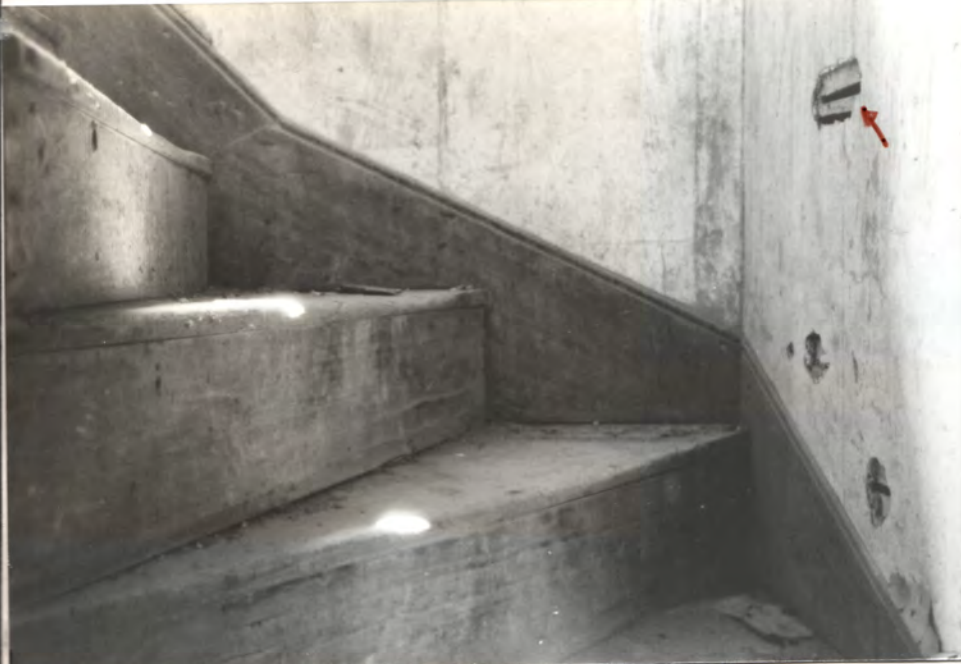
HALL STAIR AT "TURN"
 22 1/2" windows

← MOD. MAKE SHIRT "RAIL" (THIN PLT.)

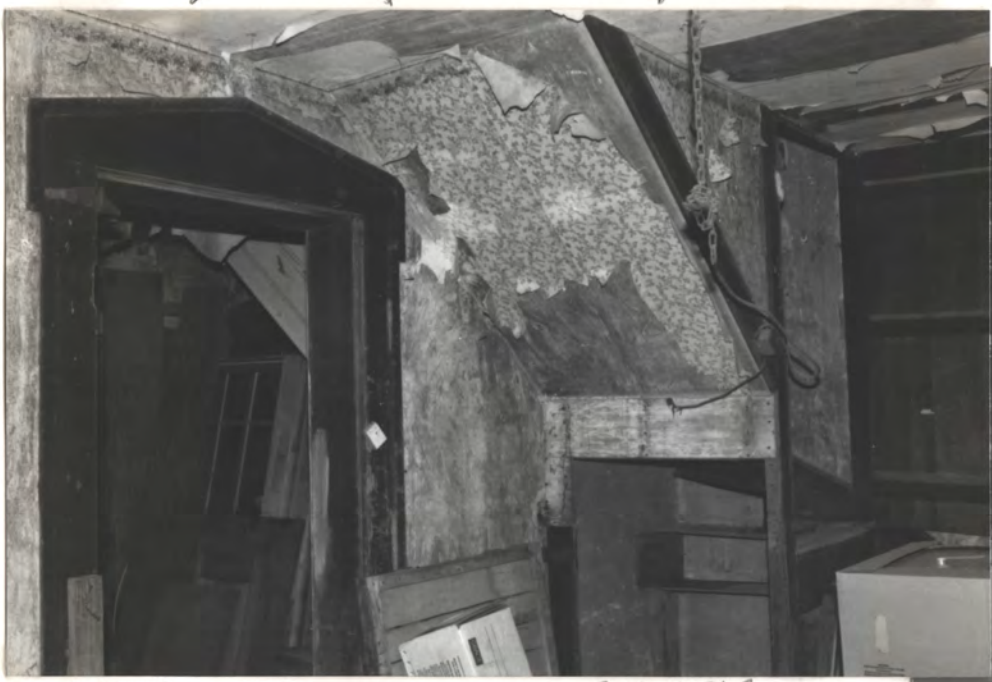
S. DOOR TO HALL

plaster on wd. bath stair enclosure

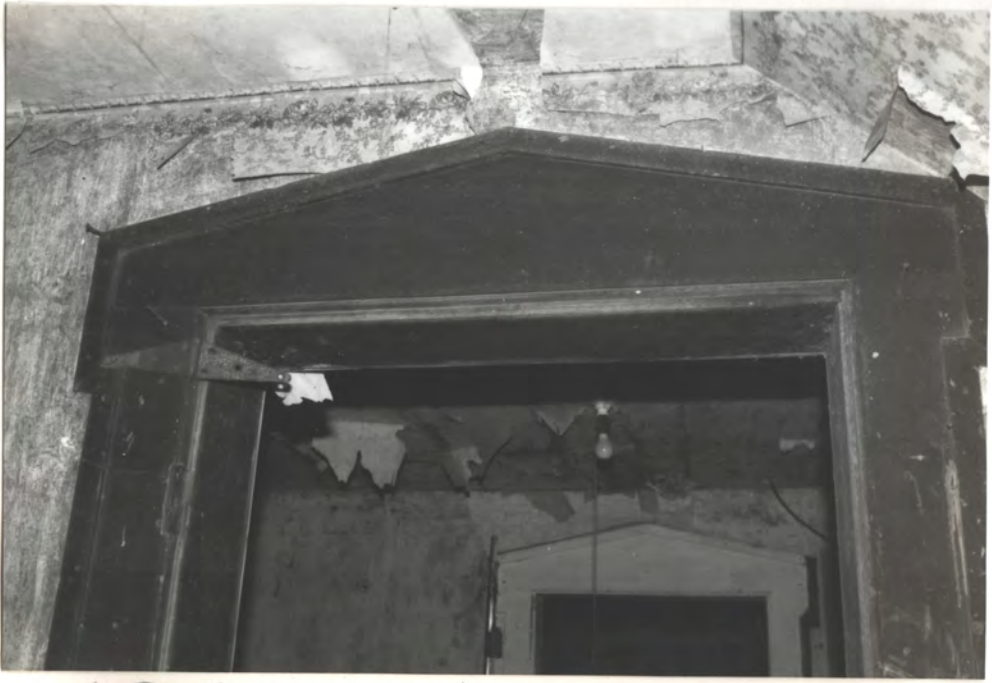
S. DOOR TO HALL (look S. into hall)

↑ opened stair door (bd. & batten)

↑ west door to former back porch

↑ loose Gk. Rev. type mantel (from S. Rm fl. 1? N. Rm. fl. 2?)
