Re: Inscho Residence (Hagan House, Mooresville)
Project No. 95125

Re: Inscho Residence
Project No. 95125

FEDERAL PERIOD + ADDNS.
IRVING-HOBAN-INSCHIO HOUSE
MADRIDVILLE, AL.
1986, 1995
JONES & HEERIN, ARCHITECTS
ANNHURSTVILLE, AL.
ARVIE P. JONES, F.A.I.A.

HAGAN HSE, MARTINSVILLE, VA.
EARLY 1800'S + LATE 1800'S ADD. & INT. REMOD.
+ C. 1960'S N. WING
photos June 1995 by Wally Insko, new owner,
for add'n's & renov. by Jones & Herin, Arch
Huntsville (Harvie P. Jones F.A.I.A.)

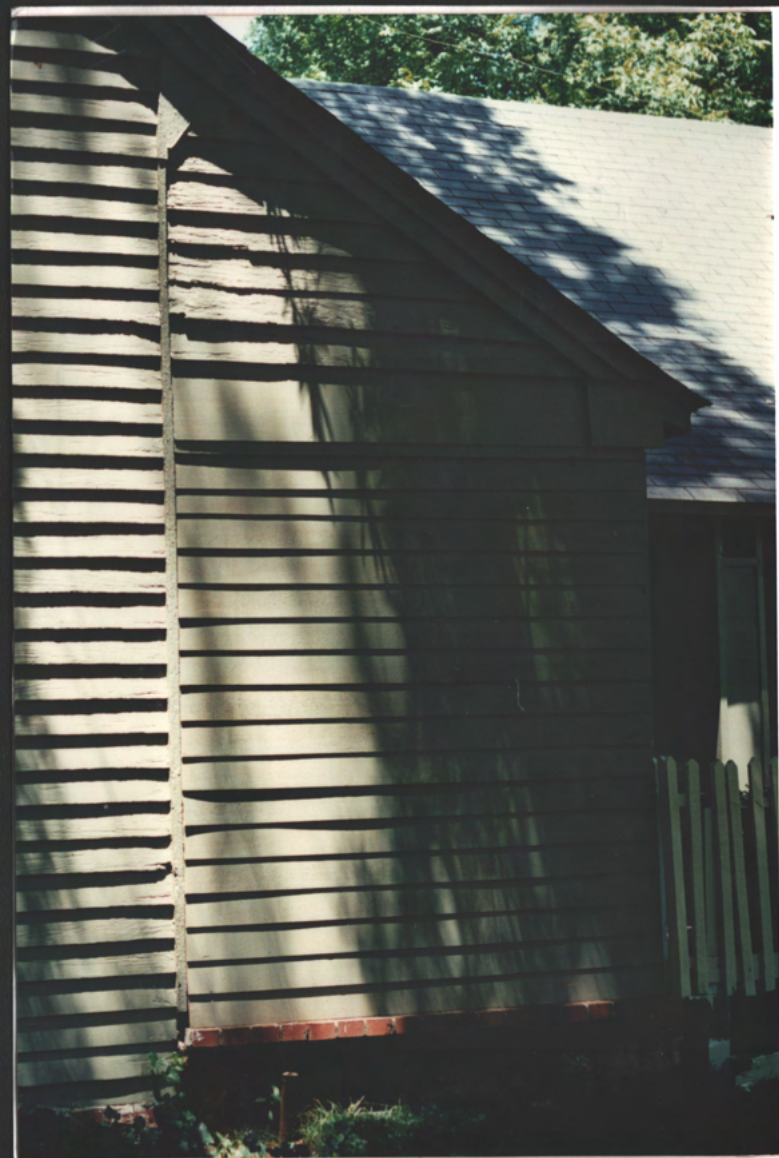
→ N
N.E. Corner of E. Wing (Vic.?)
Note joint in fascia indicating
that the drip-edge was attached later

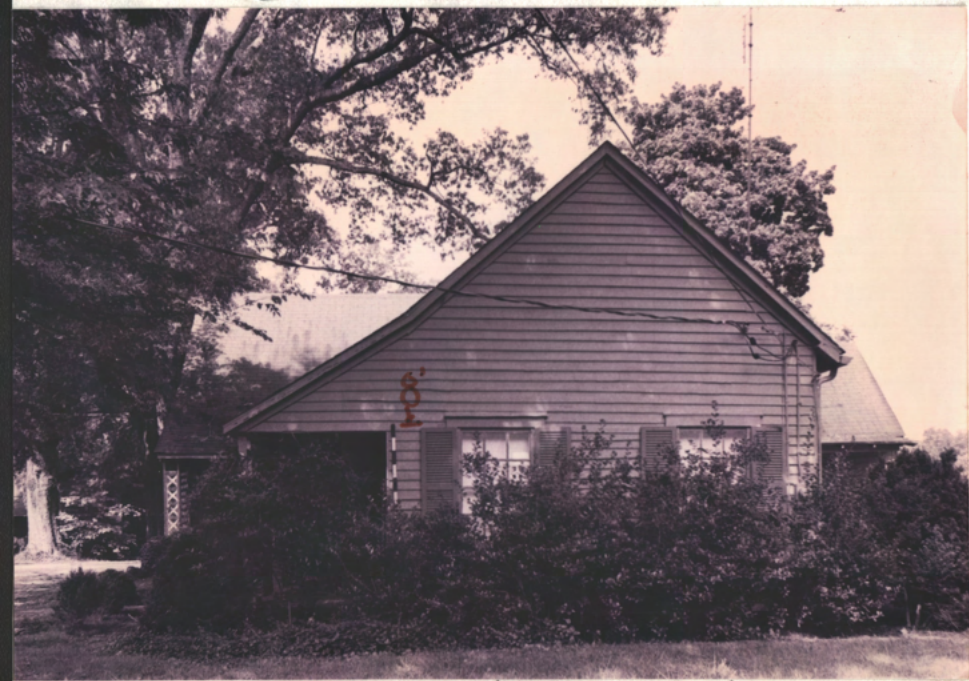
Vic. east wall →
