1850's Bledsoe - Kelly Hse (1993 owner = Charles Kelly) Al. 21, 1.5 miles N. of Snylaccuga, Al

Re: Kelly 1840's House Restoration
"Mountain Springs", H.A.B.S. Al. 428
Sylacauga, Alabama
Project No. 93027

Field Notes H Jones
 Mar. 1993 "Kelly Hse"
 c. 1840-50's "Htn. Spring" Hse

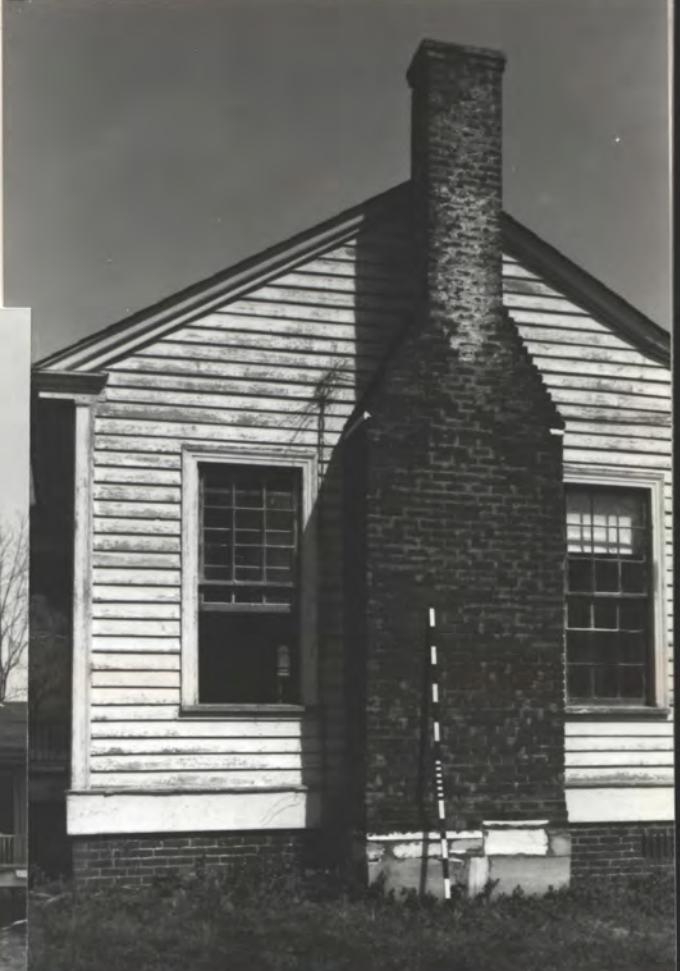
SOUTH WALL All looks 1850's except solid brick fndn. w/ full wall
