JONES & HERRIN

August 4, 1997

Re: 1829 Gorgas House Museum, The University of Alabama

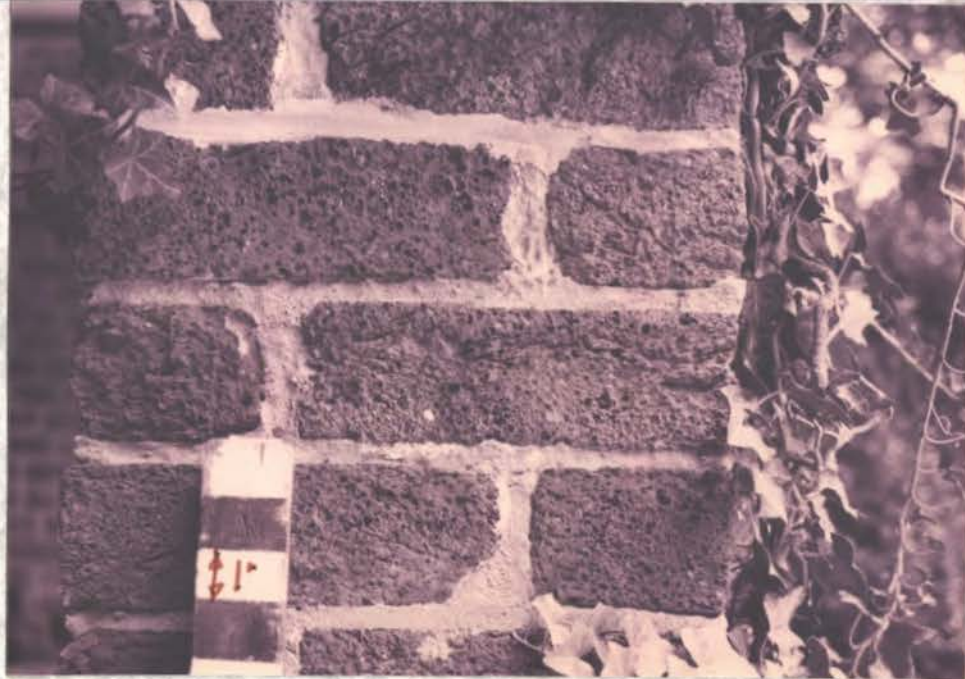
HEAVY sandblasted brick prior
at lower part of portico
