POST-1846
DEERING-
SWAIN HSE
TVSCHL005A

Re: Dearing-Swaim House
Tuscaloosa

HISTORICAL & RESTORATION COMMENTS:

DEARING - SWAIN HOUSE - TUSCALOOSA - 6 MAY 1980

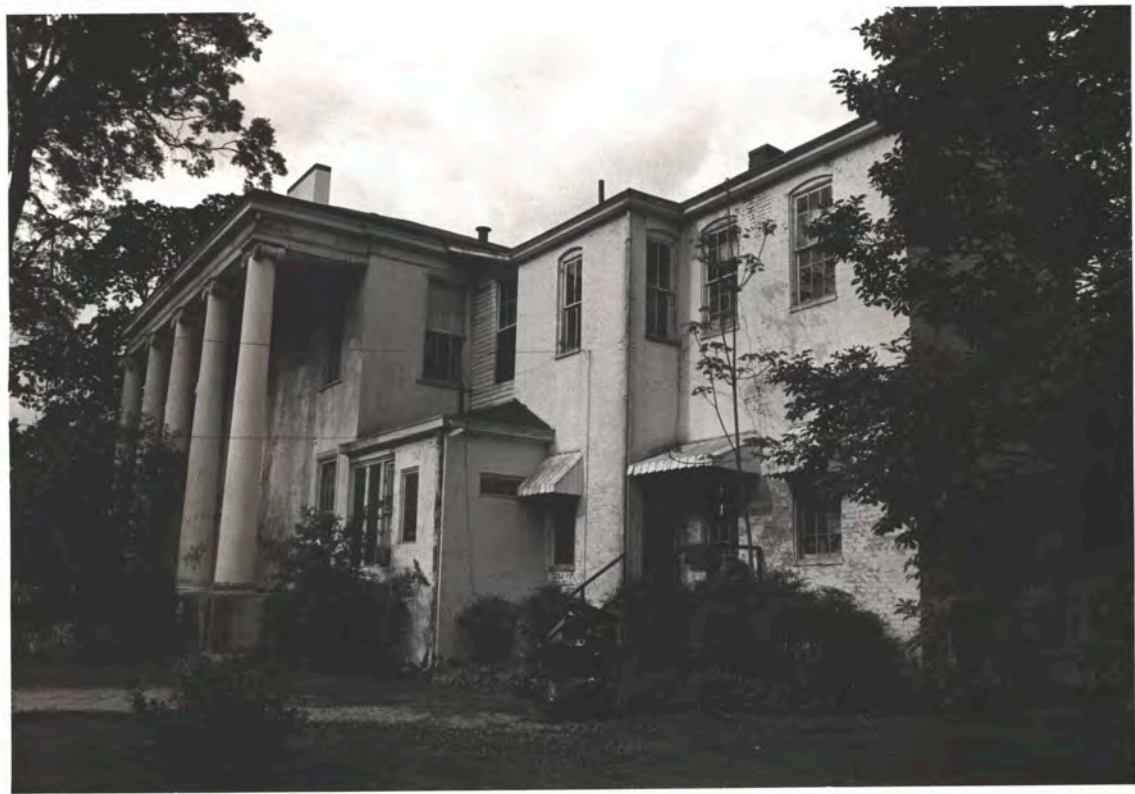
Serv. Bldg. →

→ Main
hall

"Link" between has view of serv. bldg
(also opens porch)

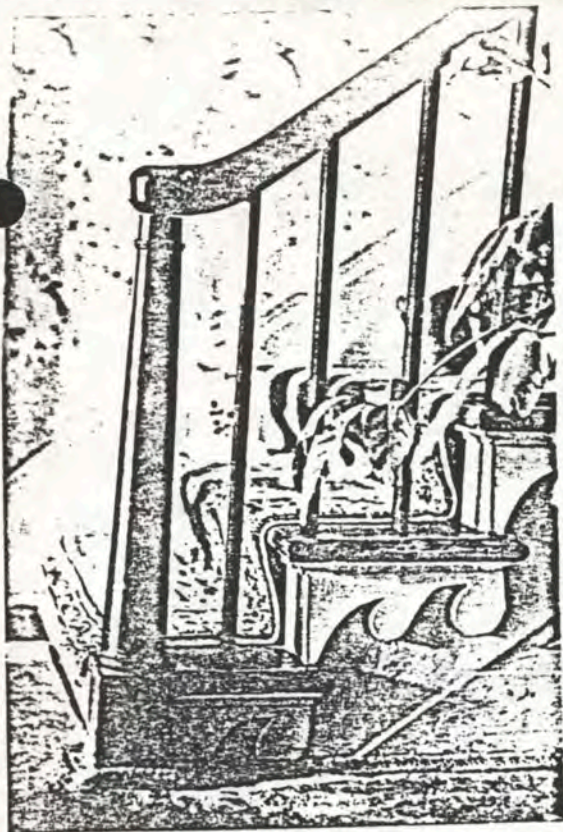
Typical
Ok. Rev. Stair (some) - ends vary
ca. 1845 "Darkroom" - Hunts with

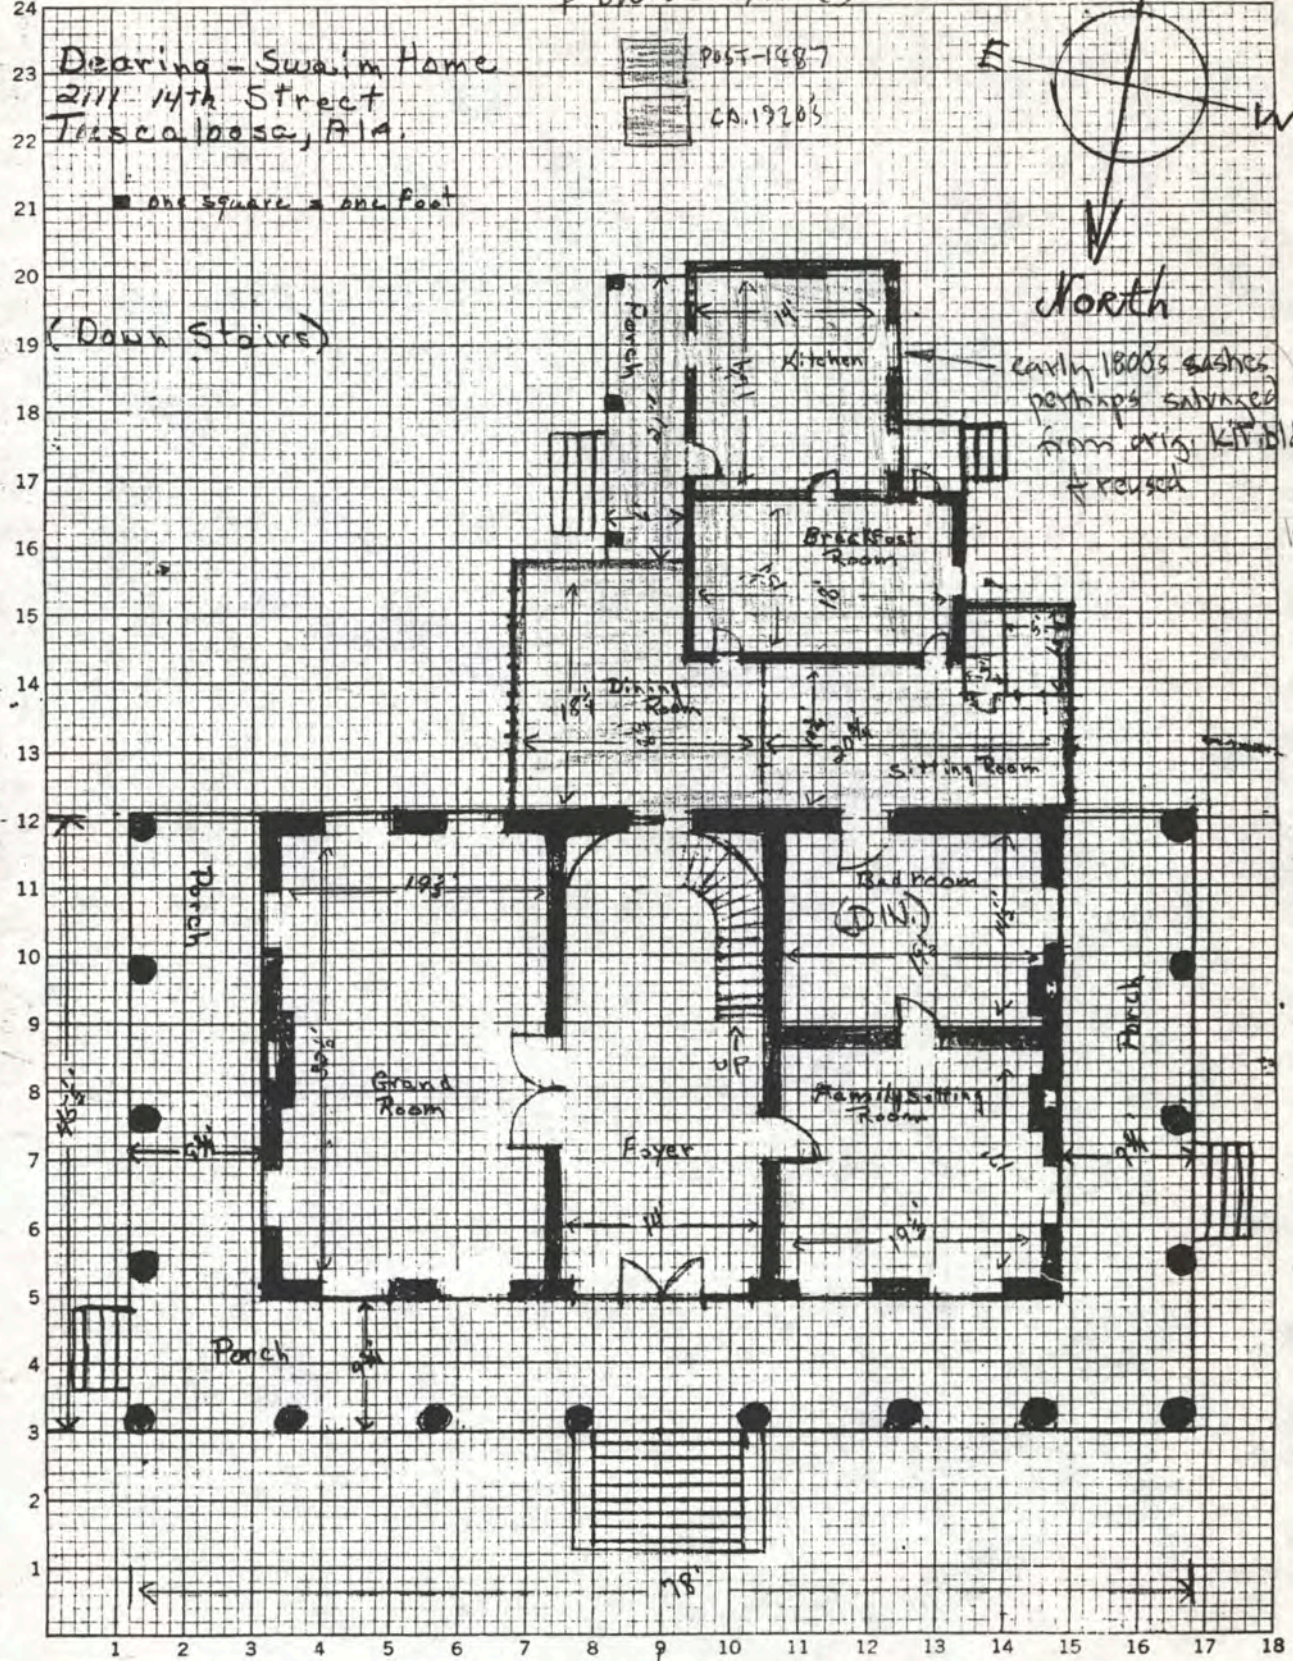
Dearing - Swain Home
2111 14th Street
Tuscaloosa, Ala.

Main Asc reputedly is ca. 1846 - may be 1850's based on cut kerf

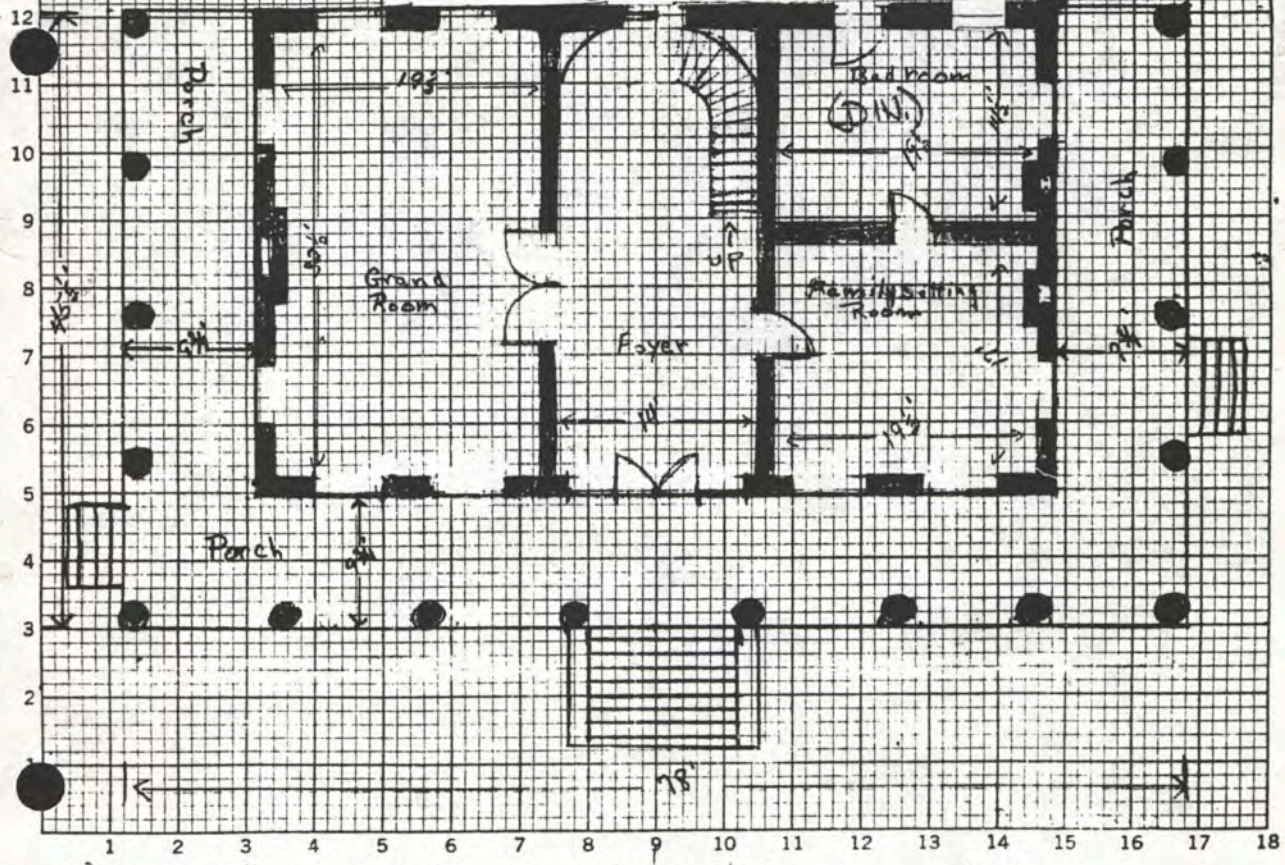
DEARING-SWAIM HSE
1ST FL. SERV. WING OVER
1 CM. = 5' ±
6 MAY 1980

Main Hse reputedly is ca. 1946 - may be 1850's based on cast knobs
