**FIRST PRESBYTERIAN CHURCH  
EUFAULA, ALABAMA**

**Preliminary Observations Report, June 18, 1997**

**Harvie P. Jones, F.A.I.A., Architect**

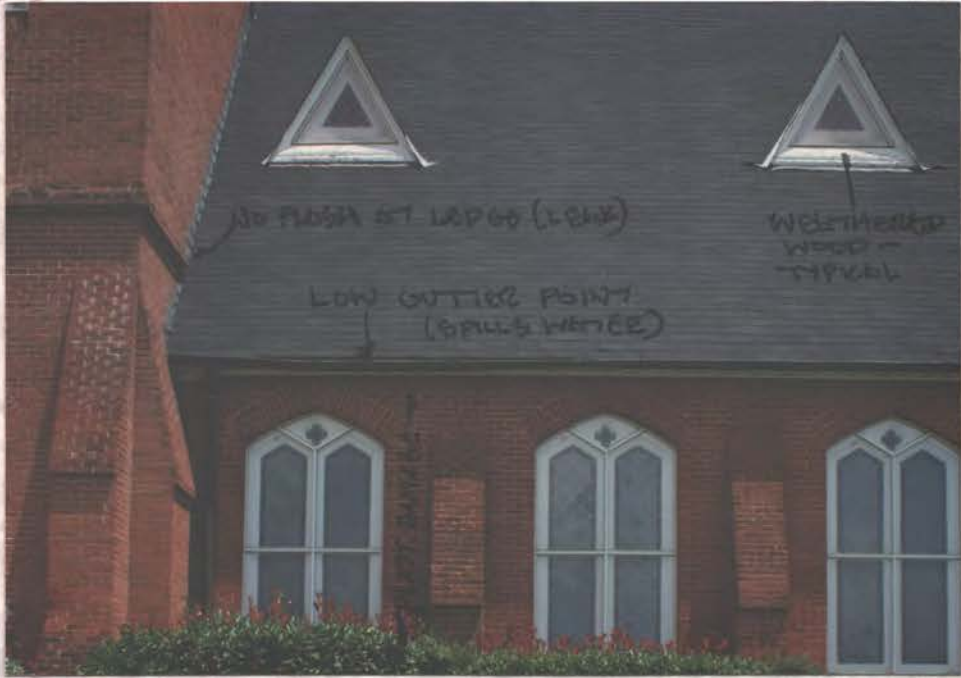
S. WALL

← STAINS  
← NO WASHING OF STAIN INDICATES BLOCKED D.S.

It also appears that the two south wall down spouts, underground drains, or both, may be blocked. The underground drains should be abandoned since they are typically found to be blocked and causing damage by subsequently blocking the down spouts. At a minimum there should be relief suppers near the bottom of each down spout so blockage in the underground drain will not in turn block the down spout and spill water down the wall.

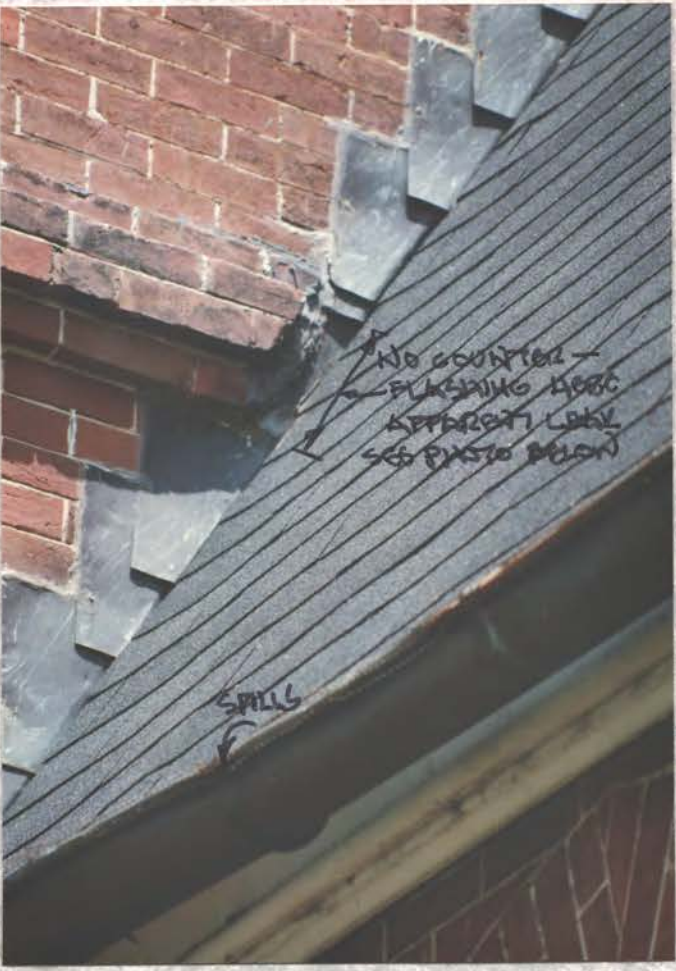
S. WALL

A. The 6 inch diameter half-round gutters are badly bent, out of level and have some split joints and are therefore allowing water to spill down the exterior faces of the brick walls at various locations. At the two interior plaster-damage locations checked, the interior damage locations corresponded with low places or split joints in the gutters, verifying that spilled water is soaking through the solid-brick walls and staining and crumbling the interior paint and plaster.

SPILL

WATER DAMAGE  
(AT GUTTER  
LOW-POINT  
& SPILL ST.  
ON N. WALL  
- P. 9

F. Due to the heavy damage to the gutters, the inadequacy and inefficient joinery of the down spouts, and the under sizing of the gutters and down spouts for this very steep roof, it is likely that the best course of action is to size and design this system per the "Graphics Standards" charts and replace the system, again using copper in a proper weight for the application.

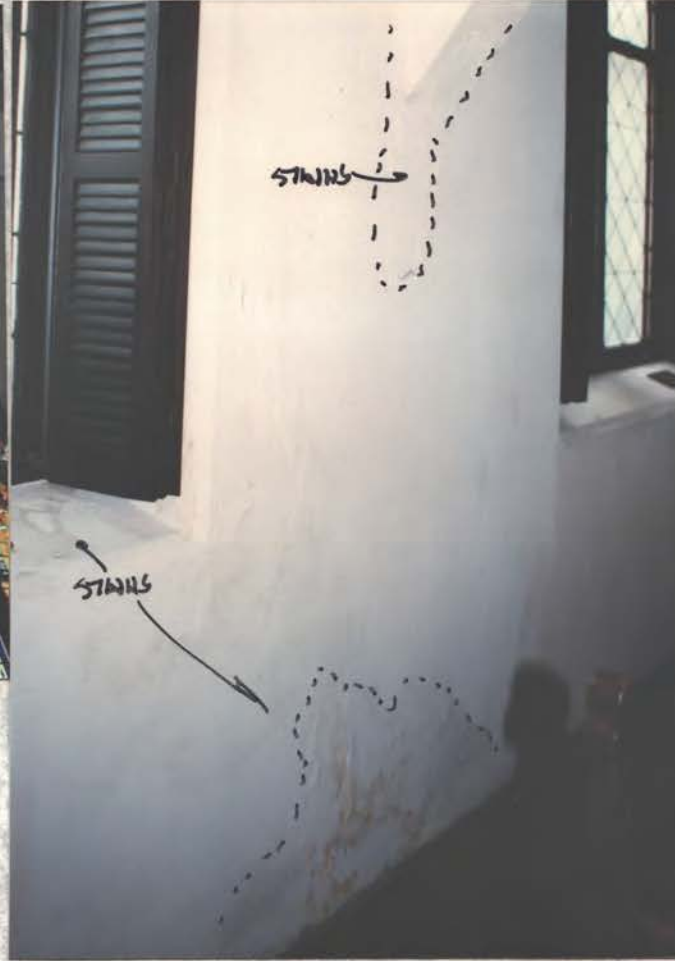
N. WALL

STAINS

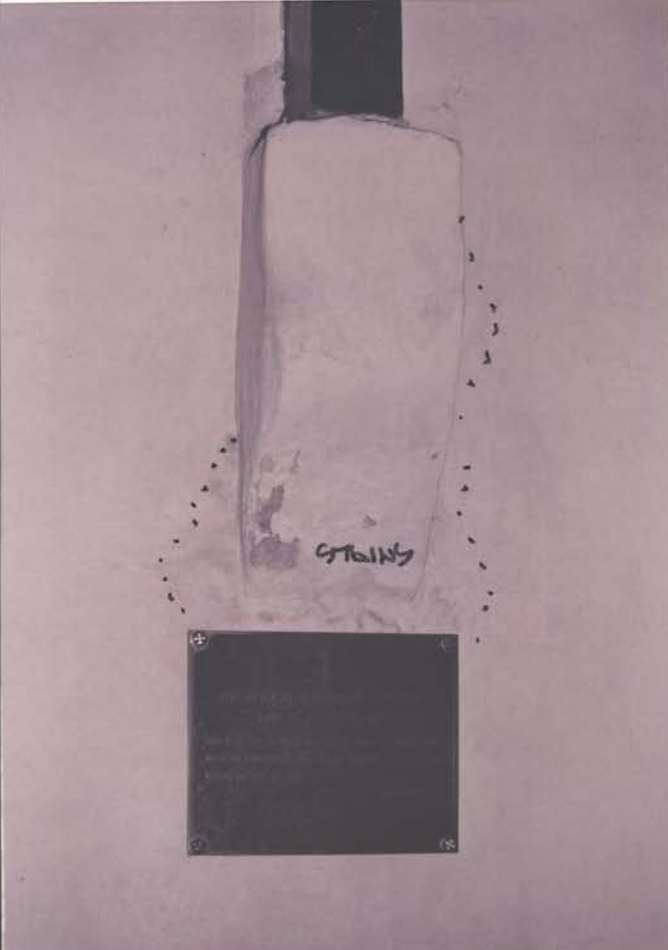
S. WALL NCHL TOWER,  
LOW OUTSIDE IS AT THIS LOC.

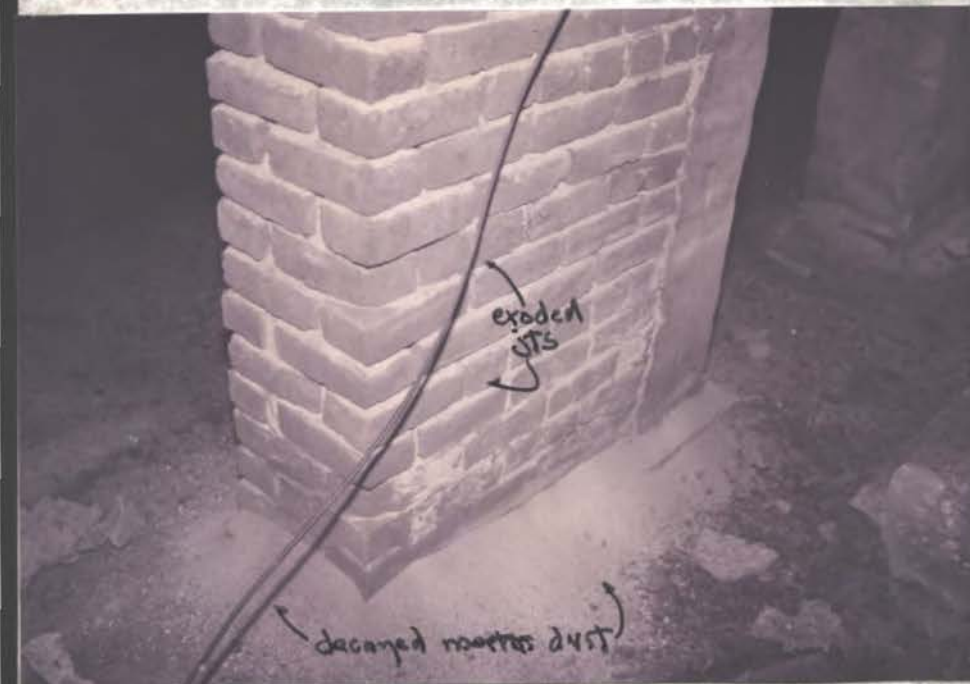
TYPICAL PIER ↗ N

The constant wetting and drying of the masonry walls and piers in the basement has deteriorated the mortar, which has turned to sand and fallen out of many joints. The powdery joints can be easily raked-out with a finger in many areas. The powdery joints must be cleaned out to at least 1 inch depth and repointed with hydrated-lime and sand mortar (diagram to follow).

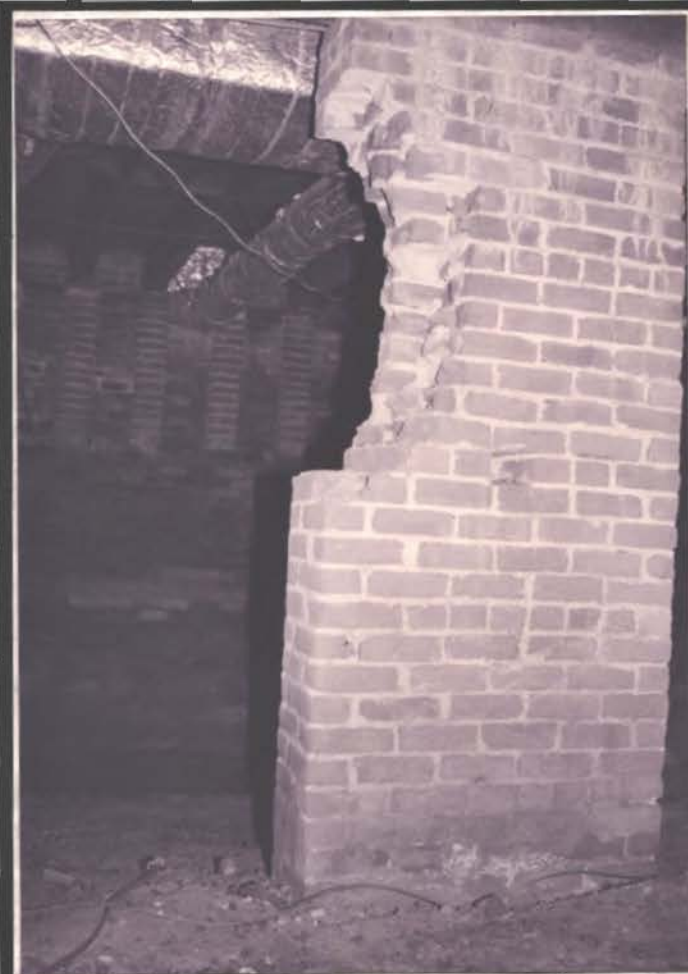
CENTRAL PIER  
(APPARENT REMOVAL  
OF BRICK FOR  
AN OLD DUCT, PERHAPS (?))
