August 1974

# NASA TECHNICAL MEMORANDUM

NASA TM X-64825

MSFC SKYLAB CREW SYSTEMS MISSION EVALUATION Skylab Program Office

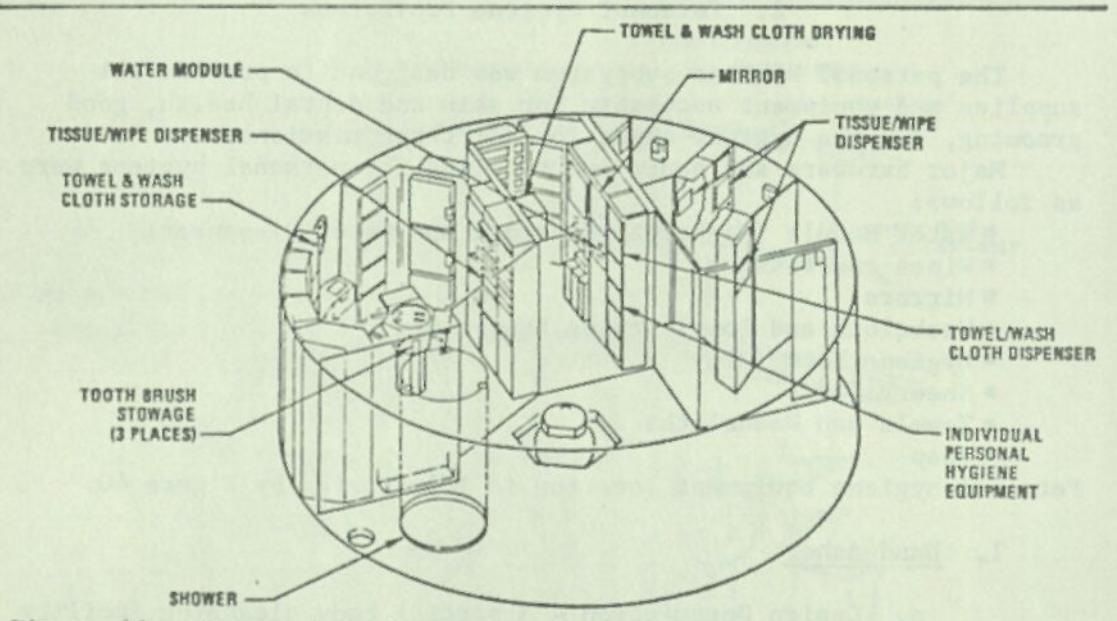
Figure 40. Personal Hygiene Equipment

During the first mission, the water dispenser valve clogged and was replaced with a spare. The second mission crew carried two spare valves for replacement in the event of additional failures; however, this did not occur.

In general, the washcloth squeezer worked well. Some of the crewmen complained about it leaking around the teflon seal and

During the second mission, the squeezer malfunctioned because of a bad Bal seal, causing water leakage. The seal was replaced, thus correcting the problem. To eliminate this problem in future designs, the crew recommended the use of a double seal.

recommended that a double seal be installed on the piston to prevent leakage and improve the water transfer interface between the cylinder and the squeezer bag. They also recommended that the system be enlarged to accept towels. The crews stated that the technique of placing the washcloth in the squeezer was important to a successful operation cycle, and that a good vacuum in the squeezer bag was also a requirement.

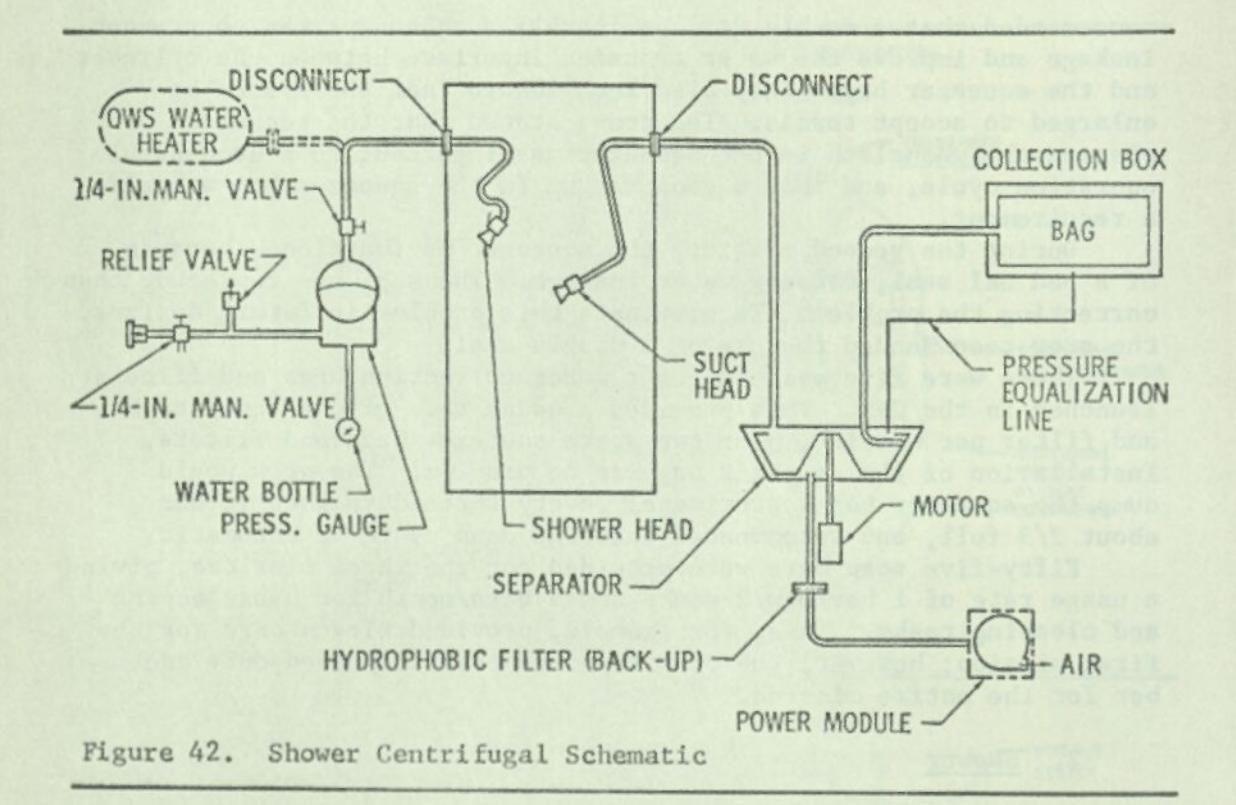
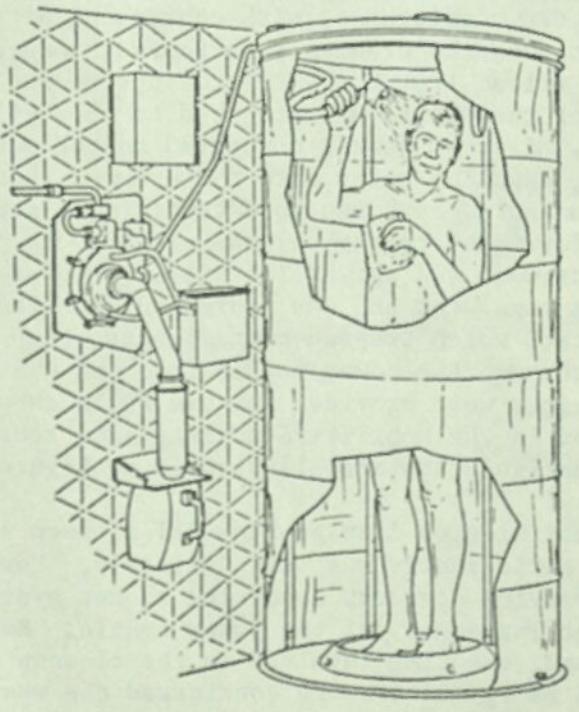
b. Post Mission Assessment - All crewmen agreed that taking a shower periodically was very desirable. However, they also complained, in varying degrees, about the shower system. The primary complaint was the inadequacy of the power module. Because of its low air-flow rates, the time involved in the cleanup of shower water too lengthy. In fact, all crewmen considered the whole showering

procedure too time consuming. In the future, the shower system should be hard-lined to minimize crew involvement. This includes both water dispensing and collecting procedures.

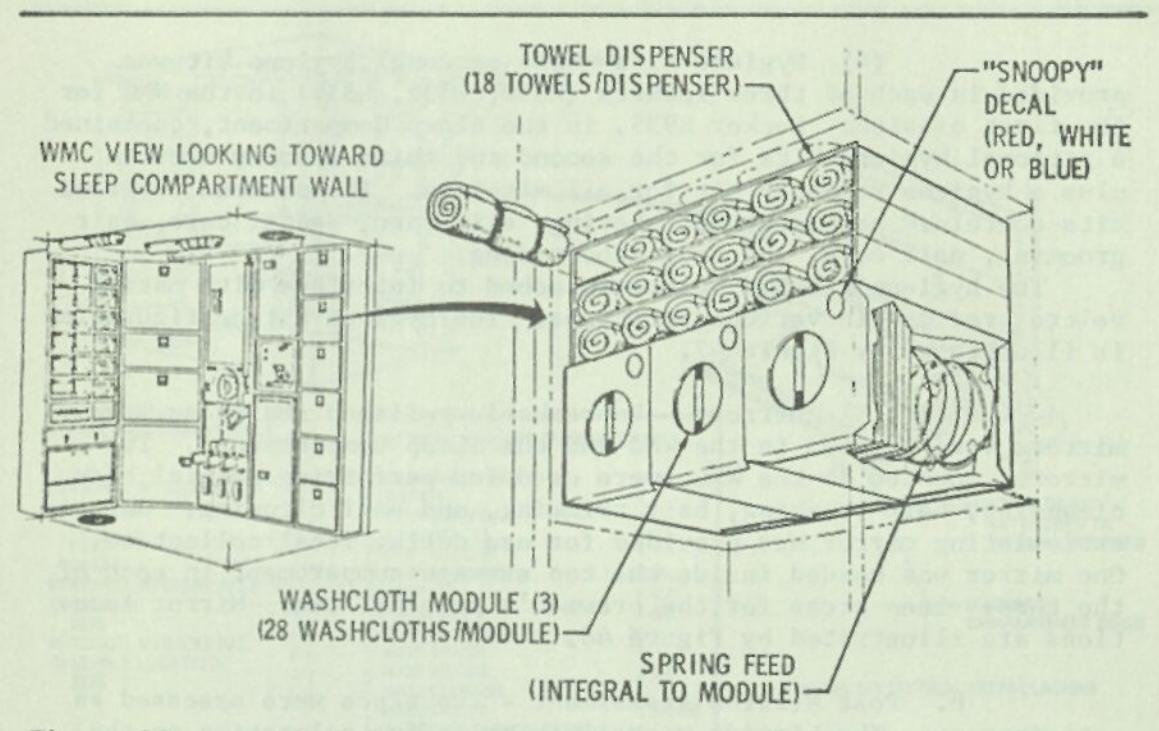
Figure 45. Washcloth/Towel Dispensers

The third crew took an additional 30 towels in the CM to supplement their on-board supply. The crews suggested that the towels be made larger and from a more absorbent material. Towel allocation should be evaluated for future flights using the information in the consumable summary.

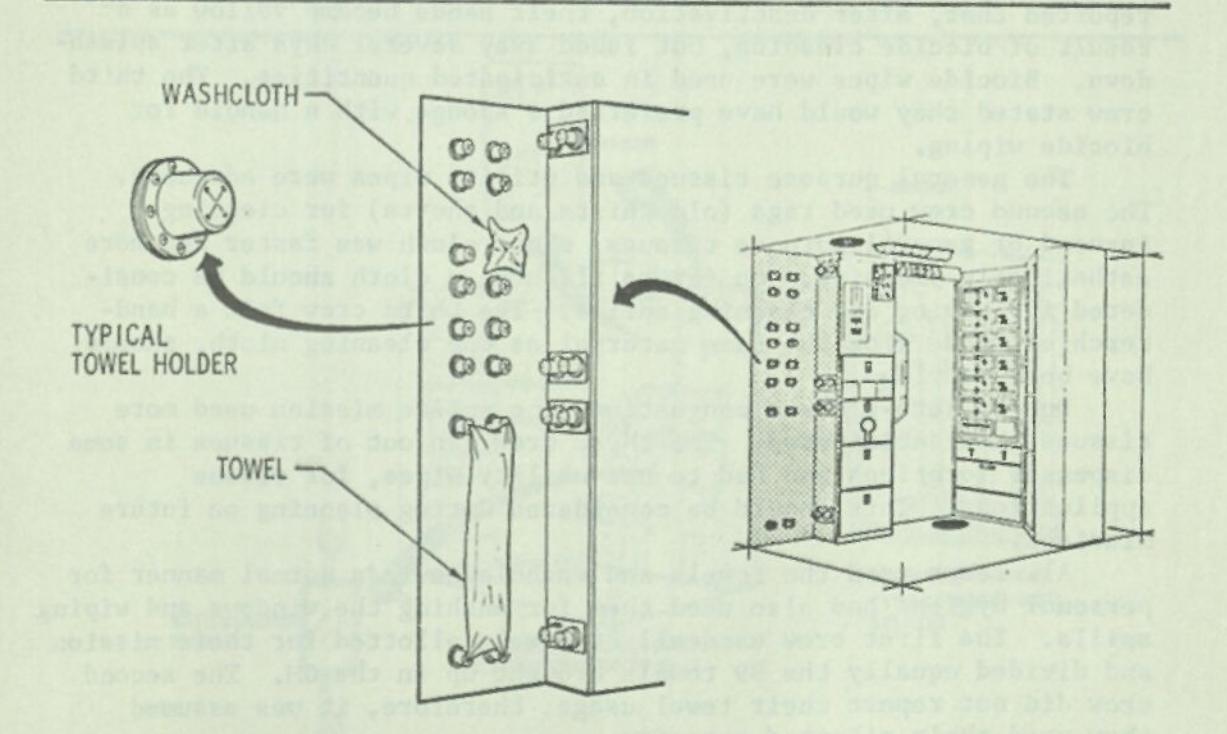
Figure 46. Washcloth/Towel Drying Area

The drying station provided a convenient and effective means of drying the towels and washcloths. The only problem reported was that the towels had a tendency to float away from the wall into the work areas if they were restrained at a single point (one corner). The third crew felt the restraints were too crowded. There was no report of having used the portable towel holders. The restraint approach should be standard equipment on future missions for towel and washcloth drying as well as a general fabric restraint.

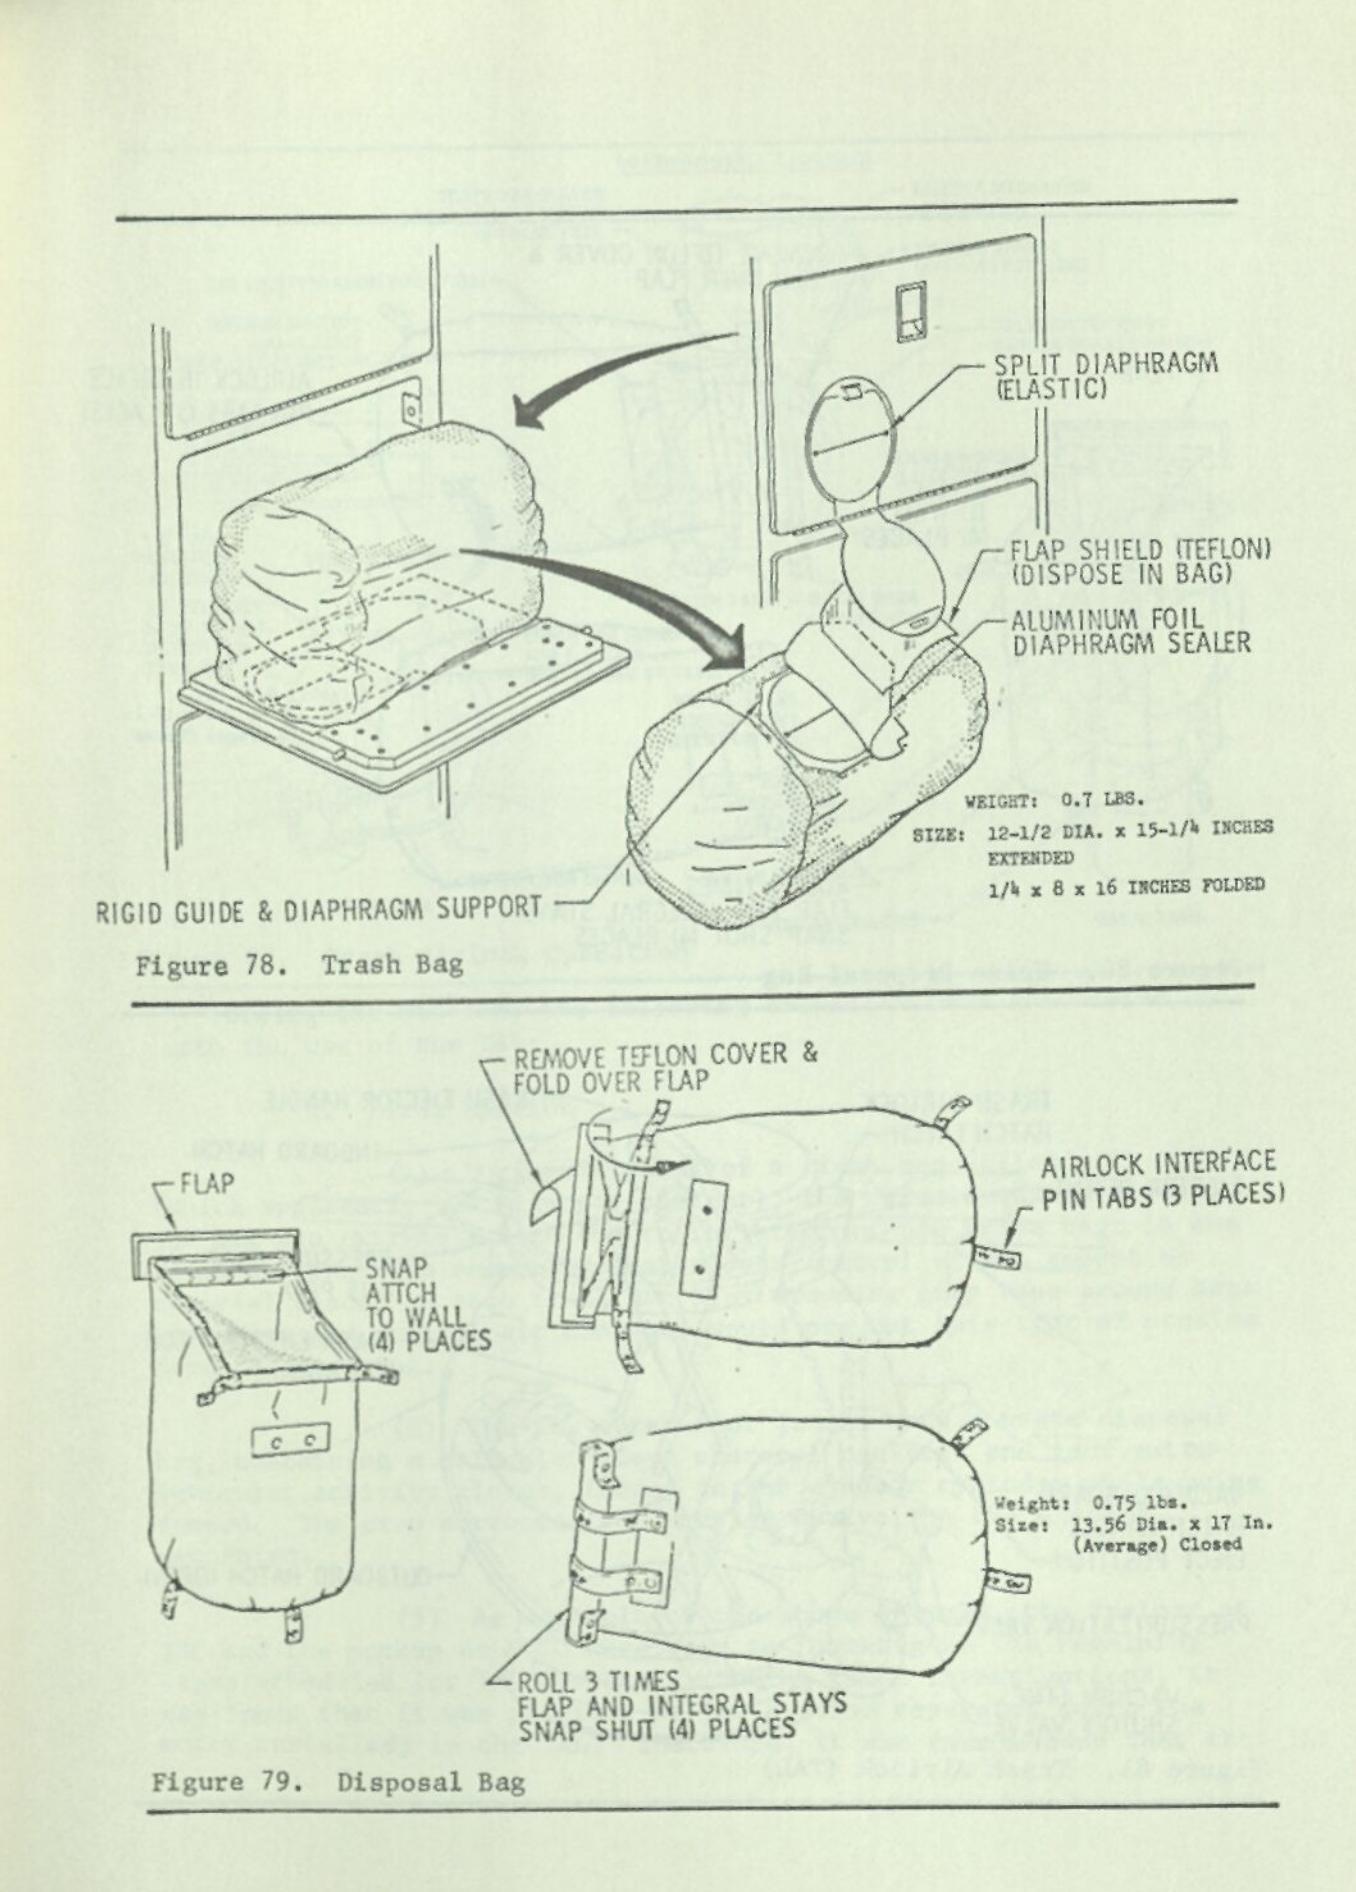
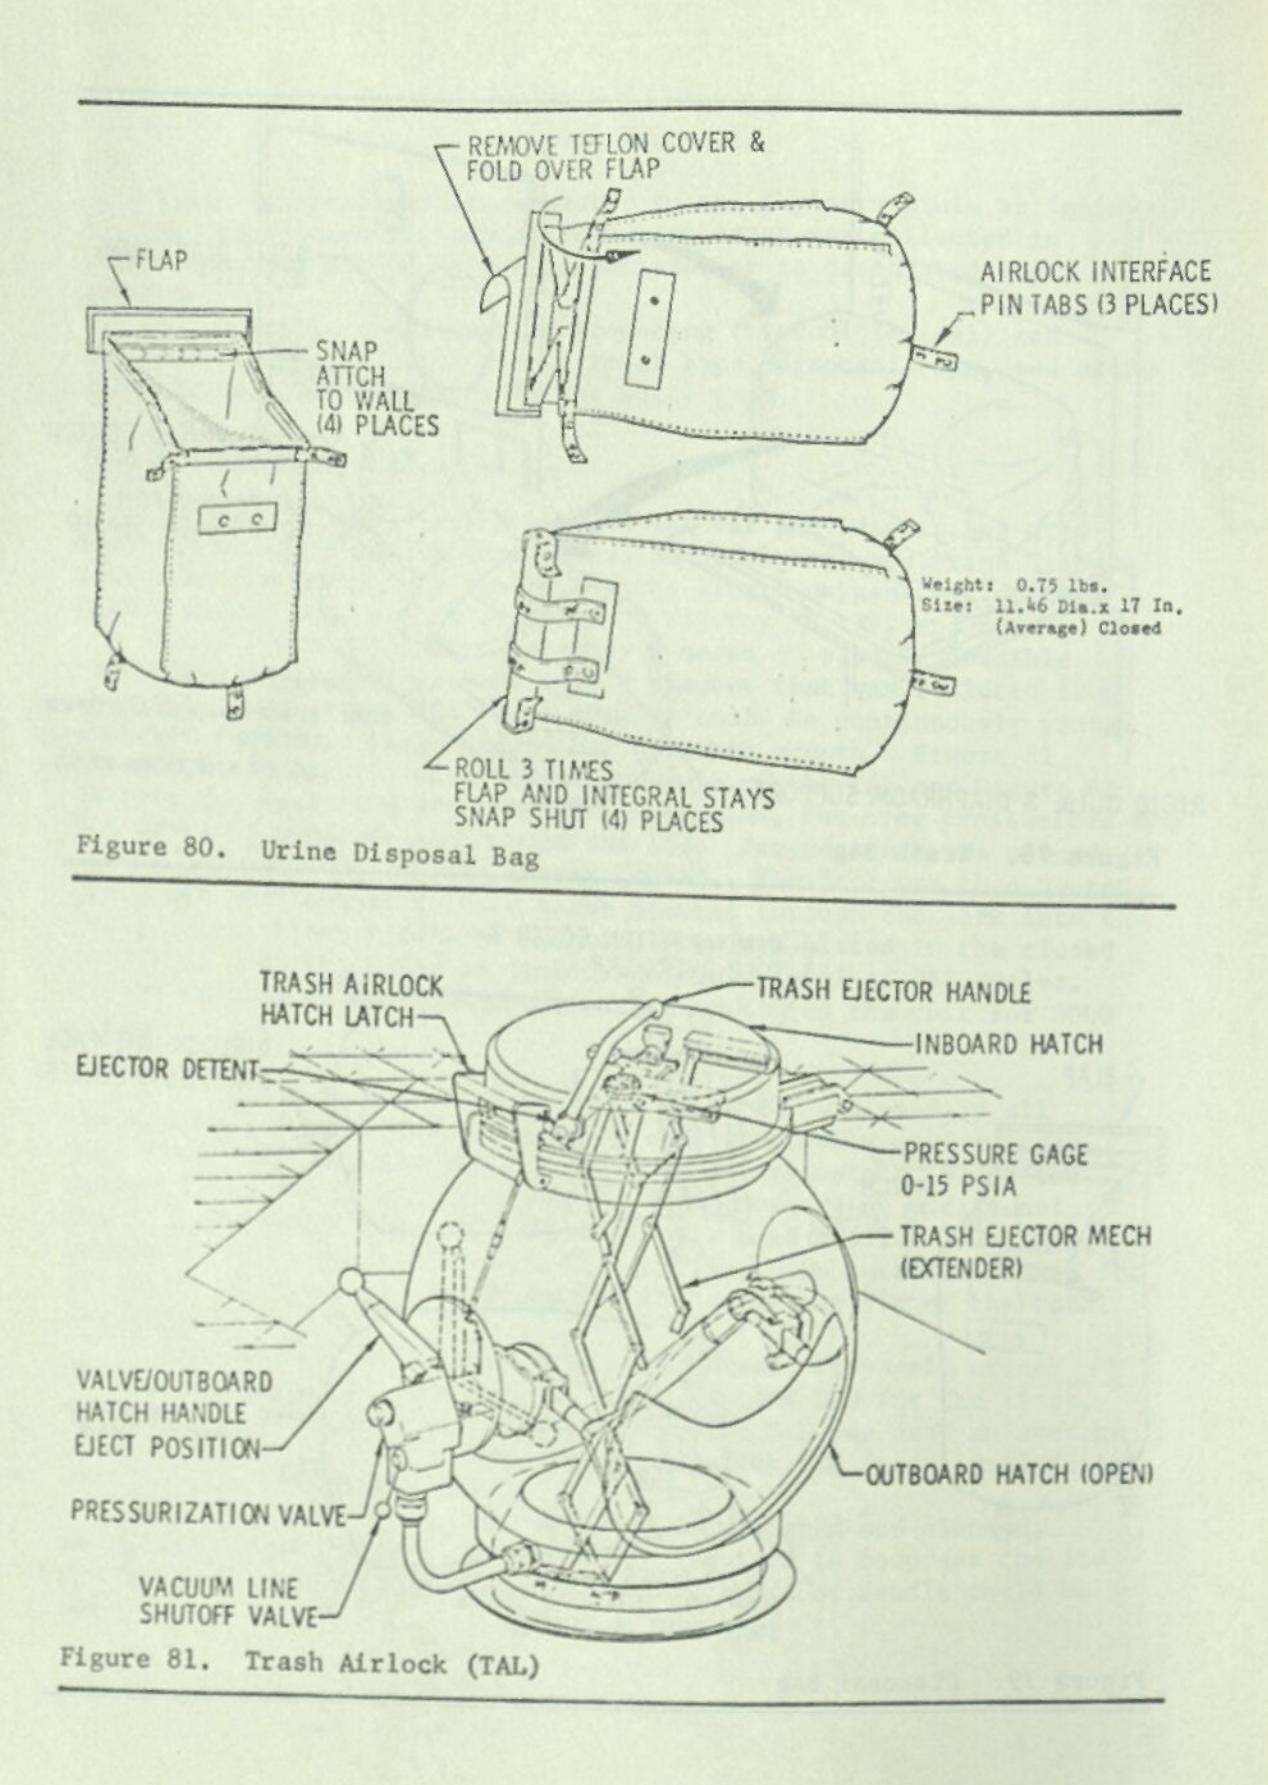
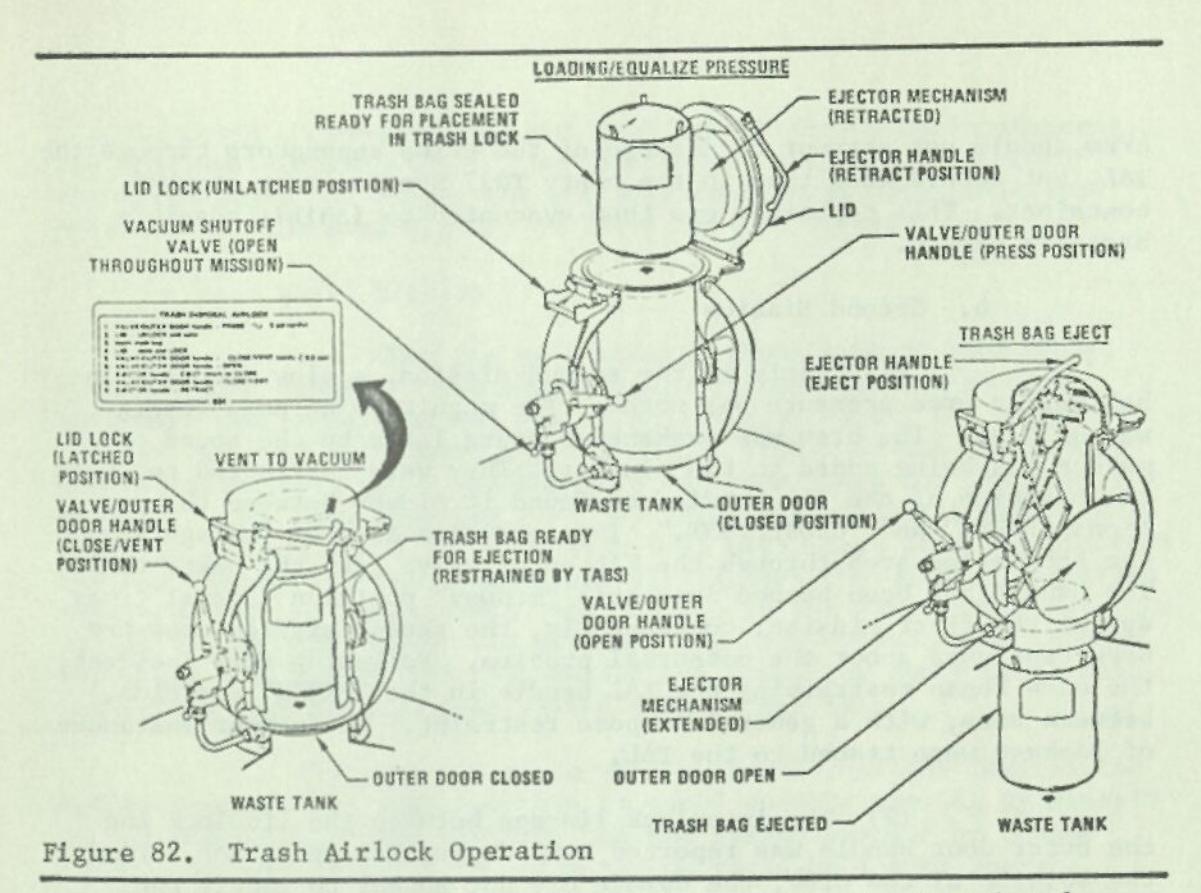
The TAL, in general, was operated as designed and planned. On occasion, excessive crew effort was required to compress the lid O-Ring and disengage the interlock before the door handle could be moved.

(2) The interlock linkage between the lid lock and the outer door handle was reported bent during TAL operation. In the opinion of the crew, the damage did not appear to impair the operation of the TAL or compromise the safety of the procedure. This opinion was confirmed by ground tests. It was not clear, even after the Second Mission Crew Technical Debriefing, whether the lid closing and locking force had increased. The force required to compress the 0-ring sufficiently to disengage the lid-to-latch interlock, so that the lid lock may be latched, had always been marginal for one man in zero gravity. The recommendation was made for the third crew to deactivate the lid-to-latch interlock by taping. This reduced the seal compression, and therefore the closing force required, prior to latching.

Very little additional risk resulted from this interlock deactivation. An assessment was made, using the mission support TAL, to determine the cause of the interlock rod damage. It is believed that the bent rod was a result of operating the lid latch while the outer door handle was in the wrong position. This situation would have caused the interlock rod to experience high compression loads and possibly cause a slight bow (permanent set). Video tapes confirmed that the bend was minor and no loss of interlock function was involved. Additionally, the interlock rod had no effect on the amount of force required to operate the lid latch.

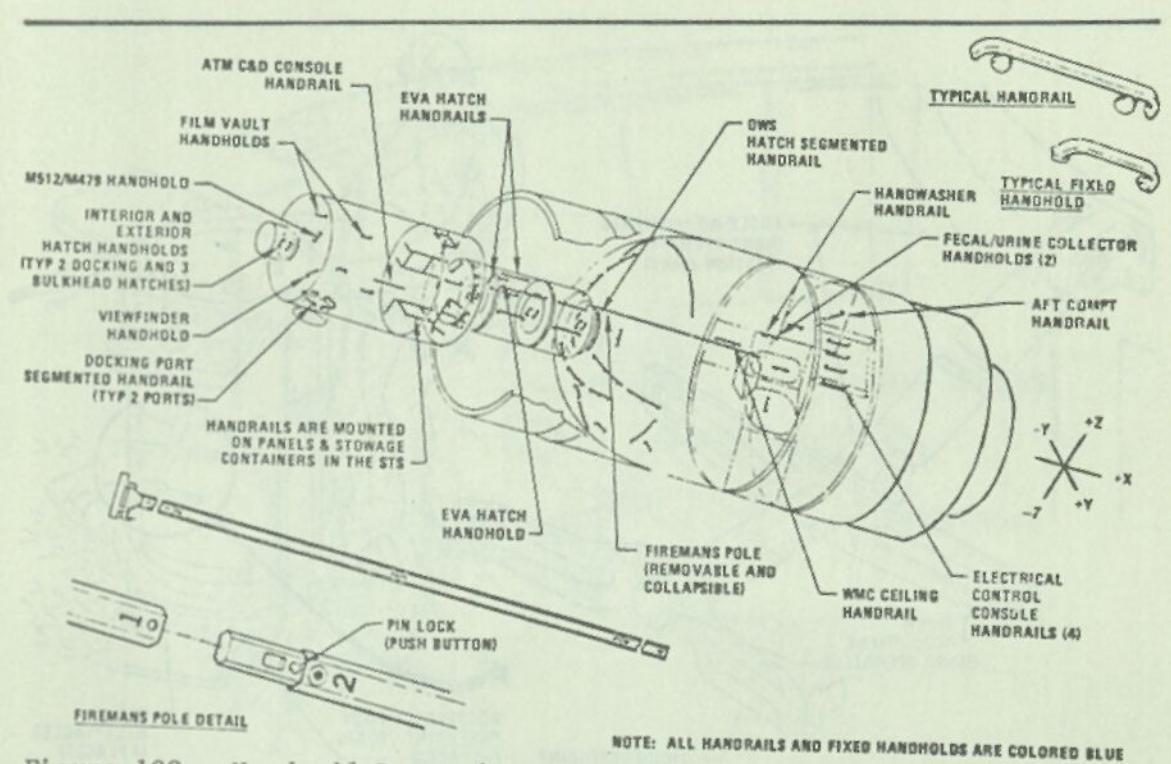
Figure 100. Handrail Restraints

(3) Fireman's Pole - The crews found this item to be useful and, at times, preferred it over the flexible strap. Due to the pole rigidity, they could grab it and change direction easily and more accurately than with the flexible strap. The only objections were that: a) it was possible to cut one's hands on the attachment roll pins, and b) the pole tended to rattle loudly when impacted, disturbing crewmen attempting to sleep.

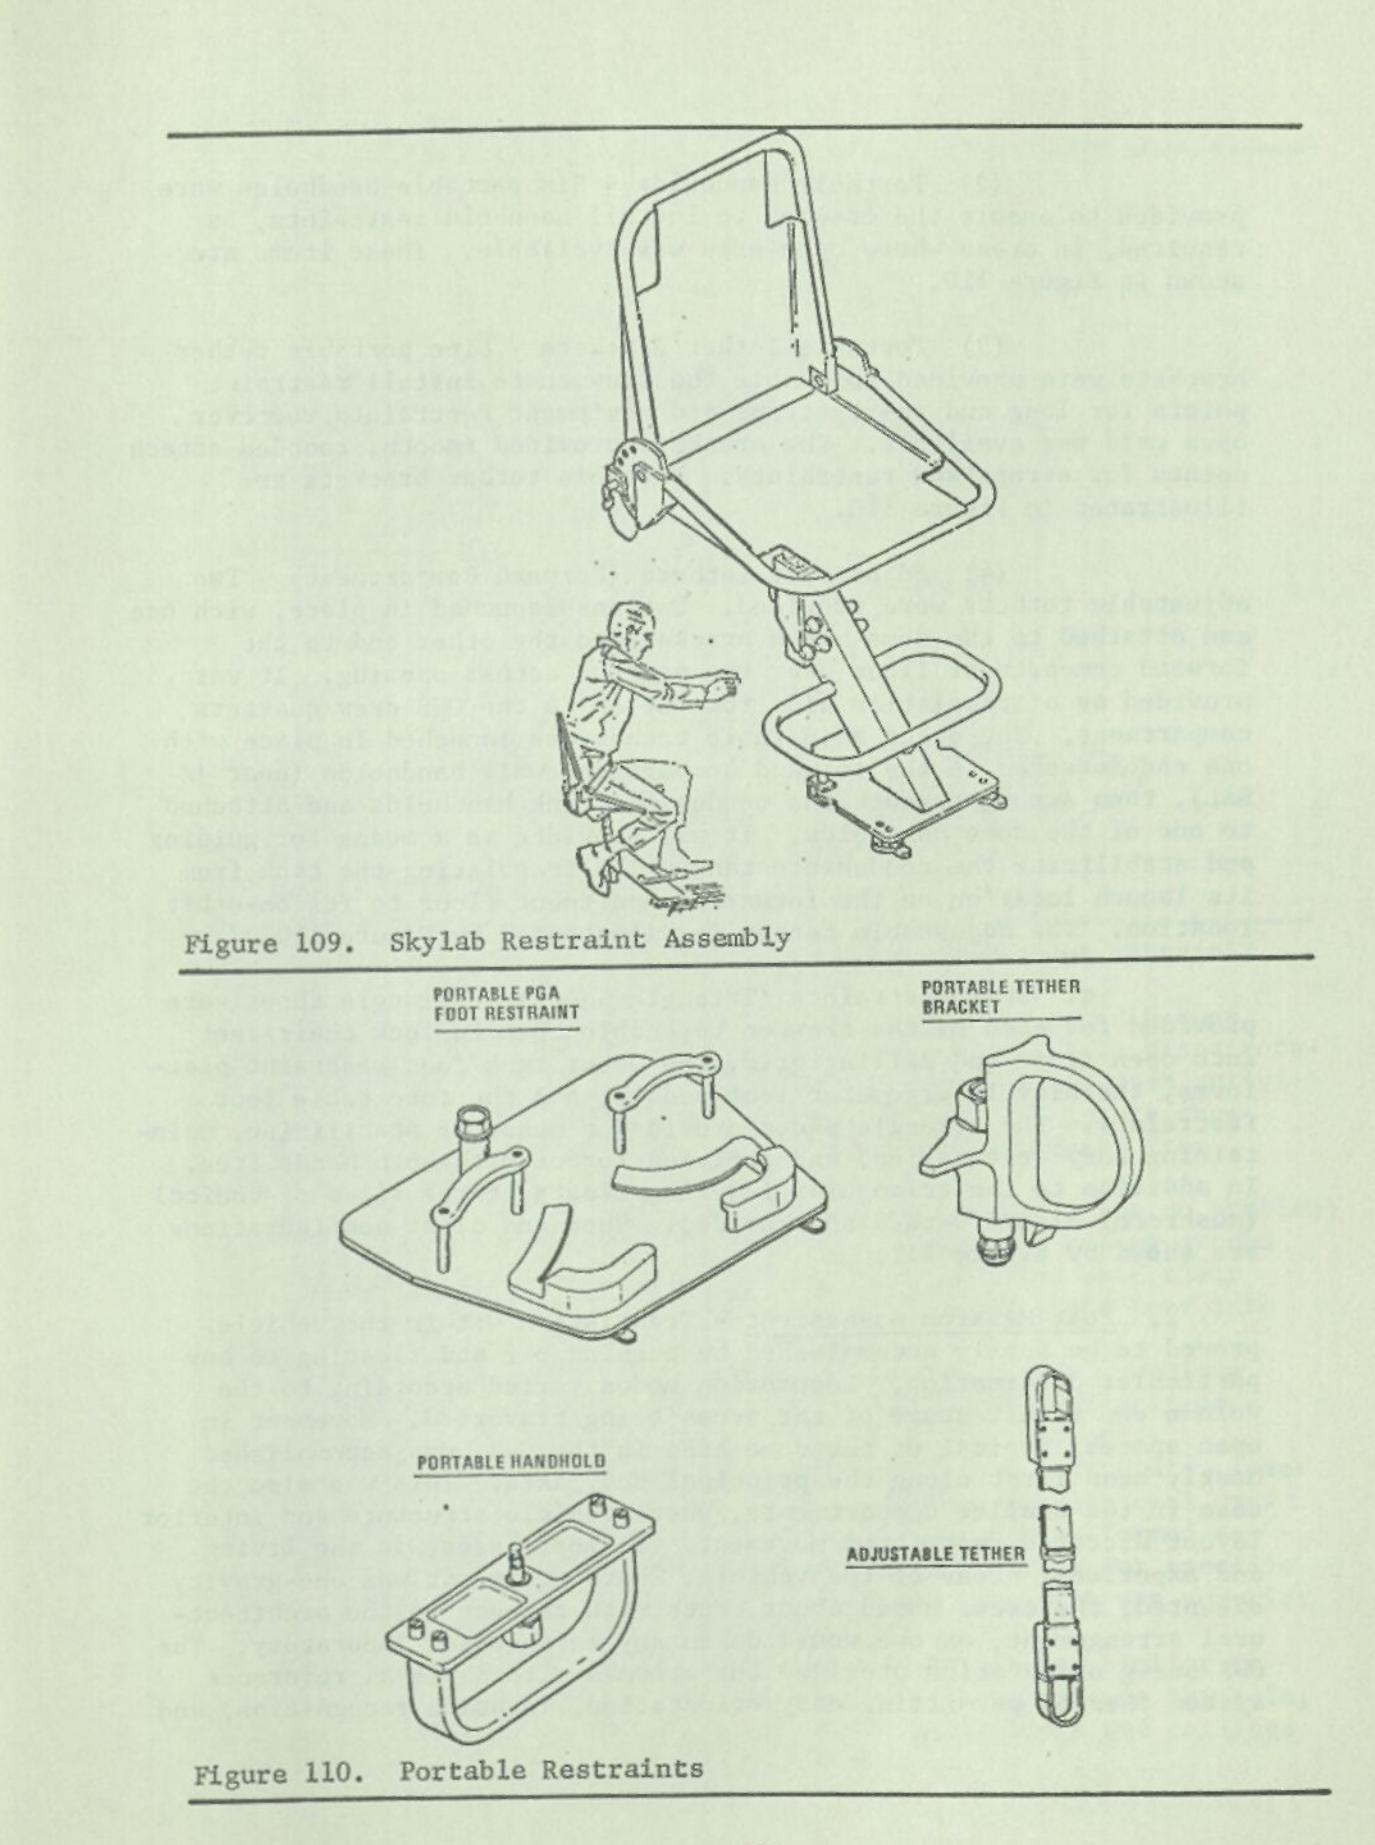
(1) Portable PGA Foot Restraints - These restraints: were successfully used by all the crews in a normal manner for suit donning/doffing, suit drying, and during EVA; were assessed as functioning satisfactorily; and were considered to be a firm requirement. One of the PGA foot restraints was modified for the Twin-Pole Sail Deployment EVA by removing the two pip pins. These pip pins, installed to keep the feet in and keep the PGA's located by themselves during suit donning and drying, worked satisfactorily. It should be noted that the third crew rated the suit donning task as being 3-4 times more difficult in zero-g than in one-g.

(2) Portable Handholds - The portable handholds were used in the vicinity of the bicycle ergometer when the first crew rode the ergometer. The second crew used the portable handholds for stability when performing the soaring mode of TO13. During the first mission, two portable handhold attachment devices (astropins) were broken. Neither the second nor third crew reported any anomalies; however, both crews felt that the portable handholds were not required.

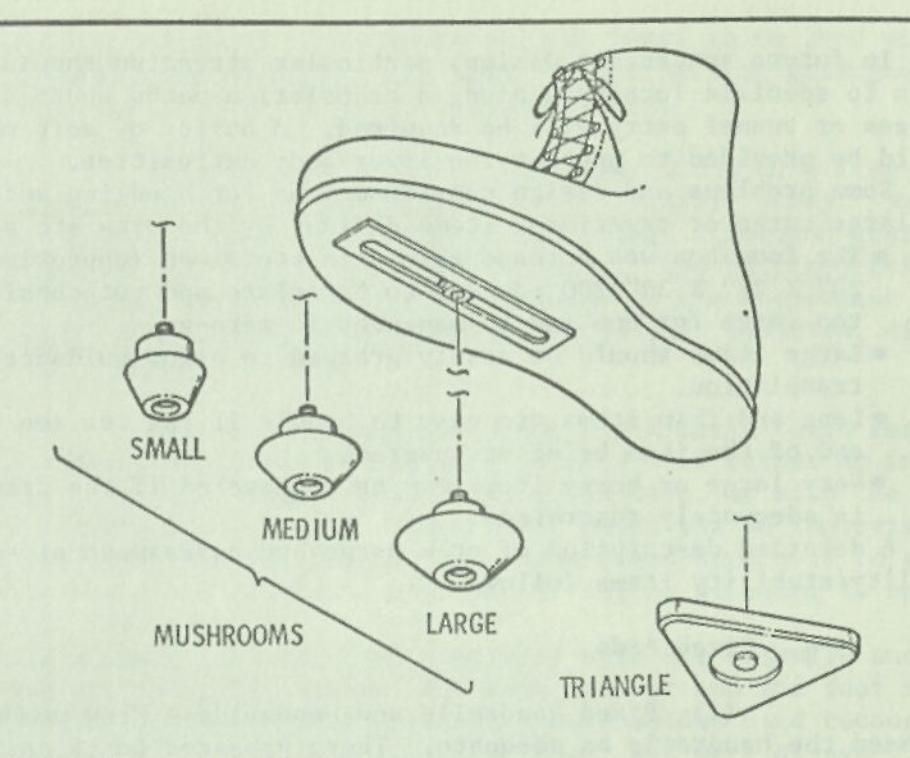
### Figure 111. Shoe Restraints

c. Shoe Restraints (Triangle Shoes) - Triangle shoes were provided for each of the crewmen to enable them to lock their feet into open floor and ceiling grid, the water tank foot restraint platforms, the bicycle ergometer foot pedals, and the food table foot restraints. The triangle shoes provided a means of stabilizing, maintaining body orientation, and applying forces with both hands free. In addition to the triangular indexing cleats, three sizes of conical (mushroom) cleats were also provided. Shoe and cleat configurations are shown by Figure 111.

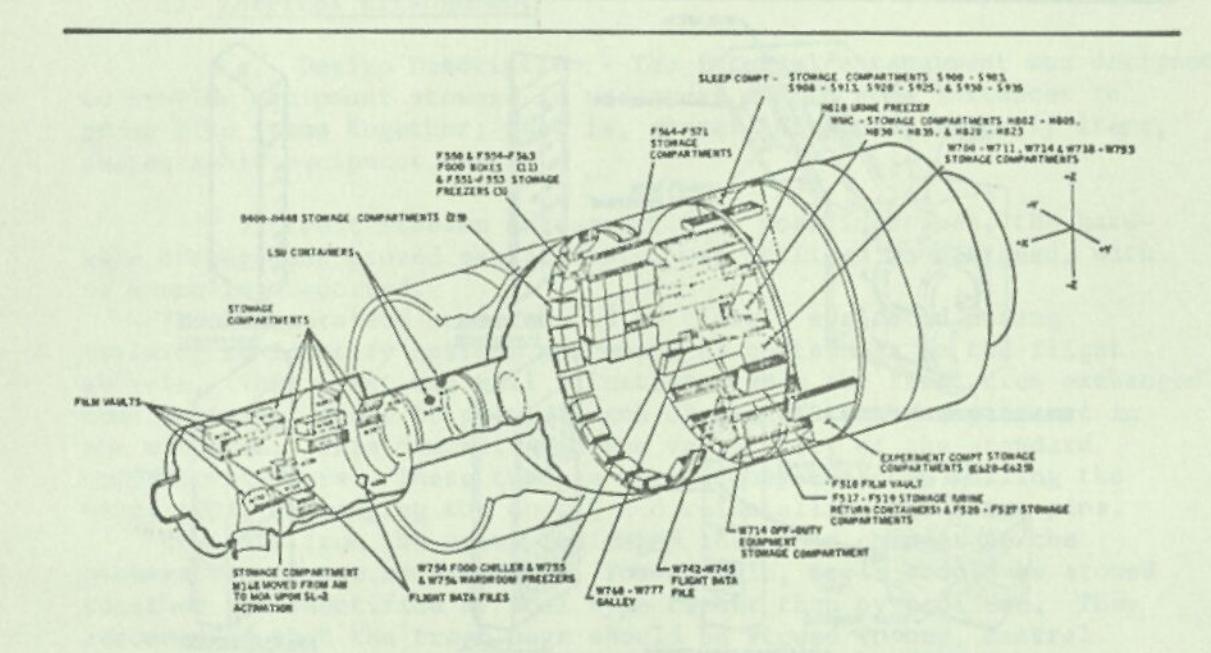
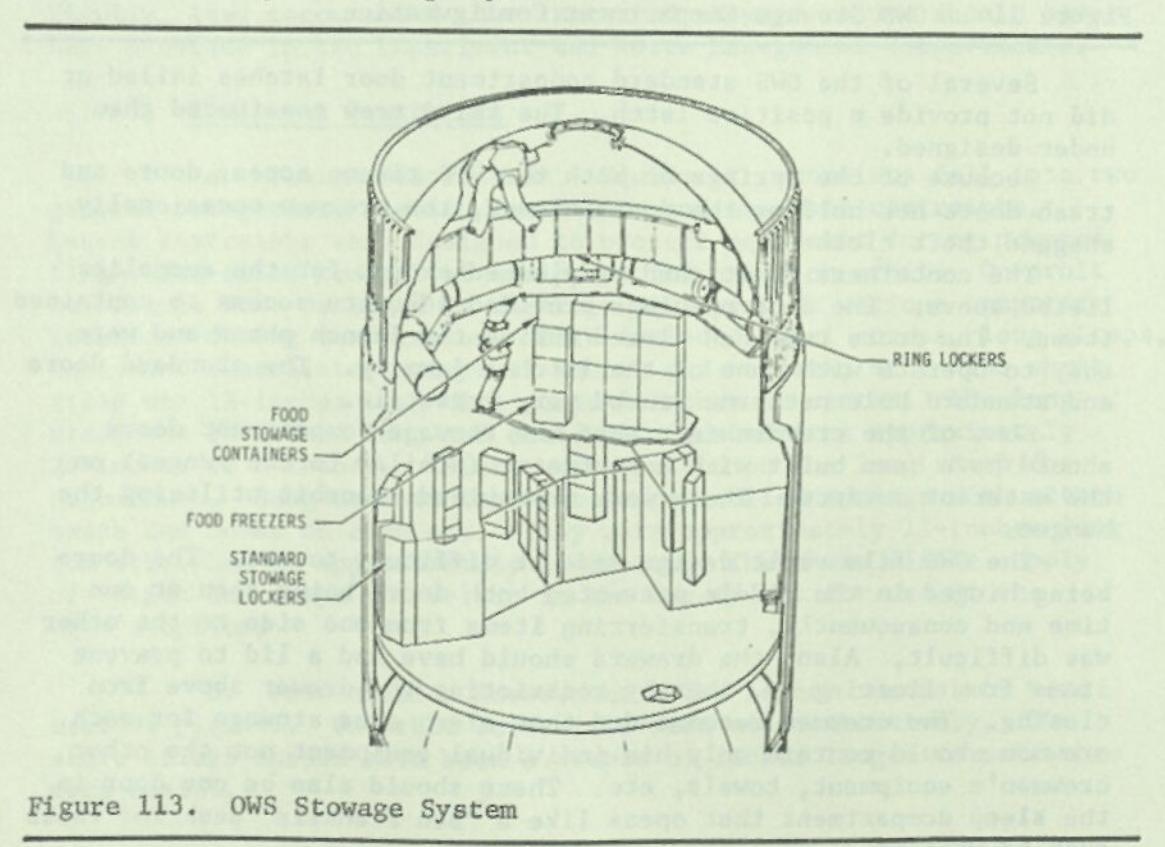
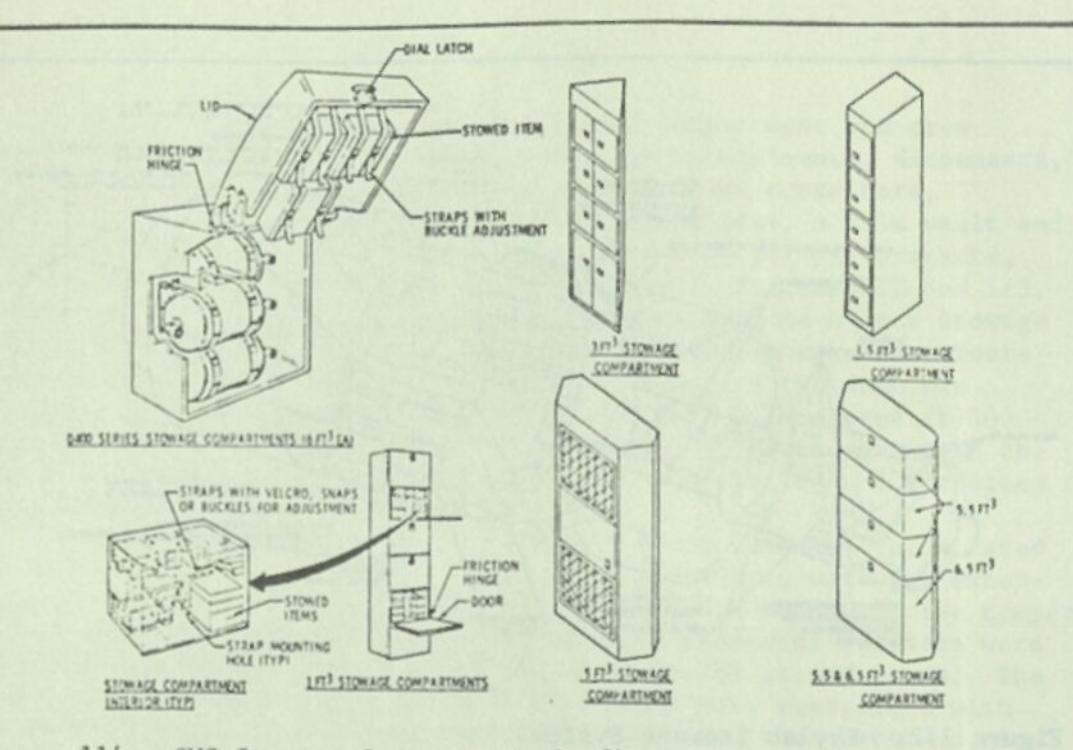
Figure 114. OWS Stowage Compartment Configuration

b. Post Mission Assessment - The third crew reported that the OWS film vault door latches did not function properly. Instances were cited where the right-hand door would come ajar when the lefthand door was closed.

Several of the OWS standard compartment door latches failed or did not provide a positive latch. The third crew considered them under designed.

The OWS film vault design made it difficult to use. The doors being hinged in the middle prevented both doors being open at one time and consequently, transferring items from one side to the other was difficult. Also, the drawers should have had a lid to prevent items from floating up, thereby restricting the drawer above from closing. The crewnen recommended that sleep area stowage for each crewman should contain only his individual equipment not the other crewman's equipment, towels, etc. There should also be one door in the sleep compartment that opens like a "Ben Franklin" desk for tasks such as writing.

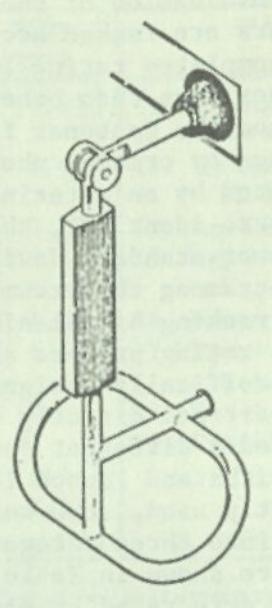
Figure 115. ATM VC Film Access Door

In addition to the fasteners in Table 11, two latches were provided outside the vehicle on the film access doors of Apollo Telescope Mount (ATM) for use during Extravehicular Activity (EVA). The center work station (VC) access door latch, Figure 115, functioned adequately but was criticized by the crewmen because its operation (push-to-open, pull-to-close) was opposite of that normally expected. It is noted, also, that a separate lock was required for launch.

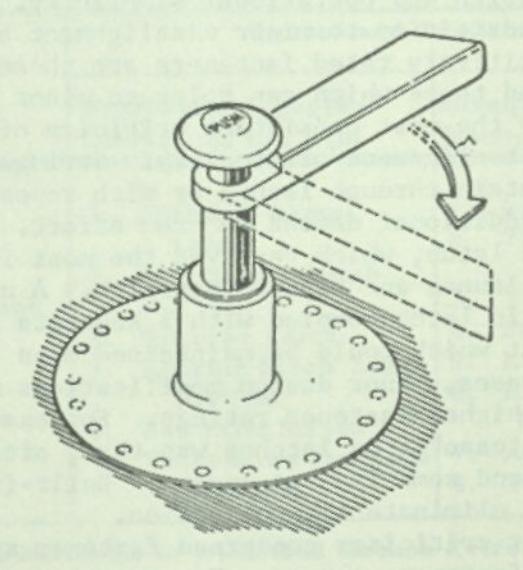
Figure 116. ATM VS Film Access Door Lock

The Sun End Workstation door latching mechanism, Figure 116, combined launch restraint and orbital operation in the same mechanism. Its orbital operation as a door lock was excellent. It also served as a handhold when in the locked position.

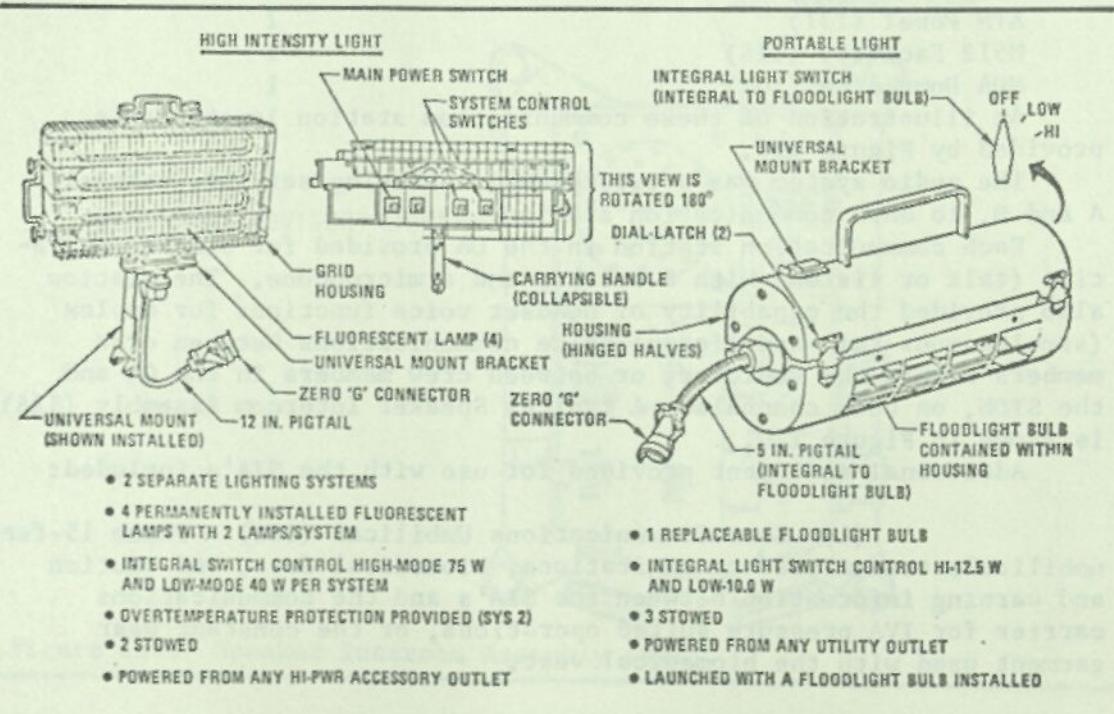
Figure 118. Portable Lights

b. Post Mission Assessment - The crew reported that they made considerable use of portable light by attaching it to the universal mount and then attaching the mount to various structural members. The portable light performed as designed; however, the crews remarked that cable management was the biggest single problem when using this light. They felt cable reels were needed as were more and better cable tiedowns.

The high-intensity lights were used as planned and met all requirements. Prolonged use of the high-intensity light in certain areas resulted in locally elevated temperatures

There were no reported bulb replacements associated with these lights.

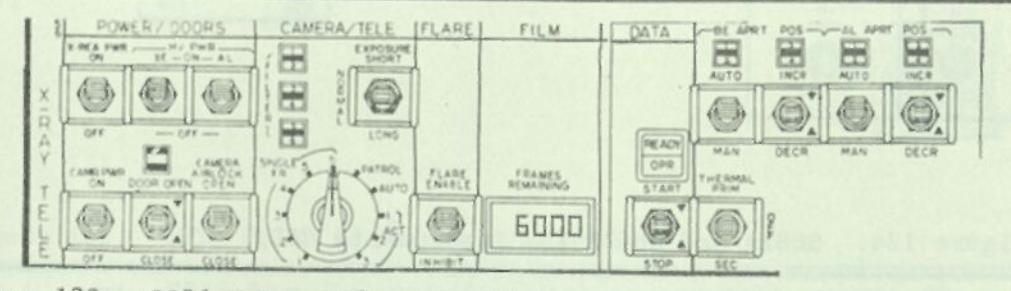
## Figure 123. S056 X-Ray Telescope C&D

b. S056 X-Ray Telescope - The S056 experiment, Figure 123, had certain internal hardware design problems; the "active modes" took an additional frame, or timed out longer than specified. This

created certain interface problems with other experiments in relation to the total time required for a particular operating set of experiments. The controls and displays allocated to the S056 experiment appeared functionally adequate, and no sequential operation problems occurred. The only area which might have been improved was the separation of functions allocated to the X-Ray Event Analyzer portion of the panel and the experiment area.

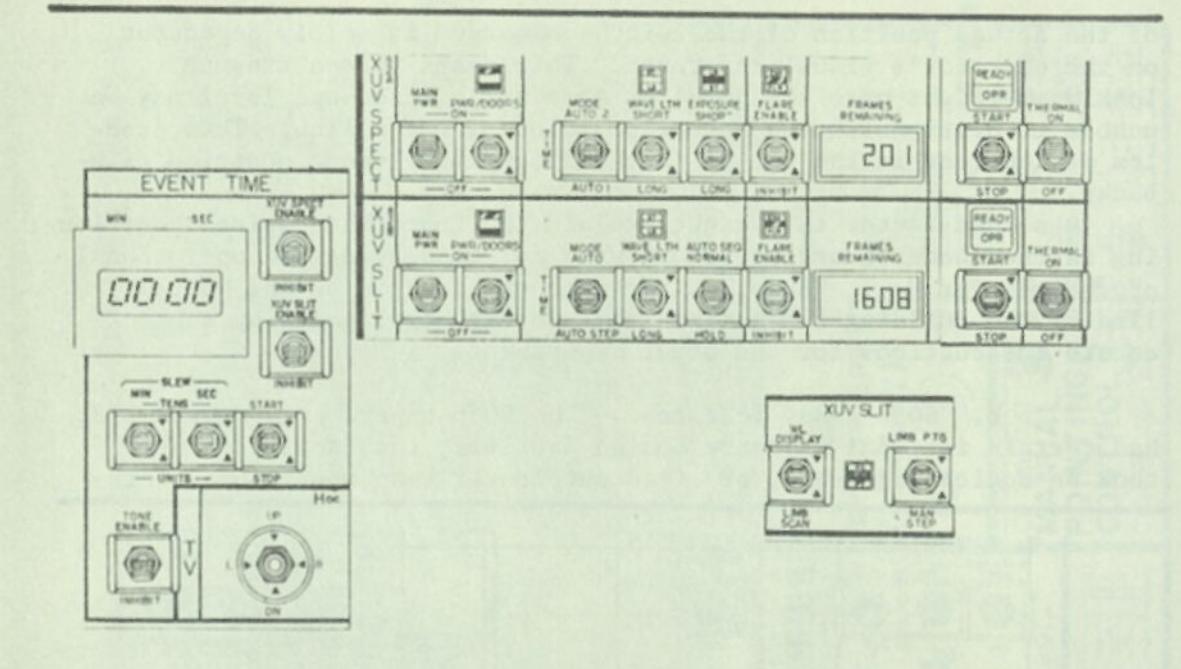
Figure 124. SO82A and SO82B XUV Instruments C&D

c. S082A XUV Spectrograph (Extreme Ultraviolet) and S082B Extreme Ultraviolet (XUV) Slit - The reason for combining discussion of these experiments is that most of the problems associated with them resulted from the similar appearance of the two (Figure 124), thereby creating many points of confusion. Indeed, in some areas on the control panel, there is a one-to-one switch correspondence -- a reasonable causal factor for error. For example, the crew would often set up an operational sequence correctly on one of the experiments but would then activate the START switch on the other experiment.

The failure of the S082B experiment timer function during the Skylab Mission required the addition of an auxiliary timer. The timer consisted of a MODE SELECT switch, a START/STOP switch, and a READY/ OPERATE light. The timer was very similar in purpose to the S054 experiment but differed functionally because of the interconnection

with the ATM electronics power distributor located in the ATM console. The interconnection between the ATM and the auxiliary timer involved the making of two electrical connections. The crew was able to perform this using connector pliers contained in the on-board tool kit. The auxiliary timer was affixed to the top of the ATM console and operated satisfactorily during the entire Skylab Mission. The crew incurred no significant interface problems with the exception of the reach distance between the two modules.

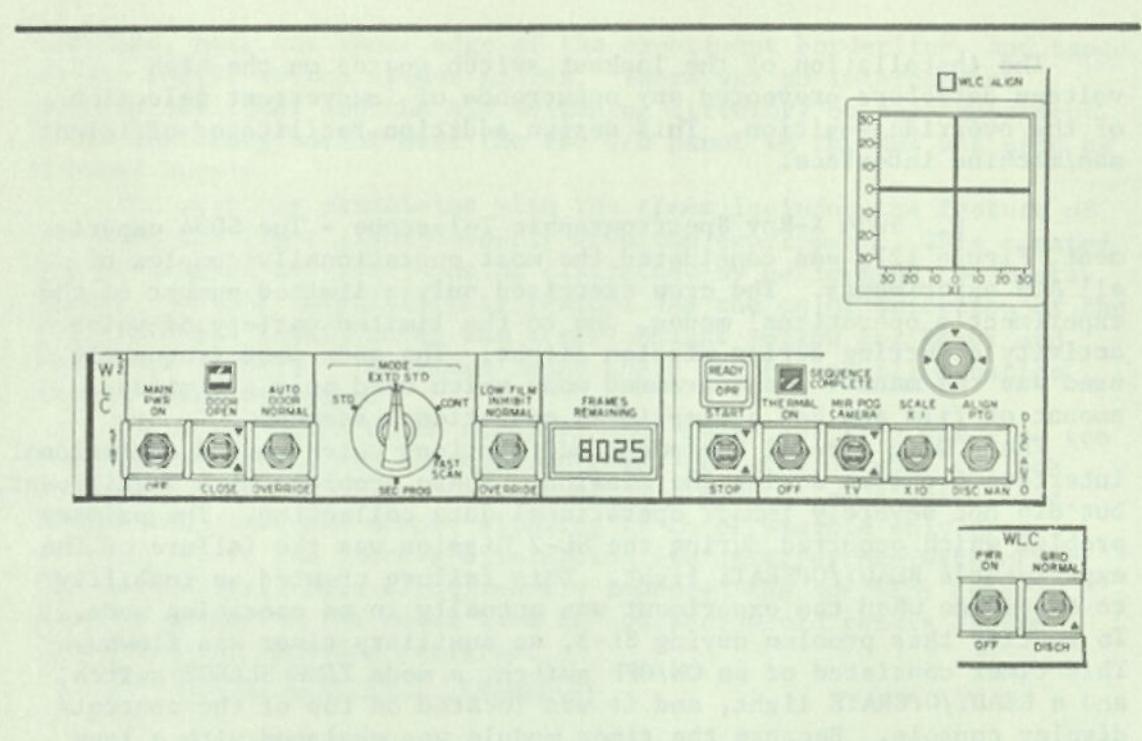
Figure 125. S052 White Light Coronagraph C&D

d. S052 White Light Coronagraph (WLC) - From its original design, the S052 experiment, Figure 125, had one inherent man/system interface problem associated with the READY/OPERATE light. The indication for an operate condition was only given after the completion of the first frame ( $\approx$ 10-15 sec). The null state before this illuminated condition served to indicate that the experiment was in an off condition, which, if the crewman were not paying close attention, could be very confusing.

The second problem area on S052 involved the procedural step of turning off the S052 WLC TV power before closing the aperture door. The crewman often forgot to perform this function (which was not required during nominal experiment operations). Althought this error was made on several occasions by the crew, no irreparable damage was done to the WLC vidicon from exposure to direct sunlight. For future designs, however, when this type of oversight must be prevented, a mechanical or electrical interlock is desirable. Reliance on crewman memory of procedures is not a dependable preventive measure.
