August 1974

# NASA TECHNICAL MEMORANDUM

NASA TM X-64825

MSFC SKYLAB CREW SYSTEMS MISSION EVALUATION Skylab Program Office

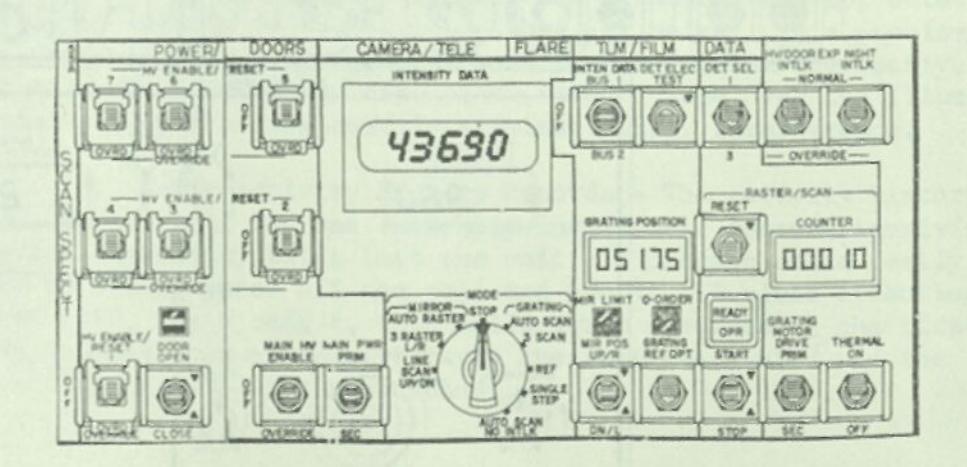
Figure 126. S055 Scannin; Spectroheliograph C&D

e. S055 Scanning Polychromator Spectroheliograph - There were no major problems in performance of the S055 experiment, Figure 126, with the unimportant exception that the crew frequently allowed the experiment to collect data past the appointed building block end times. As this instrument had no limit on film, however, this overrun factor was not significant, as long as it did not impact the overall timeline.

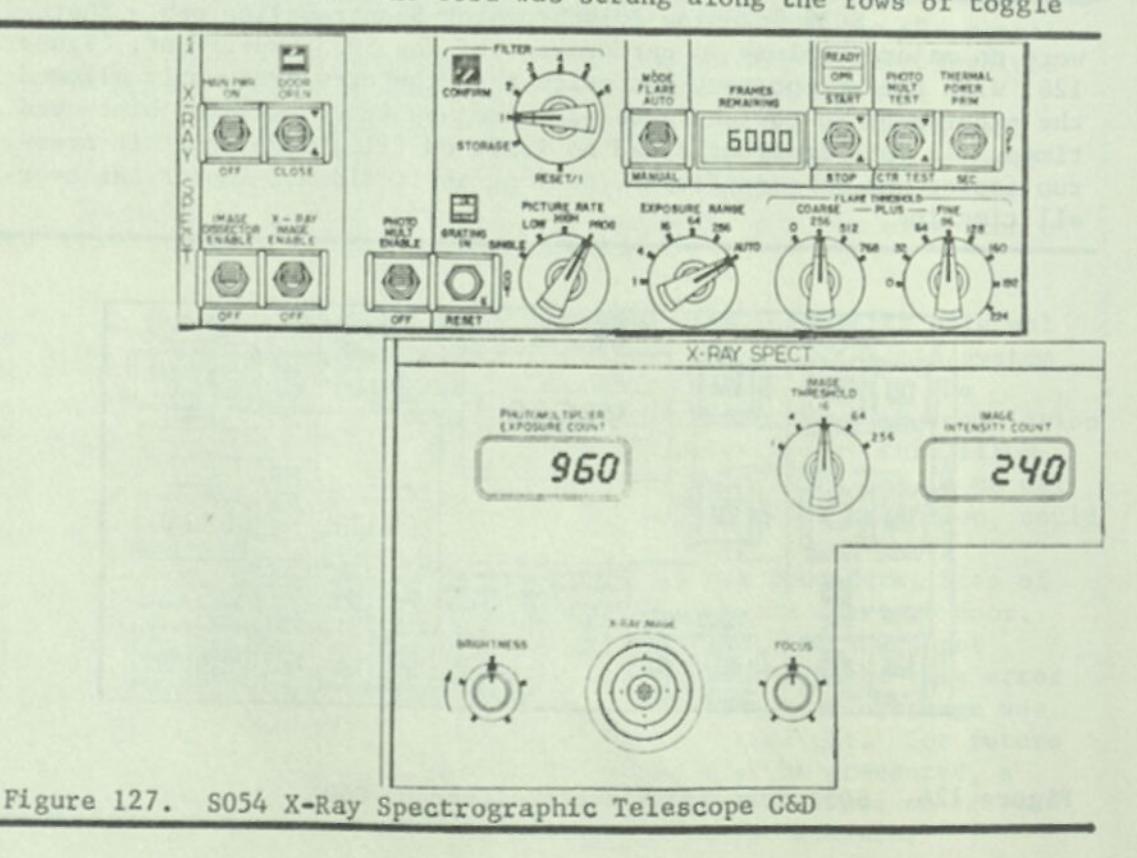
f. S054 X-Ray Spectrographic Telescope - The S054 experiment, Figure 127, was considered the most operationally complex of all ATM experiments. The crew exercised only a limited number of the experiment's operational modes, due to the limited variety of solar activity occurring during mission flight. The mode most frequently used was the manual preprogrammed mode which used only a limited amount of film and had a simplified operational sequence.

There were several equipment malfunctions which caused operational interface problems during the mission. These problems were significant, but did not severely impact operational data collection. The primary problem which occurred during the SL-2 Mission was the failure of the experiment's READY/OPERATE light. This failure created an inability to determine when the experiment was actually in an operating mode. To rectify this problem during SL-3, an auxiliary timer was flown. This timer consisted of an ON/OFF switch, a mode TIME SELECT switch, and a READY/OPERATE light, and it was located on top of the control/ display console. Because the timer module was equipped with a long electrical extension, the SL-4 crew was able to affix it adjacent to the START/STOP switch. The cord was strung along the rows of toggle

switches, near the inner edge of the experiment borderline, and taped to the toggle switch wicket guards. There was no interconnect between the timer and the ATM switching circuitry or the experiment. A 28V auxiliary outlet next the the C/D panel in the MDA was used as a power supply.

The problems associated with the timer included the feature of starting the timer simultaneously with the experiment. This created the problem of the crew's being distracted by performing two operations. Another unsatisfactory feature was the color selection of the REA DY /OPERATE light, which was a very bright yellow for READY and white for OPERATE. The crews found these colors and illumination levels quite annoying.

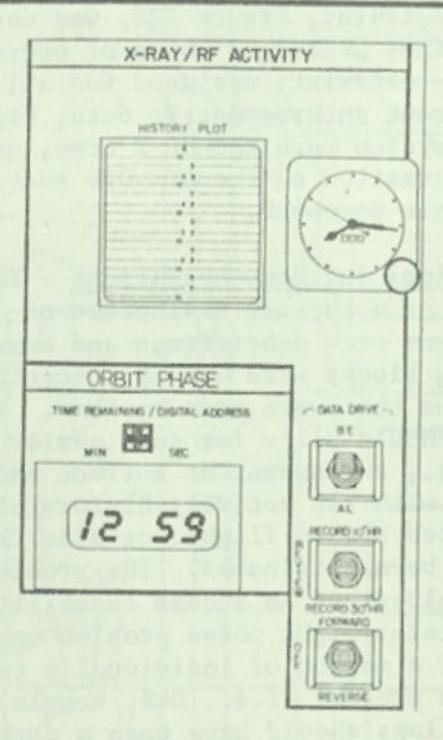
Figure 130. ATM X-Ray History Plotter C&D

b. X-ray Activity History Records - The activity history plotter, Figure 130, had one extremely undesirable feature involving the review capability built into the unit. A crewman could easily run all the recording paper off the roll and jam it, if close attention were not paid. As a result, this malfunction occurred on the first mission and was irreversible, because the unit was sealed and the stuck mechanism could not be reached.

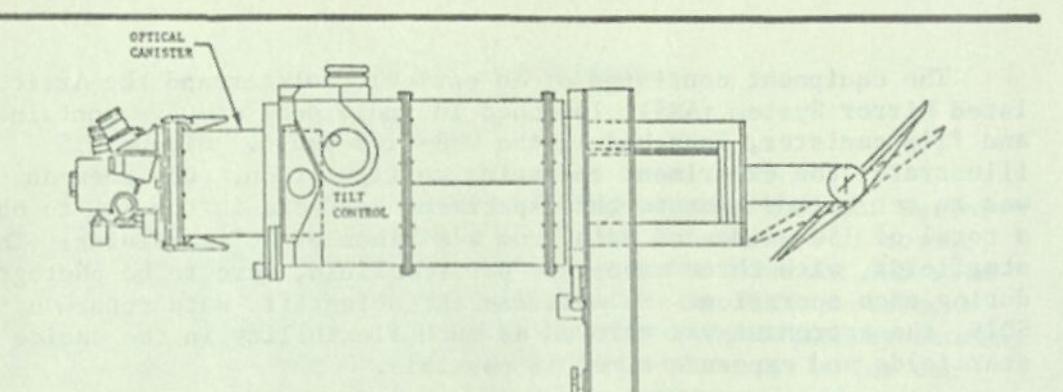
Figure 135. Experiment S019/Articulated Mirror Operating Configuration

During the repair of the AMS tilt mechanism, the mirror was inadvertently touched leaving a finger print on the mirror. At the request of the Principle Investigator (PI), no corrective procedure was implemented to remove the print in order to prevent possible additional damage to the mirror surface. Attempting to clean the mirror may have been more degrading to the mirror's viewing function than the fingerprint itself.

It was found, from the review of acquired data, that during performance of the S019 experiment, the system was extremely sensitive to motion and some blurs occurred on one S019 slide. It was felt that

this could have been caused when the canister was used as a writing surface. The PI requested that the S019 system not be touched when taking data. This was necessary for the acquisition of clear photography. The crew had no difficulties complying with this request except when opening or closing the shutter. At this time, momentary jiggling of the S019 system could not be prevented.

There was a continuous gradual degradation of the indicator on the rotation dials of the AMS. In addition to the luminescence coming out of the units digits, the crew reported they were experiencing slippage between the mirror rotation attitude control knob and the indication dial. The belt broke and the degree indicator did not move even though the crank was turning. No repair was attempted due to the radioactivity from the luminescence in the sealed dials. For all subsequent operations, the crew had to count the number of turns of the crank to determine the rotation settings. The TOO2 sextant was used to check misalignment of the mirror.

The repair work performed on the AMS tilt mechanism would have been aided by the addition of an Inflight Maintenance facility composed of a work bench and a high intensity light. An optics cleaning kit would have been valuable to remove the finger print contamination from the AMS mirror and should be provided on future flights.

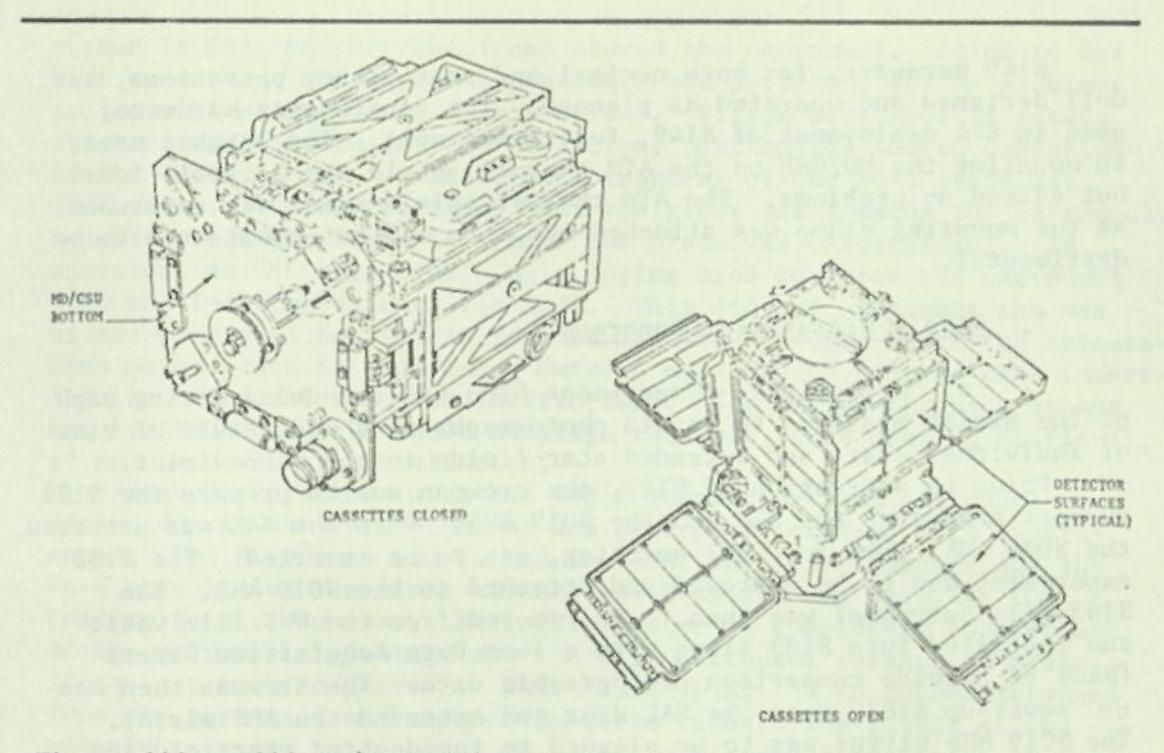
Figure 140. S149 MD/CSU With Detector Cassette Set, Operational Configuration

A problem was reported by the SL-3 crew during retraction of the SL-2 deployed S149 MD/CSU. During retraction the UXM rod tended to extend back out to space when released. The crew had to maintain a continuous retraction force on the UXM rod while the SAL door was closed (this involved a two-man effort). Once the SAL door was closed the final extension rod stopped about one-inch from full retraction and prevented engagement in the UXM capture latch. After allowing the system to warm-up, full retraction and engagement of the capture latch was accomplished. The TO27 UXM system canister containing S149 was then removed from the SAL, dismantled, and stowed.

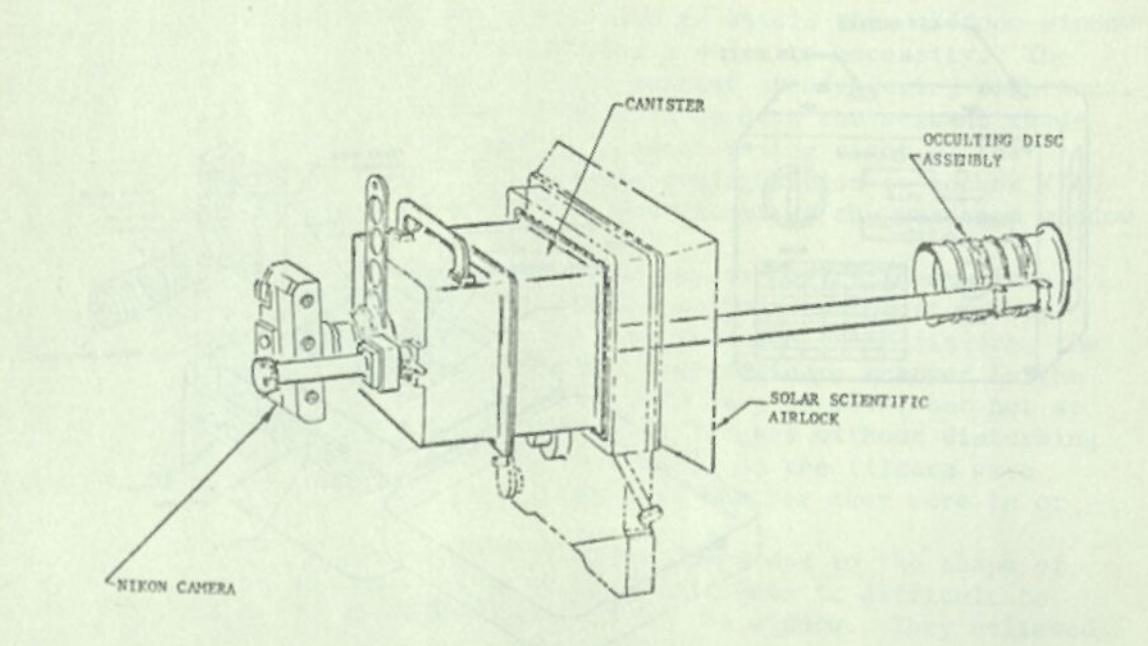
# Figure 145. T025 Experiment IVA Operational Configuration

b. Post Mission Assessment - T025 was not performed as scheduled because the solar SAL was used for deployment of the parasol thermal shield. All T025 operations were cancelled for SL-2 and alternate performance methods were developed. The SL-3 crew utilized

the T025 hardware to obtain some experiment S073-Gegenschein and Zodiacal light photography. The equipment was installed upside-down in the anti-solar SAL with the occulting disc positioned out of the camera's field of view. During this operation, the crewman used his finger to control the DAC shutter release. This proved to be difficult and fatiguing. In readiness for subsequent operations, the DAC was prepared for operation with the DAC push button cable. However, the crew was not directed to repeat the experiment.

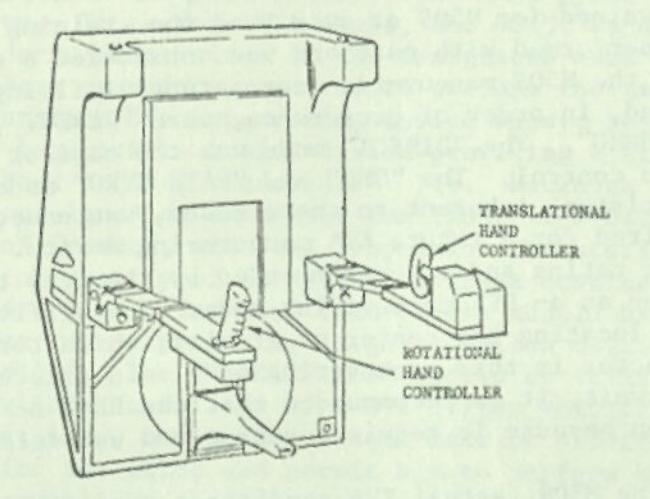
Figure 148. ASMU Operational Configuration

One modification was made to the planned M509 activities after the first suited performance. During this performance, the test pilot noted that the Life Support Umbilical (LSU) imparted undesirable dynamic forces on the ASMU during maneuvering. To reduce/eliminate these dynamic effects, the crew stripped the LSU of most of its wiring and insulation, leaving only the O<sub>2</sub> line and a communications line. This modified LSU was then used on all subsequent M509 and TO20 suited runs without utilizing the Secondary Oxygen Pack (SOP).

During an SL-4 suited run, battery problems arose causing the experiment run to be shortened. The batteries were being depleted much faster than anticipated due to time consuming delays during the test. One delay was experienced when the crewman encountered problems attaching the AM recharge station quick disconnect to the PSS bottle connector. Another delay was experienced when the SOP was depleted and had to be replaced by the LSU. During both these delays, the ASMU was on battery power thus draining the battery. These delays drained both M509 batteries to the 26-volt minimum and the M509 run was terminated after completing only 2/3 of the run's objectives. M509 was performed throughout the remainder of SL-4 and no anomalies were reported.

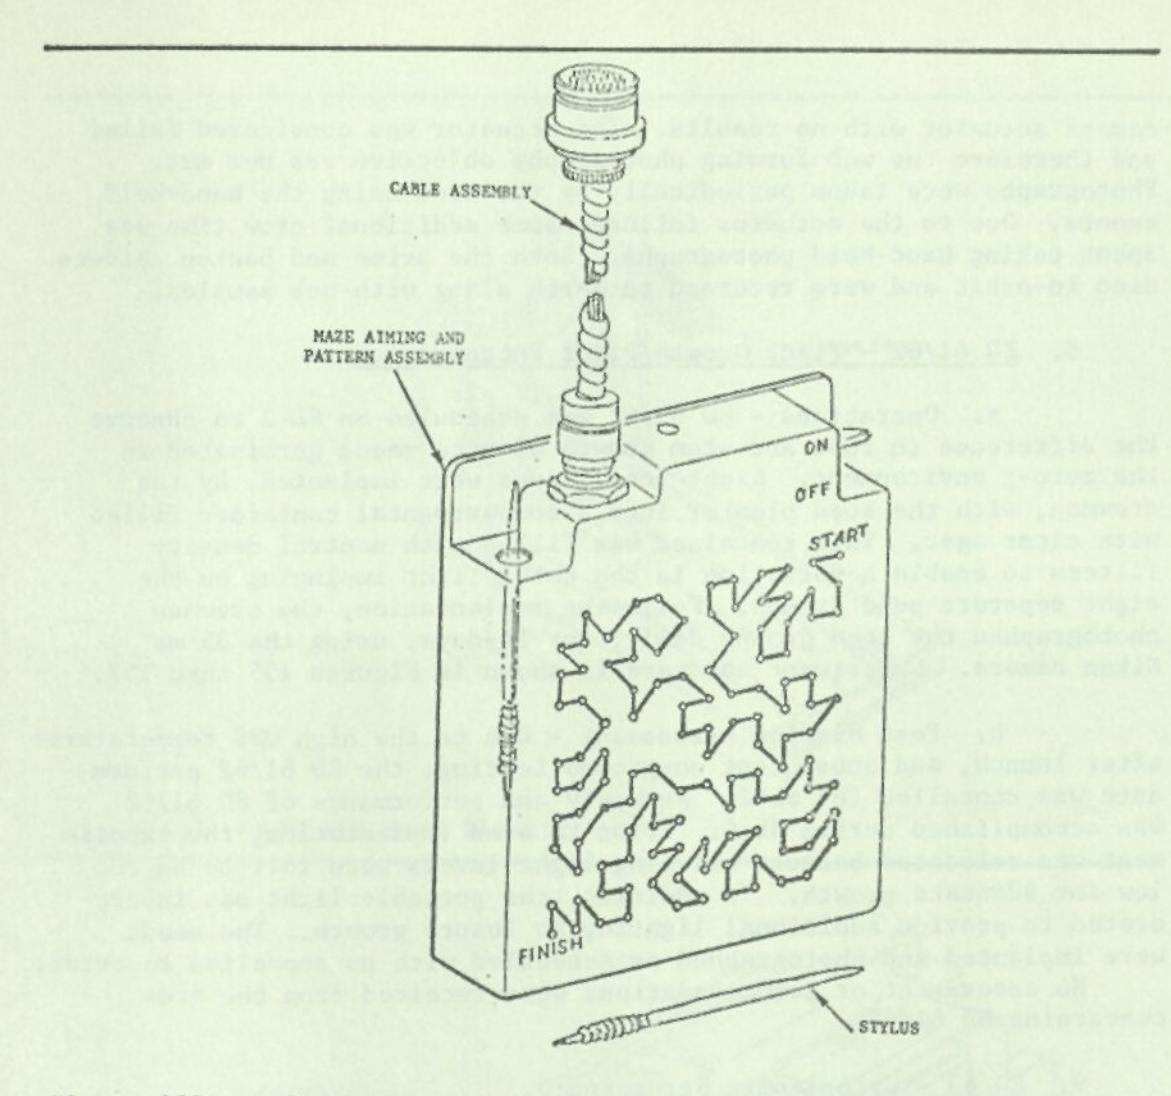
Figure 153. ED41 Experiment Configuration

The method of measuring motor sensory performance used in ED 41 was a standardized eye-hand coordination test using a maze with a 119-hole aiming pattern, stylus, and cable assembly as illustrated in Figure 153. During operation, the unit was attached to the wardroom window shelf by velcro strips and the cable was connected to the speaker intercom assembly connector. The experiment was performed once early and again late in the mission by the same astronaut. No activities, imposing either intense physical exertion or mental/ emotional strain, was to precede performance of the experiment. Inflight performance was compared with pre-flight and post-flight tests performed by the same subject.

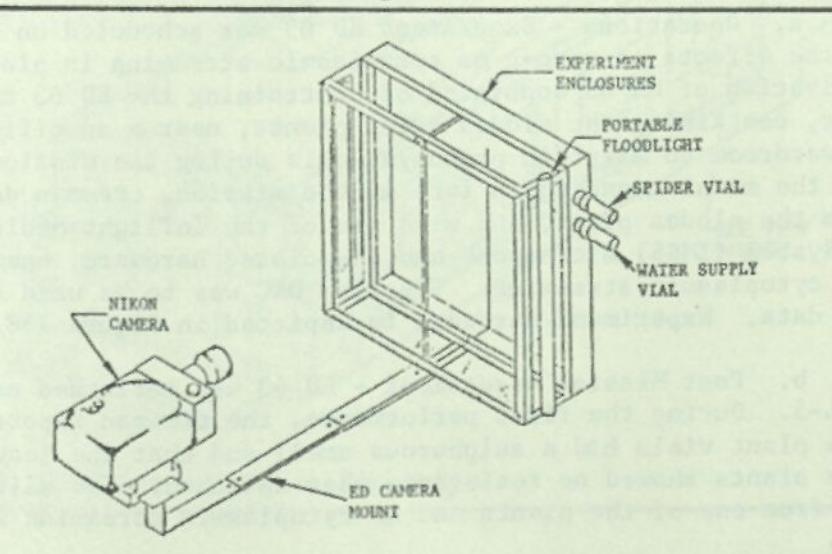
The crewman performing the experiment deployed the experiment enclosure which permitted observations of spider activity. The spider was released from her vial into the experiment enclosure and allowed to spin her web. During the experiment performance, a crewman periodically provided food and water for the spider. Still photographs were made with the 35mm Nikon camera and correlated to Ground Elapsed Time (GET) by voice recorded comments. Movie photographs were to be made with the 16mm DAC camera utilizing the automatic camera actuator which detected spider motion to start/stop the motion picture camera. Experiment operational configuration is illustrated by Figure 154. Upon completion of the experiment the spiders were to be disposed of through the trash airlock.

b. Post Mission Assessment - Prior to releasing the prime spider, Arabella, the crew reported a problem with the automatic camera actuator. Malfunction procedures were conducted on the automatic

camera actuator with no results. The actuator was considered failed and therefore the web forming photography objective was not met. Photographs were taken periodically by the crew using the hand-held camera. Due to the actuator failure, some additional crew time was spent taking hand-held photographs. Both the prime and backup spiders died in-orbit and were returned to earth along with web samples.

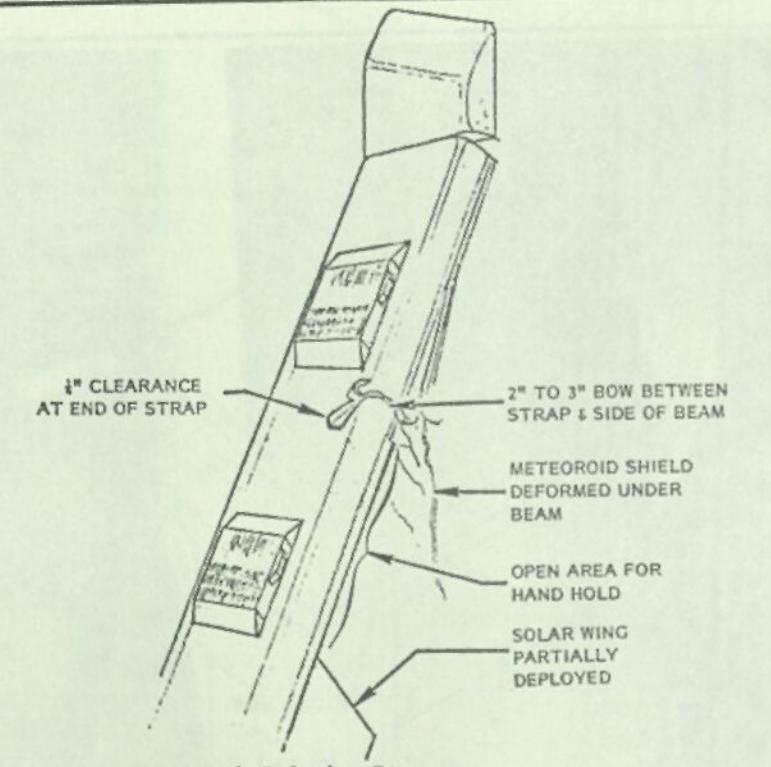
Figure 168. SAS Beam and Debris Strap

- The end of the debris strap was firmly attached on top of the SAS Beam with what appeared to be a row of bolts in the strap. These bolts seemed to be cutting into the beam skin.
- The debris strap was bowed out along the side of the beam two to three inches.
- Debris from the Micrometeoroid Shield was visible under the SAS Wing.

Based upon the data received from this discussion with the crew, a neutral buoyancy mockup of the #1 SAS Wing Assembly was prepared and is illustrated in Figures 168 and 169.

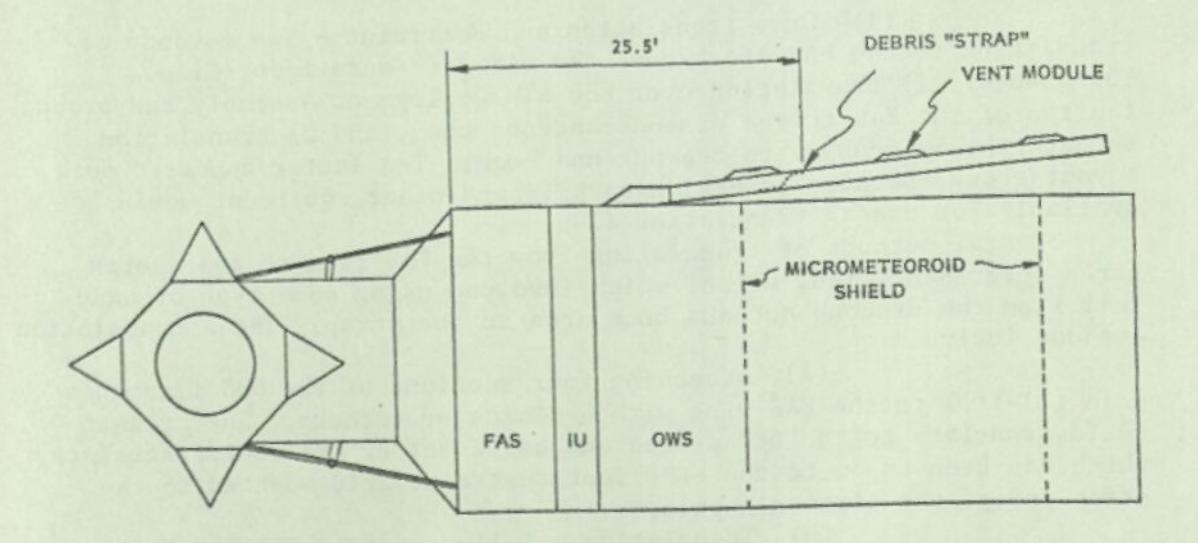
Figure 171. SAS Beam Configuration After Launch

a. Description of the Deployment Problem - It was determined by review of flight hardware drawings that the strap described by the crew was probably a section of the micrometeoroid Shield composed of two pieces of aluminum angle and an extrusion (Figure 170). By using the fly-around video tape and the Skylab Mission Support Mockup, this strap was determined to be approximately 25 ft. below the top of the FAS and 1-1/2 ft. below the first vent module (Figure 171). For the SAS beam to be erected, this strap would have to be either cut or pried away from the beam skin.

It was also predicted that if the strap were removed, the SAS beam would rise approximately two feet at that point on the beam and would then stop because of frozen oil in the damper/actuator. The beam would then have to be pulled up with a force of approximately 15 lbs. (measured at beam end) to break the damper/actuator mounting bracket in the beam hinge mechanism.

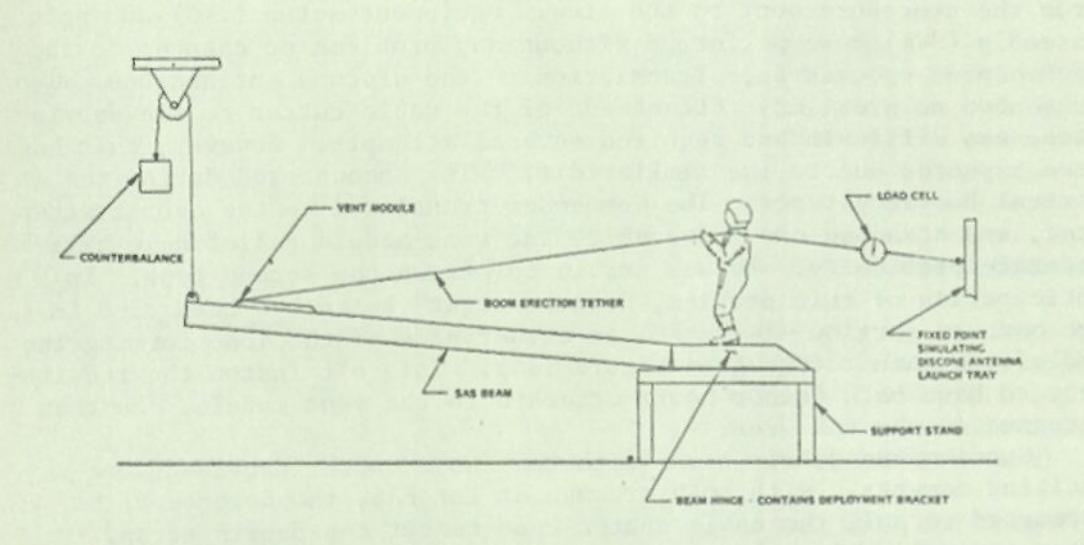
# Figure 177. One-g SAS Beam Deployment Test Setup

(2) One-g Testing - On June 1, 1973, a SAS Beam deployment test was conducted to verify that a crewman could exert enough force on a tension line to break the deployment bracket in the beam hinge. The SAS Beam mockup was held by a support stand on the hinge end and by a counterbalance/pulley system on the other (Figure 177). A tension line, fabricated of SEVA clothesline (PBI), was attached to the vent module and a fixed point that simulated the discone antenna launch tray. A load cell was mounted in the line to record the tension.

During the test, the bracket broke at 167 lbs of tension which was lower than the maximum tension (309 lbs) that the suited crewman could generate.

Additional tensile strength tests were performed on the two tethers being considered for use as the tension line. The OWS Adjustable Tether (fireman's pole tether) broke at 240 lbs. The SEVA sail line (PBI) broke at 375 lbs. Therefore, the PBI was selected as the Beam Erection Tether (BET).

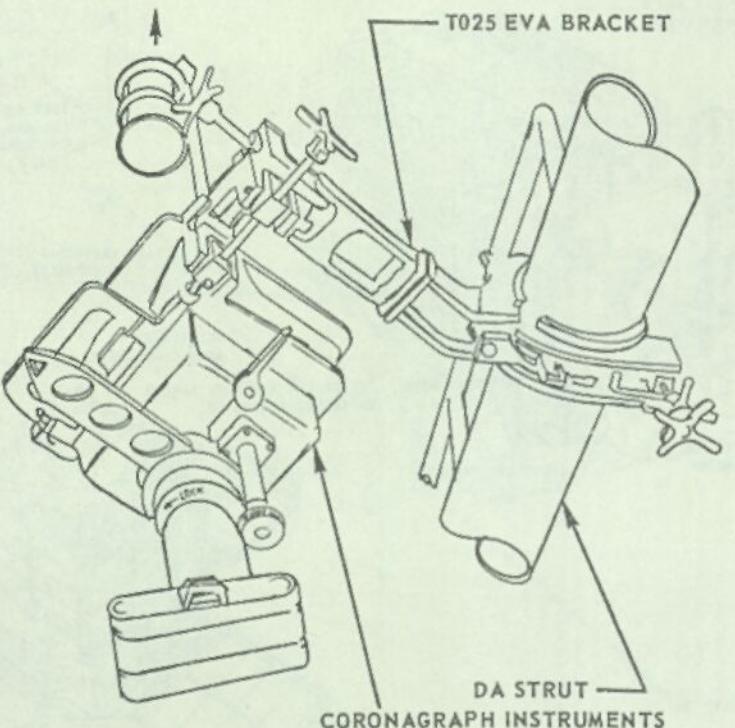
Figure 188. TO25 EVA Configuration along with the preceding S201 and T025 experiments, was mounted on the

The experiment apparatus consisted of a newly designed and built adjustable EVA bracket, the coronagraph canister and camera, and an occulting disc mounted on a boom (Figure 188). The EVA bracket was to be mounted on a DA truss near the D-1 handrail at the Fixed Airlock Shroud workstation (VF).

For the first EVA of SL-4, the TO25 apparatus was mounted at the VF. During camera operation, the shutter speed control knob became loose. Only five photographs out of a planned 40 were obtained.

Instead of trying to repair the camera during EVA, the picture taking sequence was stopped, and the equipment was returned (after removal of the thermal blanket cover) to the AM. There, following the EVA, the TO25 hardware underwent troubleshooting, and the crew successfully repaired the shutter speed knob. The TO25 hardware was used during subsequent EVAs to obtain ultraviolet and visible photographs of Kohoutek. Throughout the remaining three EVAs, no problems occurred with operation of the camera or EVA bracket, and subsequent TO25 experiment performance was without incident.
