# DEVELOPMENT OF LOX-HYDROGEN ENGINES FOR THE SATURN A POLLO LAUNCH VEHICLES

# A. J. BURKS, Assistant Manager

June 10. 1968

NATIONAL AERONAUTICS AND SPACE ADMINISTRATION

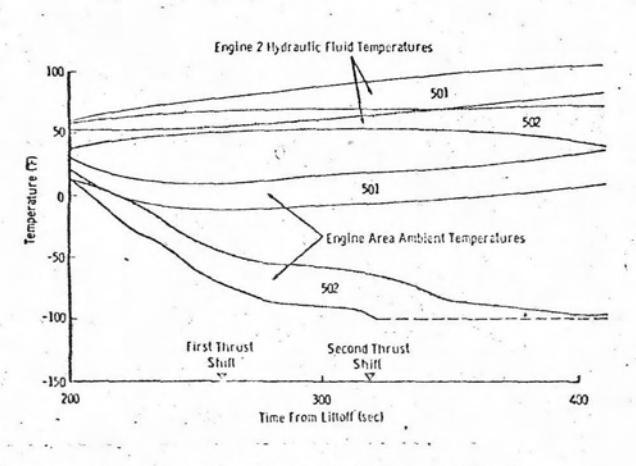
Environmental Changes. The 502 flight was normal by 501 standards until 225 seconds after liftoff. At that time temperature began to drop rapidly in sclected engine areas as shown in Figures 19, 20, and 21. Engine 2 cutoff was preceded 0.3 seconds by indications of hot gas impingement as depicted in Figures 22 and 23.

Cooling trends were established by 280 seconds after liftoff and were accelerated at 320 seconds. Both time intervals correspond closely with thrust shifts. Just prior to engine number 2 cutoff the engine and thrust cone area indicated hot gas impingement. Following engine number 2 cutoff there was a cooling trend in the engine 2-5 quadrant indicating a cryogenic line rupture.

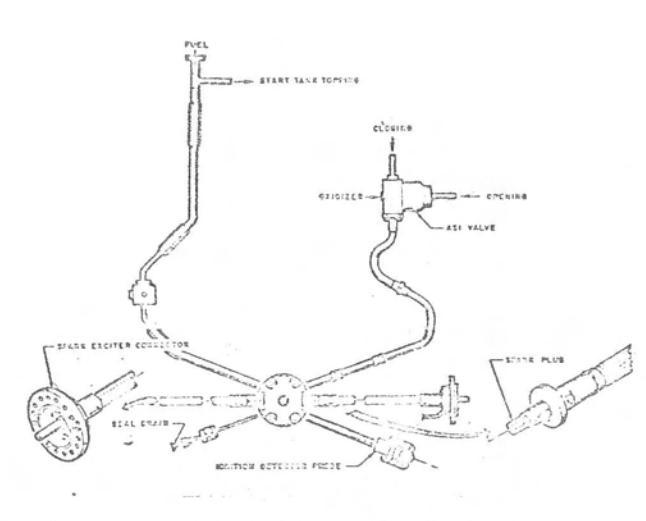
Figure 24. J-2 Engine Ignition System

The most probable suspects for causing this type of anomaly is a leak in the augmented spark igniter (ASI) fuel or oxidizer line with the fuel line the prime candidate. (Figures 24, 25, 26, and 27.

It has been postulated that a small leak occurred in the line and continued to manifest itself until there was a complete rupture. At this point hot gases from the combustion chamber would backflow through one leg of the ruptured line in the vicinity of the ASI port and result in hot gas spewing out one part of the break and raw cryogenic propellant coming out of the other severed end. This phenomena has not been completely duplicated under controlled conditions at the time this paper was written.

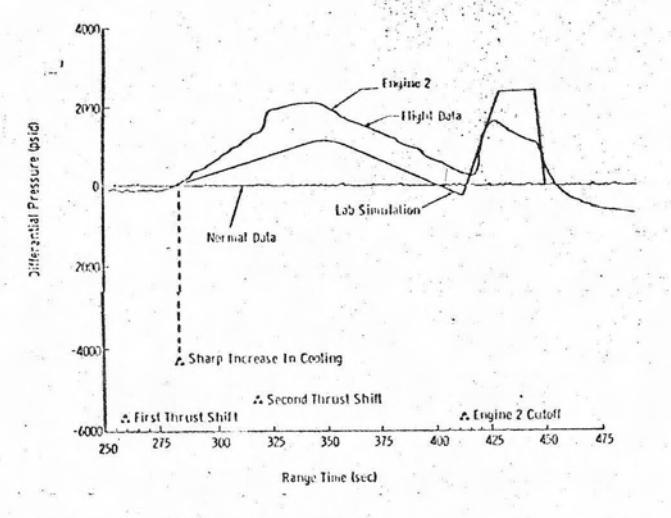
Indicated Yaw Actuator Malfunction. As shown in Figure 28, coincident with a sharp increase in cooling, the yaw actuator  $\Delta P$  began to increase rapidly and reached a maximum point corresponding to the second thrust shift exhibited by the engine. It was postulated that the indicated malfunction was the result of a cryogenic propellant leak in the vicinity of the actuator.

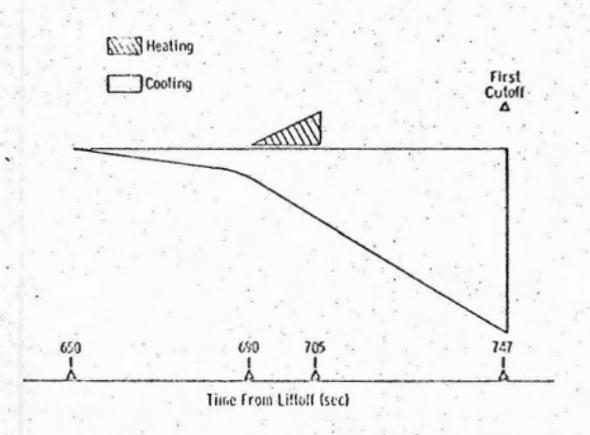
The chamber pressure dropped, fuel pump discharge pressure increased, both the fuel and LOX injector pressure decreased, the fuel injector.temperature rose, and the fuel pump speed went to zero rpm. Figure 31 indicates that both heating and cooling occurred external to the engine during a 15 second time interval.

A sharp drop in the cylinder oil temperature of the yaw actuator was recorded at 695 seconds to correspond with the previously mentioned environmental changes.
