## DEVELOPMENT OF LOX/RP-1 ENGINES FOR SATURN/APOLLO LAUNCH VEHICLES

LEONARD C. BOSTWICK  
NASA Marshall Space Flight Center  
Huntsville, Alabama

AIAA Paper  
No. 68-569

# AIAA 4th Propulsion Joint Specialist Conference

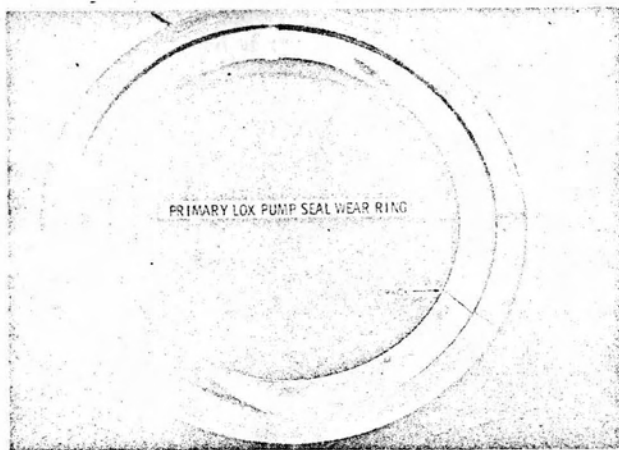
Figure 34. LOX Pump Primary Wear Ring

Turbopump LOX Primary Seal Wear Ring Cracking. During production support testing, the wear ring in the LOX primary seal was found cracked on two engines after 1700 and 700 seconds test time, respectively. The evidence of a cracked ring was the appearance of a sharp spike in the LOX seal cavity pressure at engine shutdown. Suspected cause of failure was overheating of the wear ring due to out of specification properties of the carbon. Comparison of photomicrographs of normal (within specification) carbon grain structure with that of the lot used to manufacture the cracked rings revealed distinct differences in grain structure. The photomicrographic examination of the cracked rings showed changes in the heat affected zones due to overheating. Through this investigation, the cracking cause was traced to only one lot of "out of spec" carbon that got into the system. The bad carbon was purged from the stock and the wear rings were removed from suspected pumps. Improved traceability, stock control, and quality controls were incorporated at the vendors and Rocketdyne plants to prevent recurrence. The crack is clearly shown in Figure 34.
