JOSEPH ADAMS  
LOG HSE  
N.E. LIMESTONE CO.  
AL.

Log hse (dogtrot) - Joseph & Amanda Adams,  
Upper Ft. Hampton Rd., N.E. Limestone Co., AL  
Copy Feb. 1994 H.P. Jones, FAH, Huntsville, AL  
from copy owned by relative, William Lakin Bond  
of 426 Eustis Ave, Huntsville

MORRIS LOG HSE  
LIMESTONE CO.  
AL. (OVER)

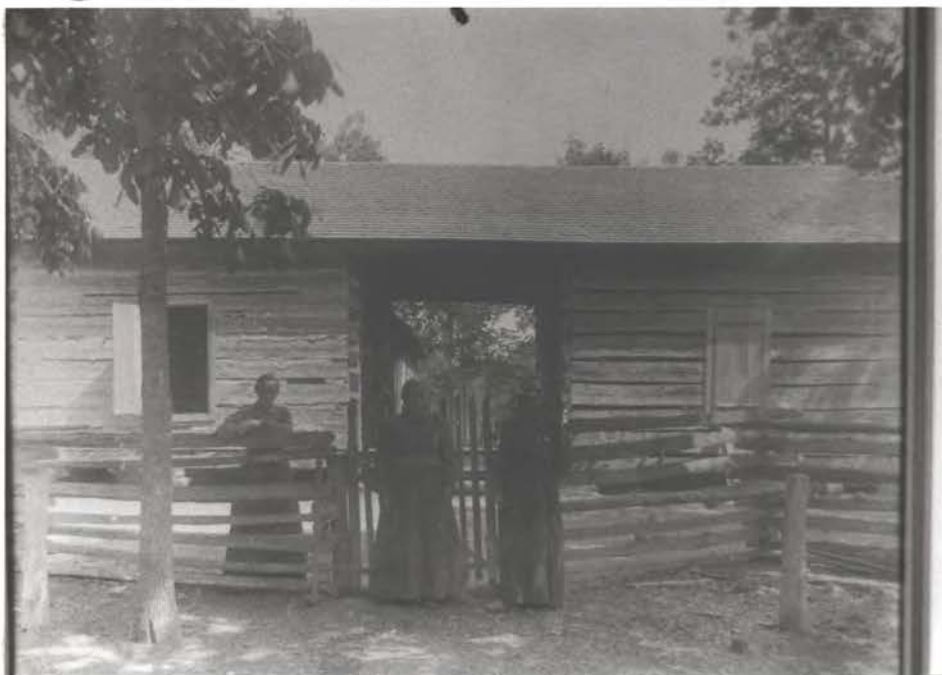
Note NO WINDOW SASHES (shuttered open, only).  
Indicates early 1800's date for hse constr.

Note split-rail fence, common in N. AL.  
as late as 1940's (survivors)

Photo unlabeled, perhaps 1870-90(?)  
Shingles look new, machine-sawn  
Note no sash in window oppo.

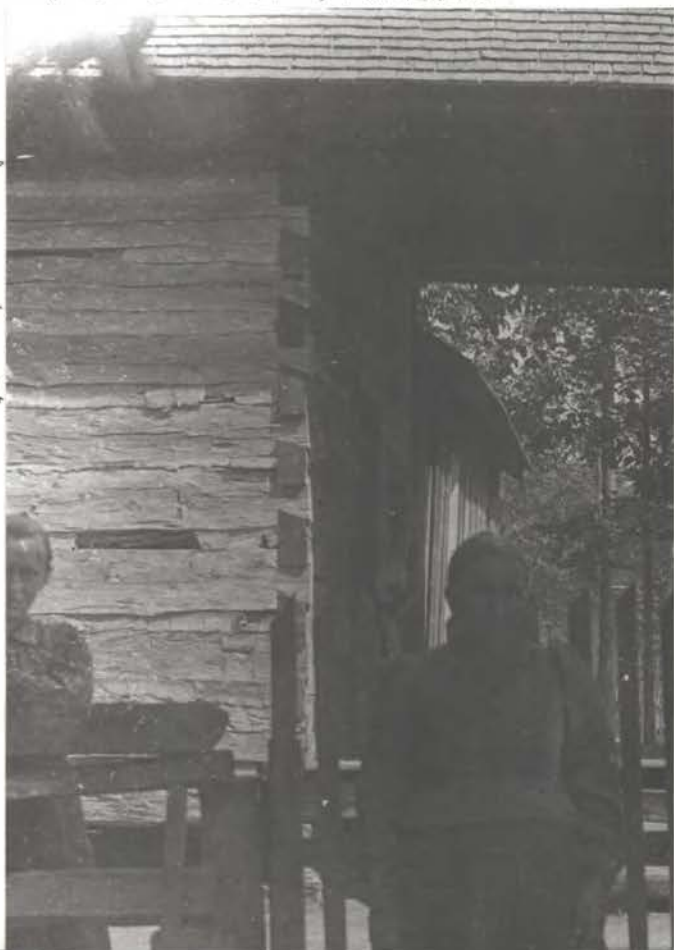
No chinking or dabling in this pen (is in left pen)  
∴ This pen probably used for store only
