LIMESTONE CO  
NEAR TANNER  
"FLOWER HILL FARM"

C. 1846  
WASHINGTON - PRYOR HSE  
Photos Sept 1990 H. Jones

C. 1846  
WASHINGTON - PRYOR HSE

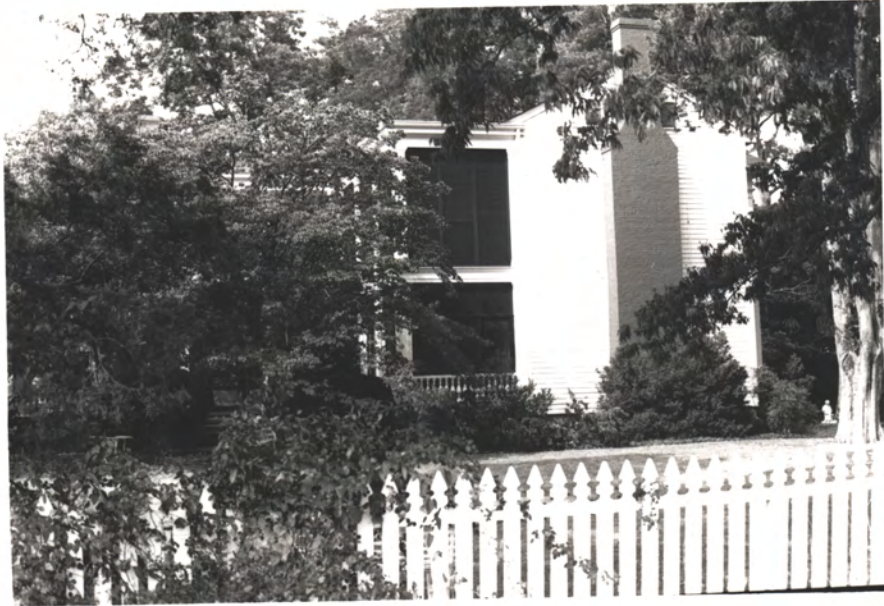
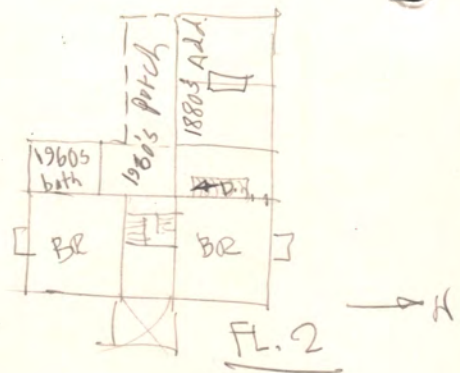
12nd fl. porch towers  
 covered a bath rm  
 porch =  
 c. 1960's

Replaced orig. shell-roof 1st fl porch w/ single cols, no balustrade

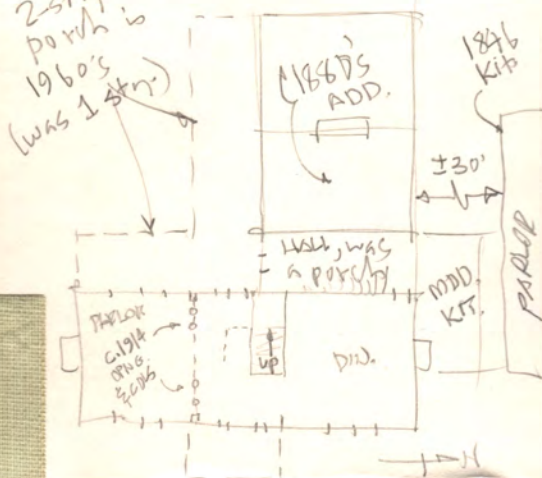
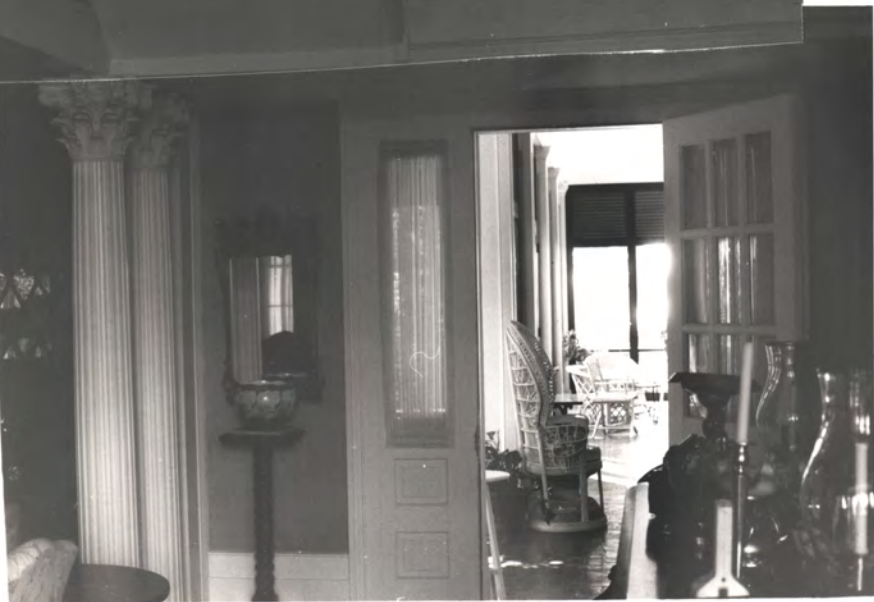
2 story  
 porch is  
 1960's  
 (was 1 story)
