1887 + c.1895 + c.1960 OSCAR GOLDSMITH - DONOVAN HOUSE, 501-6 FRENCH ST., HUNTSVILLE, AL. - TWICKENHAM HISTORIC PRESERVATION DISTRICT
 SKETCH PLAN - VERIFY ALL DIMENSIONS & CONDITIONS AT SITE
 DEC. 27, 1996 LARRY P. JONES F.A.I.A.

RESTORED VIEW, 1887 GOLDSMITH HOUSE WITH 1894-98 TOWER & PORCH
500 FRANKLIN ST. , HUNTSVILLE , AL. , JOE WATSON, RESTORATION BUILDER
PORCH PER 1894-98 EDWARDS MAPS & C.1920 POSTCARD VIEW
HARVEY P. JONES, FAIA , JONES & HERRIN, ARCHITECTS, 7 JULY 1997

1887 Goldsmiths House Rear Addition - 501-6 Franklin St., Huntsville, Al.
Plan "A" Dec 31, 1997 H.P. Jones, FAIA

1887 Goldsmith 1st + 1894-1898 tower
506 Franklin St. - Huntsville, AL

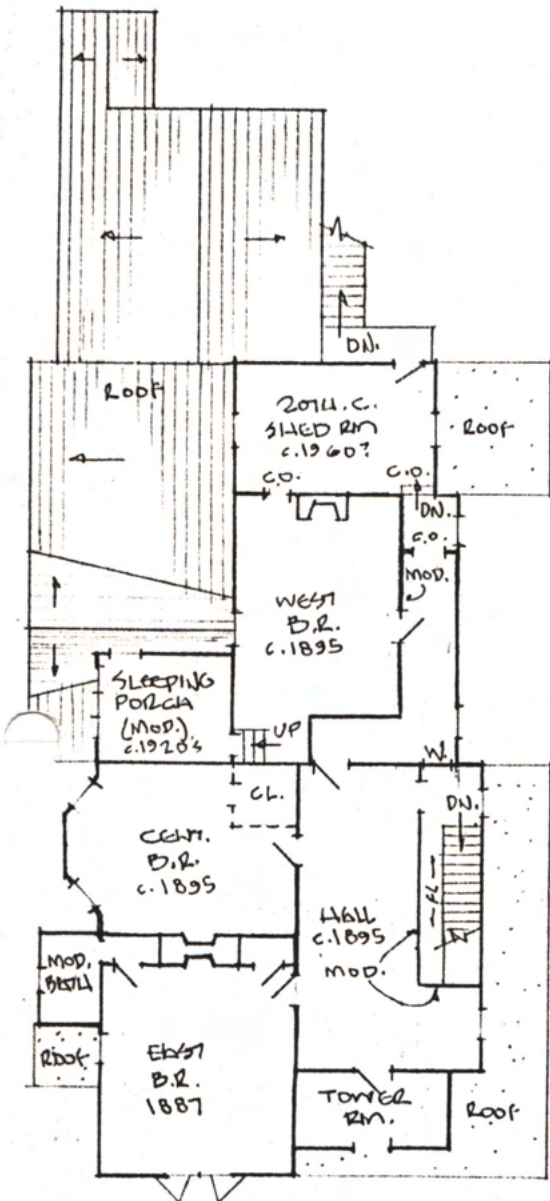
FL. 2 SKETCH PLAN

BLDG. ON 1861 MAP
 APPARENT PRE-CIVIL WAR CHIM. (SEE BLDG. ON 1861 MAP)
 CHIM. REMAINS IN 1996

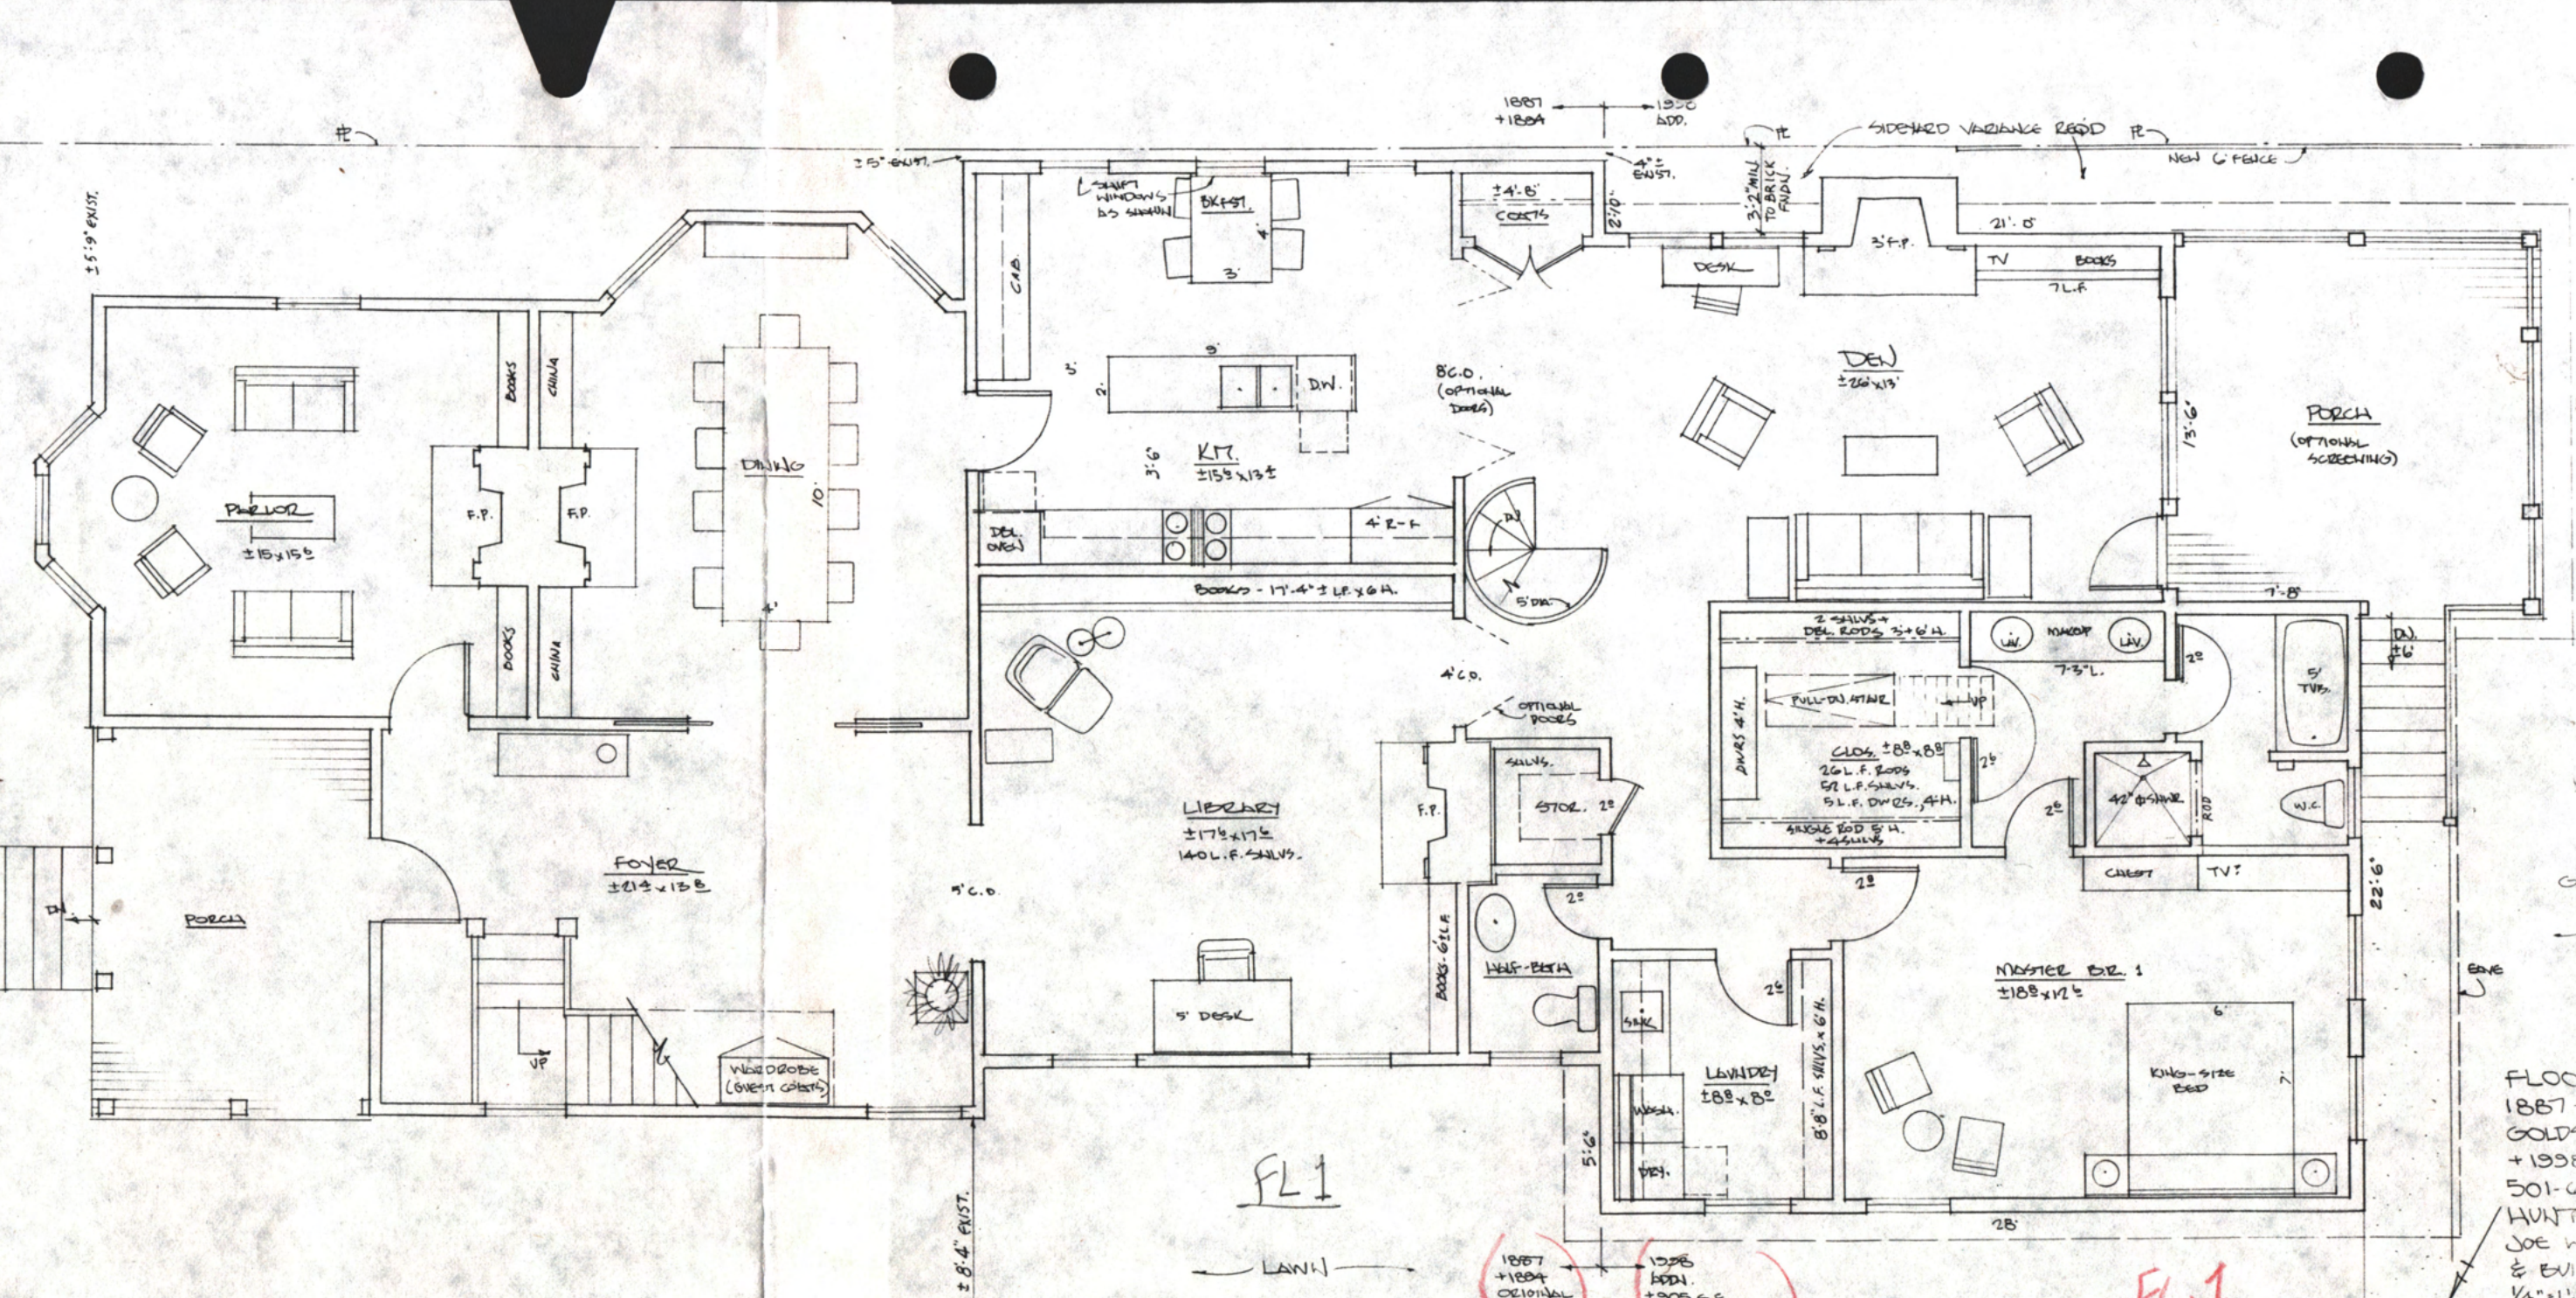
1887 + 1884 ORIGINAL

1938 ADD. ± 903 S.F. + BSMT & PORCH

FL 1
 Dec. 97 prelim. - Holmes Goldstein-Dorman

FLOOR 1887 + 1884 + 1938 501-6 HUNT-JOE W. & EXH. 1/4" = 1'-0" DIM.

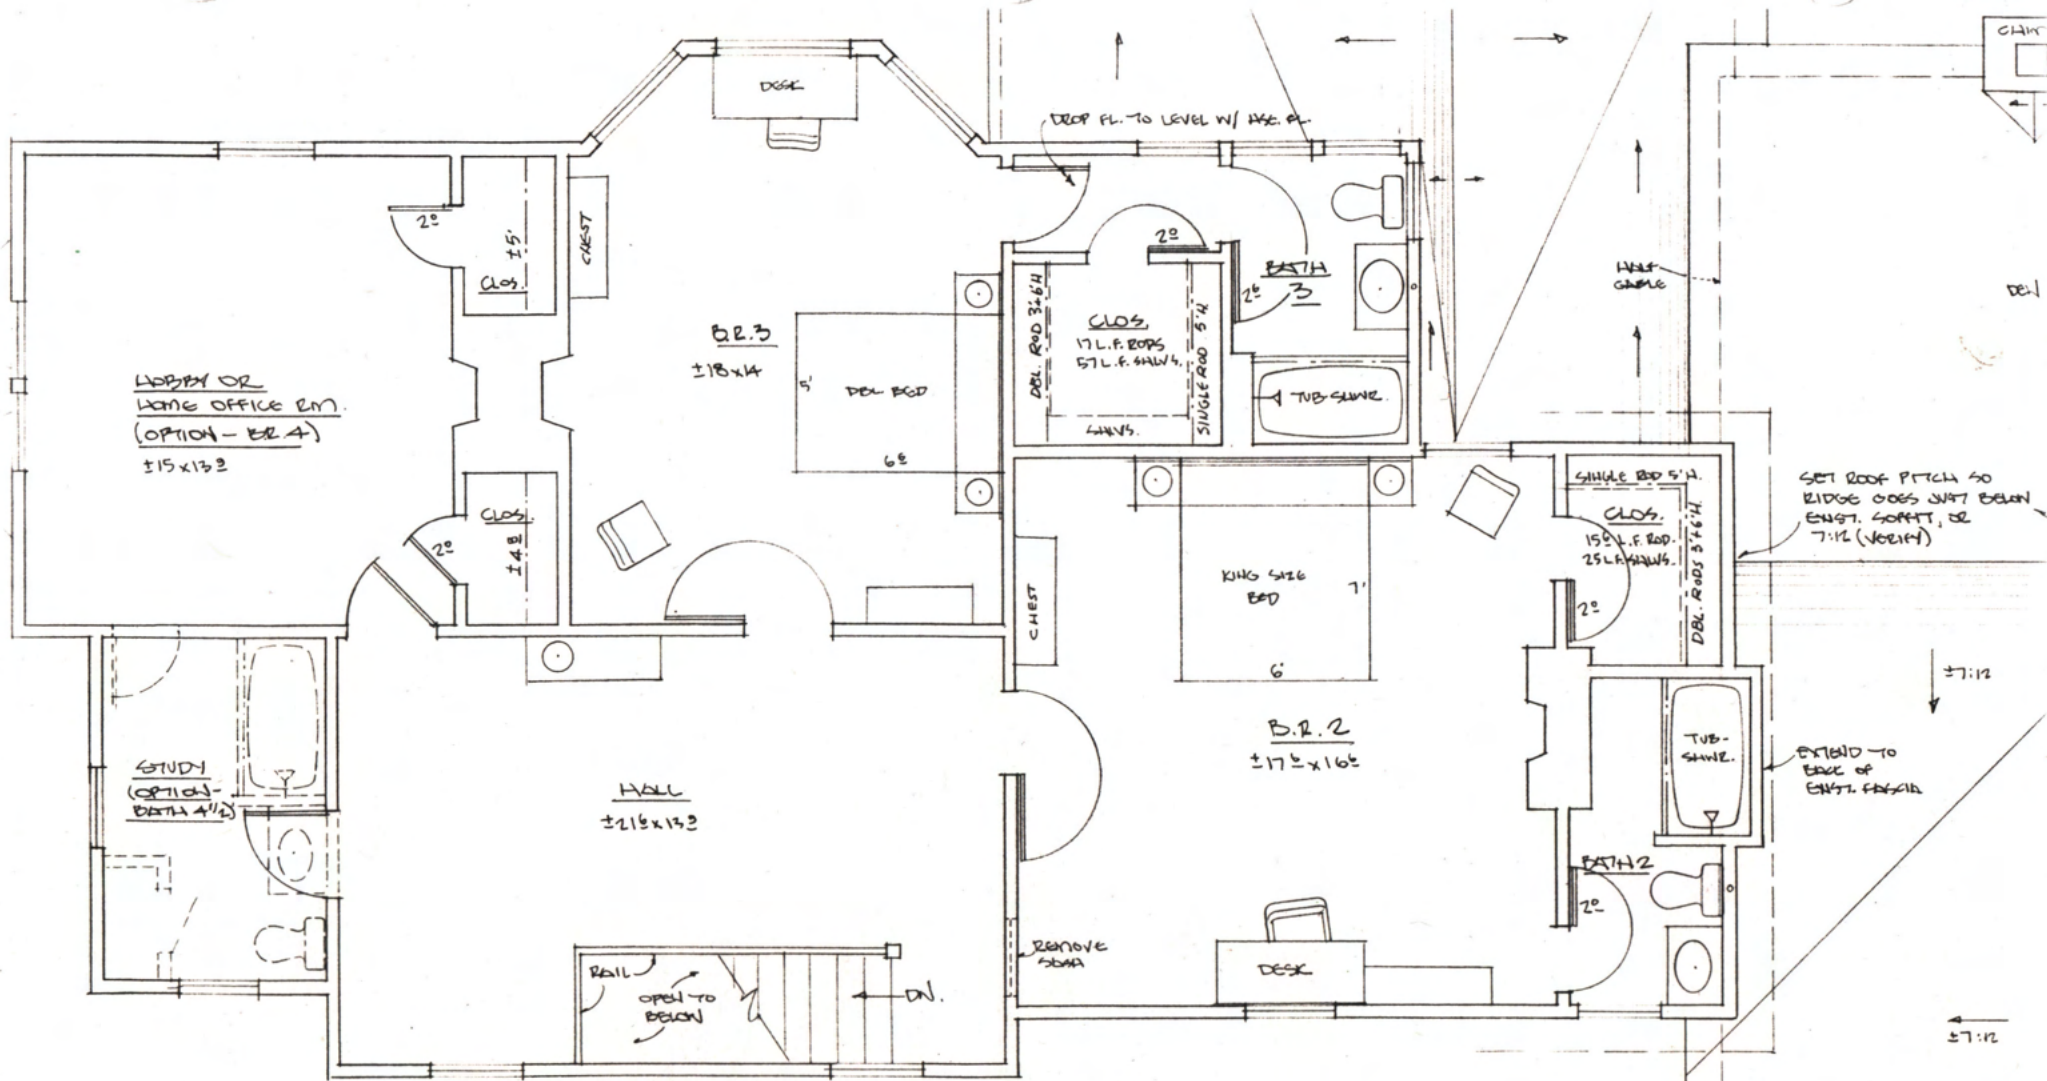
F. 2 of 1887 + c. 1894 hse

EXIST. 1998 ADDN. (1.5M.)
 (SOME INT. REVISIONS)

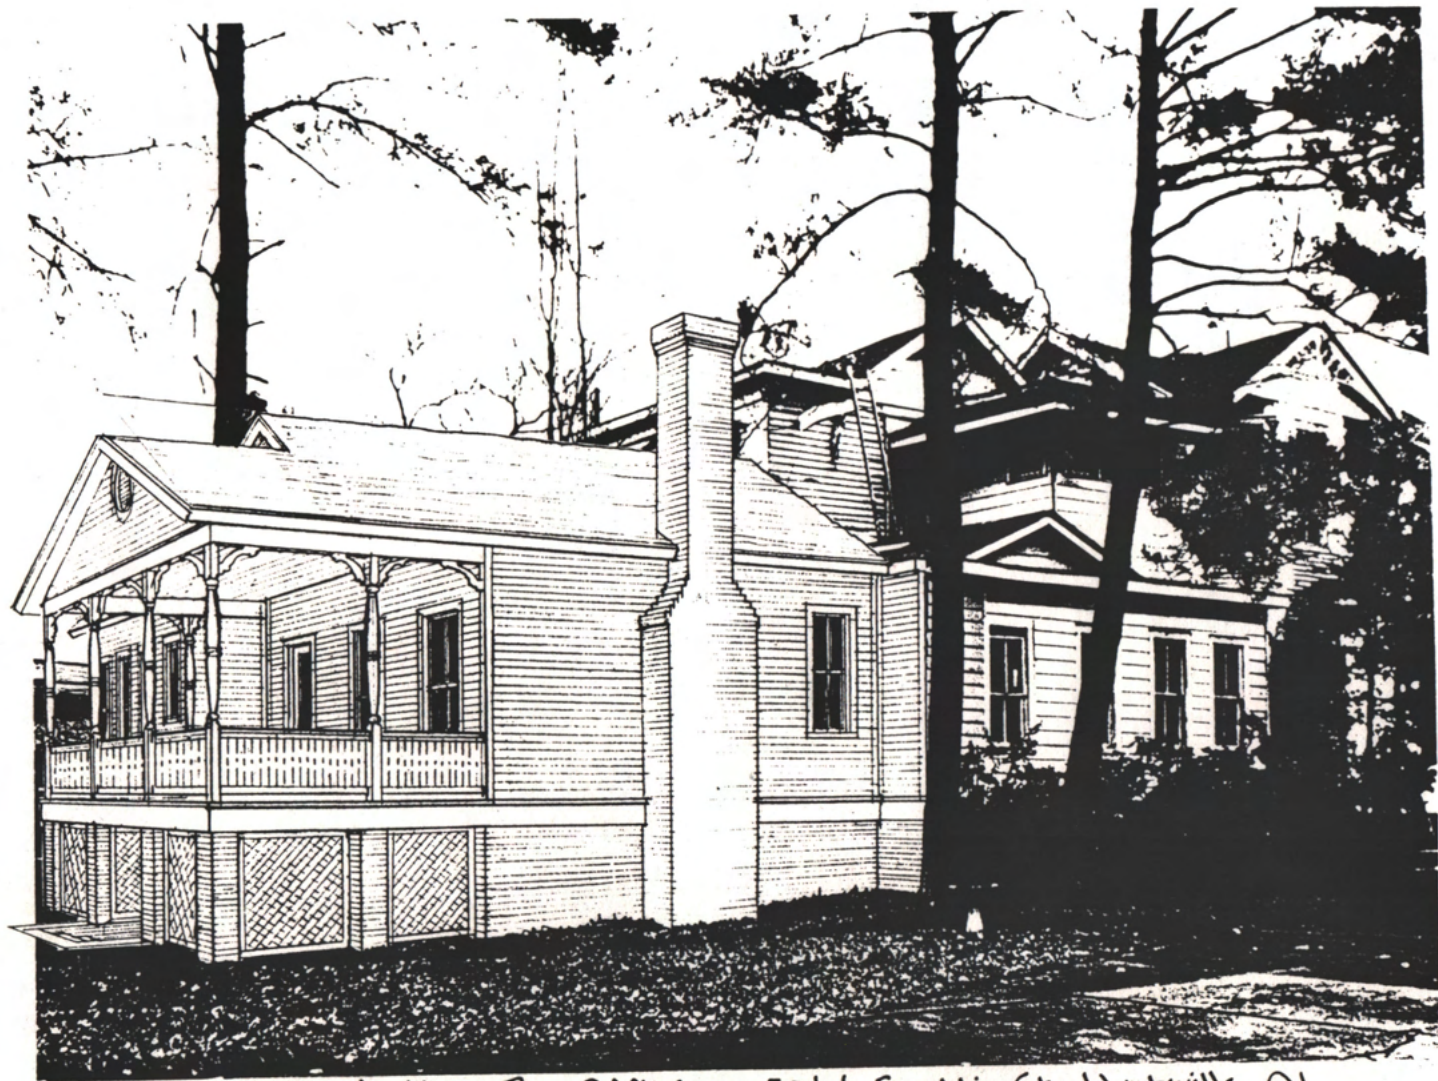
REAR VIEW WITH 1998 ADDITION (LOOKING N.E.)

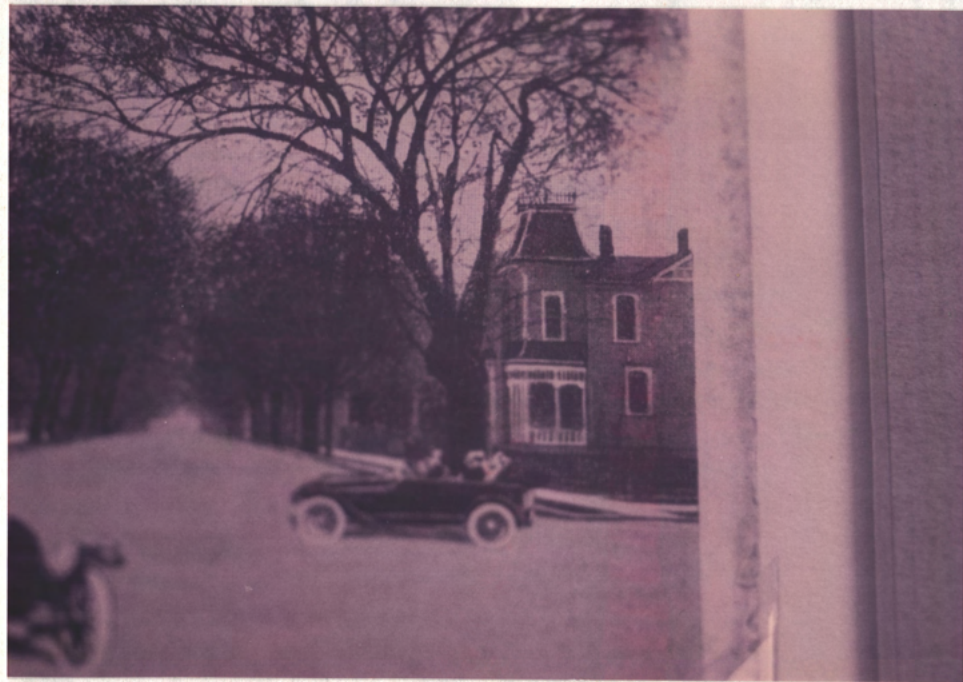
c. 1920s postcard (based on cars) - Franklin St. looking S. past Williams Ave.
 Copied 8 Mar '27 125000 from postcard in
 "Burger King" xostan. in Whitesburg Dr., Huntsville AL

1887 Goldsmith 12x after
 tower added in c. 1896

Sheet-iron cresting on porch roof 18 in 1996, stored in garage (see 1996 photo)

Joe - in looking at the 1920s photo & the 1997 photos
it appears that the chimneys had a simple
corbelled cap:

Using the 2' width as a scale on the 1920's photo,
the chimney top is about 4'-8" - 5'-0" above the
ridge-line.

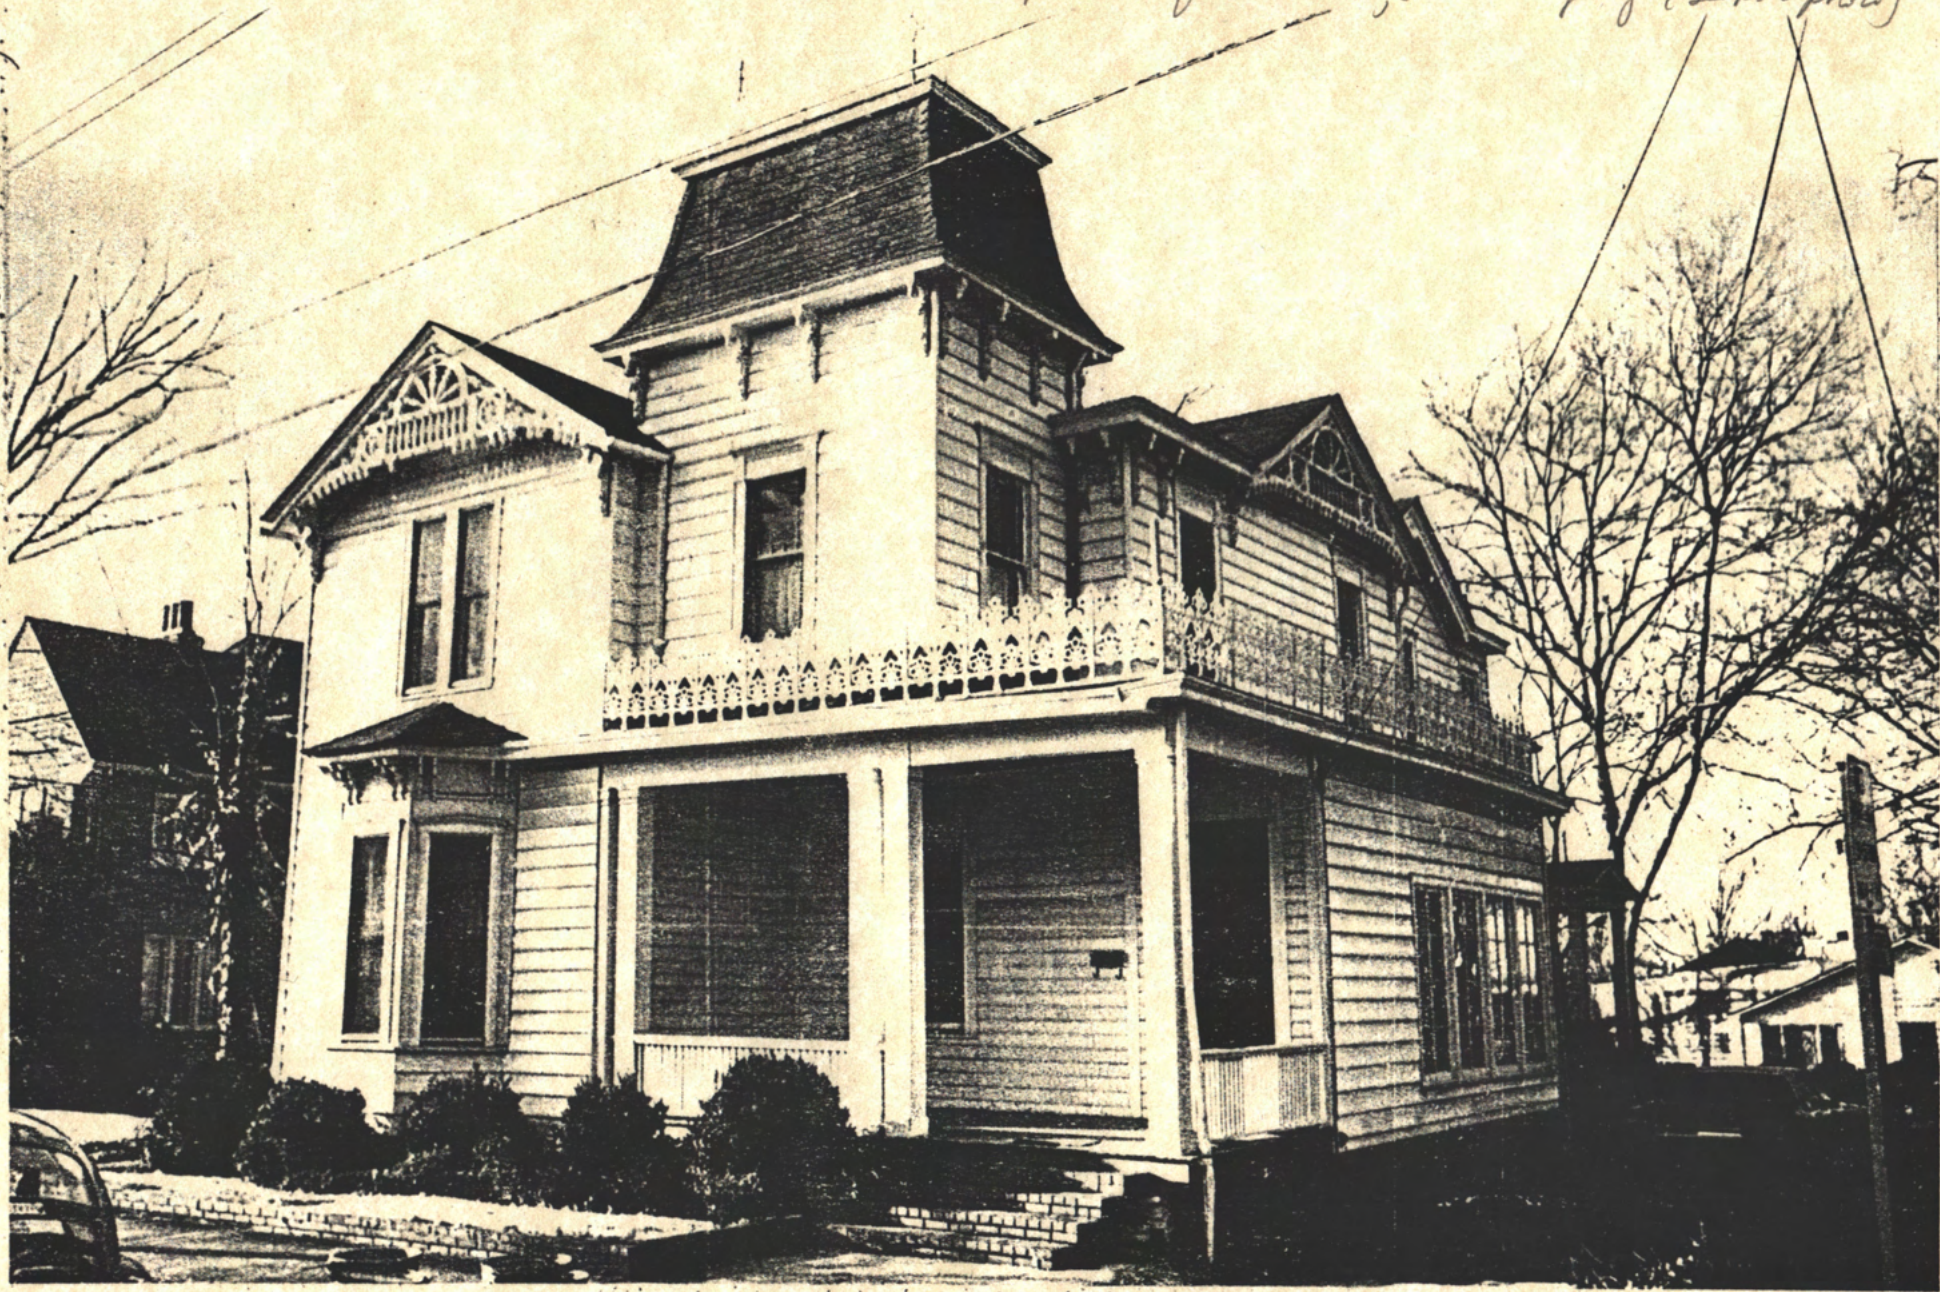
1887 Goldsmith-Dorson Hse, 501-6 Franklin St. - Huntville AL, w/ alum. siding
photo 1973, Casey Cooper

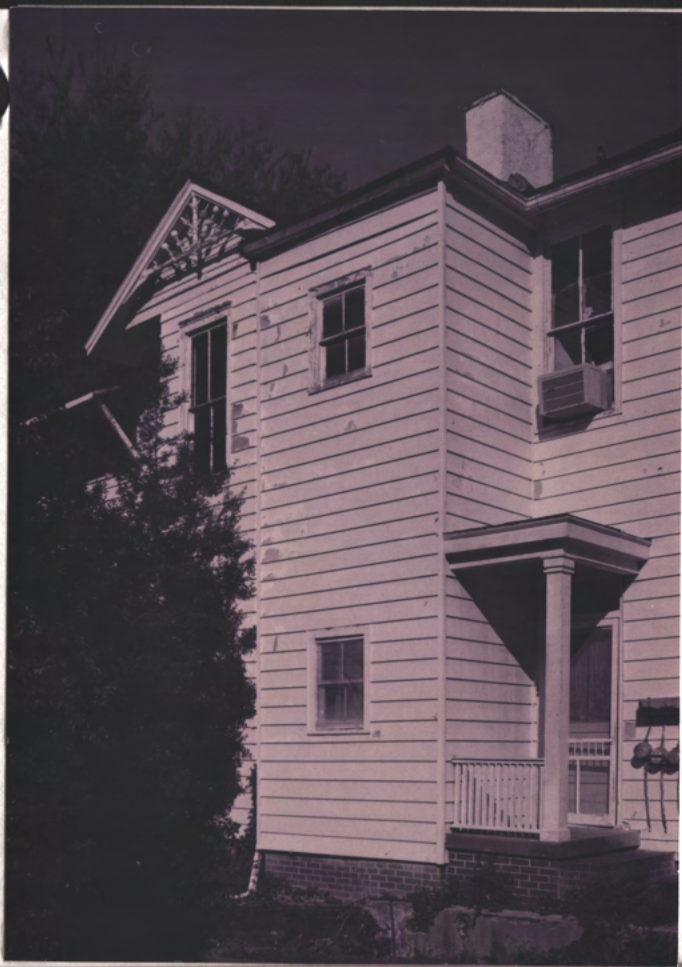
506
Franklin St.
Huntsville
AL
1974

1887 speculation or rental here
built by Oscar Goldsmith, sold by him
in 1890. Tower added between 1894-1898
by comparing the Sanborn Maps of those dates
1891 from news paper of 1887

porch has
metal filigree
cresting.
See H's
1970's slide
Is stored in
gar. now.

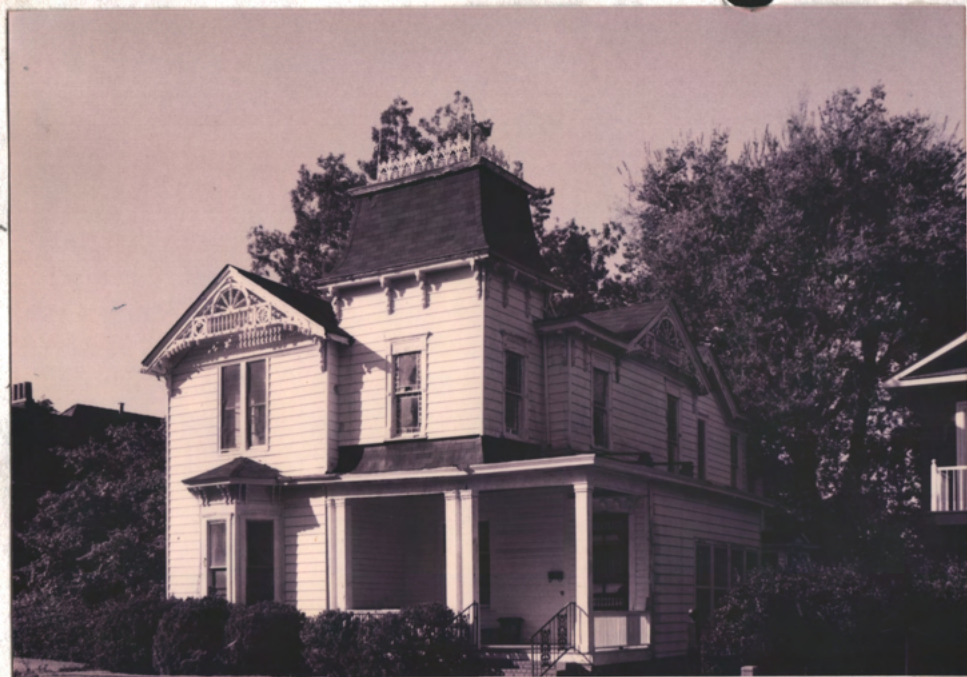
Tower added (See plans at lower left) 1894-98 → W
Porch looks only 20th c. See Sanborn Maps

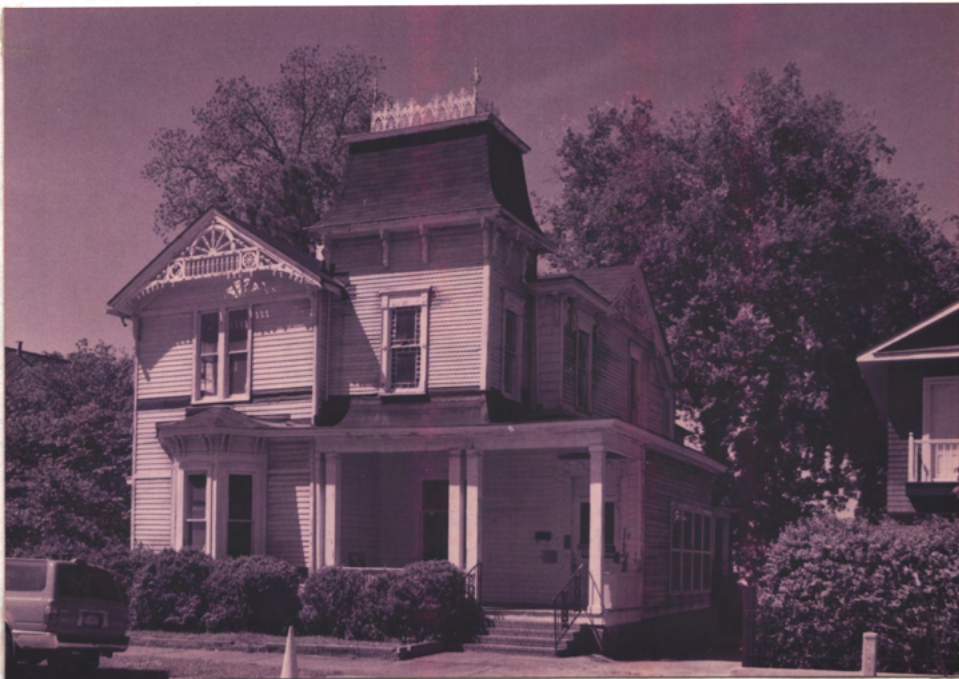
c.1950's aluminum siding being removed by Joe Watson, owner-archt. - May 1997 (HW photo)

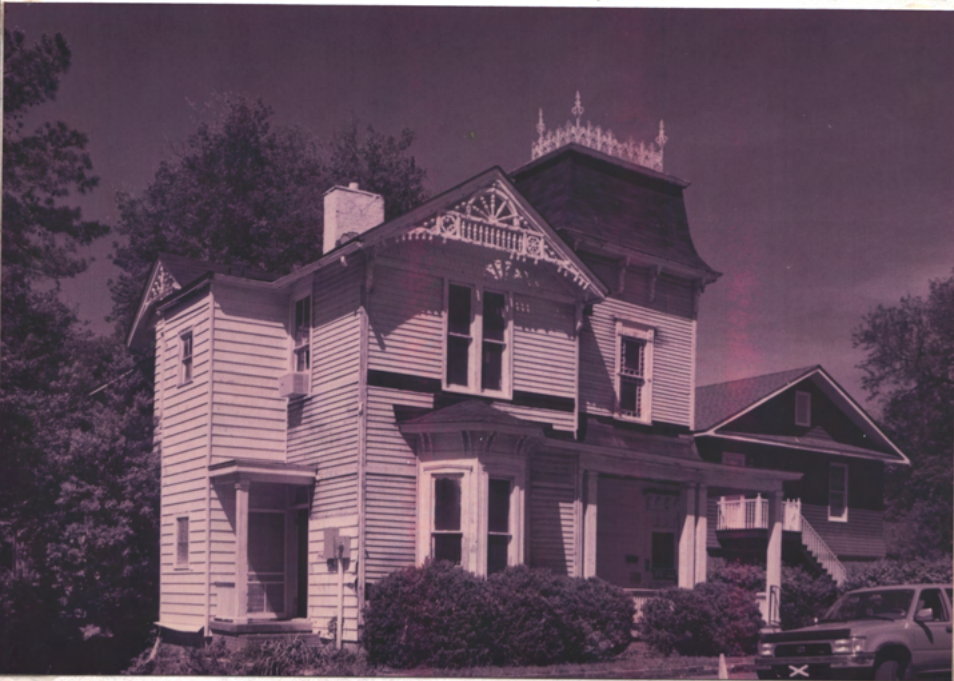
S.E. corner

Wide siding = c.1950's alumn.
Narrow = 1887 wood

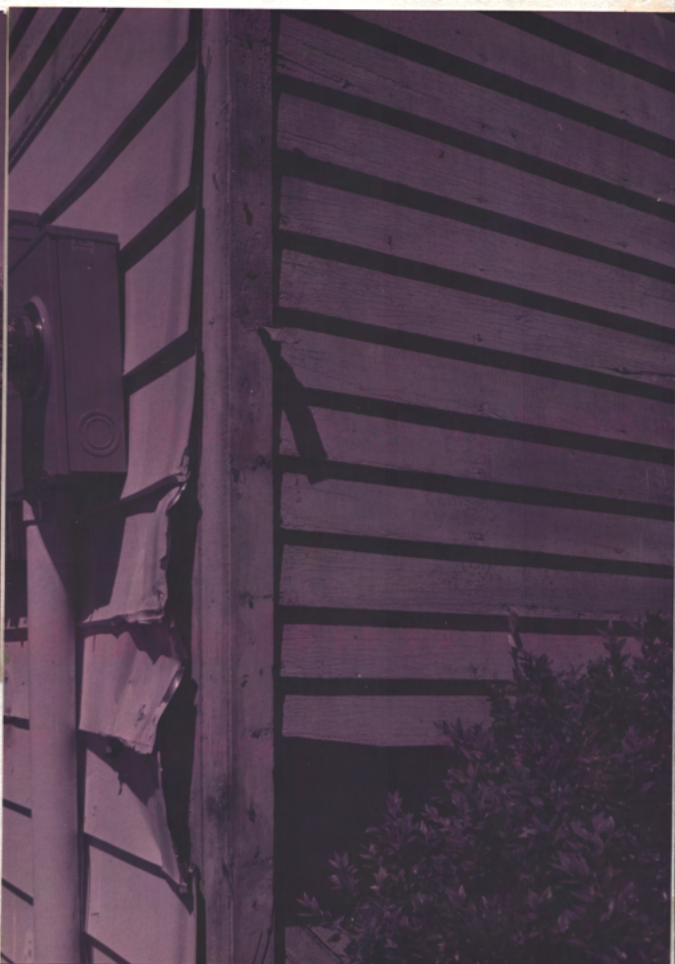
* ————— *
20th cent
per S. Wall
Chim is pre-1861 per brick & 1861 wgp

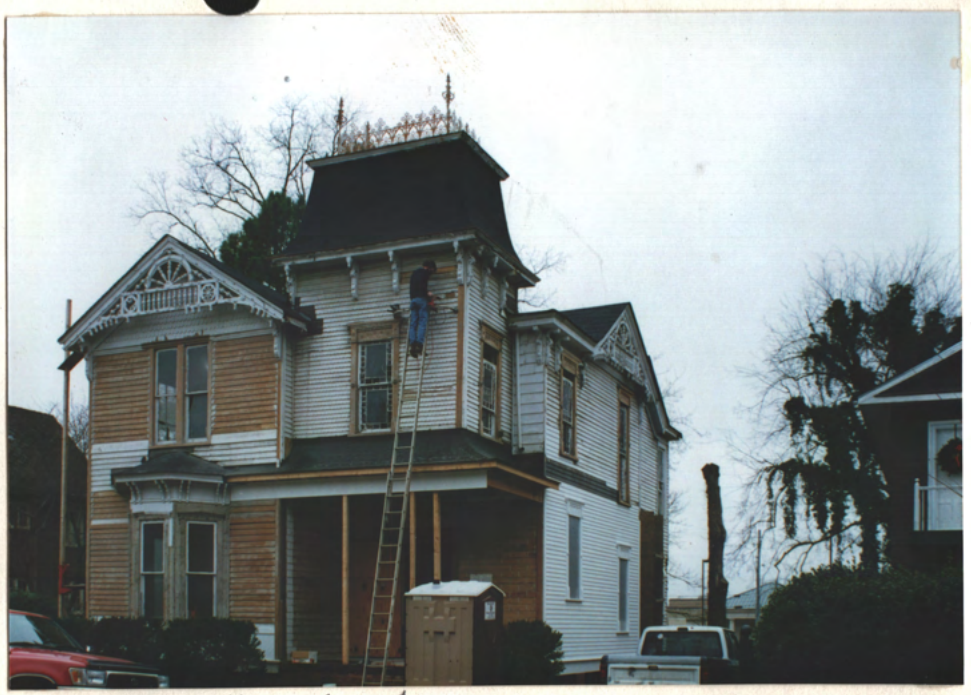
→ H
E. F. FROM ↑
Joe Watson, owner of bldg.
Porch being restored per two early photos of Somborn maps
of 1894-98

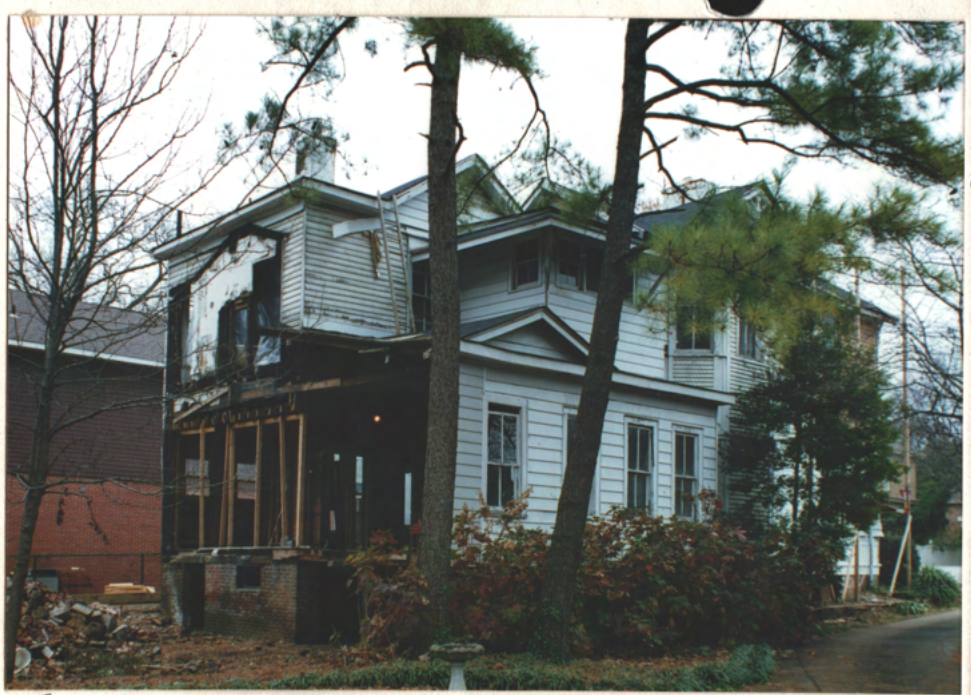
W. view w/ c. 1950-60 makeshift S. side
addns. removed

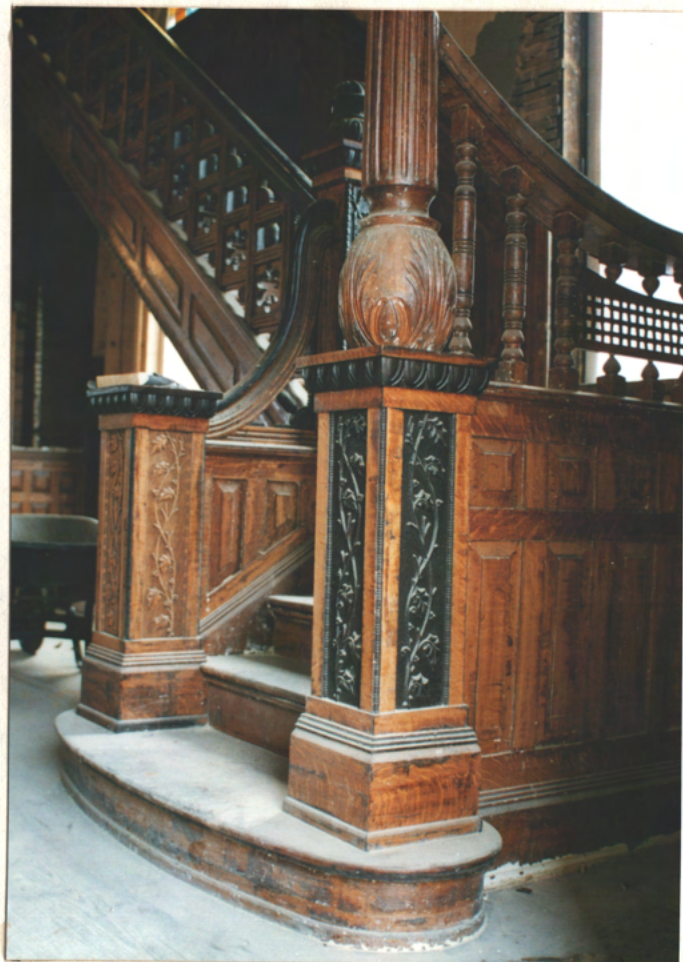
c. 1894-8 second stair
being demed
(black is non-orig. paint)
