S-II STAGE MANUFACTURING

The Toughest Weld of All

Half mile of delicately fused metal unites panels of thin-skinned Saturn S-II, second stage of moon vehicle

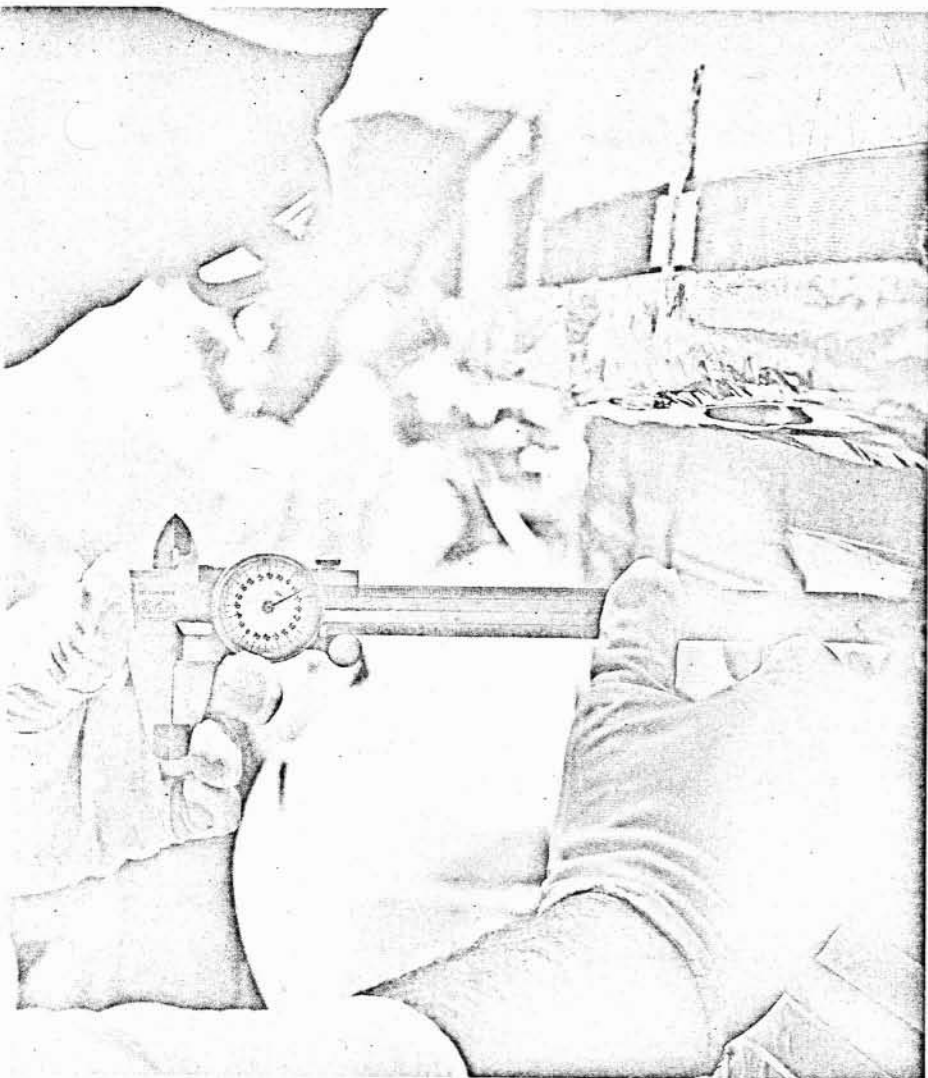
Left above, checking offset of two welded cylinders with vernier caliper is key operation. Mated cylinders must be matched to tolerances within thousands of an inch.

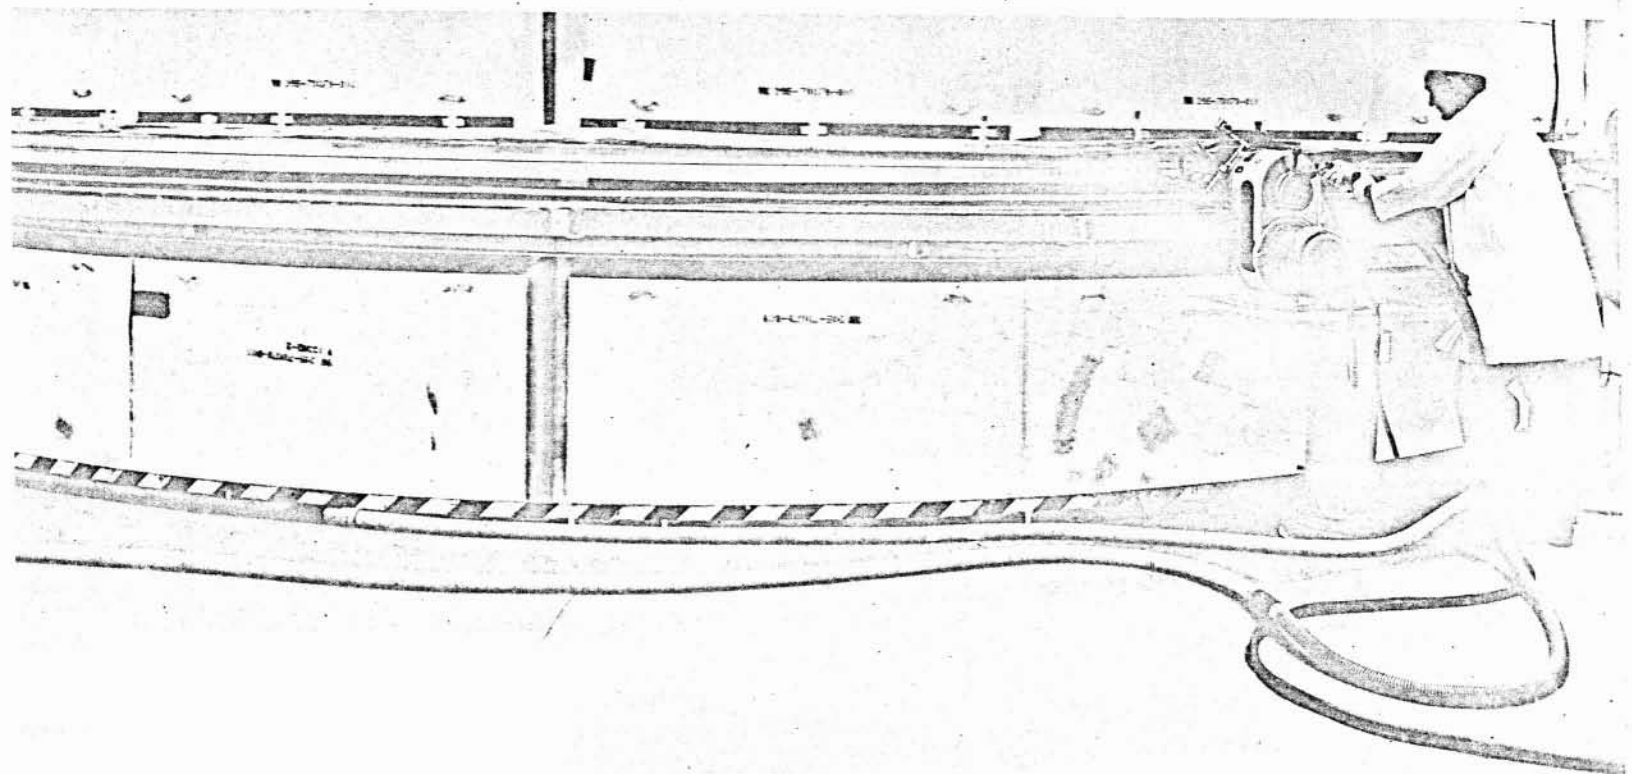
Under "rotary concept," left, the welding torch remains stationary and cylinders revolve around it, much like a giant phonograph record with weld machine as needle.

It was decided, too, to change the actual mode of welding in station 1-A. The standard "skate" style had been used, wherein the tool is moved around the periphery of the stage. Under the newly recommended "rotary" concept, the tool remains stationary and the bulkhead and cylinder revolve around it, much like a giant phonograph record with the weld machine as the needle. NASA had effectively used this method on the Saturn V's S-1C booster stage. The basic advantage gained here is that better control can be maintained, because there is less chance of movement in the trim and weld head. This process is also time saving and easier to handle. Operators can remain in one spot without moving bulky cables around.

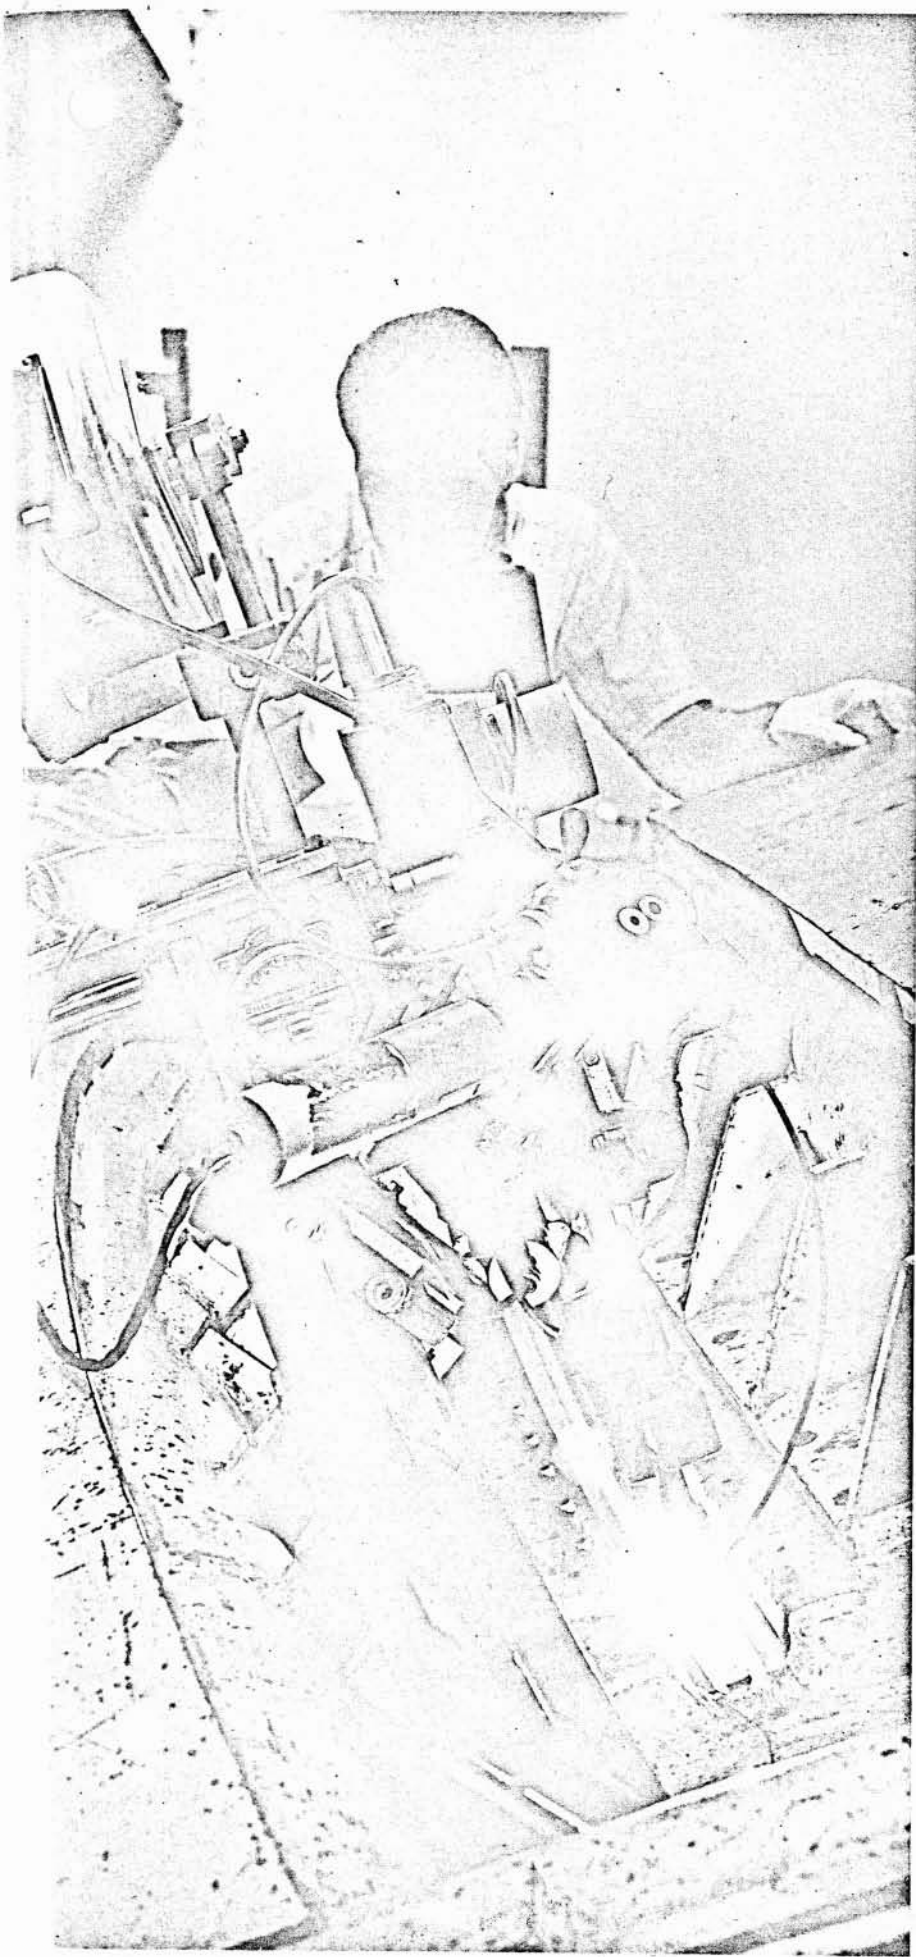
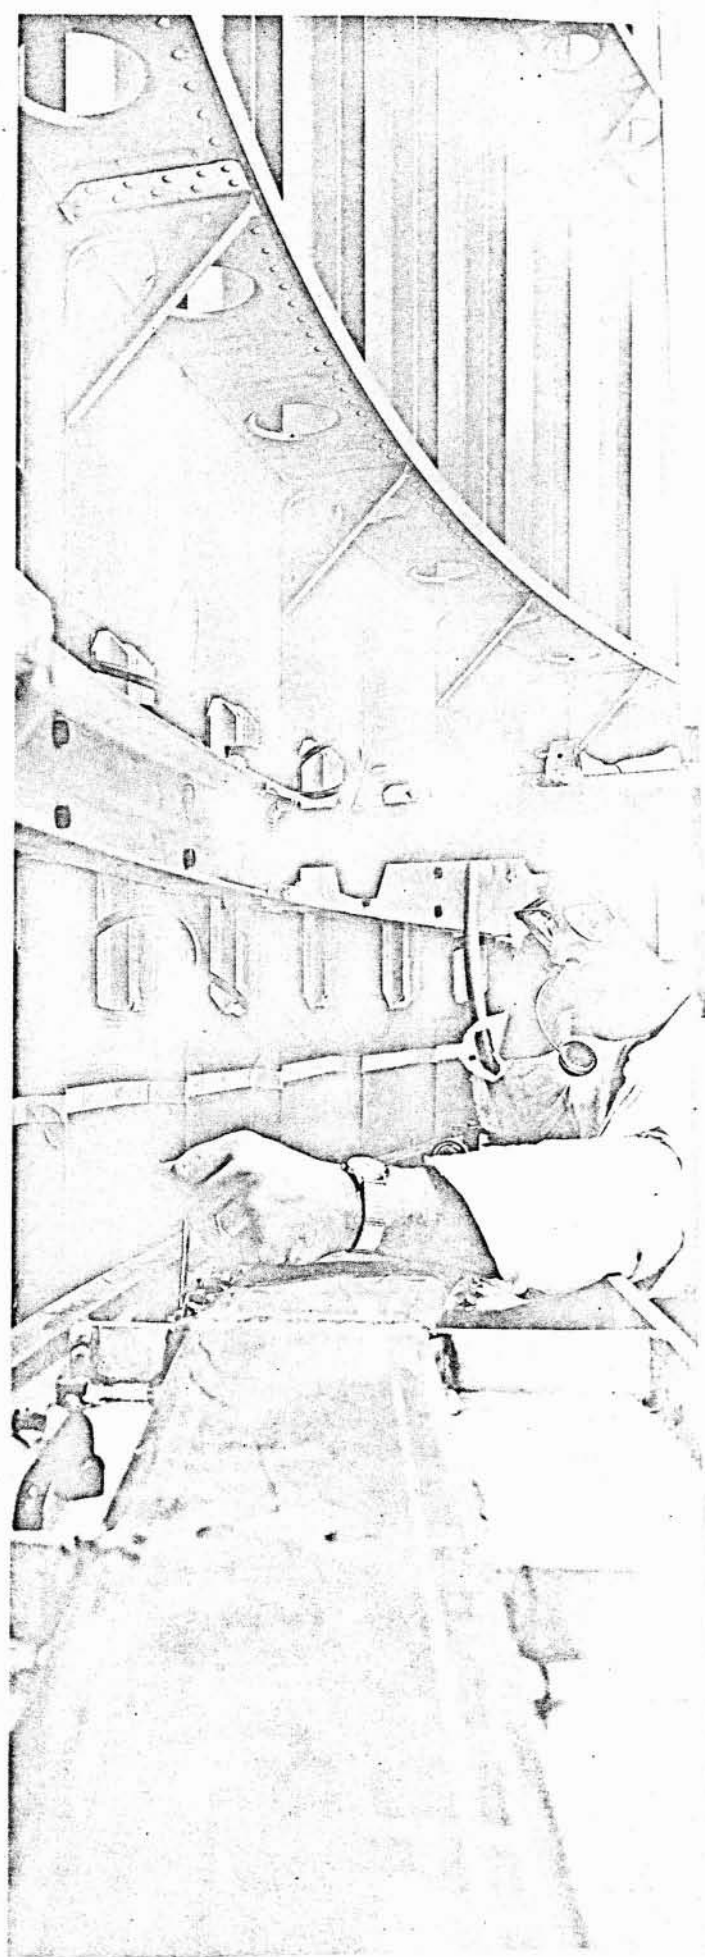
Intermediate bulkhead panels are welded to thicker, waffled outboard panels, right, at L.A. Division, then sent to Seal Beach.

The Saturn V second stage is made of dozens of panels and frames, which, joined together, become cylinders and bulkheads, and ultimately full-size tanks. Some of the work begins at the Los Angeles Division. Here, intermediate bulkhead panels are welded to thicker, waffled outboard panels, and are sent to Seal Beach. There are a dozen panels for each bulkhead and they are joined, two at a time. Picture sections of an orange that are regrouped and you have a fair idea of how the operation works. Bulkhead panels are called gore sections, and they are clamped vise-like into a fixed position by a clamshell beam. The welding torch is mounted on a skate track on the outside of the structure. Like a miniature locomotive moving at a precise, geared speed, it rides upward, 12 to 20 feet, uniting the two pieces of metal by heating them to a melting temperature that causes fusion. This is called meridian welding. The ingenious skate, which moves vertically or horizontally, on straight lines or around curves, trims, welds and x-rays in sequence as it goes.

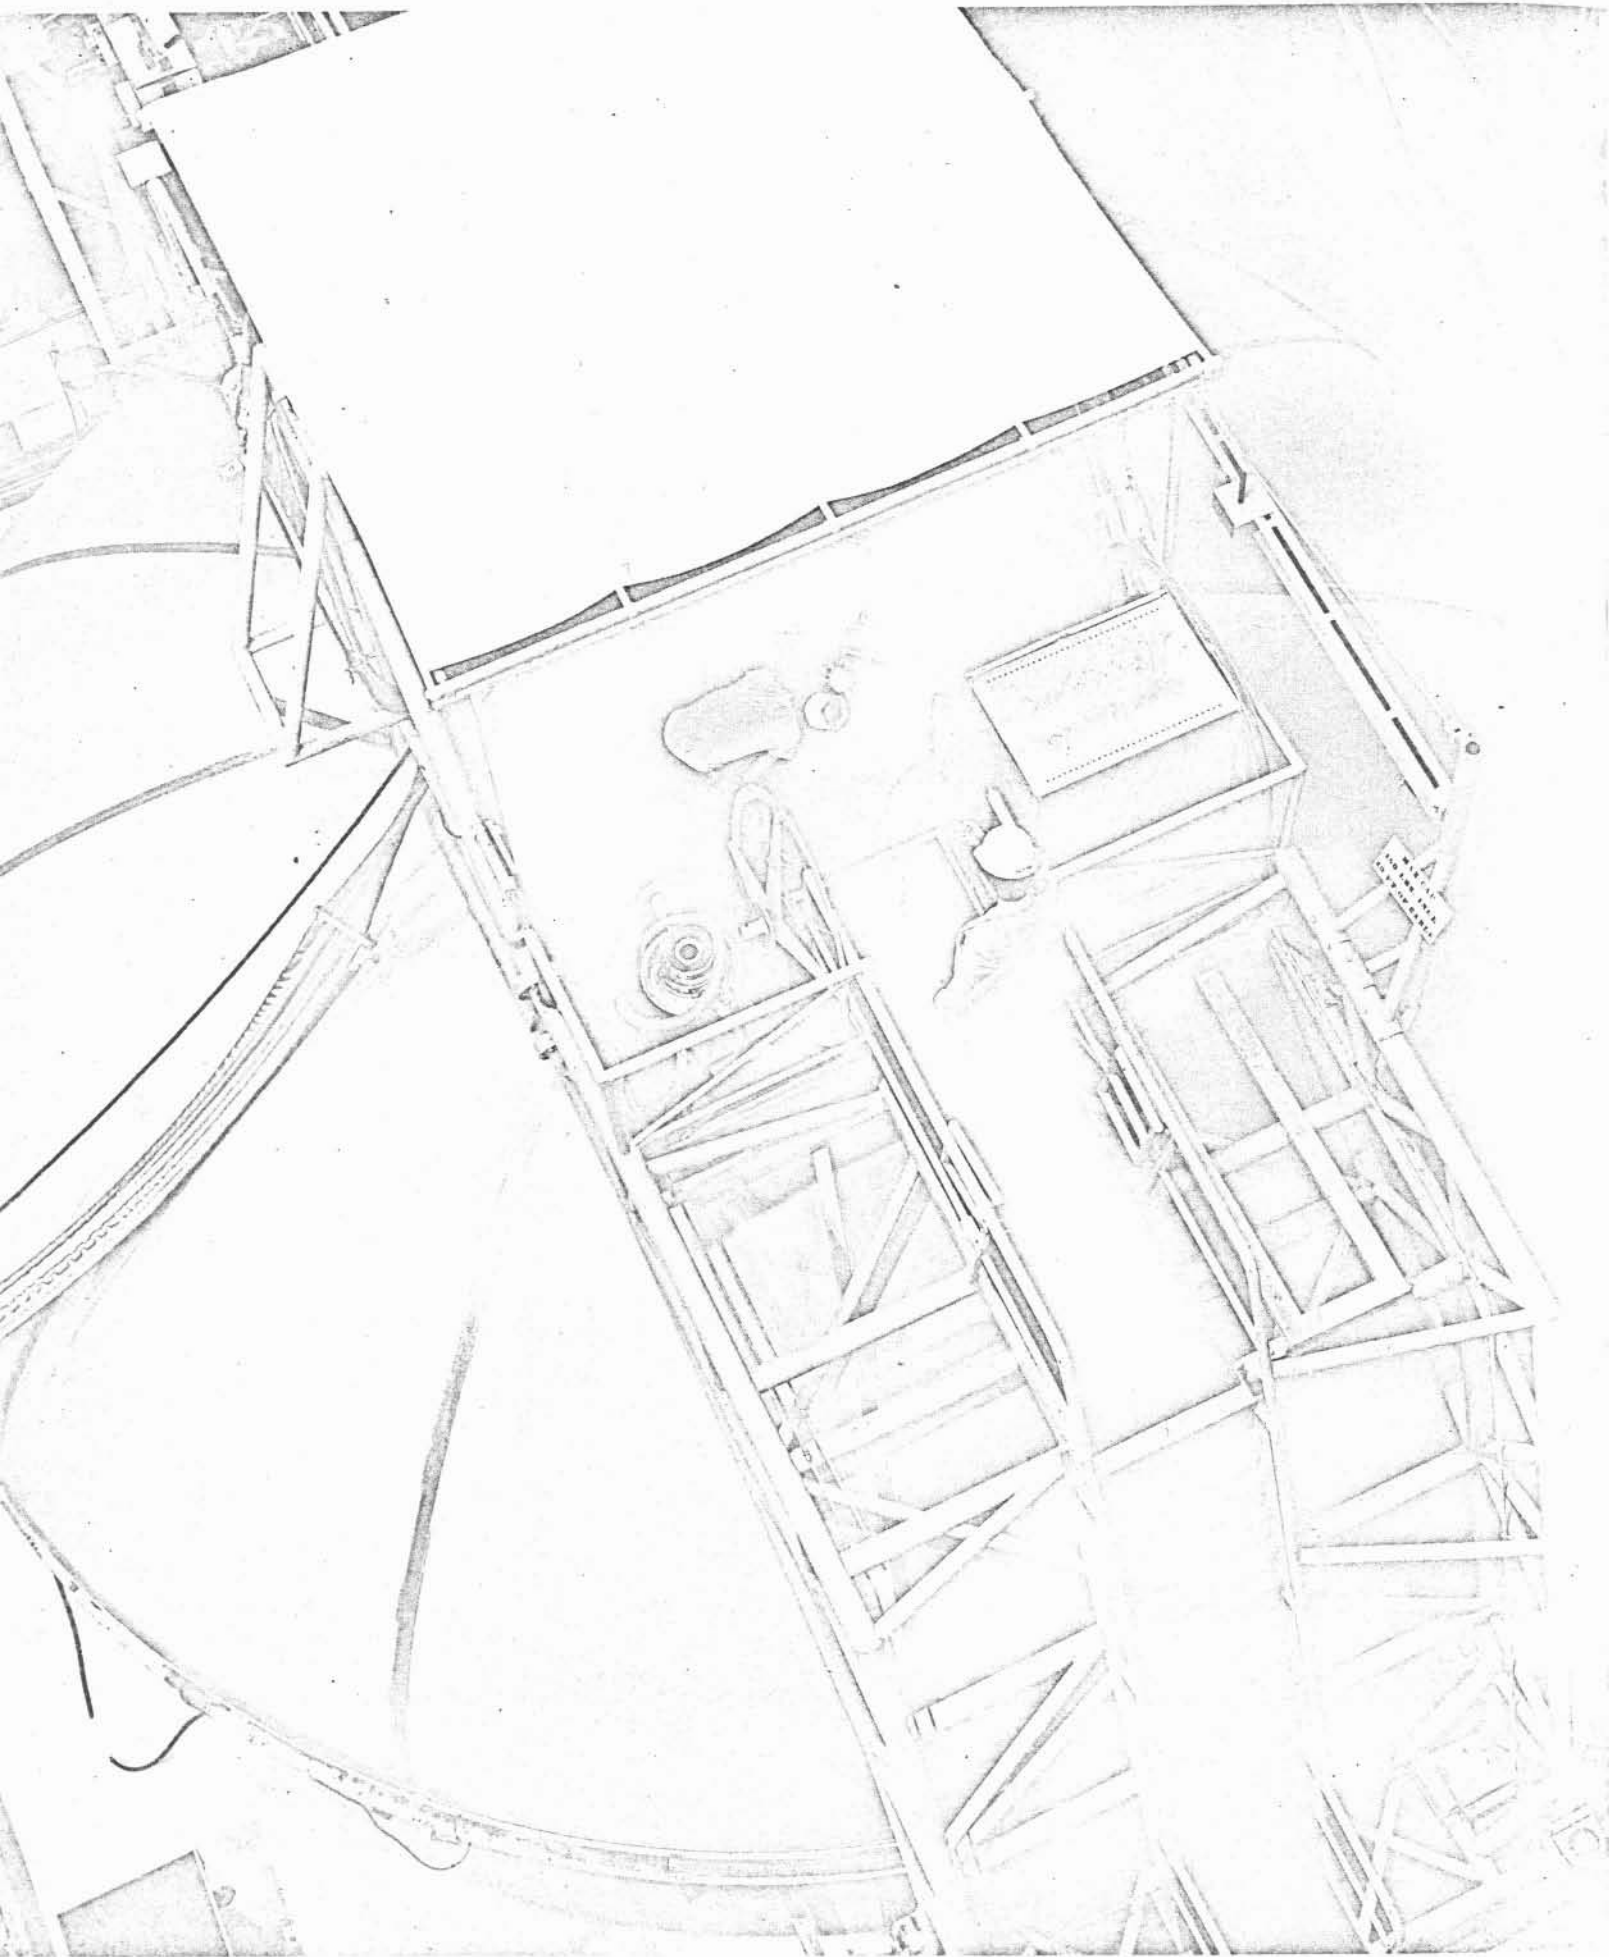
To match cylinders within thousands of an inch, backup bars, far right, were redesigned with a built-in flexibility. Spaced screws can be alternately tightened or loosened until the cylinders mesh perfectly.

The solution? Backup bars which are placed inside the stage during the alignment process were redesigned with individual screws spaced every few inches, thus giving the bars a built-in adjustability. The screws can be alternately tightened or loosened until the bulkhead and cylinder mesh perfectly.
