PROPULSION AND VEHICLE
ENGINEERING LABORATORY

MONTHLY PROGRESS REPORT

November 1, 1967, Through November 30, 1967

MPR-P&VE-67-11

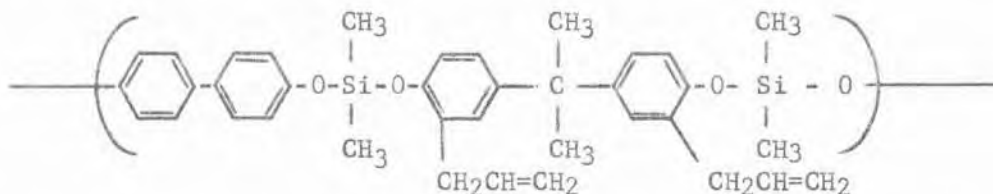
The previous crosslinking studies of an aryloxysilane polymer modified by incorporation of an allyl-containing diol,

showed that 25 mole percent of the olefin-bearing monomer is sufficient to yield a crosslinked polymer which is infusible at 250°C. A modified aryloxysilane polymer illustrated below,

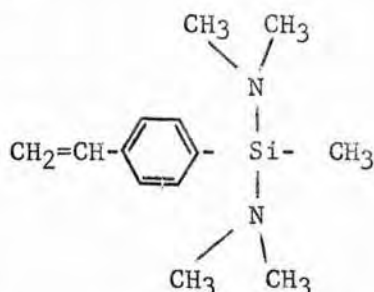
Current attempts to vulcanize or crosslink the polysilphenylenesiloxane elastomer by way of a millable formulation have been directed toward incorporation of a small number of *p*-styryl groups along the polymer chain. The preparation of a suitable comonomer, *p*-vinylphenylmethyl-bis-(dimethylamino)silane,

has been attempted by condensation of the Grignard reagent of *p*-bromostyrene with excess trichloromethylsilane and subsequent treatment of this condensation product with dimethylamine. A pale yellow oil, boiling at 94-98°C/0.5 torr, has been recovered and is presently being characterized. The styryl group has a considerably higher reactivity toward peroxide initiated addition polymerization than the $-\text{Si}-\text{CH}=\text{CH}_2$ or $-\text{C}_6\text{H}_5-\text{CH}_2\text{CH}=\text{CH}_2$ groups, and silphenylenesiloxane polymers containing the styryl configuration should be more readily crosslinked with standard peroxide catalysts.
