Re: 1850's Unitarian Church Exterior Restoration
Project No. 96072

Re: Circa 1851 Unitarian Church
Project 96072

Re: Circa 1851 Unitarian Church
Project No. 96072

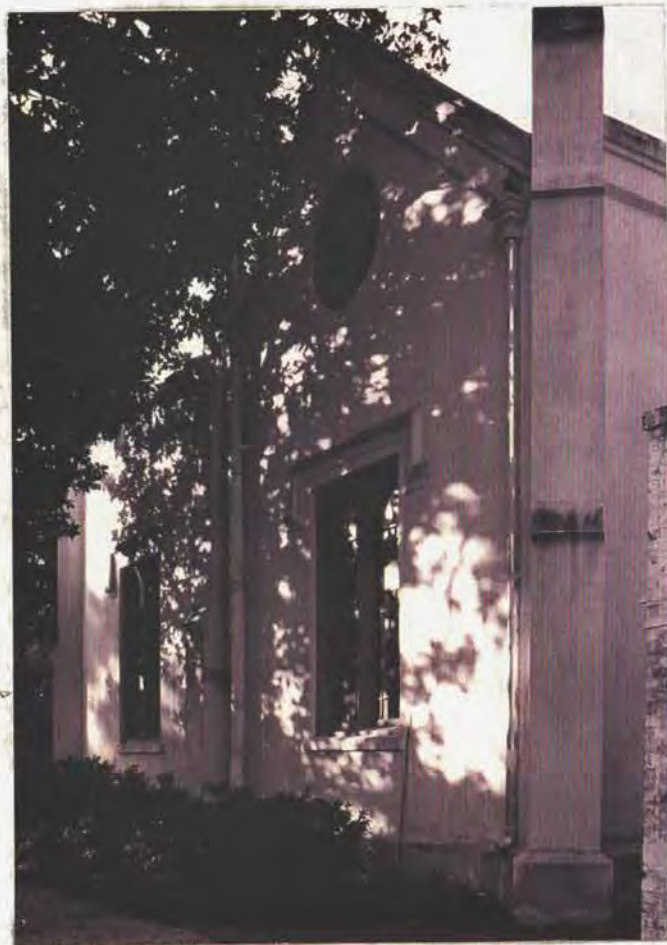
leaves on
soil

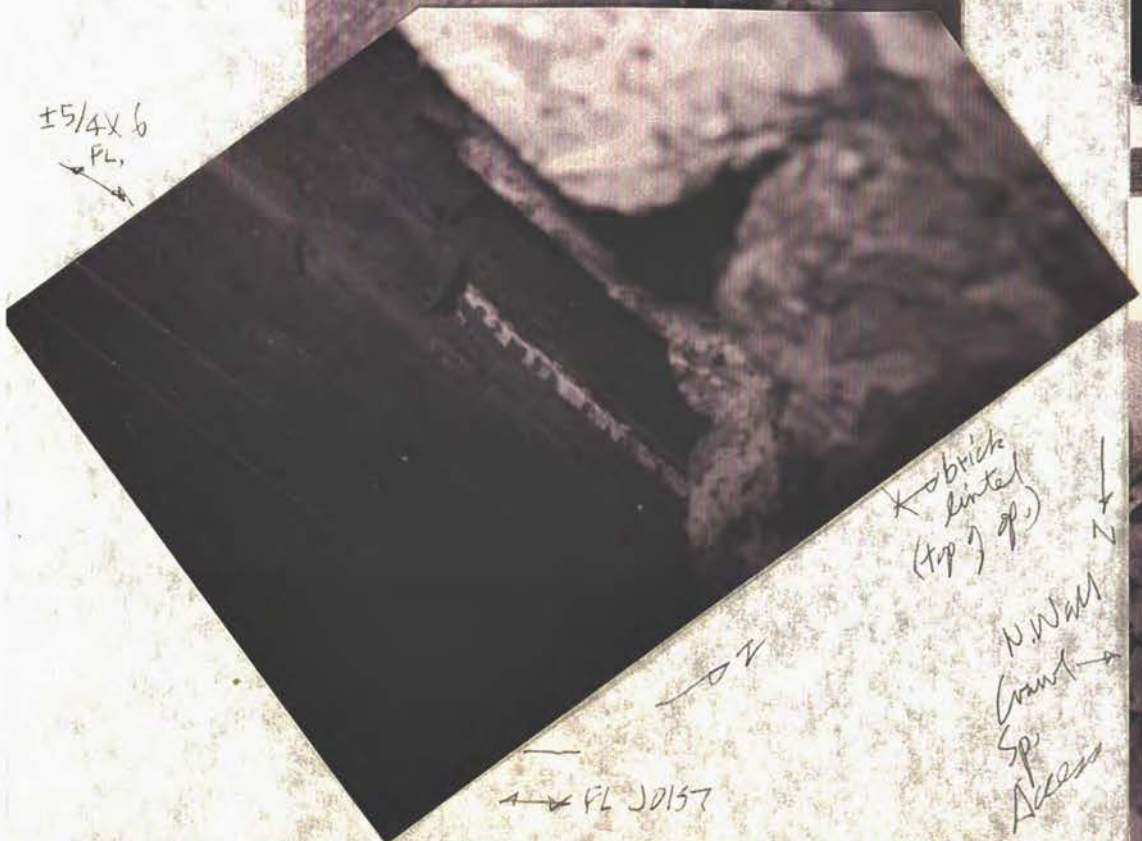
N.W. Wall
Crawl
Sp.
Access

← brick
lintel
(top of op.)

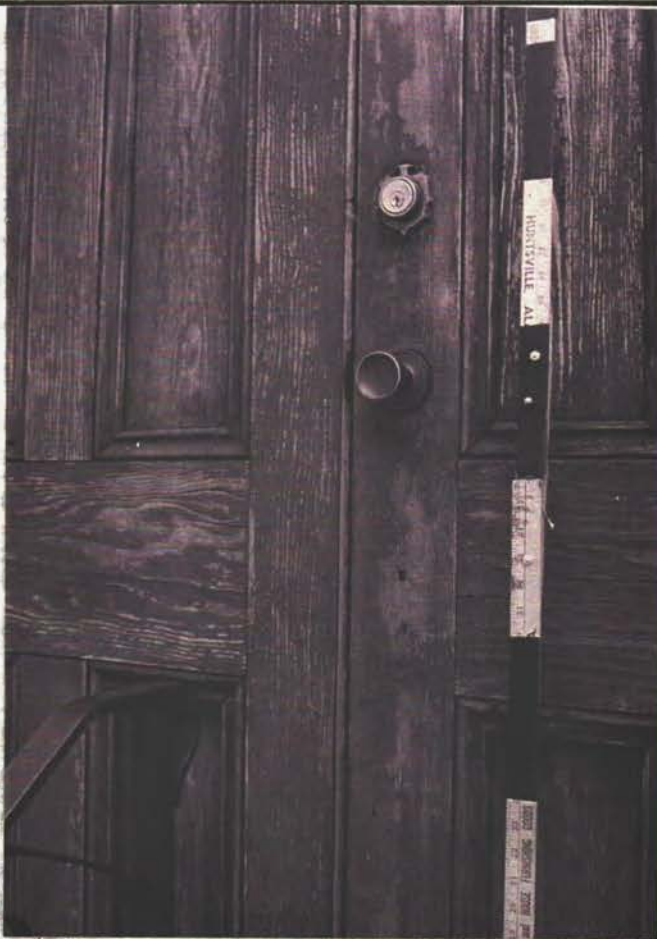
12. The east front doors are apparently circa 1950-70 (wire nails, blind tenons, fast-growth pine, varnish finish). The two bottom hinges are of c.1850 unitary cast-iron "fast-pin" fabrication, with some modern and some original screws. The two top hinges are much later, of steel. The entry locksets are tulip-knob types typical of the mid-20th century, and should be replaced with an appropriate type.

c. 1950-60's front door (first - front with pine, birch mortise, wire rails, "tulip" knobs)

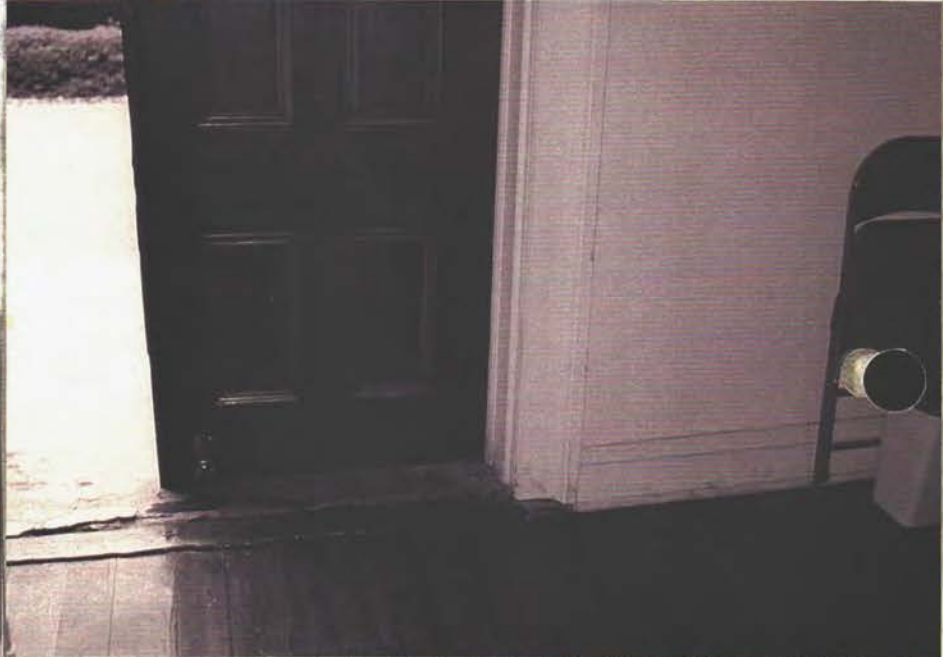
* PATCH AT ORIG. HINGE CUT

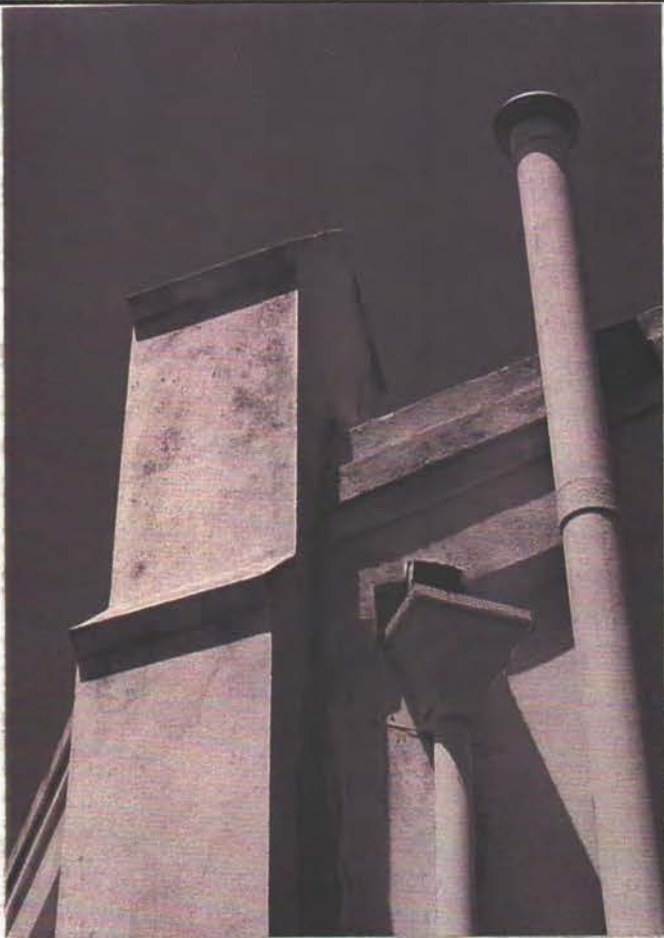
S.W. Buttress

gas vent

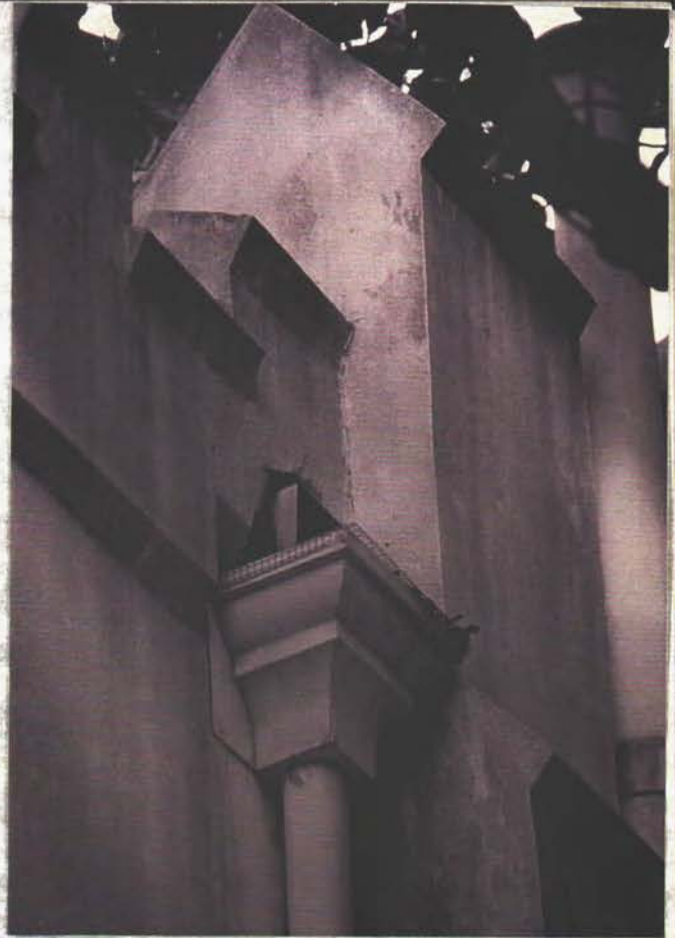
N. Cent. Buttress

gas vent

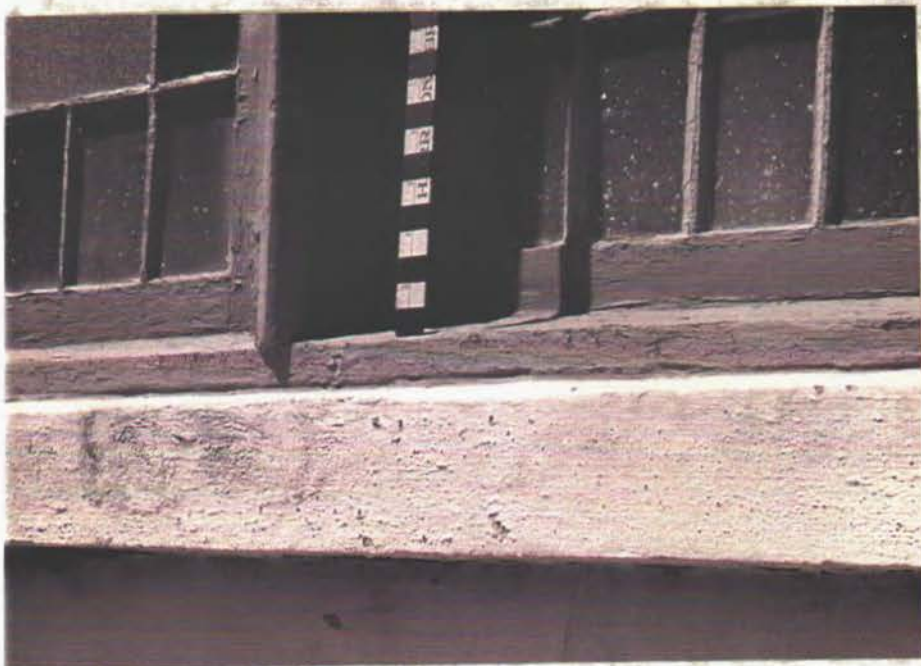
S. Sash (later sashes, orig frames & trim)

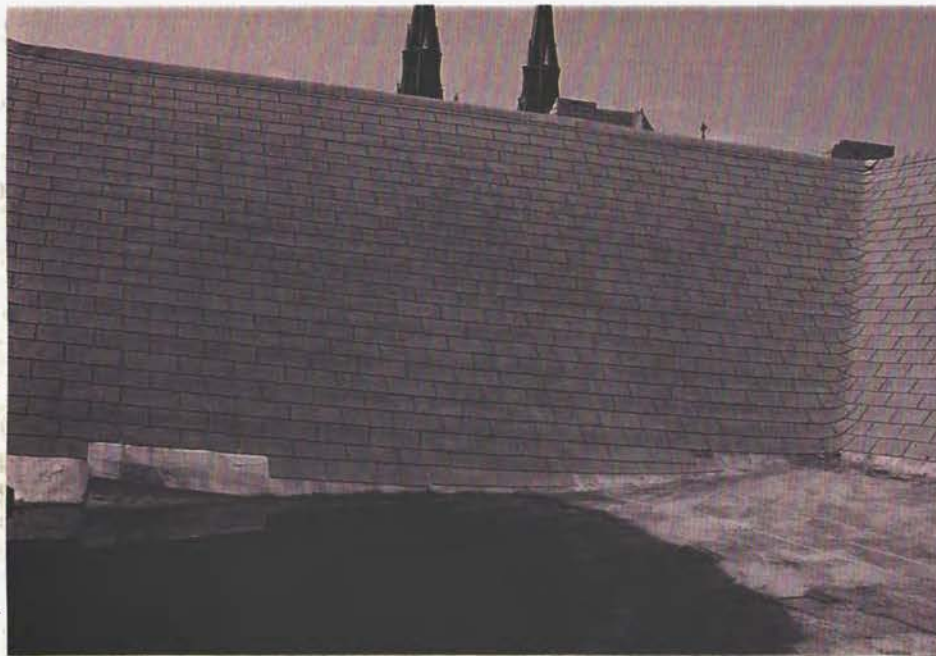
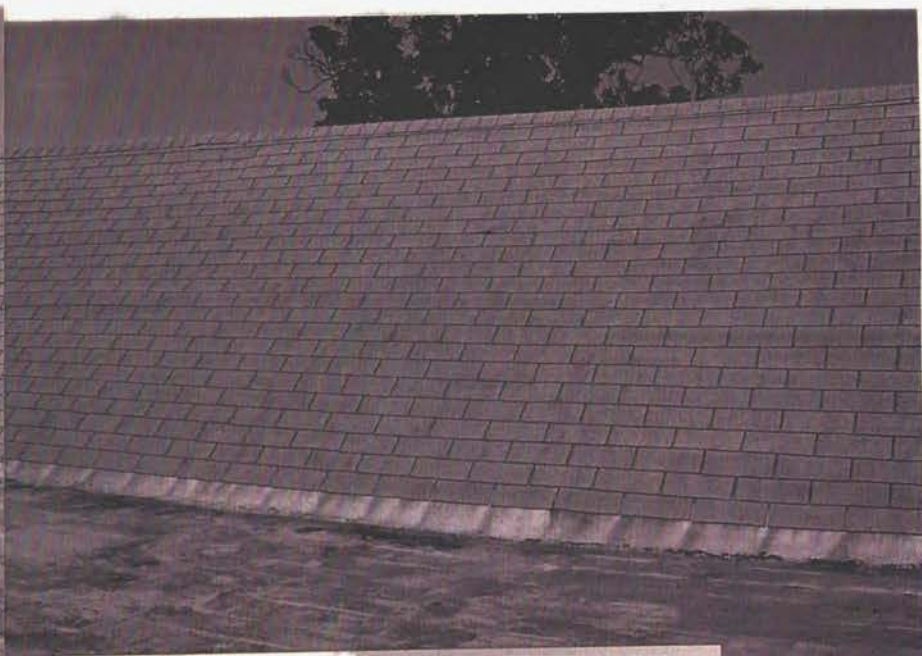
S.E.
Corner
of Street

pond 12th d.
last year

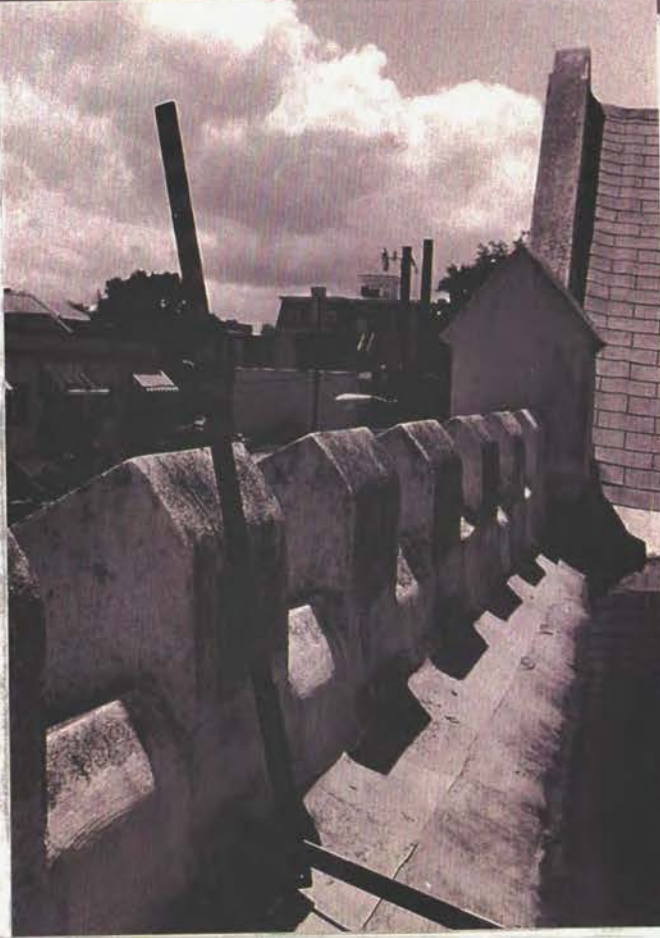
S.W. of
Street!

pond

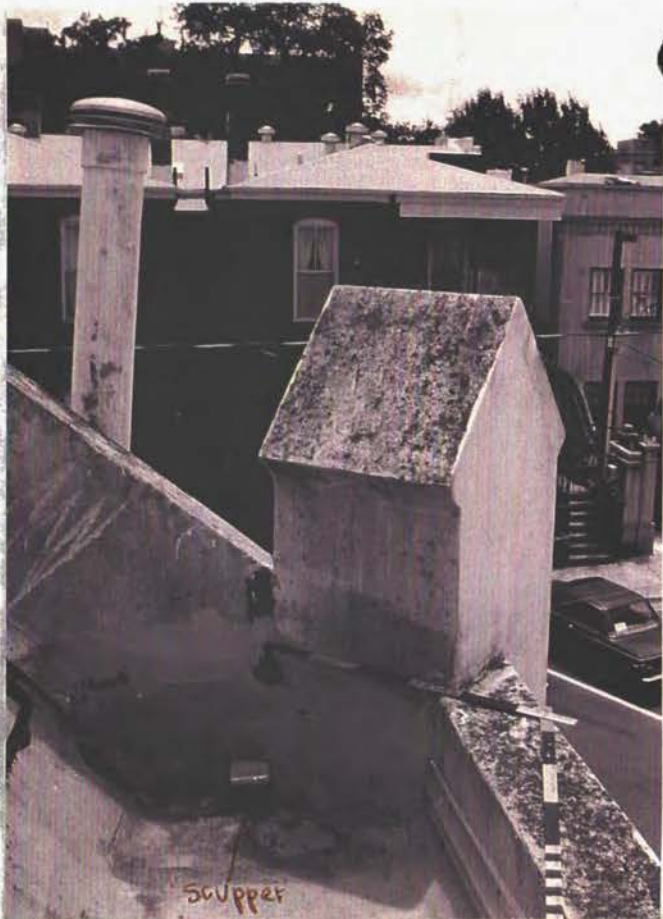
rusty
gutter
flash

scupper

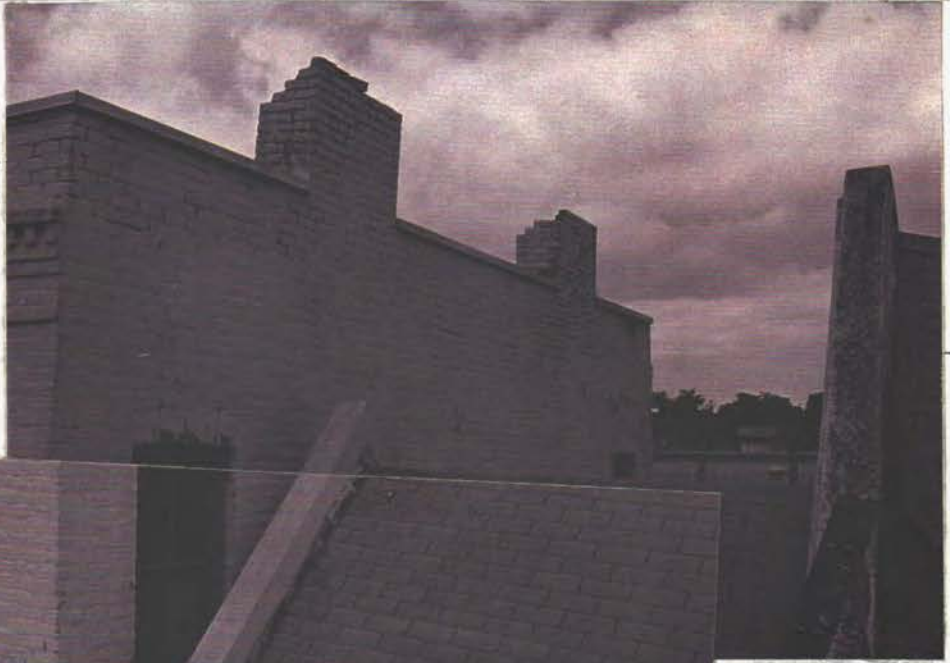
$\pm 18''$ w. slot
between cornice
1870 manse

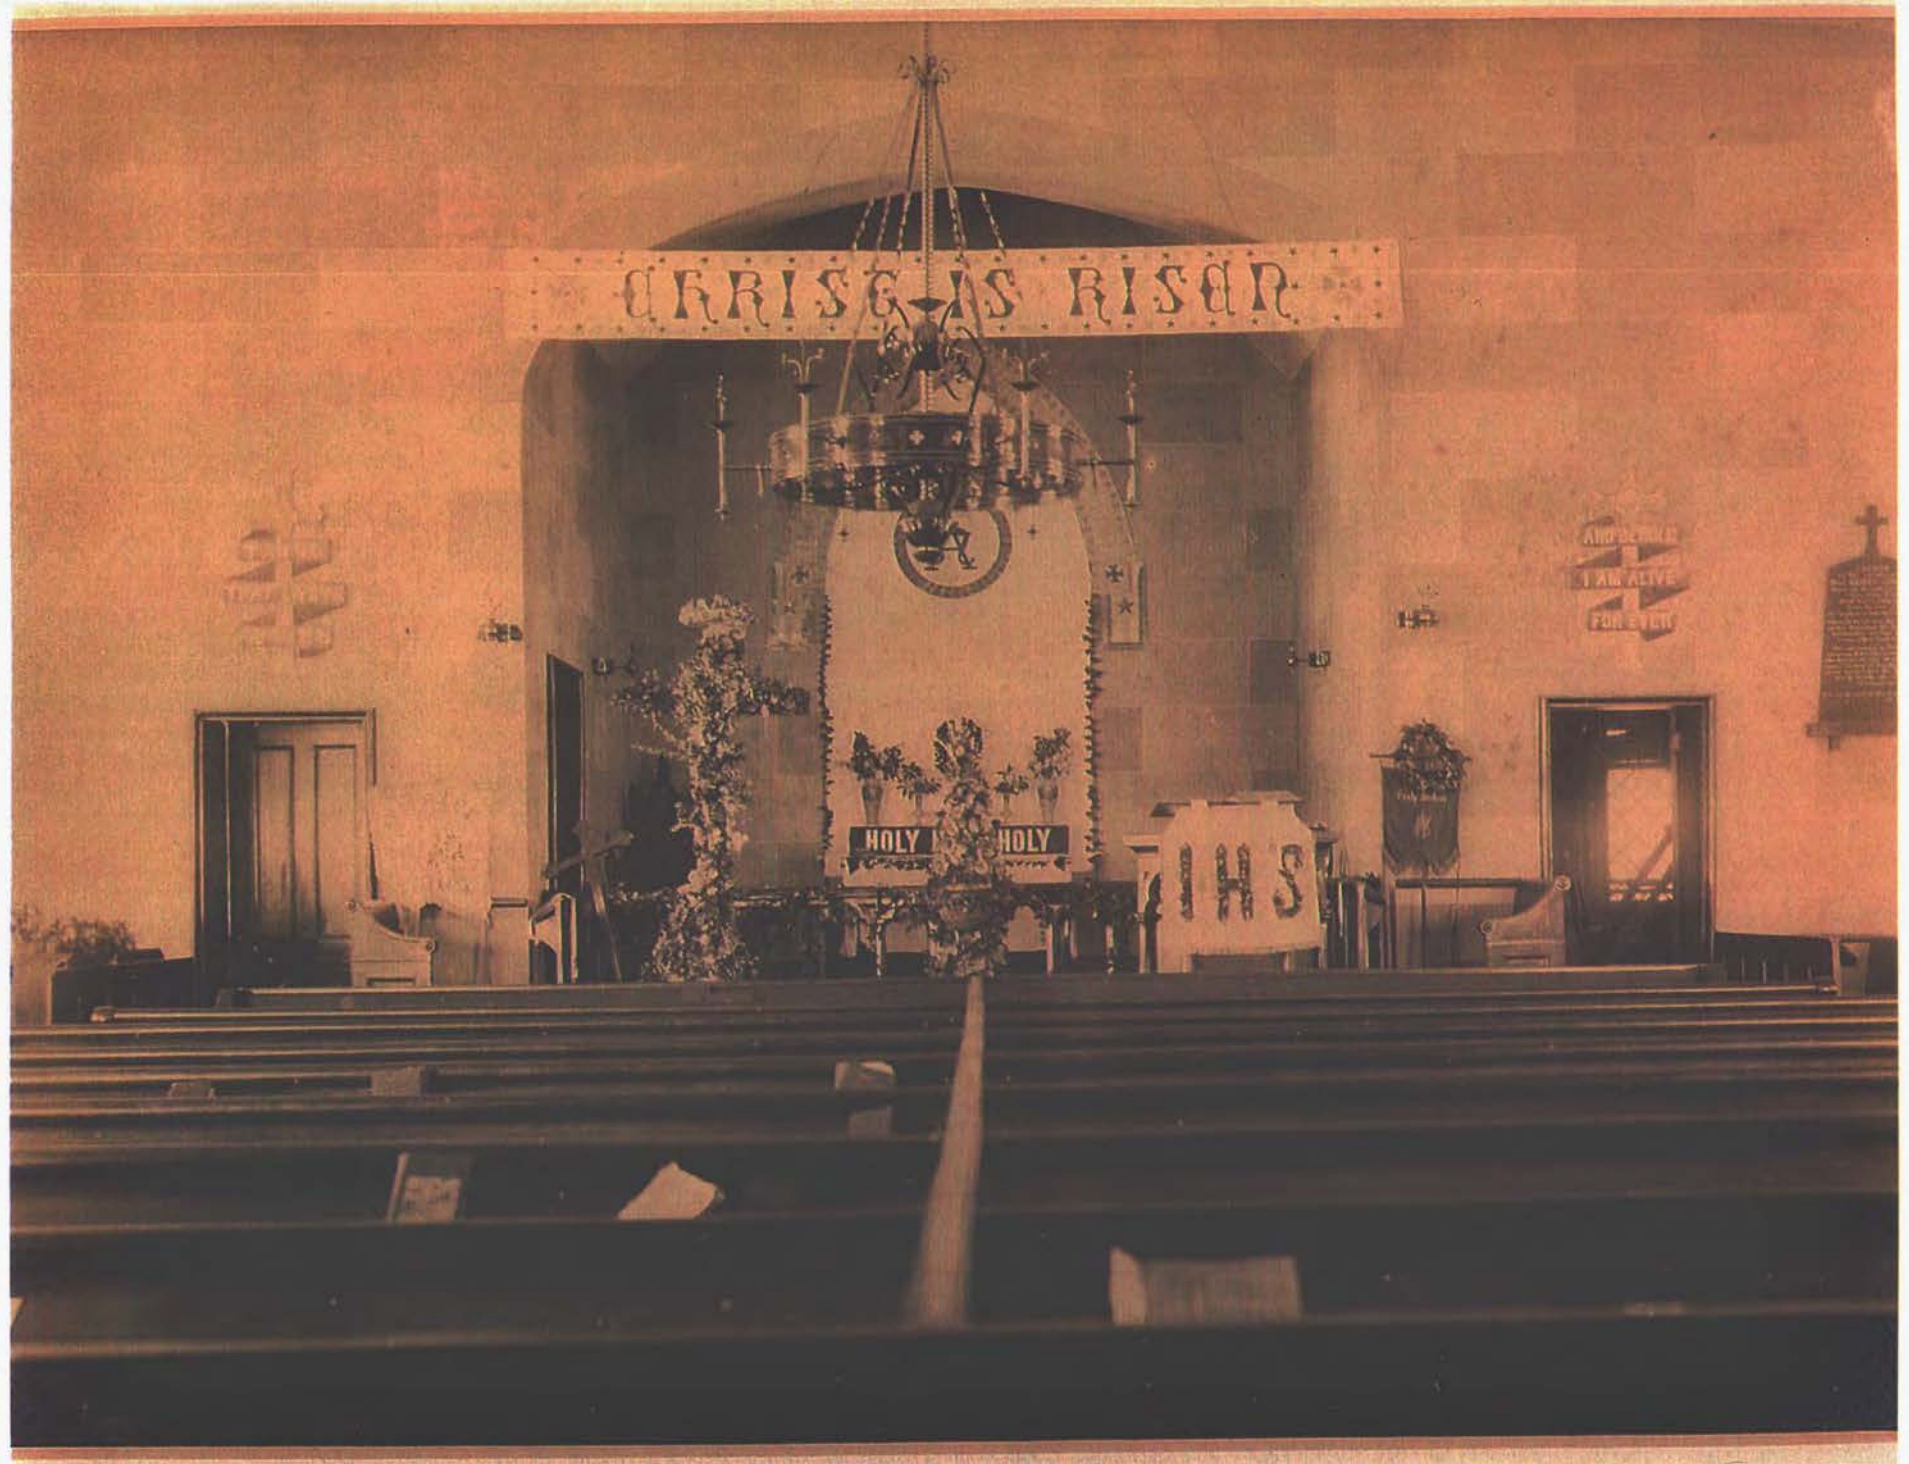
2. Kite design of glass set in a window

Lts = yucc
c. 1920s
Art Deco

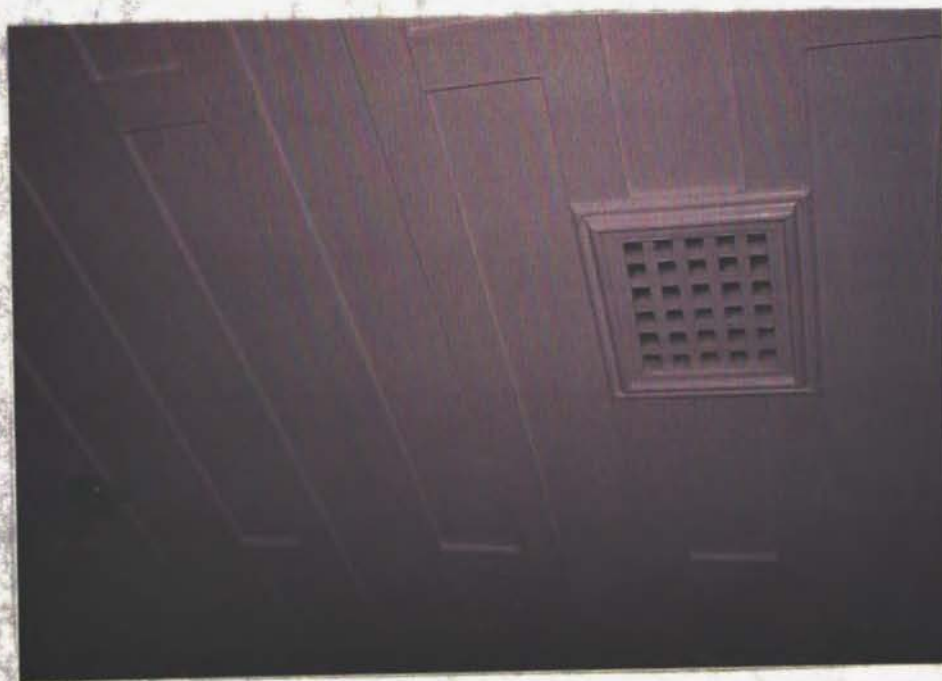
NOTE
 $\pm 3'' - 5''$
 SAG
 ↙

Orig. ceil. was plaster of rotary - some lath, pale pink paint
 (STW in place in attic).
 This cell perhaps ca 1870. Plaster ceil. probably cracked
 soon & repaired due to way roof was framed.

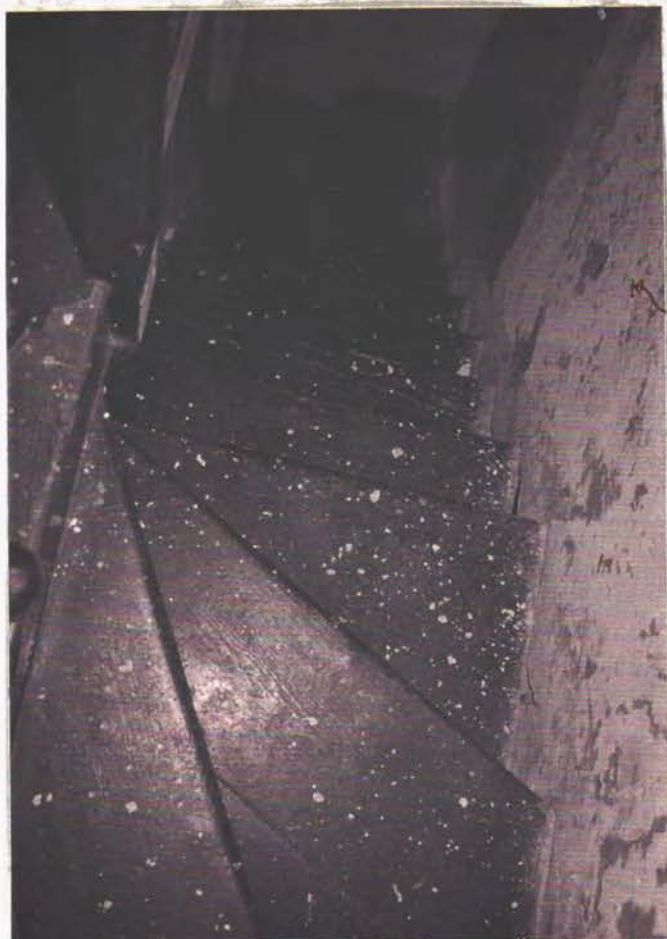
"Ashlin" saw lines still visible in plaster
↙

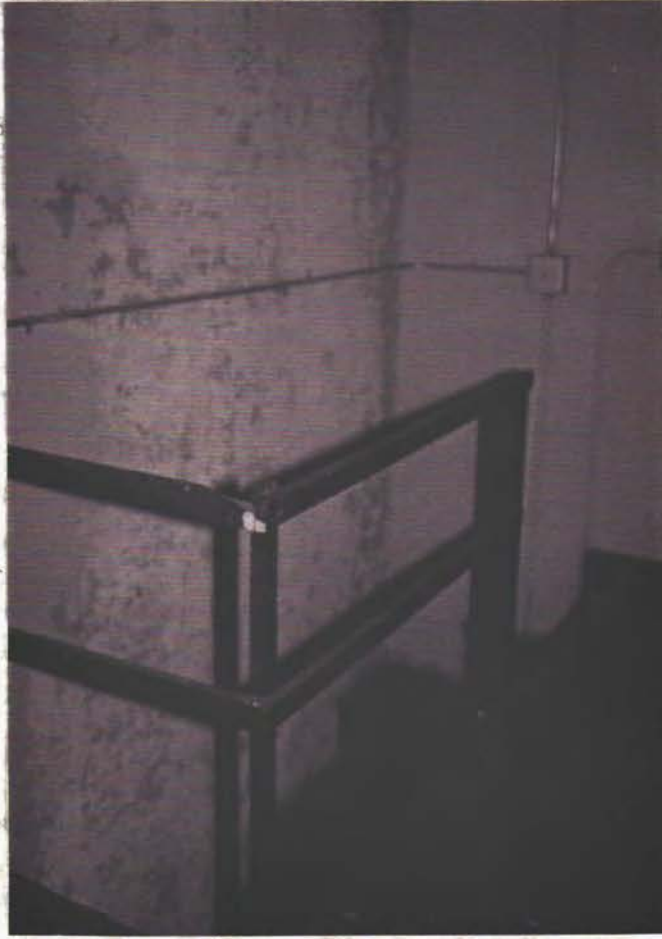
Rail probably orig. (?)

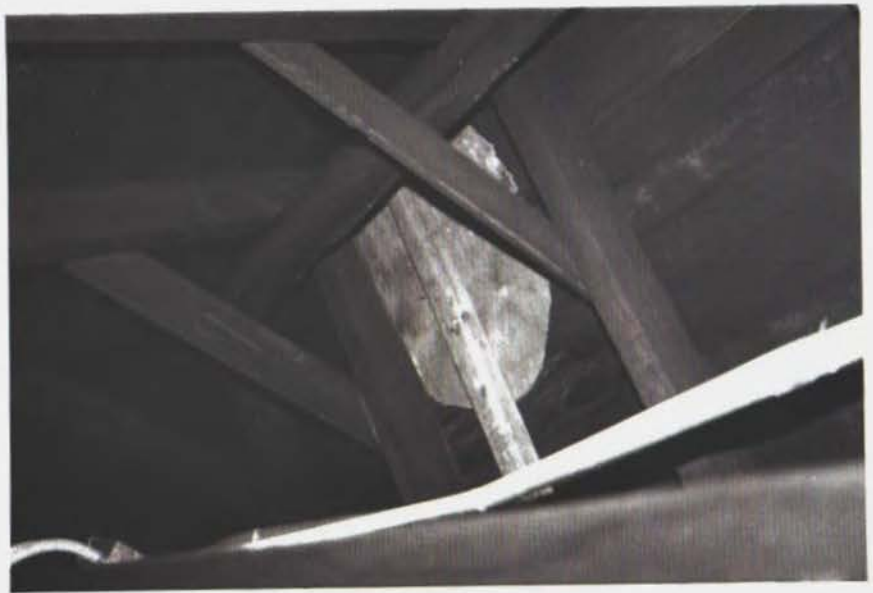
Sect. looking west
N76

Ceiling Joists
2x6 @ 12"

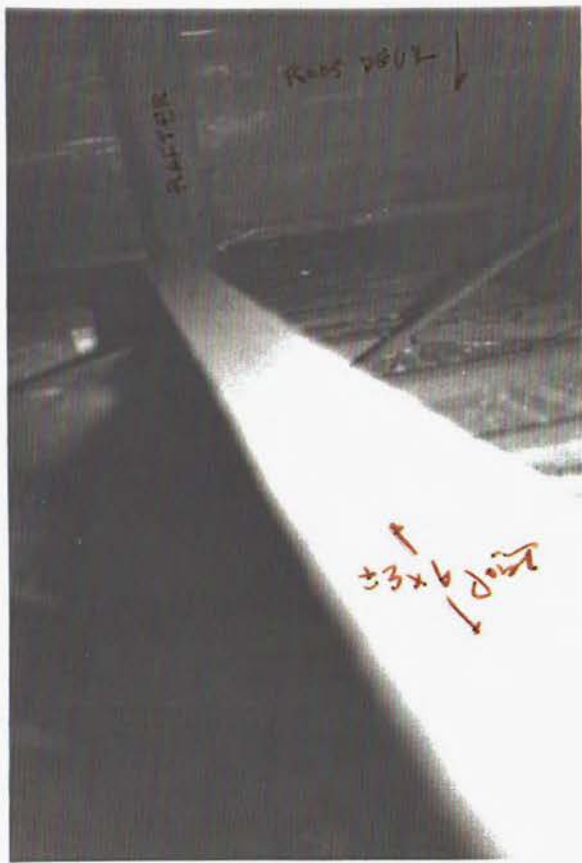
1851 wood lath (rotting some)
→ plaster & lt. pink paint

← air vent (see rt. cell)

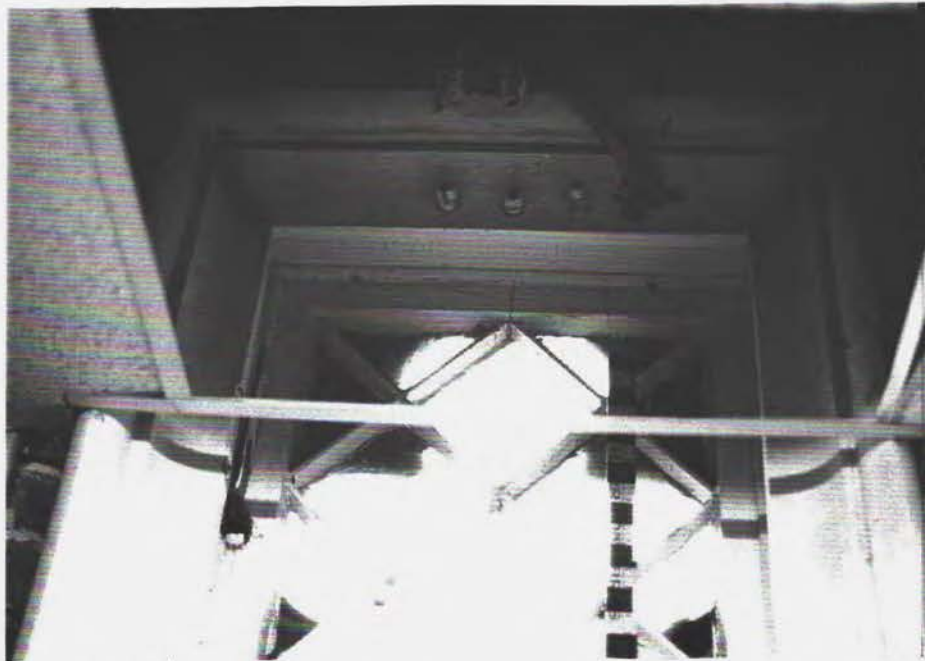
ONLY original sash, per hist. photo (diamond) - paneled.
This is in west wall of S.W. anteroom.

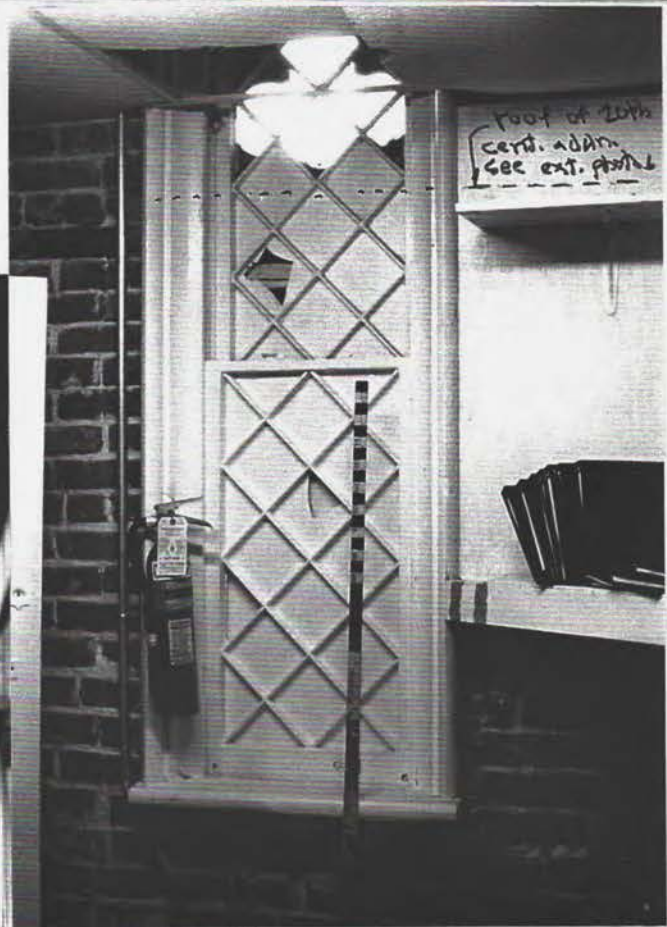
Original apte sash may be behind plaster in later baptistry (?)

Foot of 20th
cent. addn.
See ext. photo

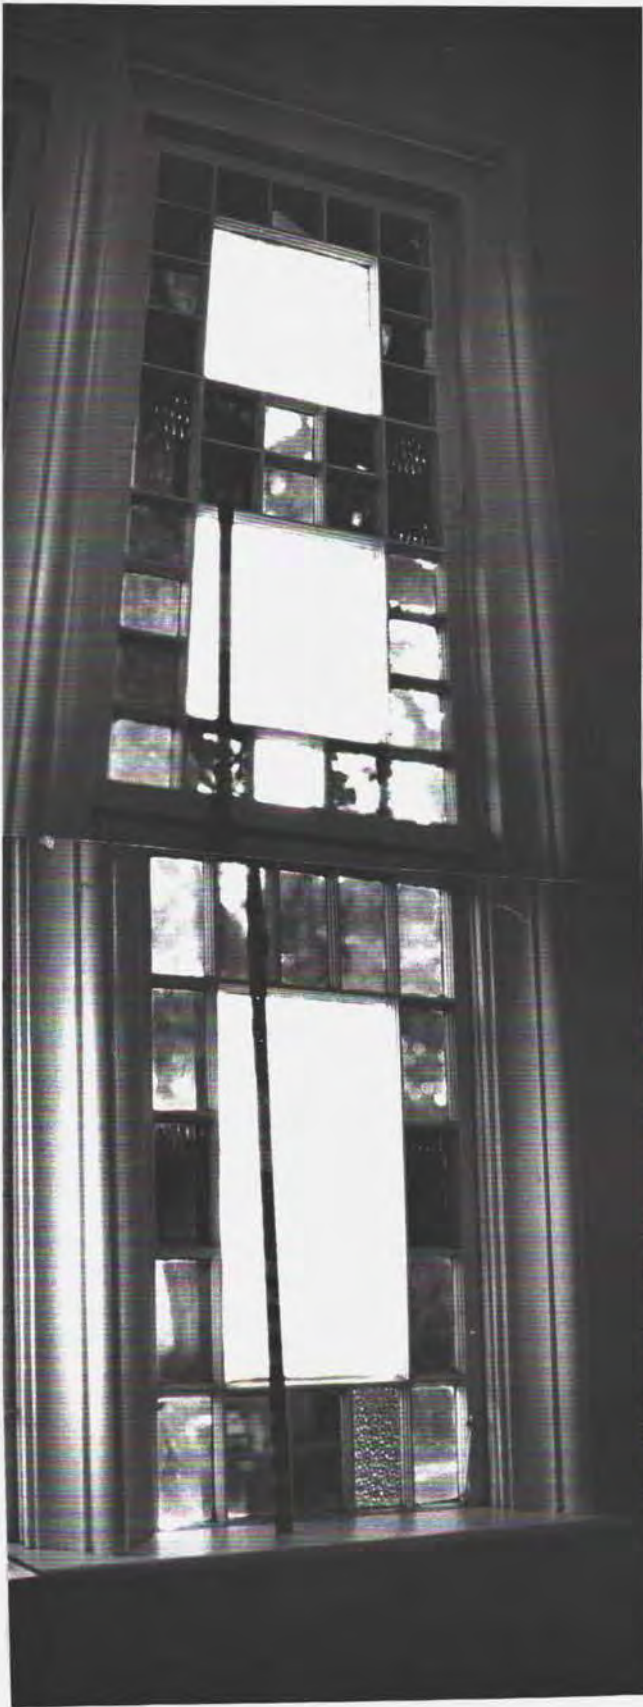
glass
has
harsh,
bright
lines
