CIRCA 1795 GEORGE SPENCER HOUSE
WARREN SQUARE, 22 HABERSHAM STREET
SAVANNAH, GEORGIA

Re: Mills Lane c.1795 Spencer House
Project No. 92013

Re: Stone and Spencer Houses
Project No.(s) 92012 & 92013

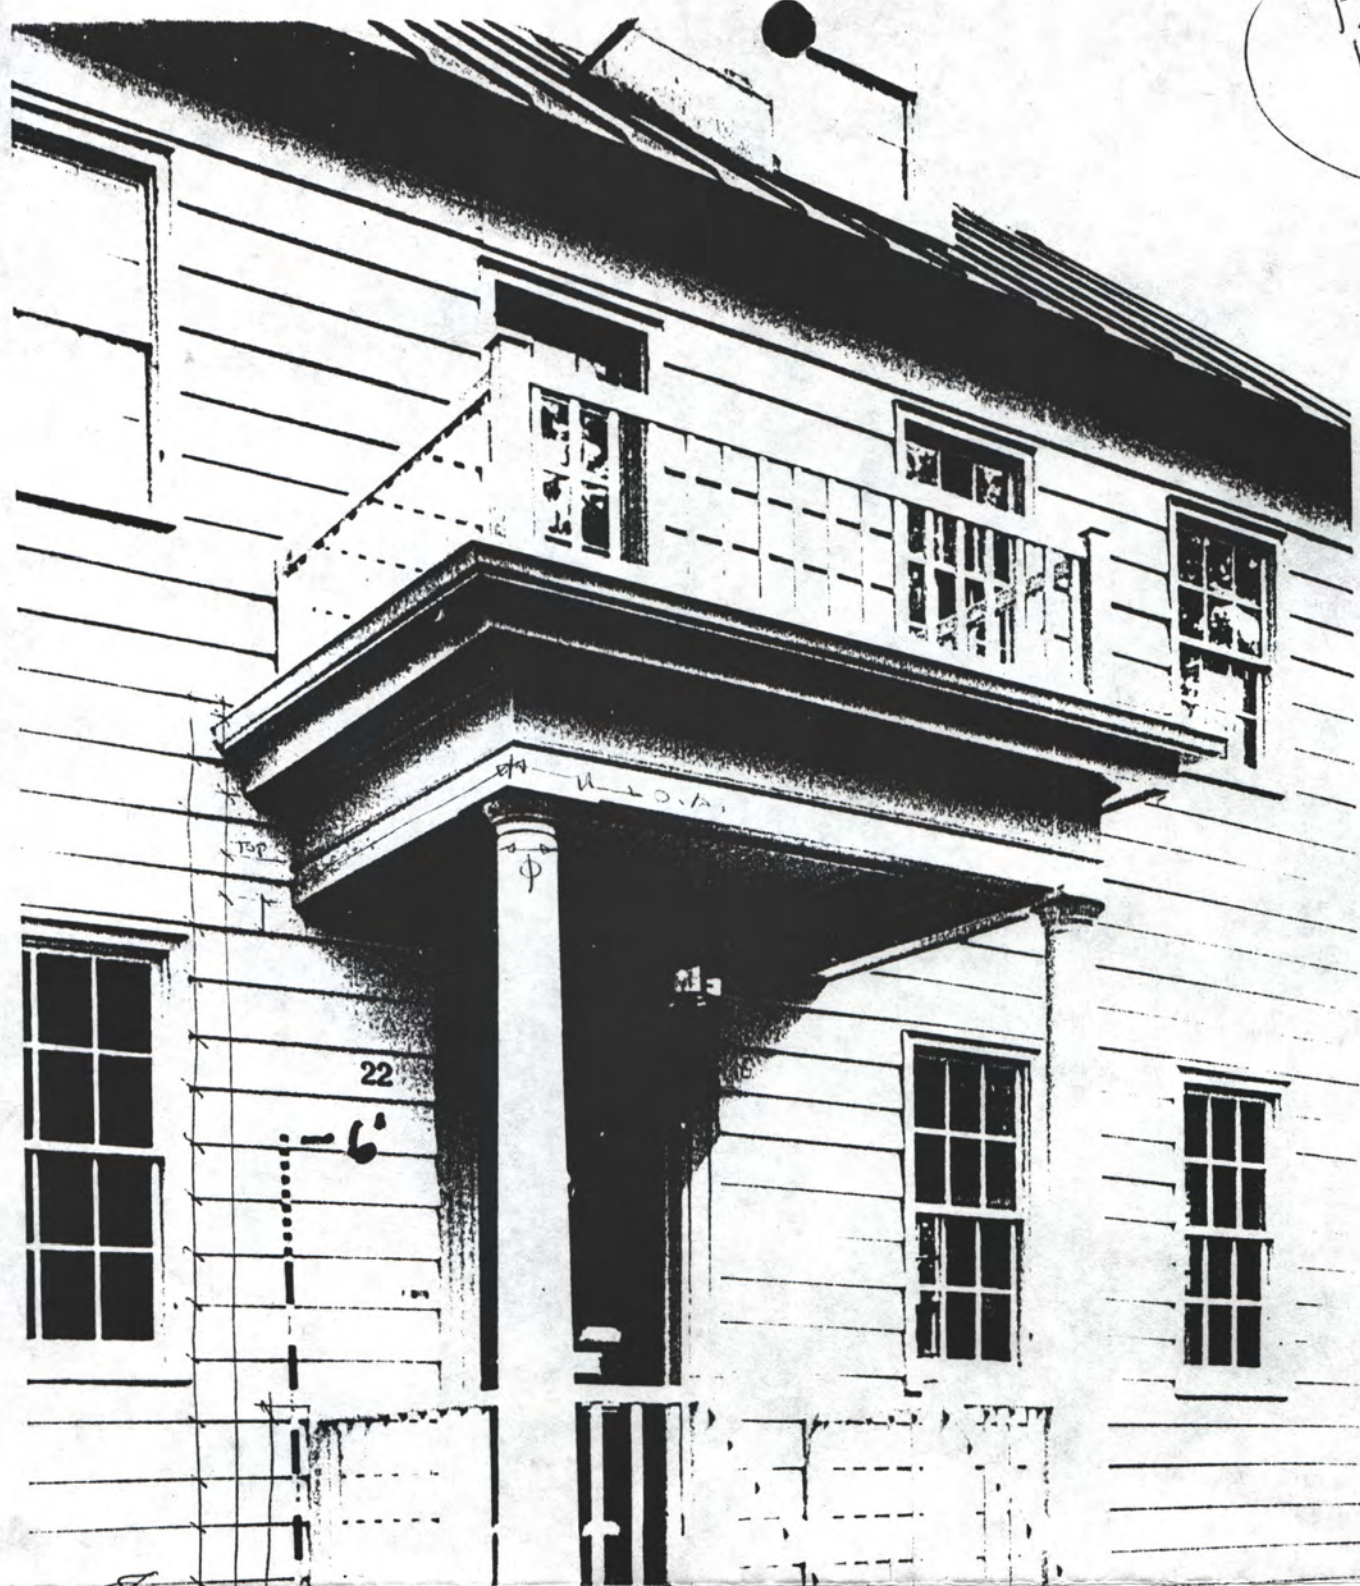
Portico
dimensions
needed
AP Jones
4 June 92

Vert.
Dims.
needed
+ need all other
plan dims. at
top + floor

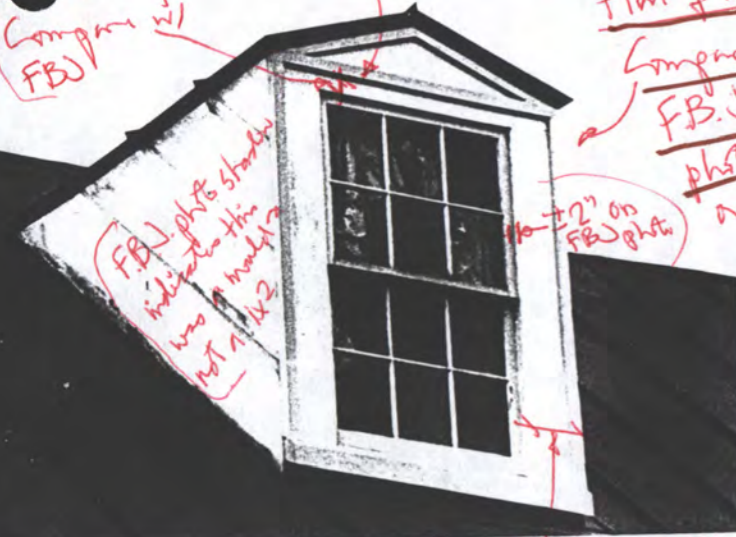
AD Jones
skinning.
Compare w/
FBJ

projections
 $\pm 1/4"$ on FBJ photo,
 $\pm 1/2"$ w.
AS REBUILT:
Dormer looks
flat & dead.
Compare w/
F.B. Johnston
photo for
original
config.

too wide. Compare w/ FBJ
note like this

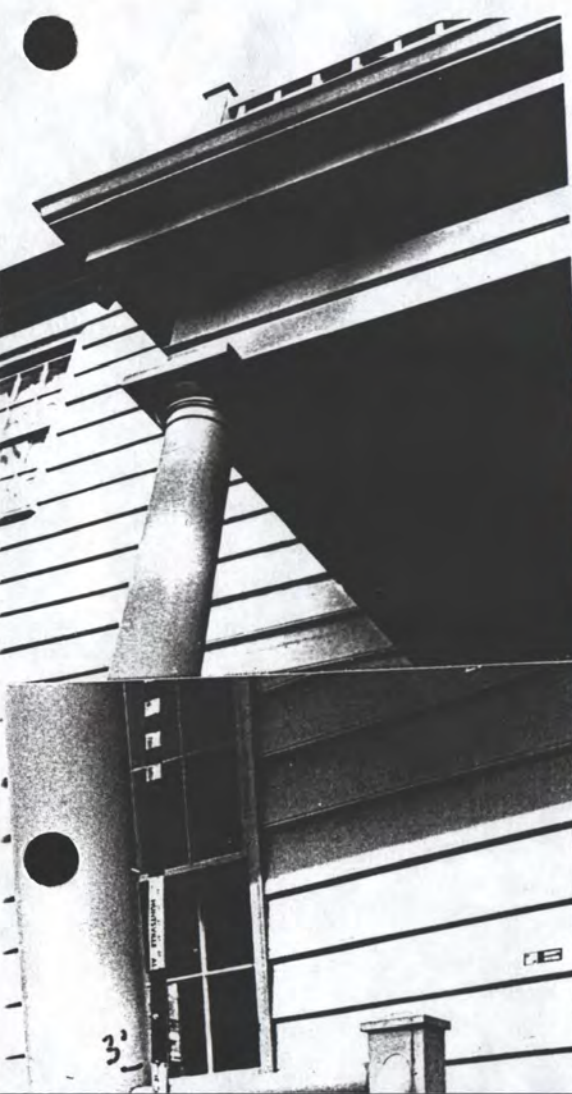
7 - width = good proportion, not like now
1 - shadow indicates this
is at least $1/4"$ deep,
looks much better
than present $3/4"$
2 - shadow indicates
sash is set back
2 or more inches
from face = much
better than present $3/8"$
3 - Note blind-hinges.
Do you want to
put blinds back on?

Rebuilt dormer
are poorly proportioned
while those
in the F.B. Johnston
photo. Would be
good to rebuild

Eave
is
approx 3"
wider than
FBJ photo
= too wide

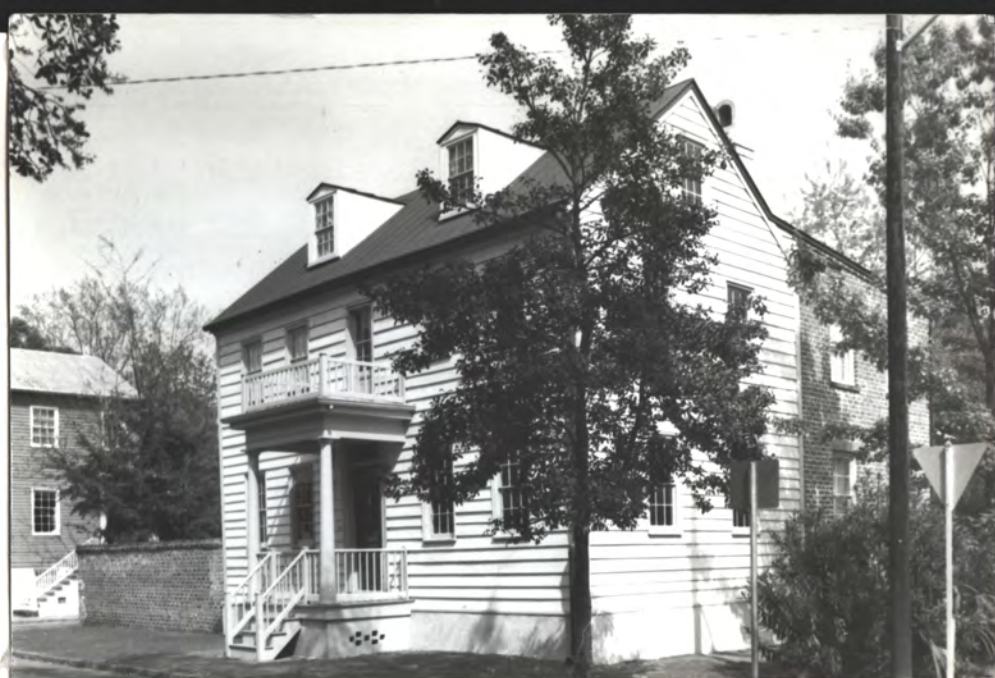
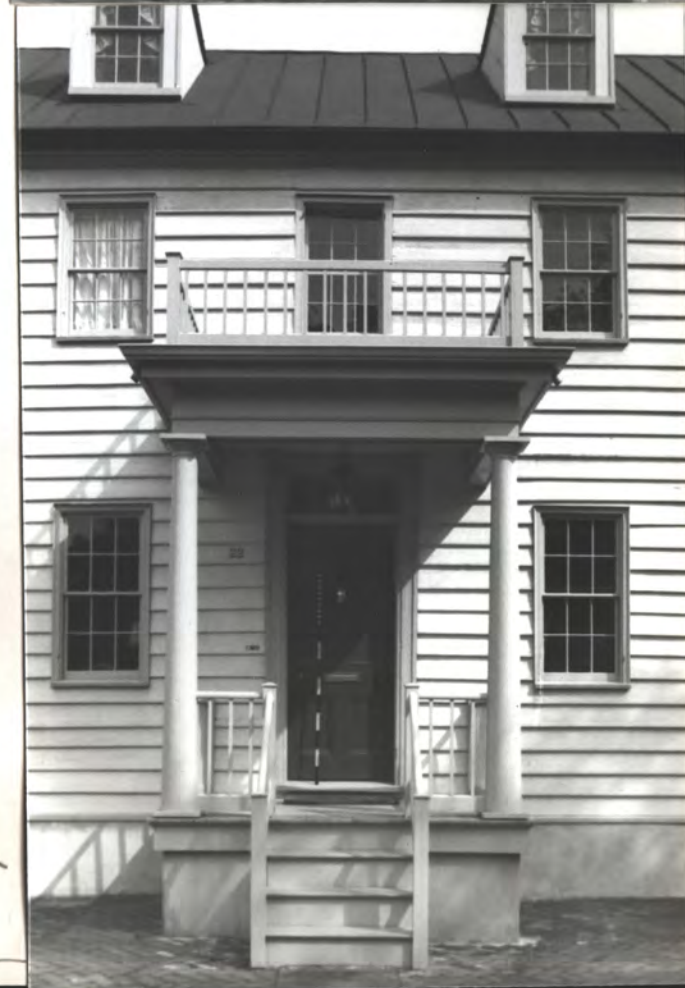
Mar.
1992
"before"
photos

fl. 2 door
& balustrade
at portico =
probably not
original
features
Roof proportions
not per 1920's
Frances Benjamin
Johnston photo

Compare w/ 1920's Frances Benjamin Johnston photo
U = too wide, too short, such not necessary

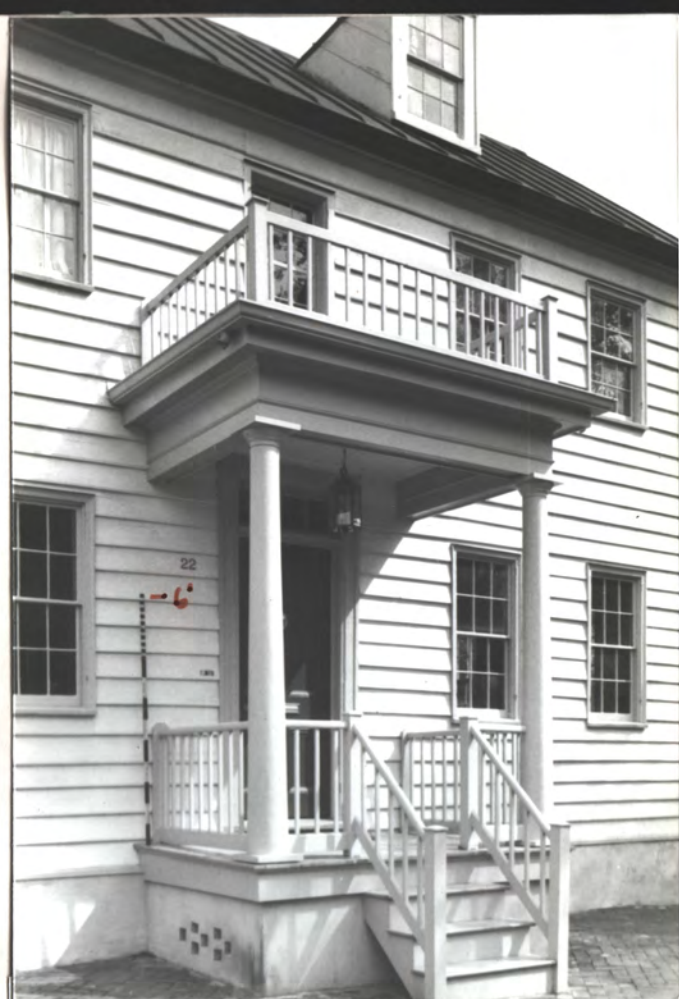
A ←
 Col. are
 solid wood
 = probably
 original to
 this stoop
 = early 19th cent.
 address per Larin
 Lenka research
 K
 Balustrade
 = c. 1988 by
 J. Lenka
 + see 1930's
 photos
 4

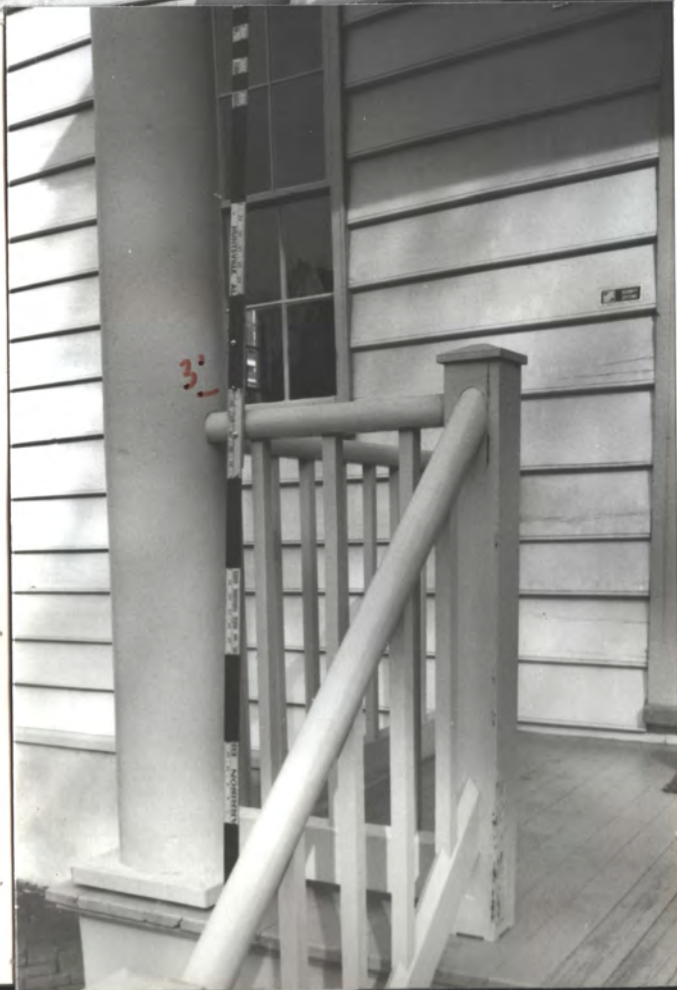
N
 ←
 narrow-bd.
 (50 ft) = 1960's
 modern

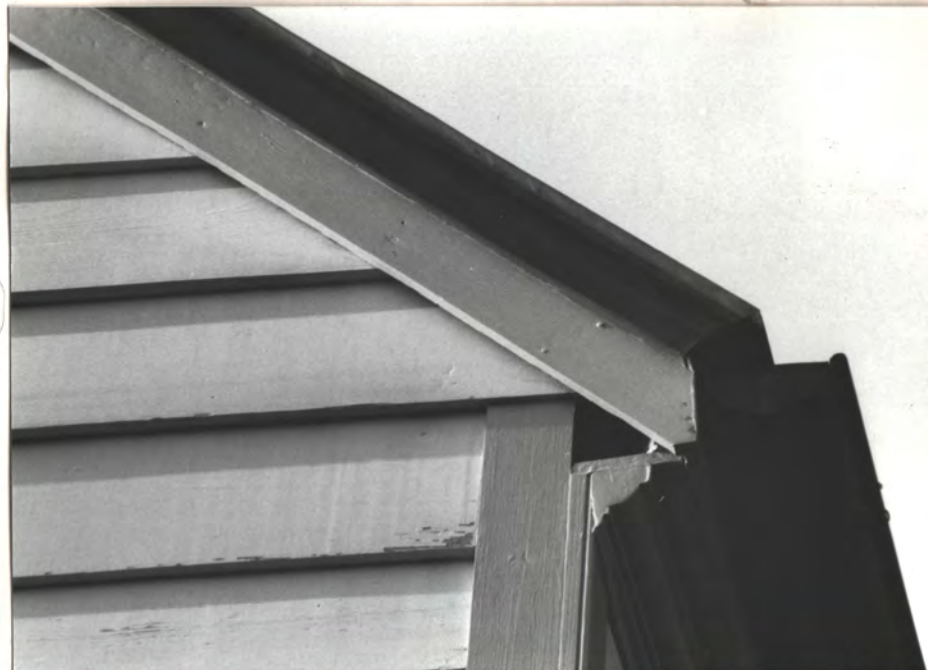
Palisade-fascia probably modern = $3/4"$ (not $1/8"$),
 no taper, no bottom - bend
 Hole not there in 1930's 1955 photo

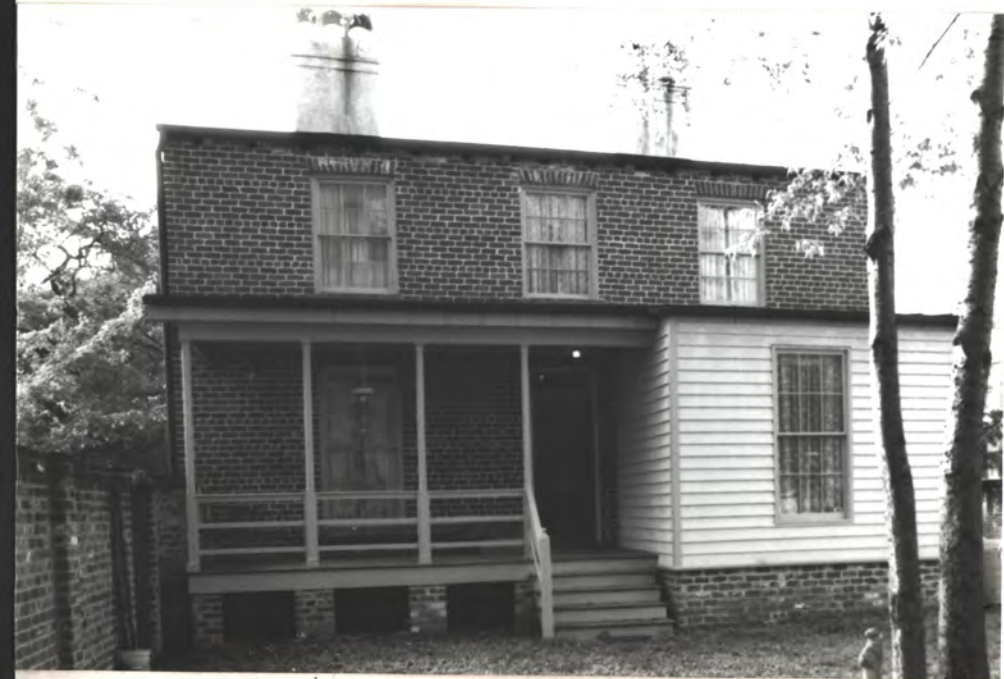
porch + frame x m = 1980's

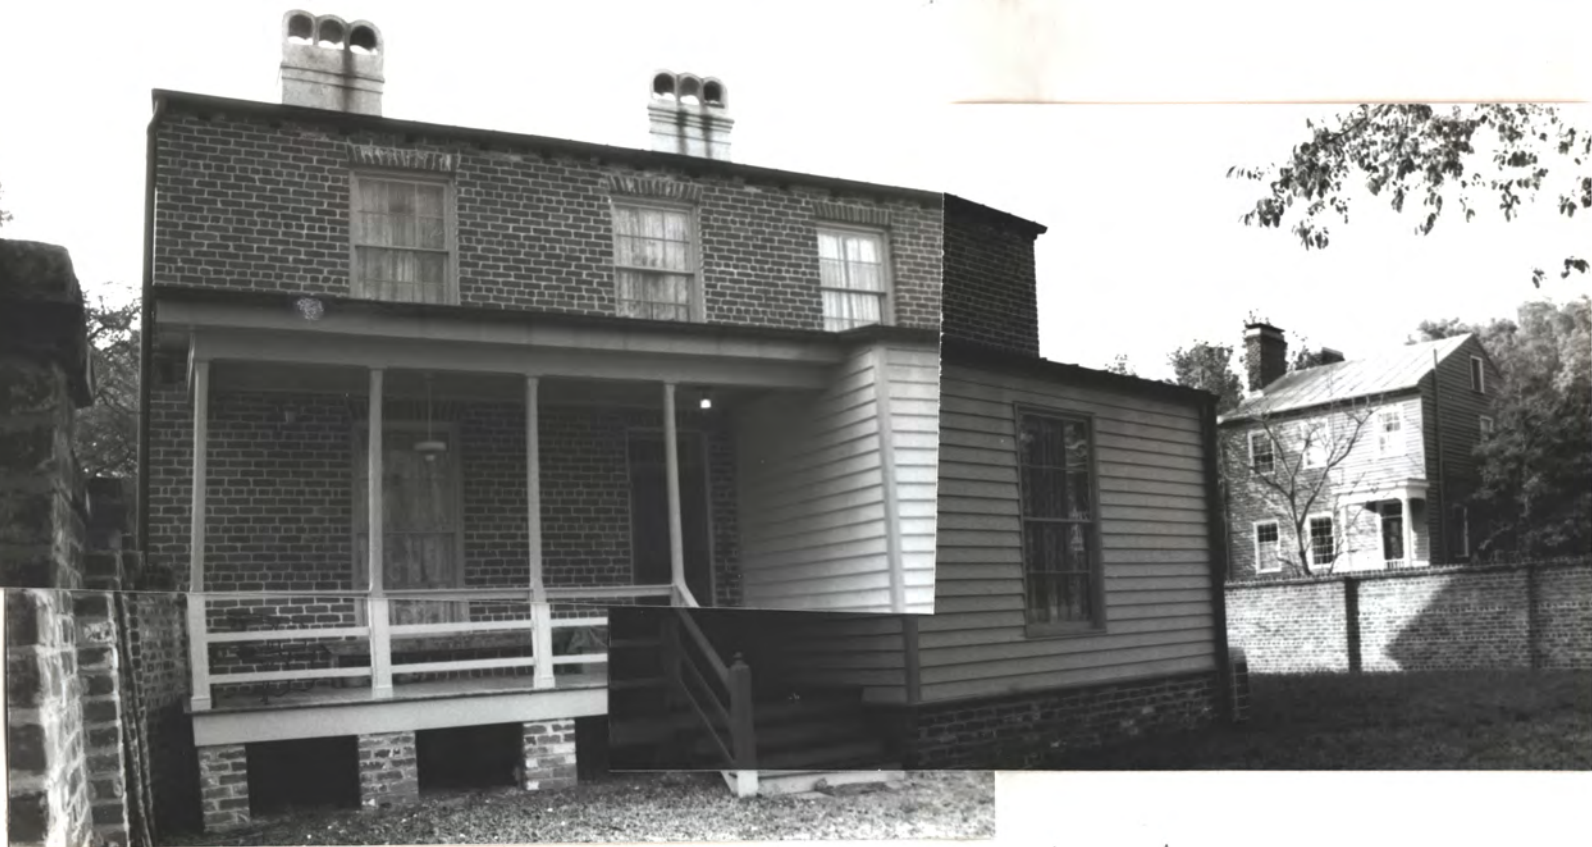
1980's east porch of both addn

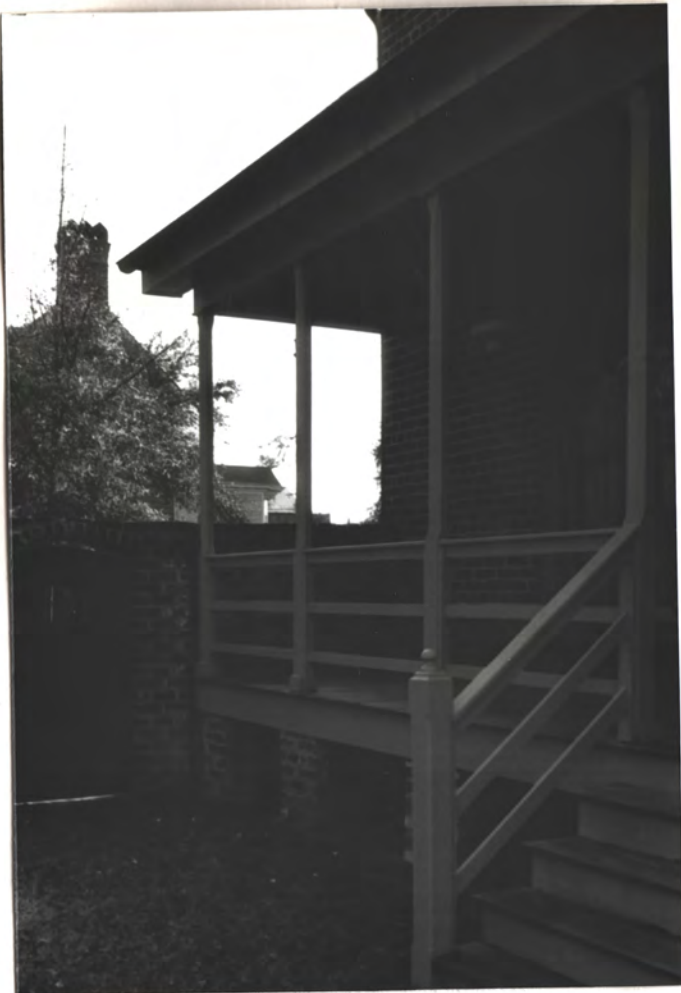
1980's E. porch → N

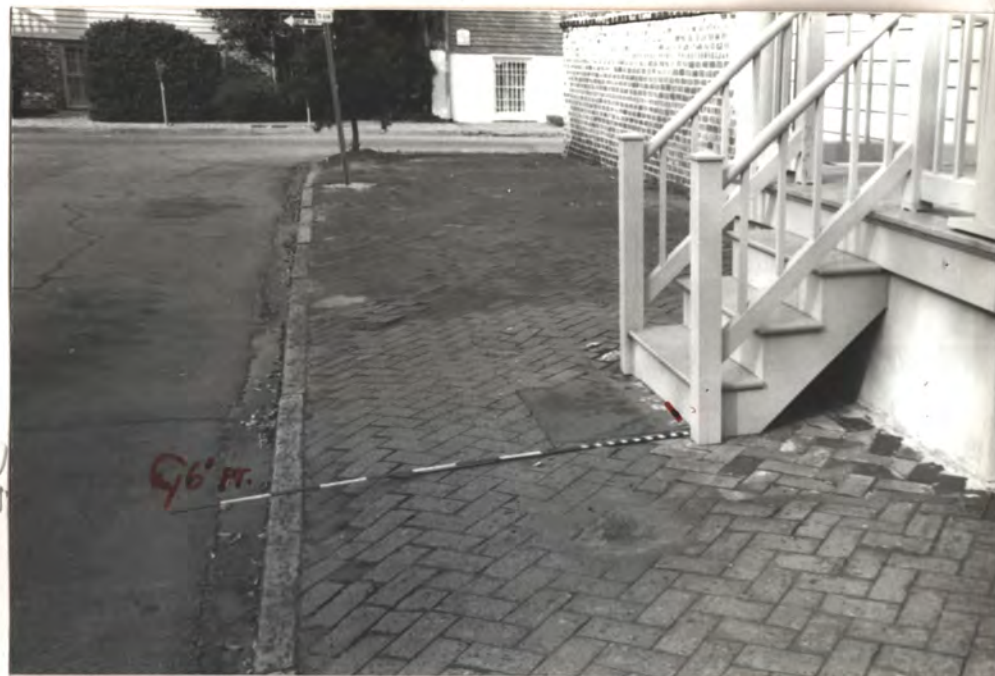
Habersham St. ↗

↳ Note depressions at former step corners (H&B's)

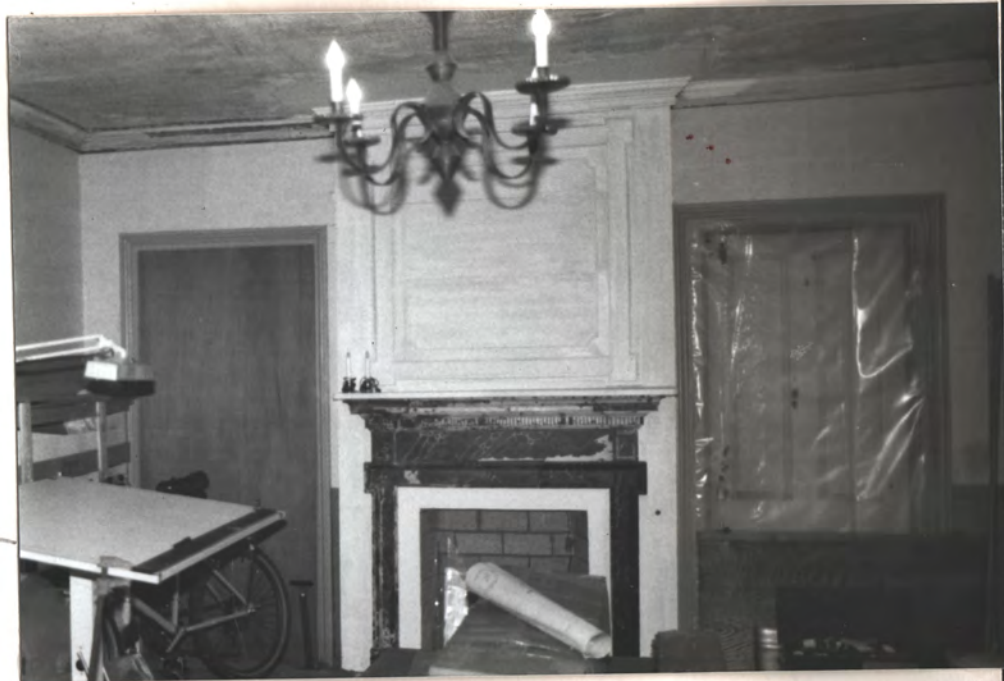
Ft. 1 S.W. Rm.

↳ Georgian mantel w/
original marbeling exposed in 1940's

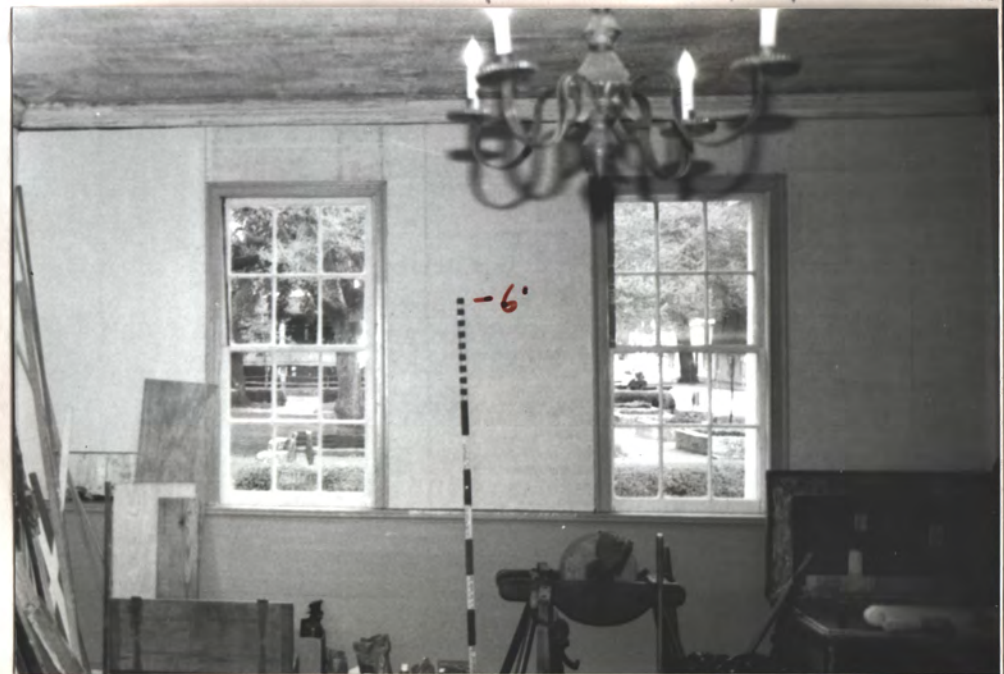
↳ remov. wall panel w/ all
wallpaper layers under (1940's restm.)

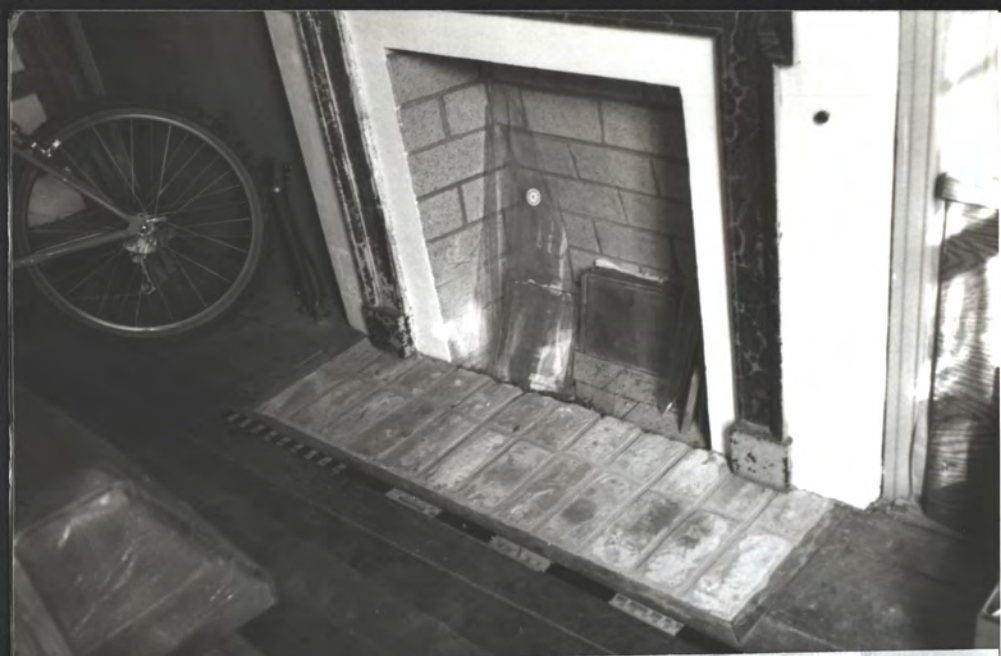
Fl. 1 S.W. 1795 Pm

Georgian mantel w/ original (or early) painted marbling re-exposed by removing later paint, in 1980's restor. (owner's wife did work)

Hearth = 1980's.
Owner says pattern is original (?)

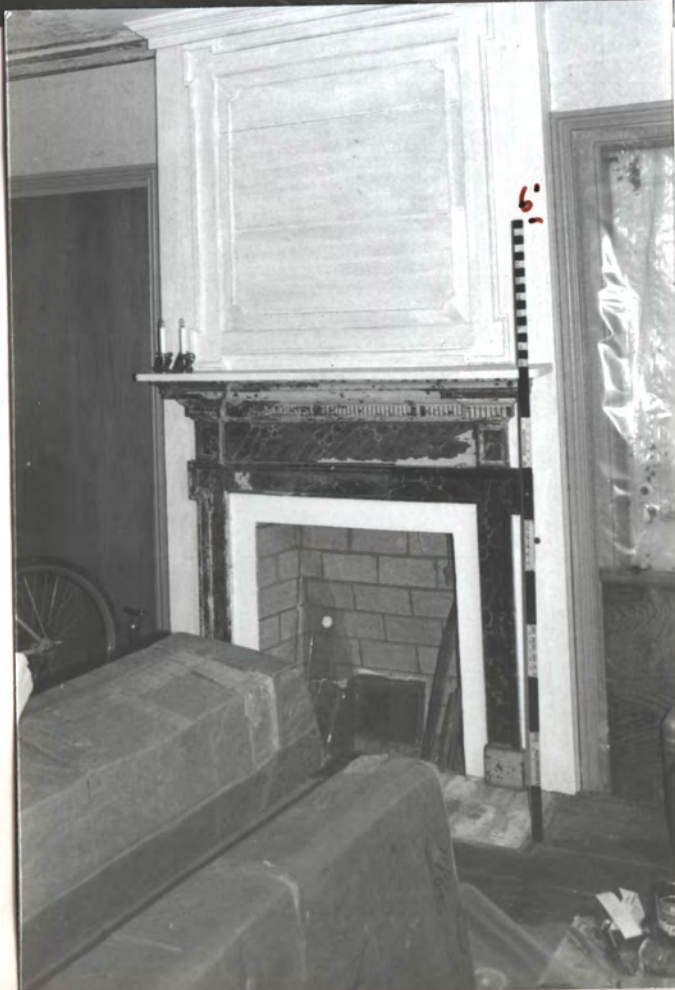
1980's mod yellow firebrick

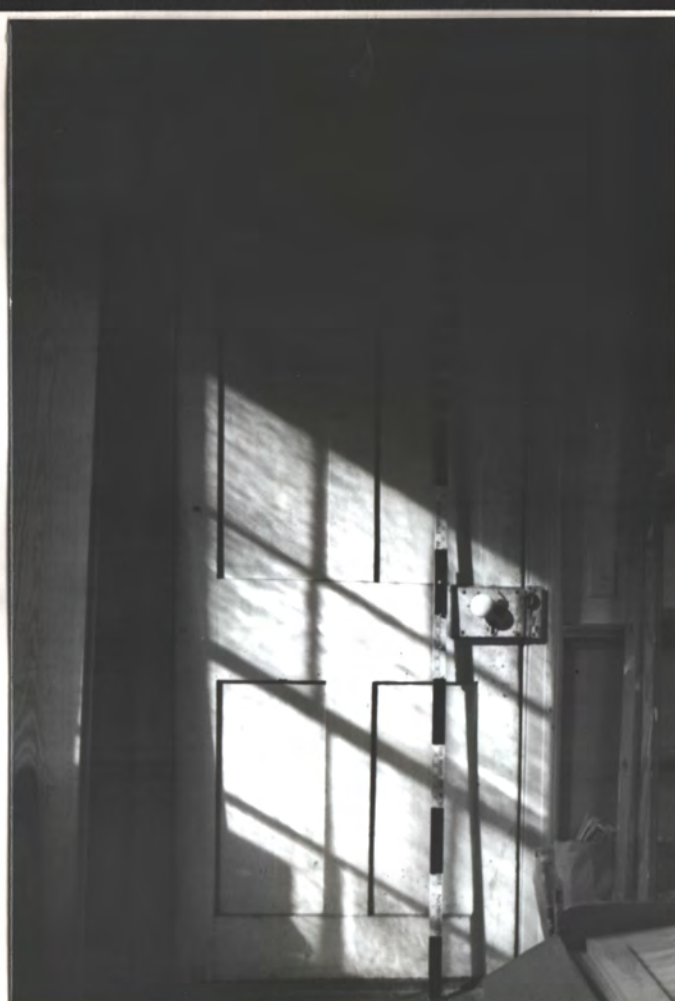
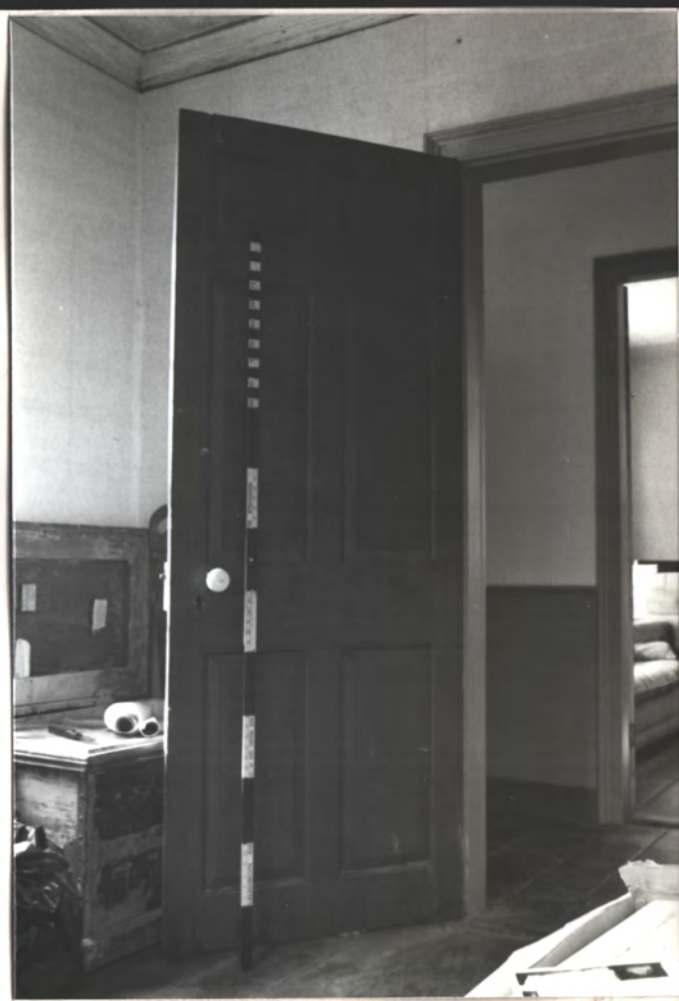
Fl. 1 S.W. 1795 Plan
Door at N. wall, to hall

Note
2-Knuckle
hinge =
unusual

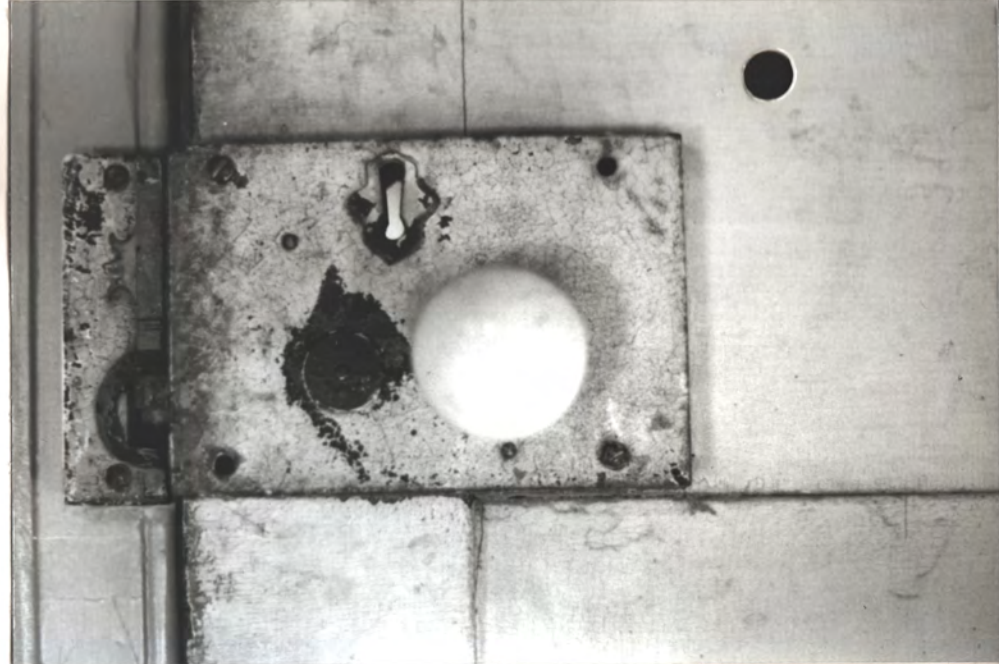
Fl. ↓
1795
SW Run

White J
Garnie
later
knob

↑
locks at
N. door
(^{"Carpenter's"}
brand)
upside down
= not uncommon.

Wide-bd.
dado lock
orig. of
early

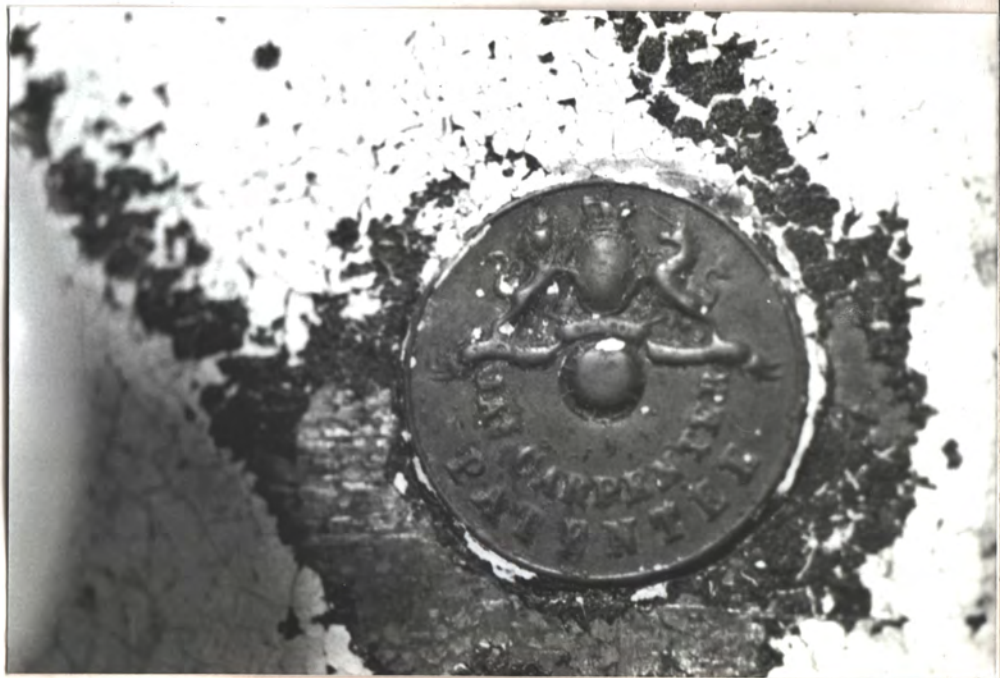
Small brass trademark on door lock
 = "Carpenter" brand (English)
 = typical of Fed. Period U.S.

Mantel
 probably 1850's,
 orig. to this coll.

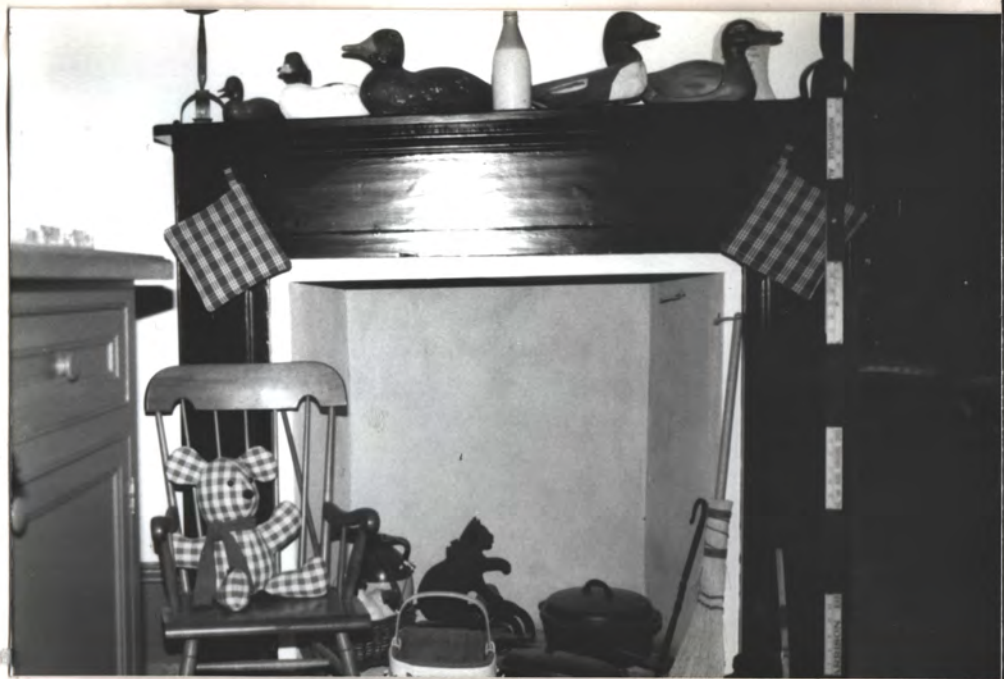
1992
 KIT.
 (Not
 orig.
 KIT)

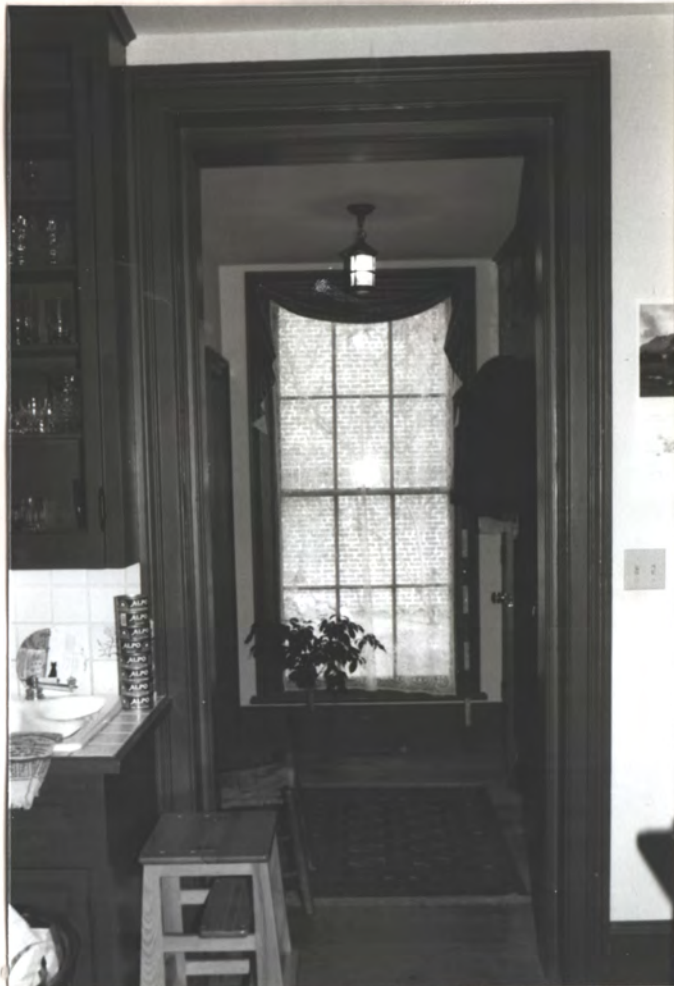
1980's new (H.C.) addn.
for bath + cab., store

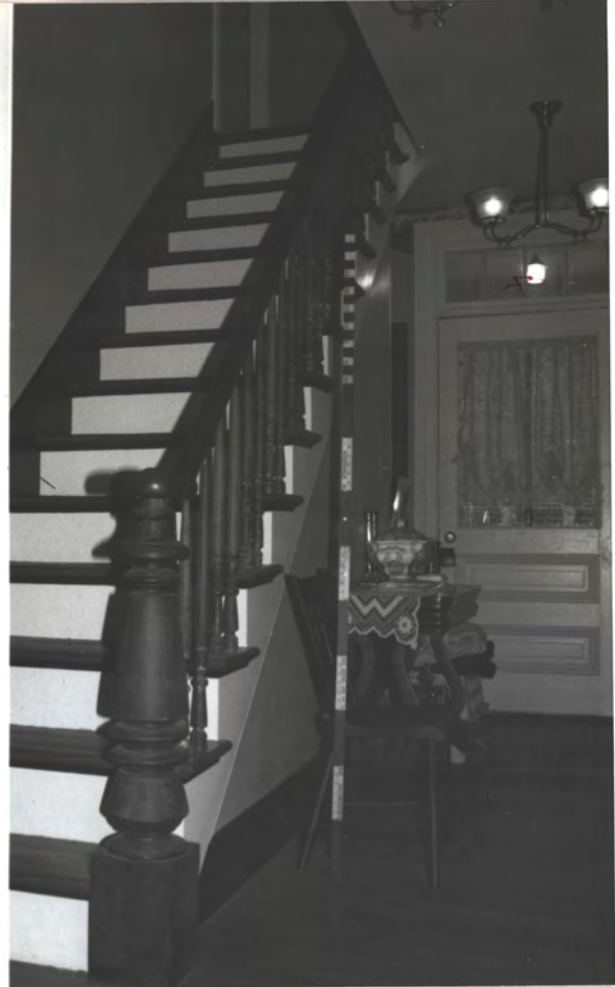
† presumed 1850's stairs
 (This address is 1850's)
 Looks right for that date

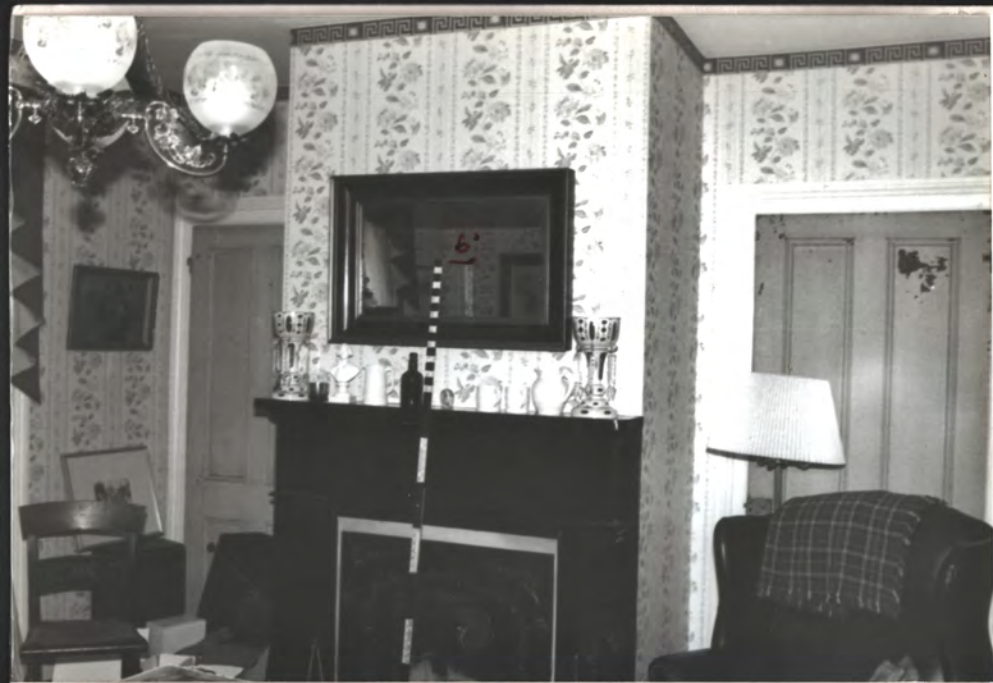
1850's mantel → N

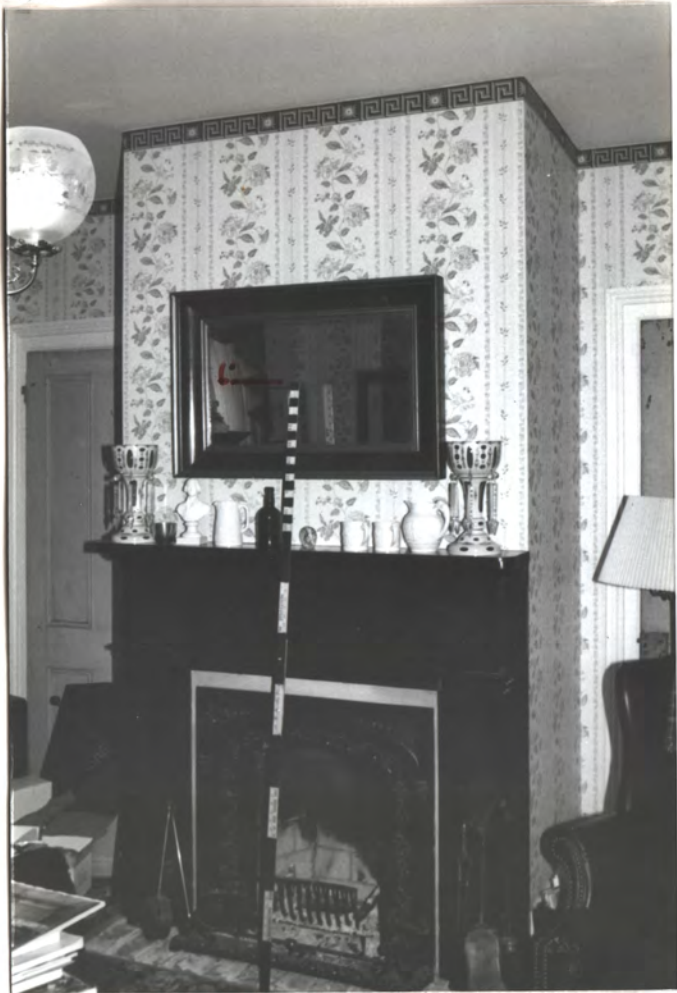
Fl. & S.E. - B.R.
1850's mantel

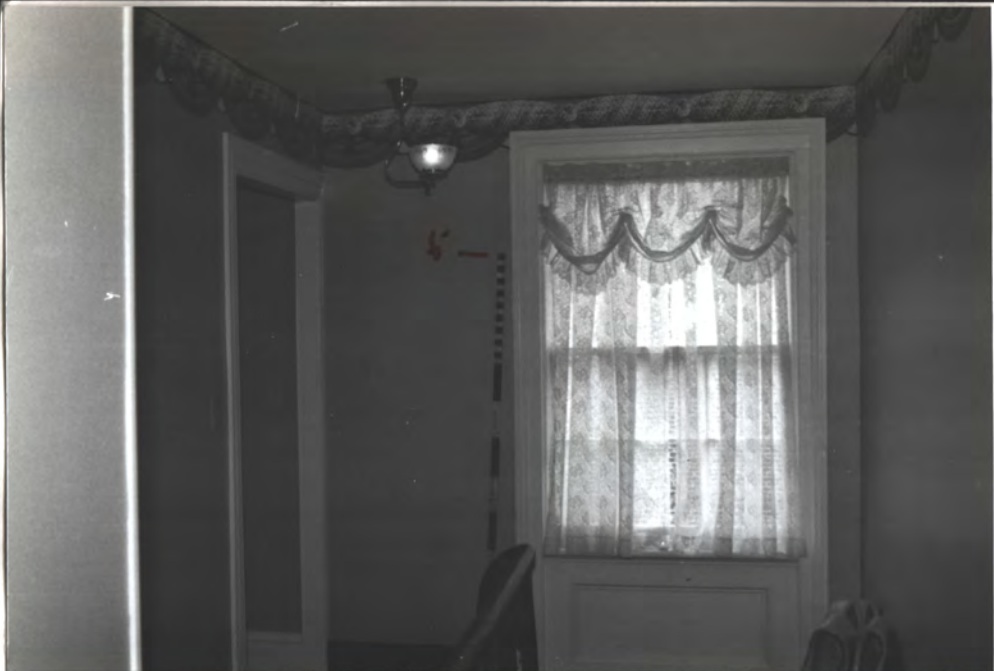
door to bath

1980's reproduction

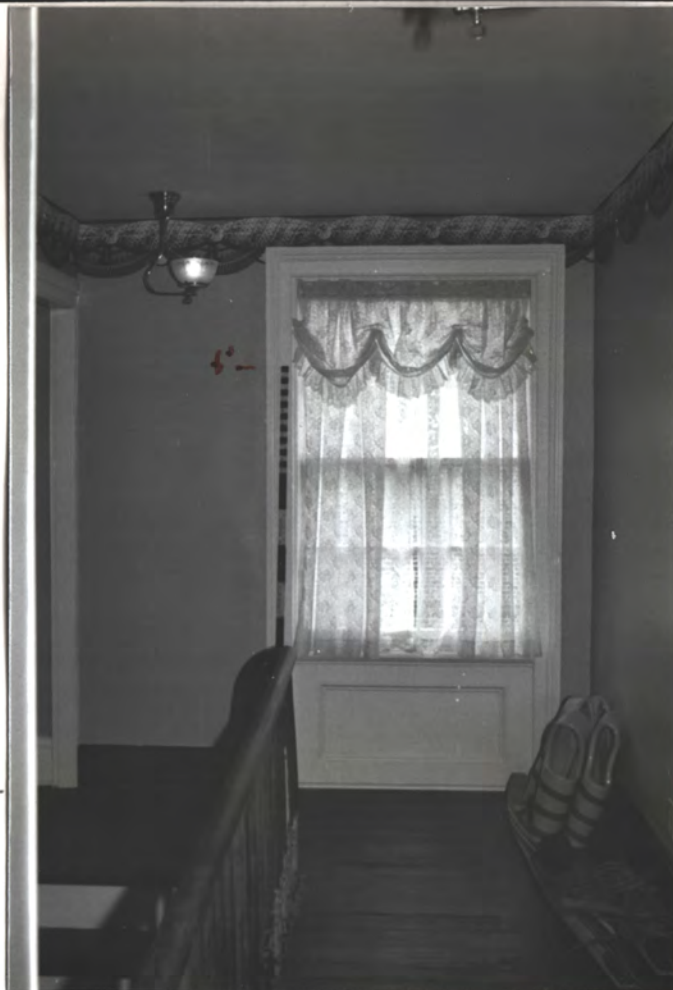
1980's owner
← says this was a door.
Confirms w/ HKS photo on p. 1, although door would be 20th ←

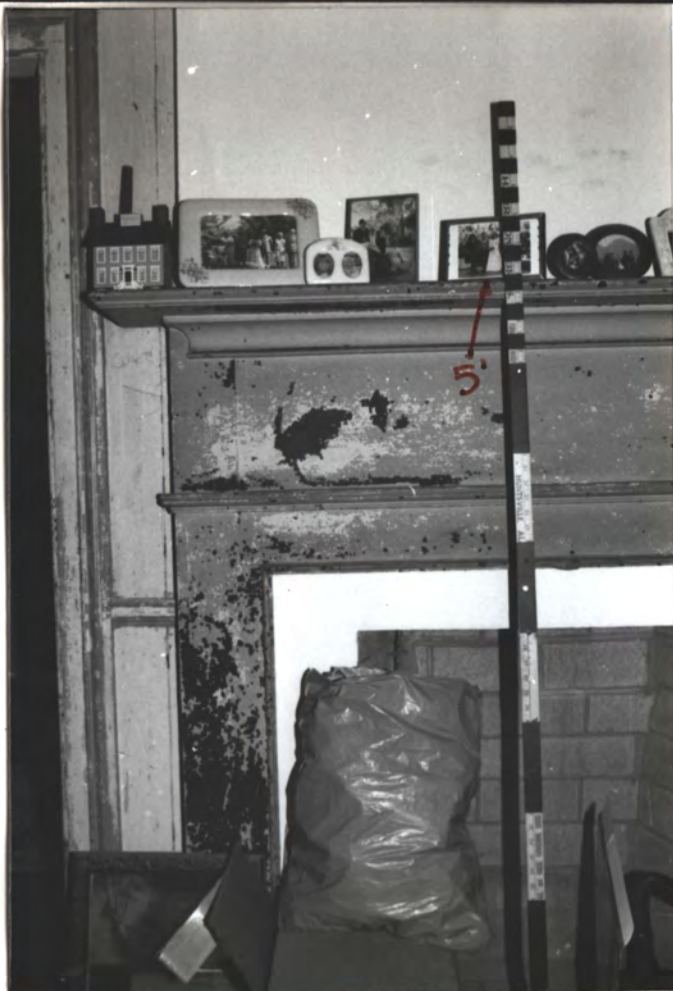
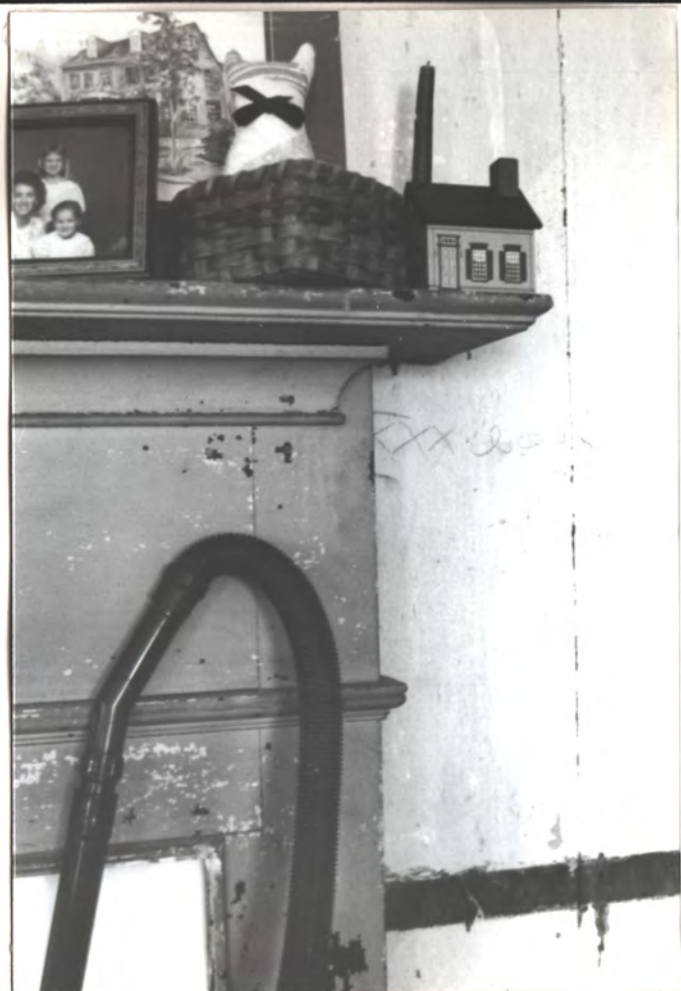
Fl. 2 N.W. Rm mantel

Looks maybe 1850's. Too heavy for typical Fed. period mantel (?)
Yellow firebrick = 1980's

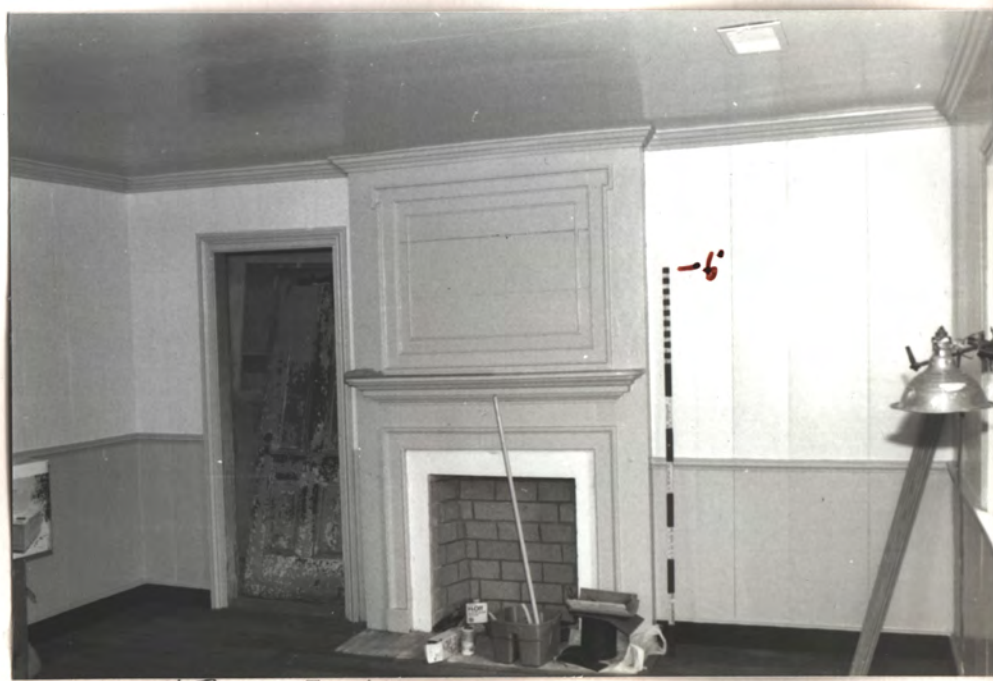
FL. 2 S.W. 1795 Ren

Georgia mantel + overmantel.
