CIRCA 1795 GEORGE SPENCER HOUSE
WARREN SQUARE, 22 HABERSHAM STREET
SAVANNAH, GEORGIA

Re: Mills Lane c.1795 Spencer House
Project No. 92013

Re: Stone and Spencer Houses
Project No.(s) 92012 & 92013

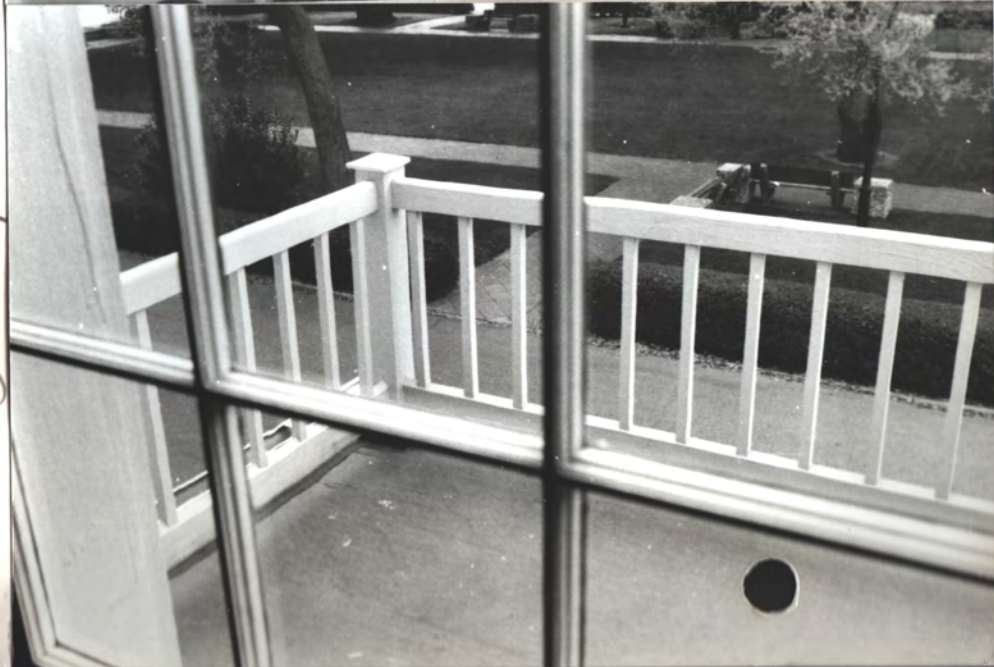
Portico roof
 (1940's sheet rubber)
 from Fl. 2 hall.

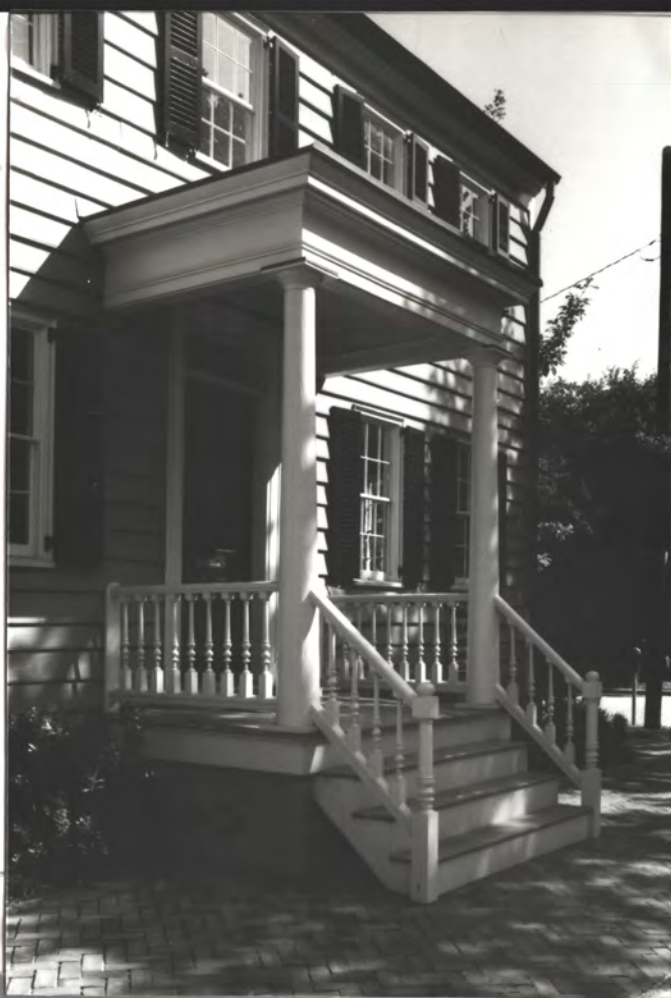
Dormer proportions
corrected from
1991 records
to fit
Francis Benjamin
Johnson early
20thc. photo
(narrower, such
set deeper)

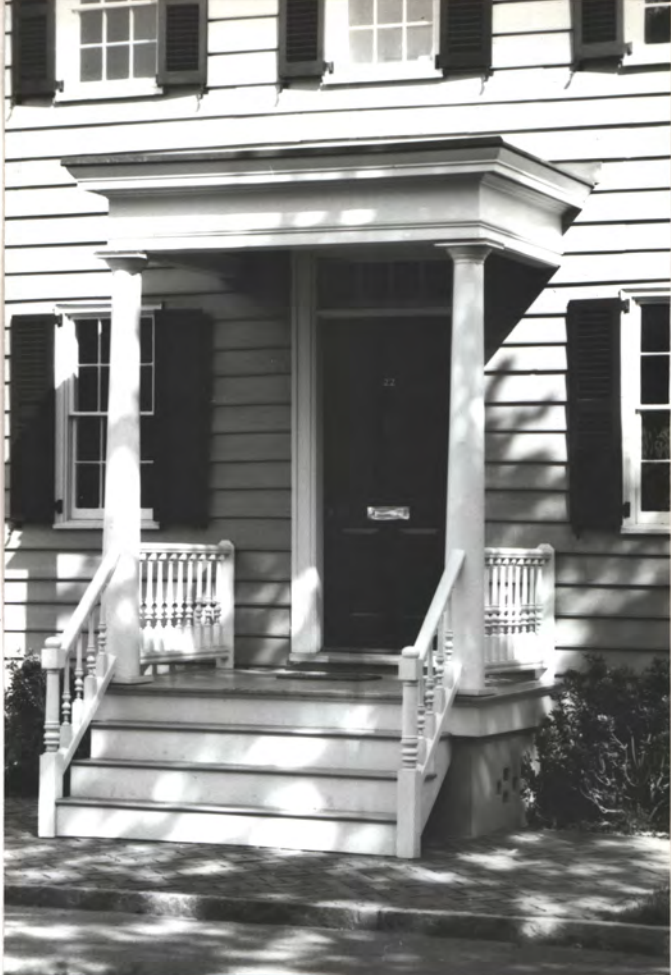
Porches now revised to fit
FX Mrs Benjamin Johnston early 20th c. photo

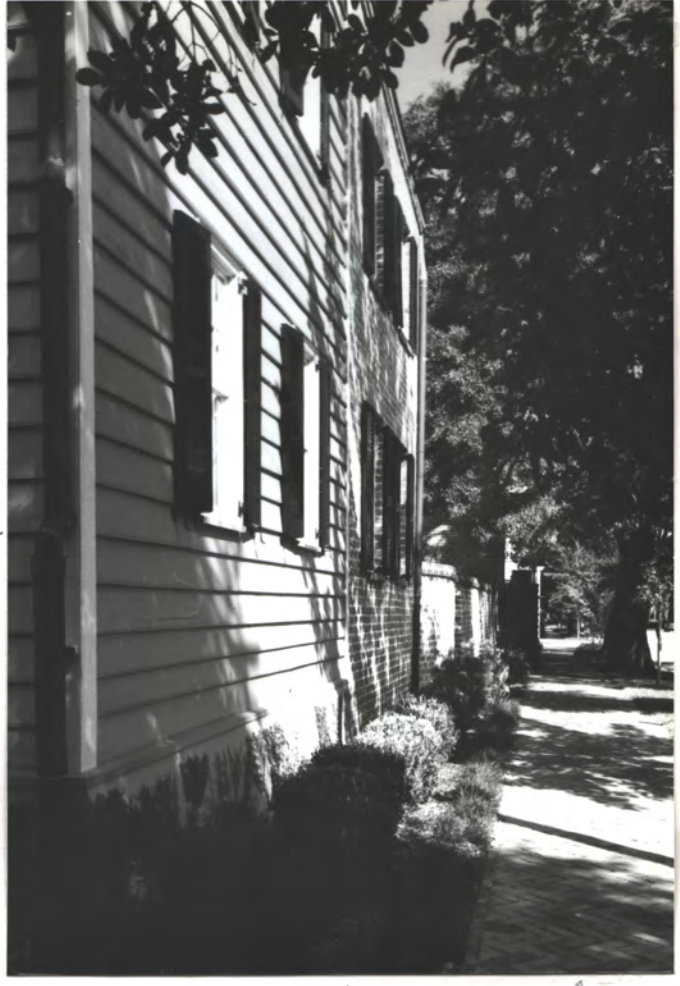
walkway rebuilt

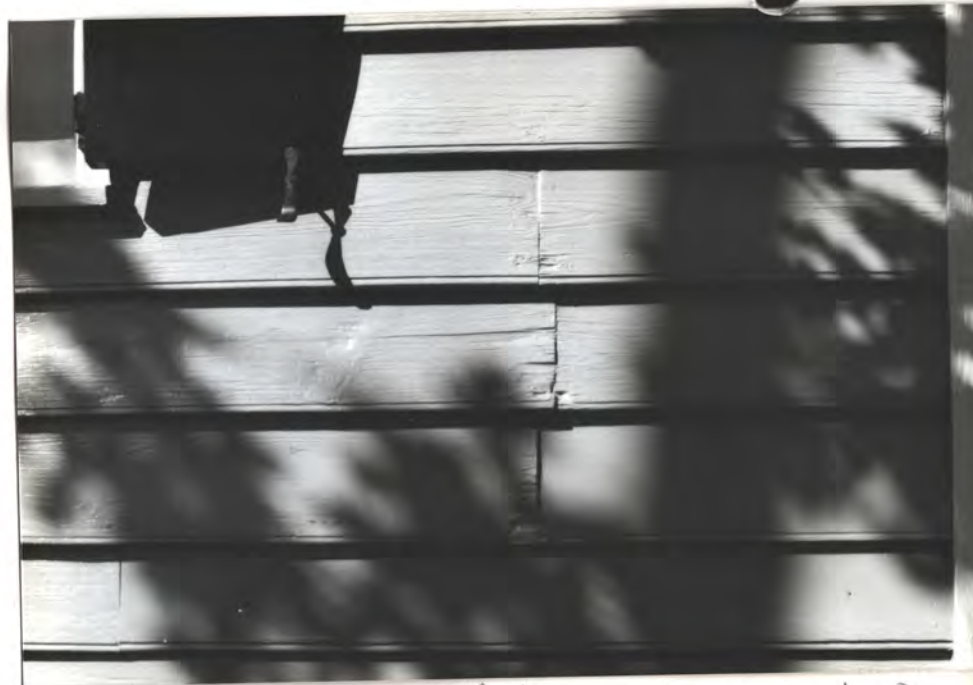
S. Wall → c. 1950's add

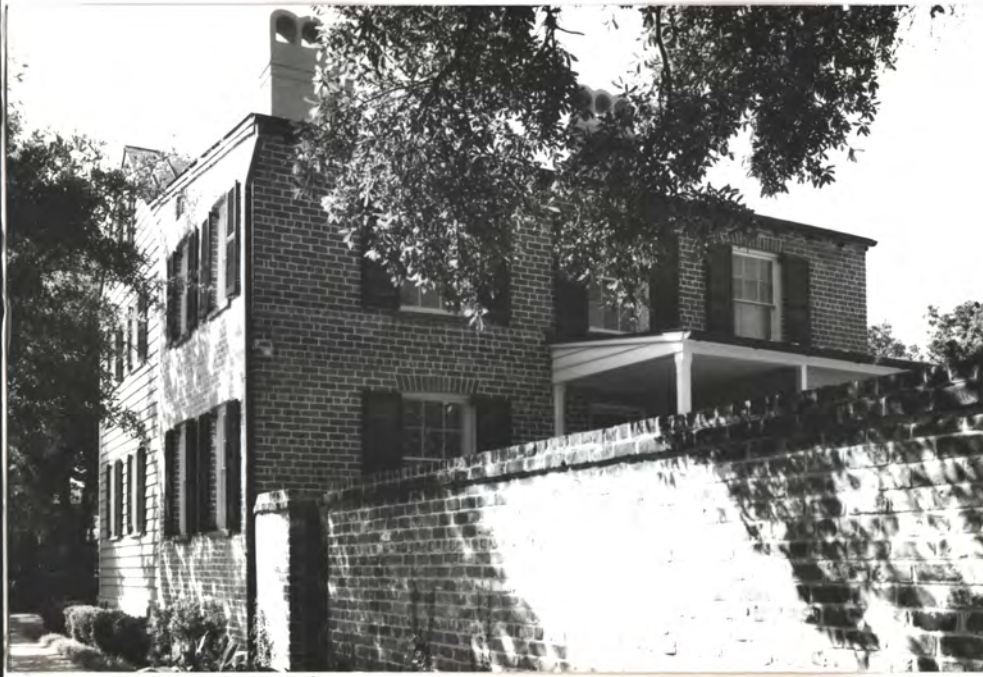
S. Wall (orig + infill details)

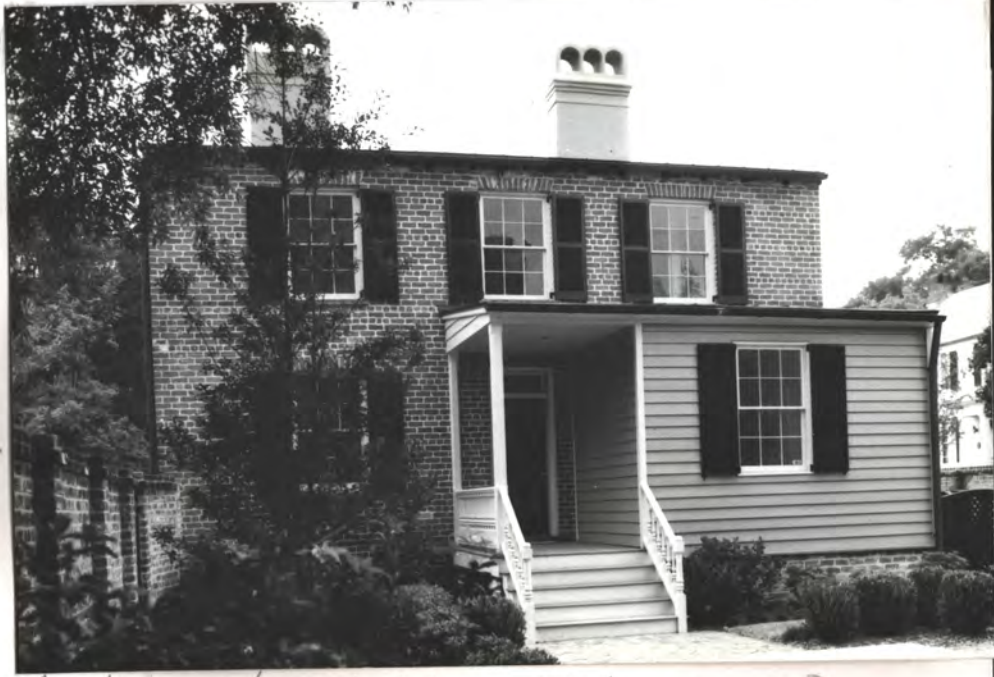
gta revised → East end

East end (revised from 1991 reconstruction)

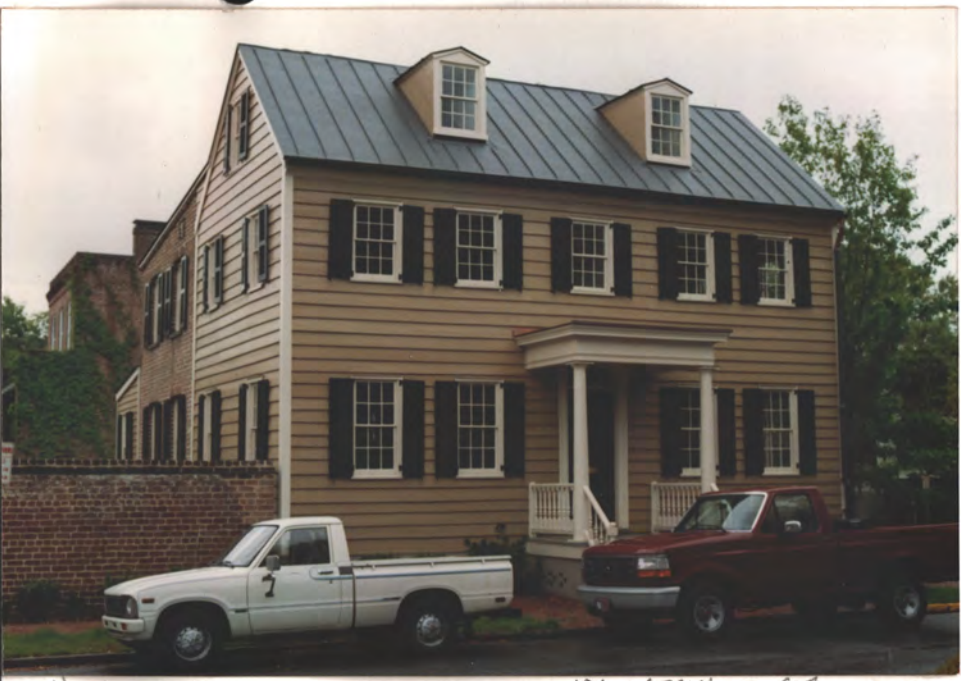
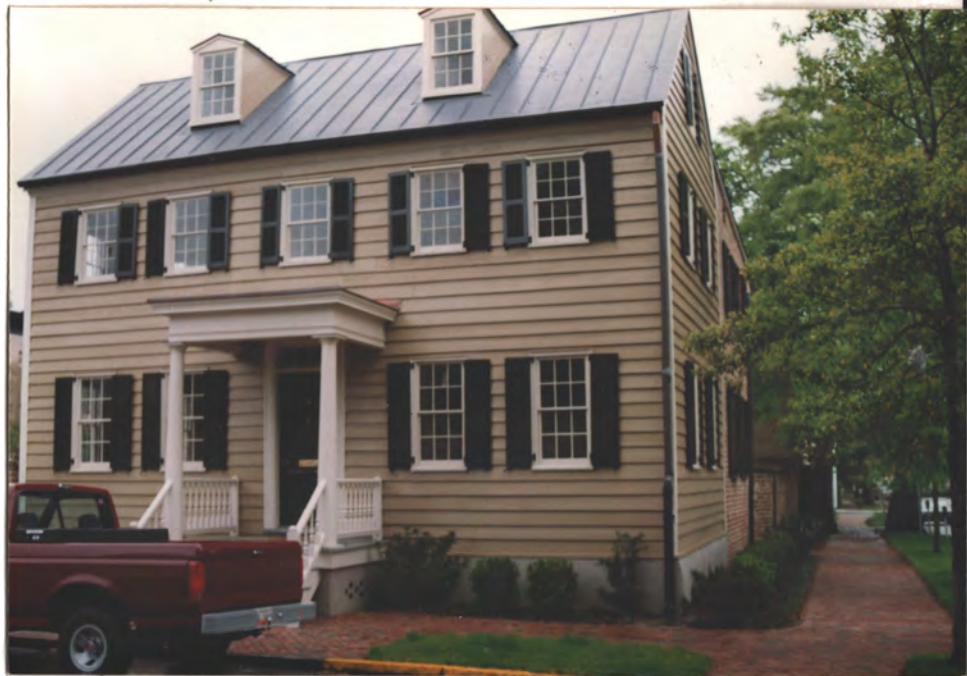
Dormers corrected per 1920's photo by Frances Benjamin Johnston

Dormer
roofs for
Low -
not per
HJ details
or per
Frances B.
Johnston
photo.
Too bad!

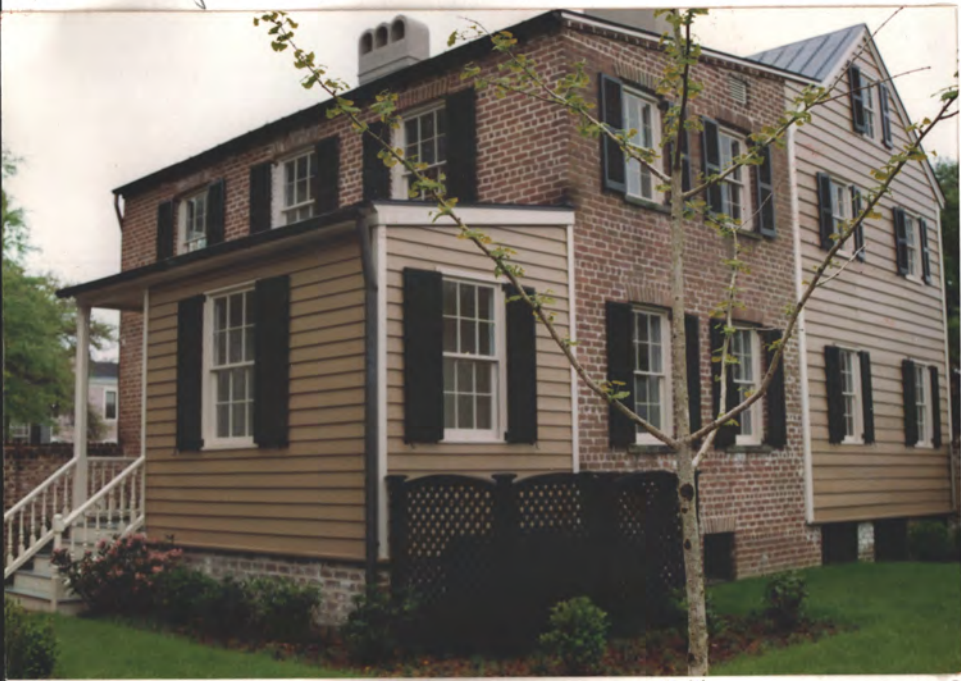
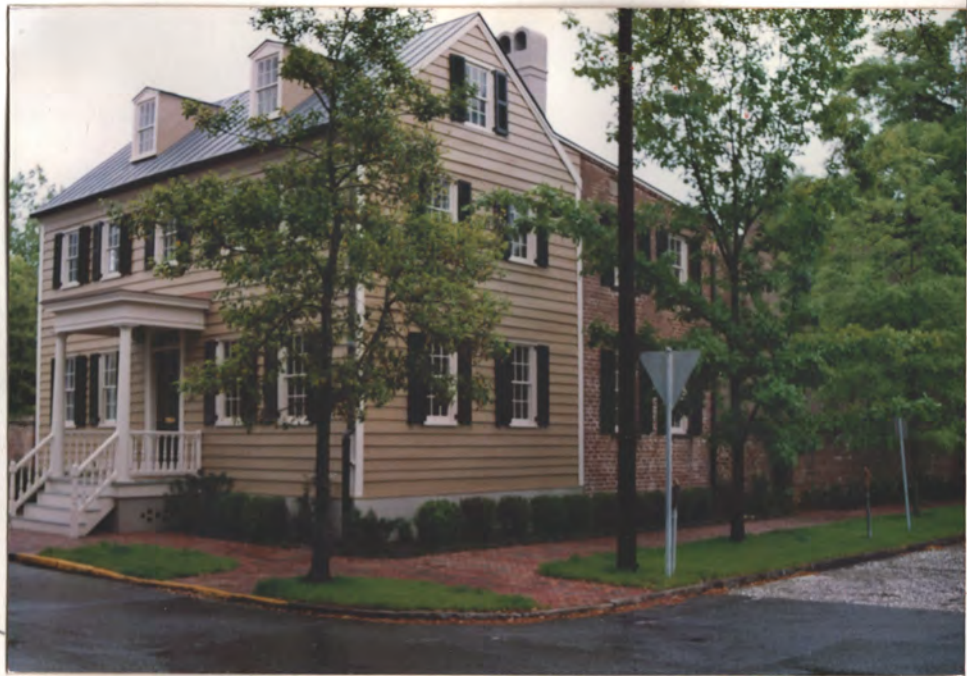
Portico proportions corrected per 1920's photo by Frances Benjamin Johnston

"bushes
by owner,
not HJ"

wide steps per MMS Lane, not per FBJ photo

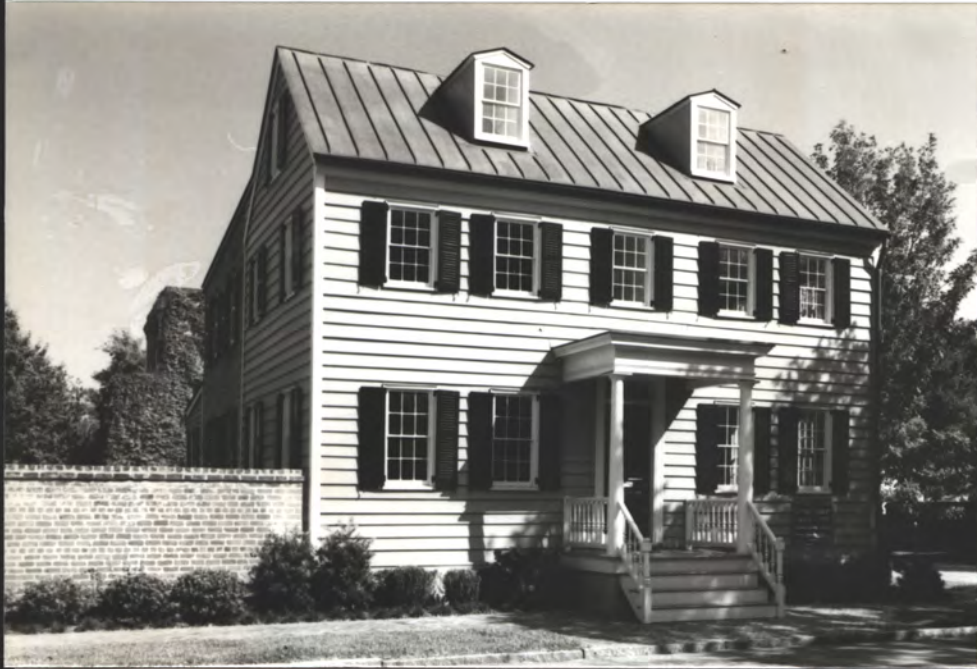
N ← 1980's Dormers & portico were out of proportion,
per the 1920's Frances Benjamin Johnston
photo. Here rebuilt to original proportions.

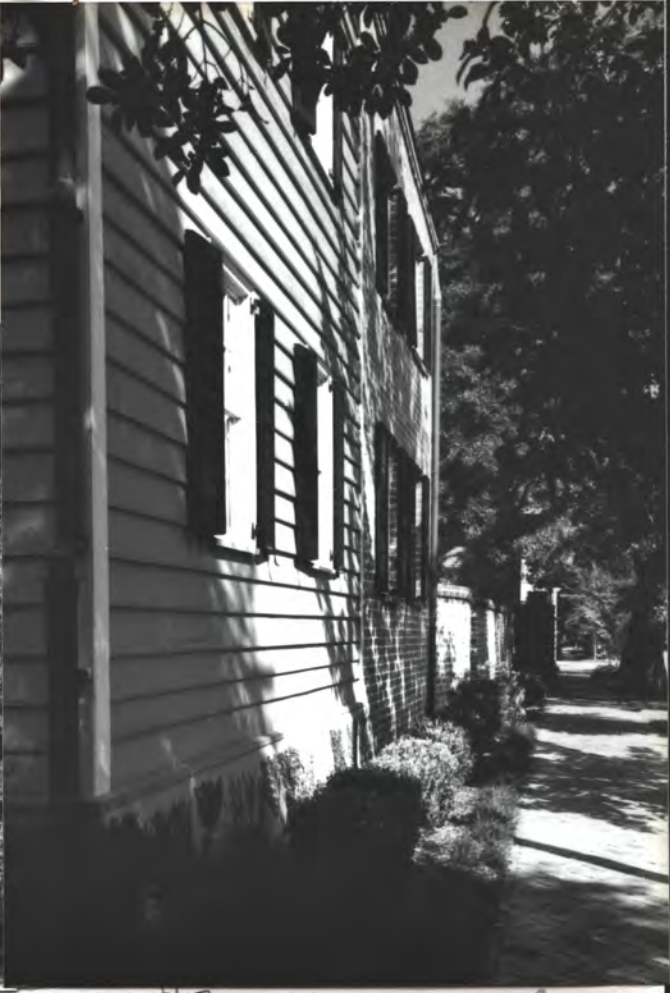
↑
walks =
"Bickerstaff
Woodsmalls"
per AD details.

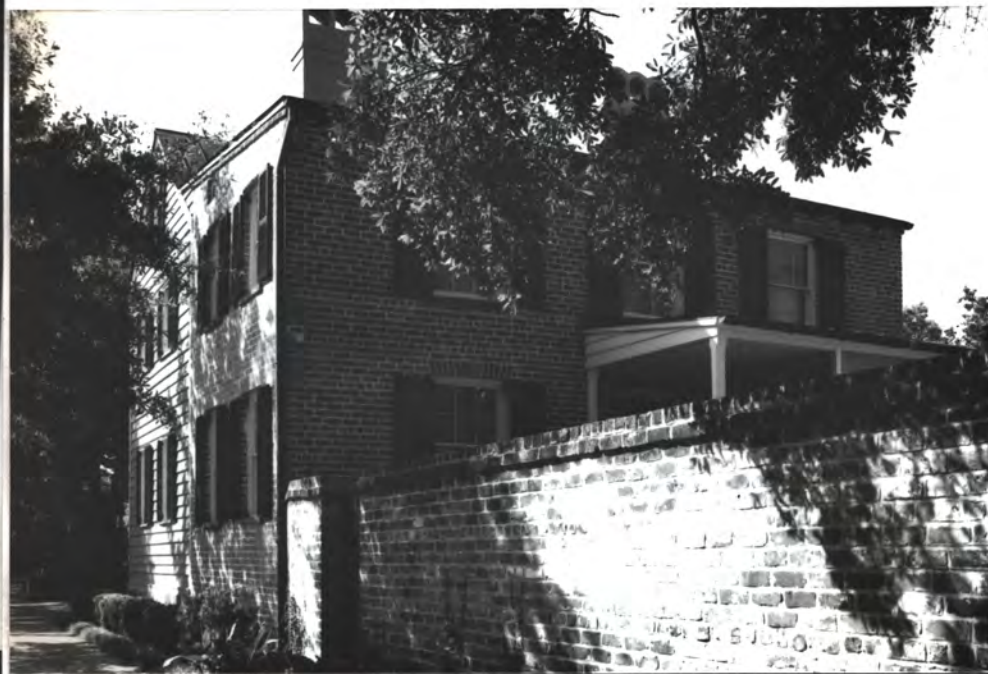
↑ gate & back porch revised by MB/AD
to be appropriate to mid 19th c. address
(1980's porch was "Bunker Park-His" style)

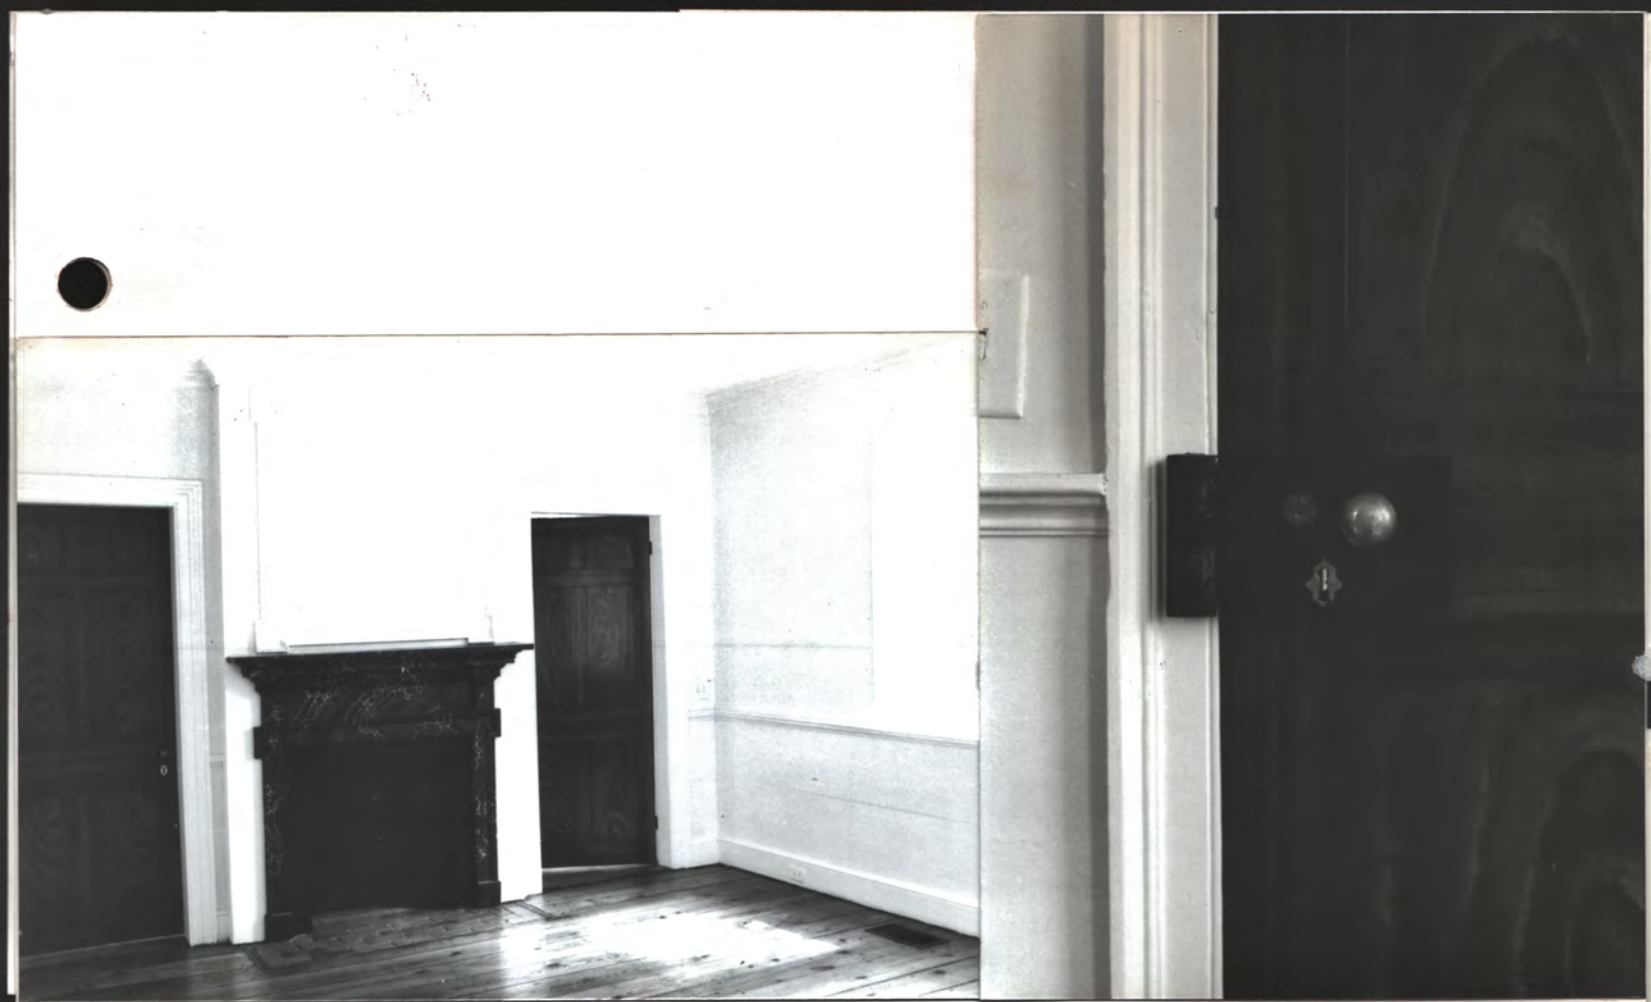
H ← Fl. 1 S.W. Rm, hangars - Georgian mantel, 210cm wide, matching, measured.

Half door at fl. 1 S.W. Rm (1993 Graining, orig. look) ↗

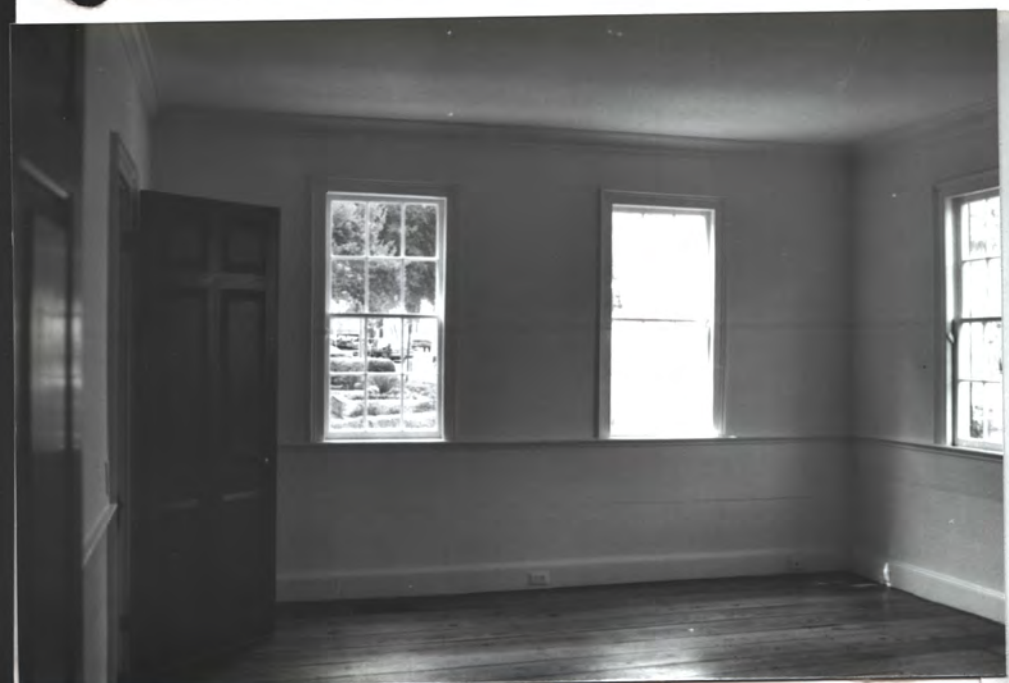
↖ N Fl. 1 N.W. Rm

Half door at fl. 1 N.W. Rm (1993 graining) orig. look ↘

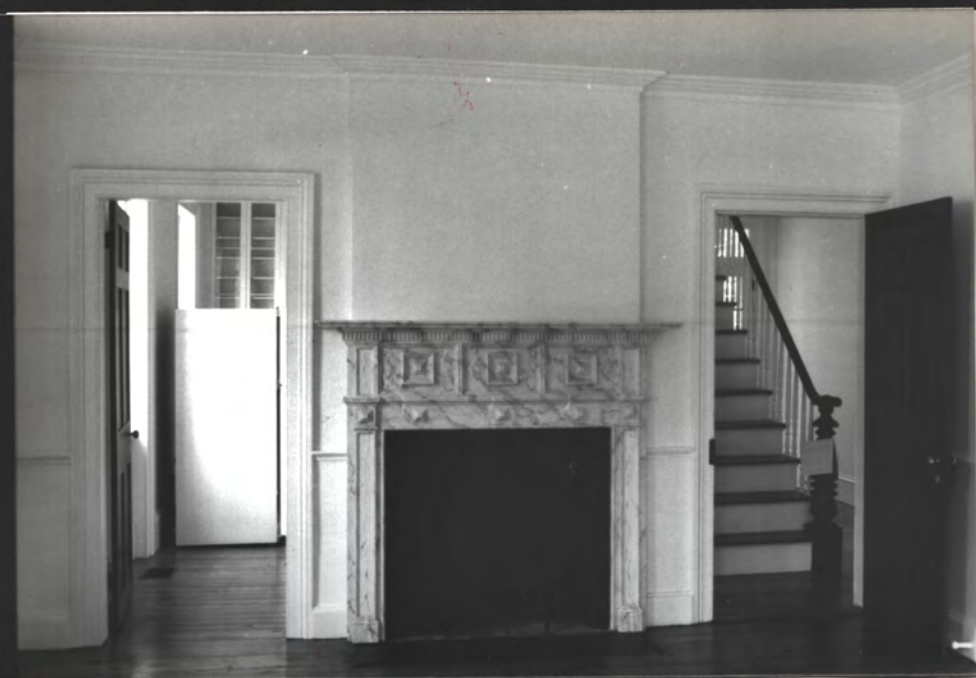
Fl. 1 N.W. Rm, orig. m/MW, 1993 marbeling ↙
