## Borders-Blackmon House Offers Important Record of Slave Artistry

CIRCA 1840 BORDERS - BLACKMAN HSE, ANNISTON, AL.  
 H.A.B.S. RESTOR. + ADDN. 1990 DR. GEORGE & SUSAN GIBBS.  
 JONES & HERRIN, ARCHITECTS - H.P. JONES, F.A.I.A. - HUNTSVILLE, AL.

c.1840 Borders - Blackman Hse, Anniston, AL (HABS)  
after restoration in 1990 by Jones & Kerrin, Arch.  
Harrie P. Jones, FARA, Huntsville, AL  
Owner - Dr. George Gibbins, Anniston  
Photos H. Jones, June 1993

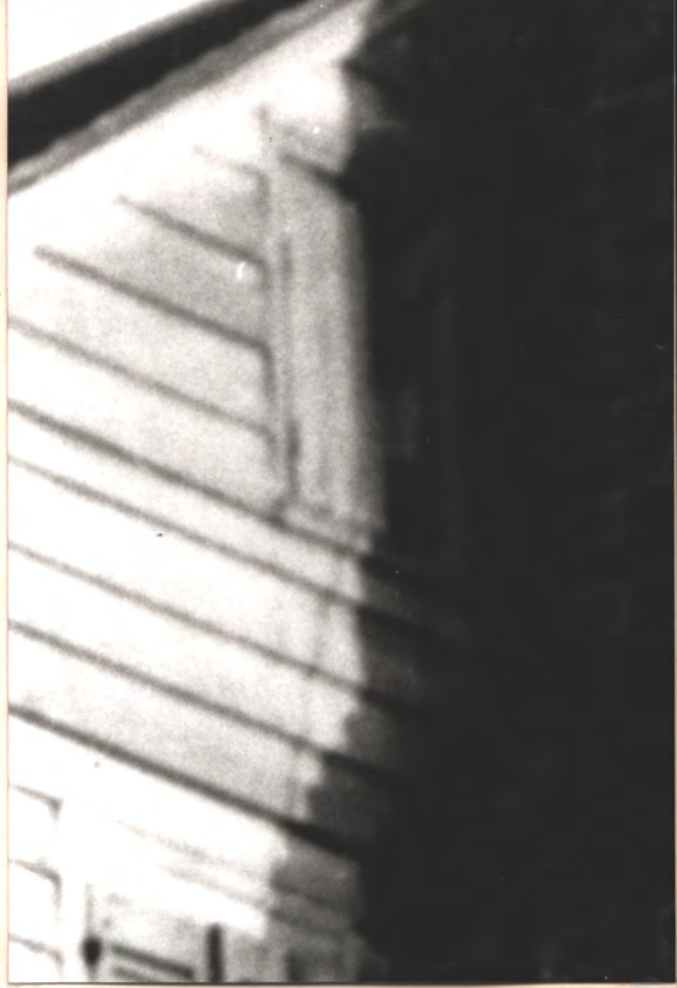
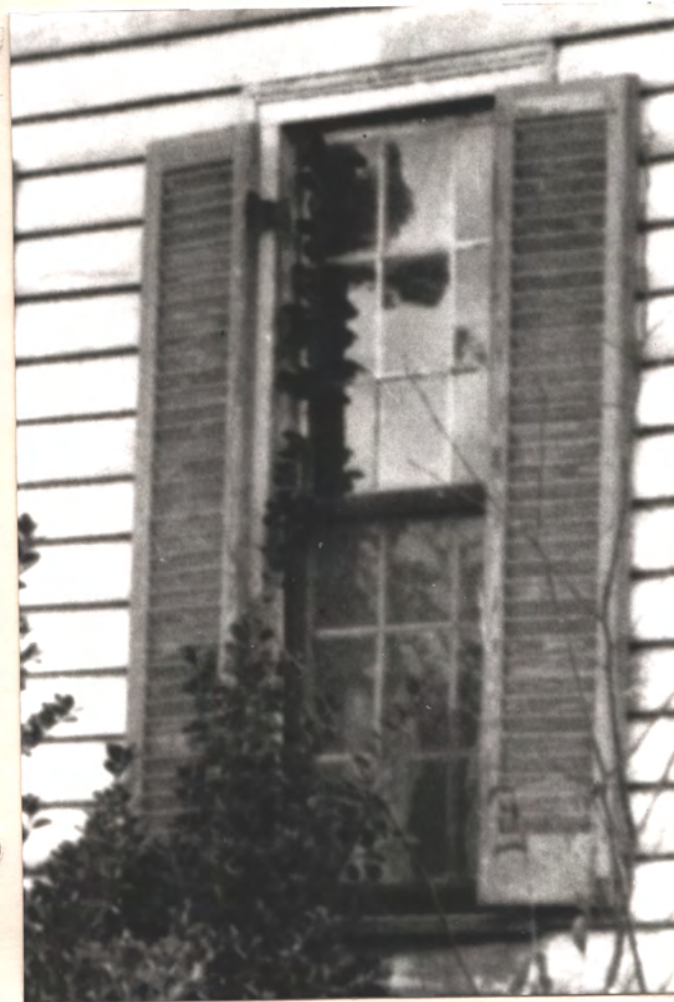
Details of  
N. front  
photo on  
pg. 1

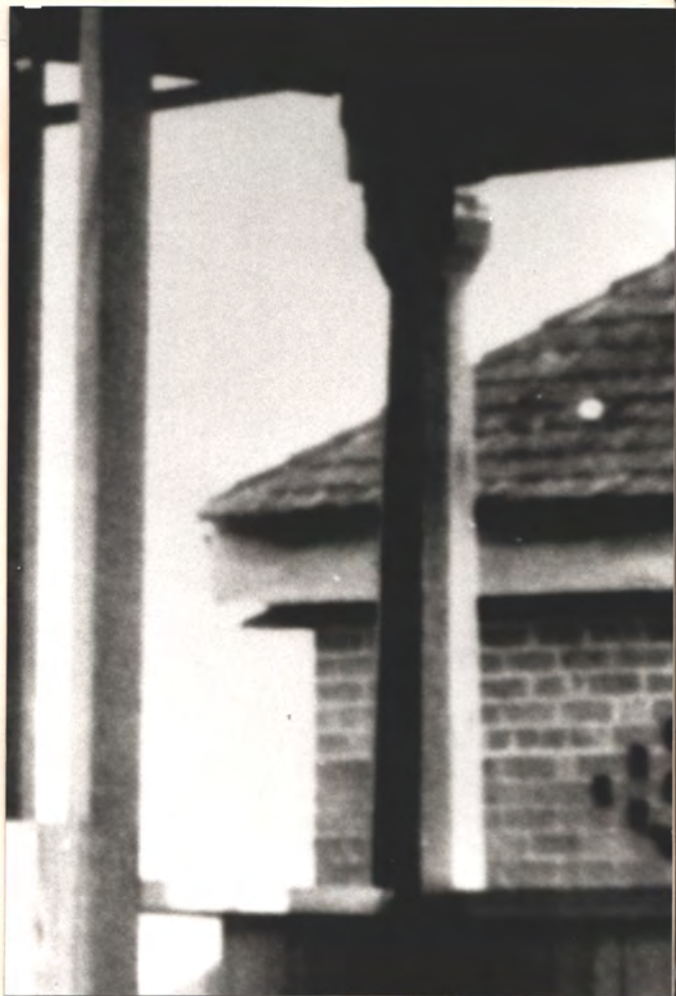
"Remodeling" (1936)  
All of this porch gone  
by 1989 - HJ

One of these cols. found  
in barn. See det. photos  
& field measurements

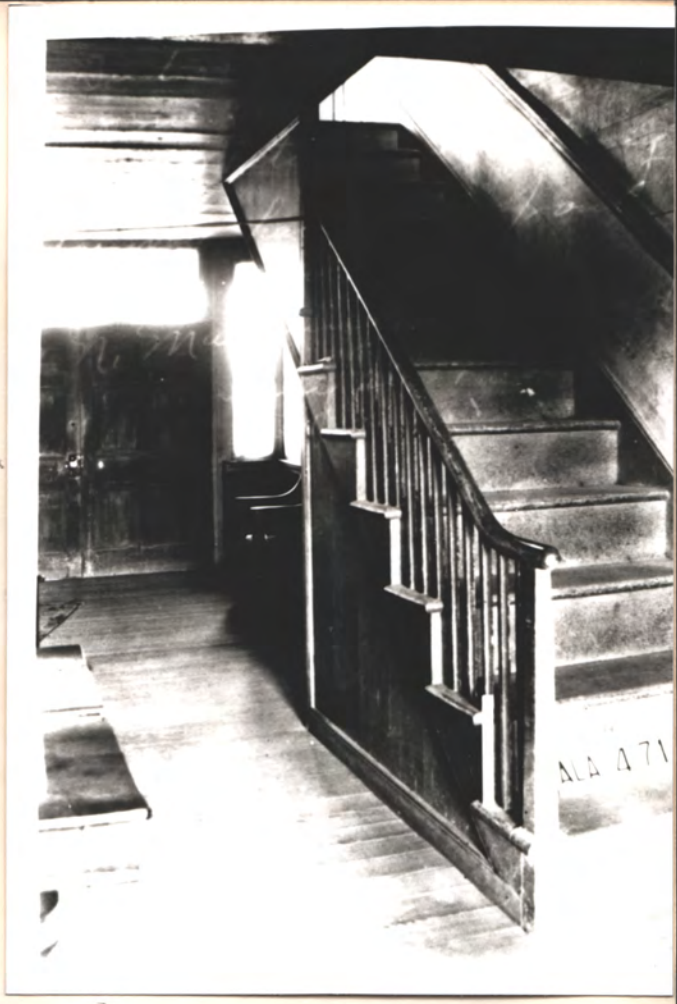
Note bd. wall of ceil. now  
cov. w/ gyp. pl. in 1989

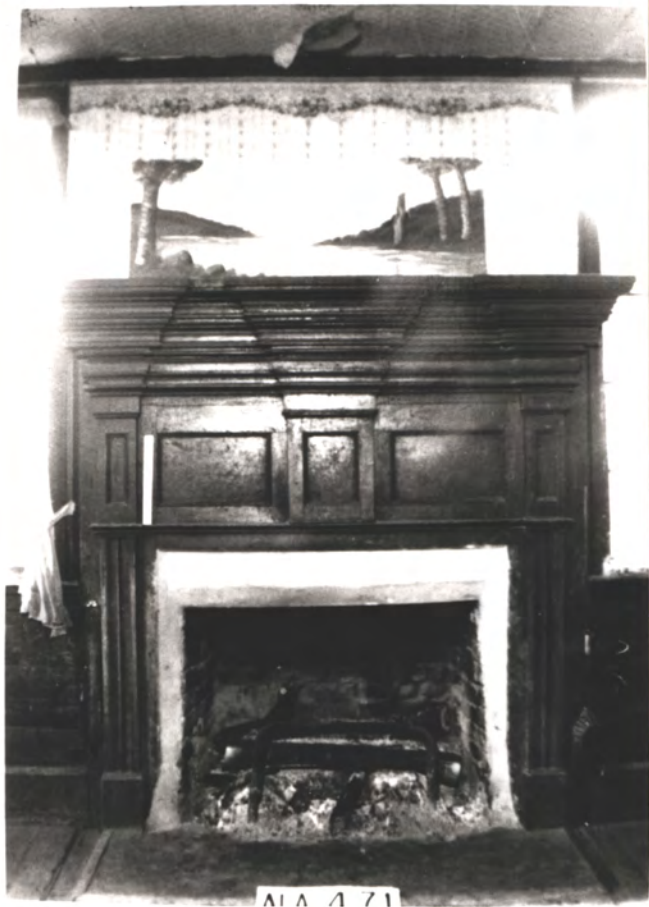
N.W. front rm. →

↙  
this  
seals  
replaced  
by 1989  
See 1989  
photo

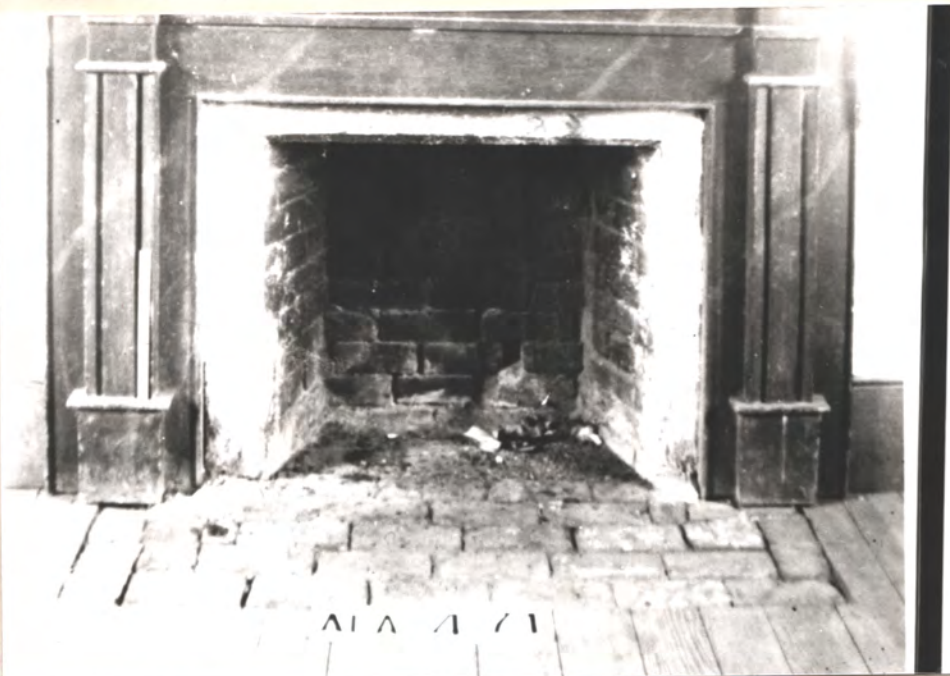
← Hearth detail - pattern = typical of 1800-1860 →

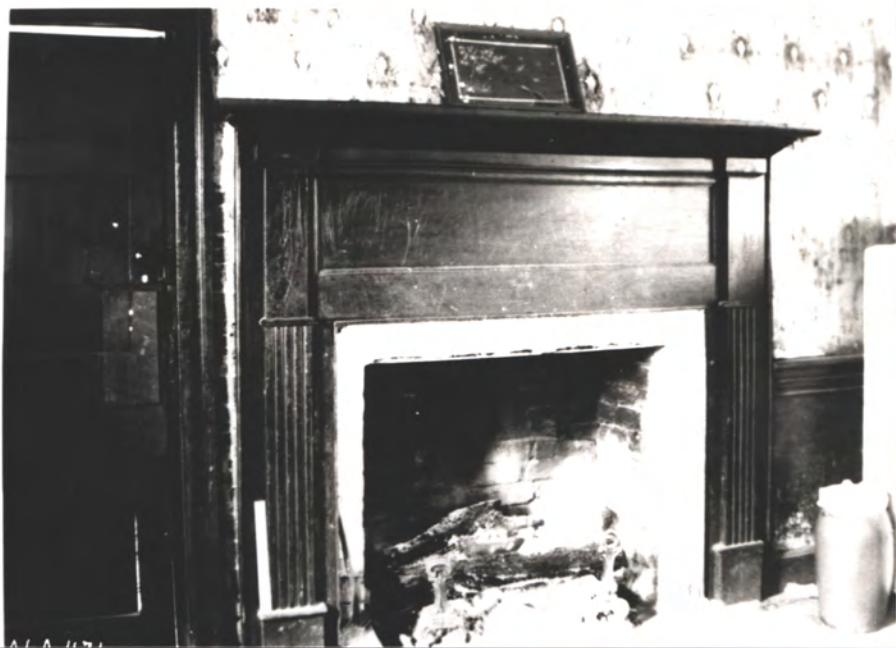
Rm BY KIT.

Note black finish  
(paint) = typical of  
Fed. mantels

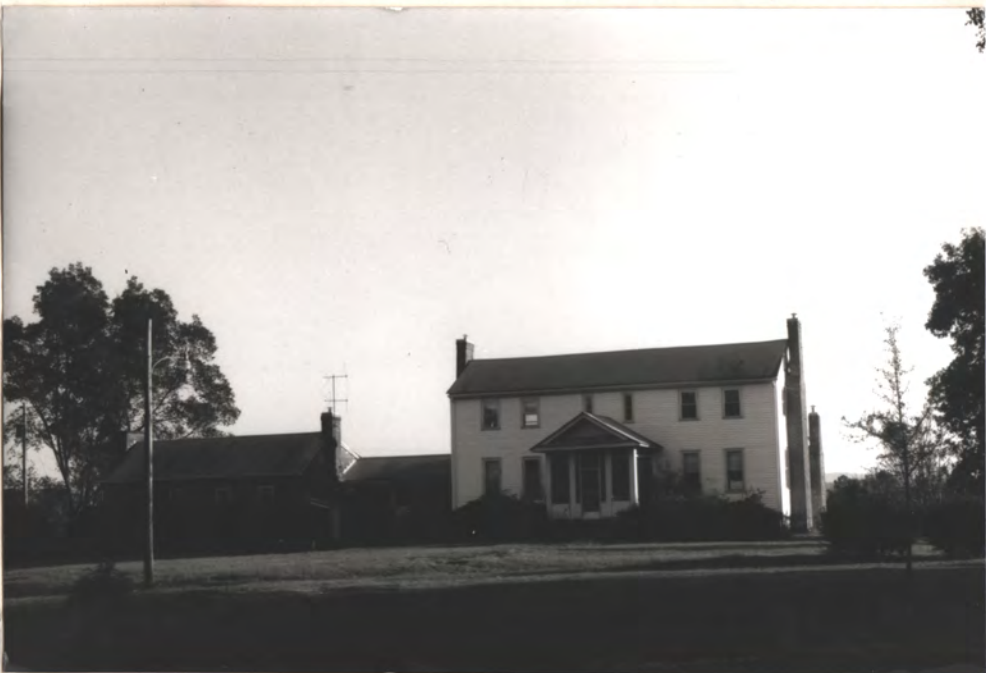
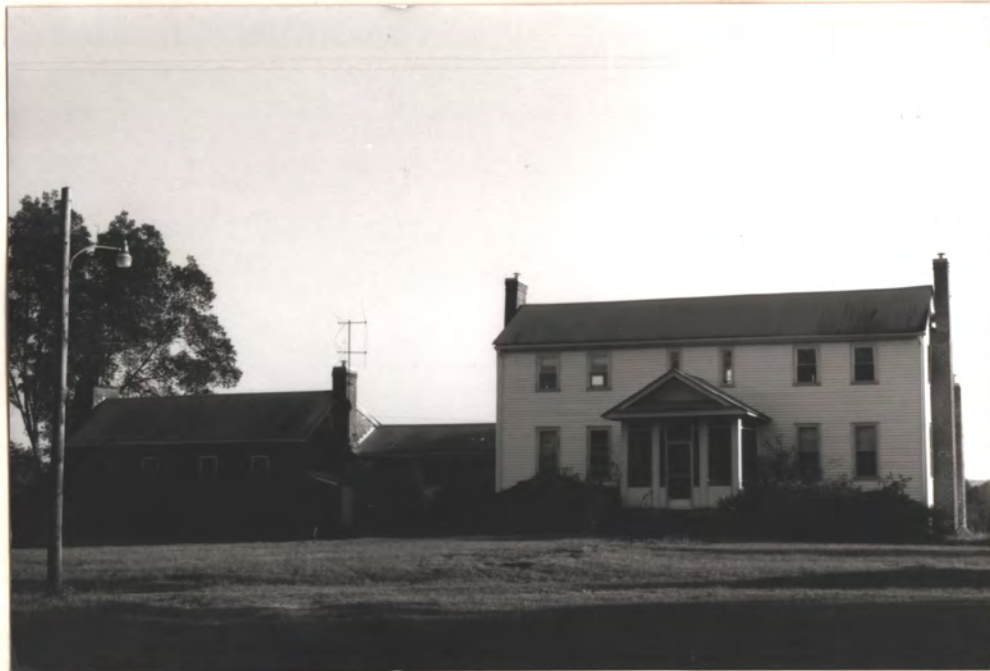
NORTH FRONT

portico roof not orig. - was a decked 1-fl. portico

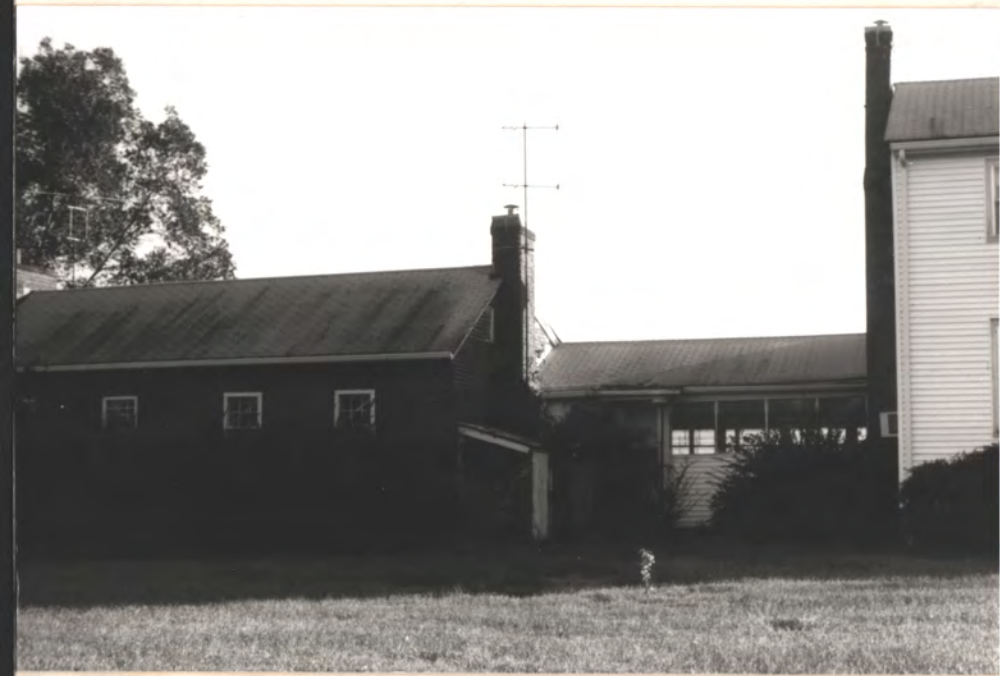
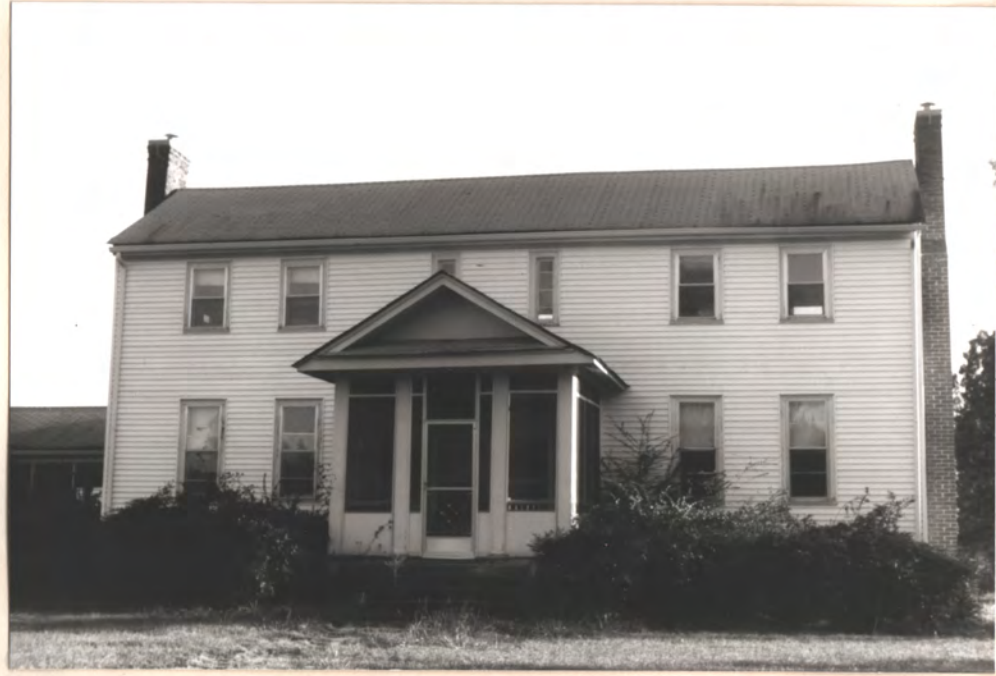
K17.  
orig. crow-step gables gone.  
See HABS 1936 photos

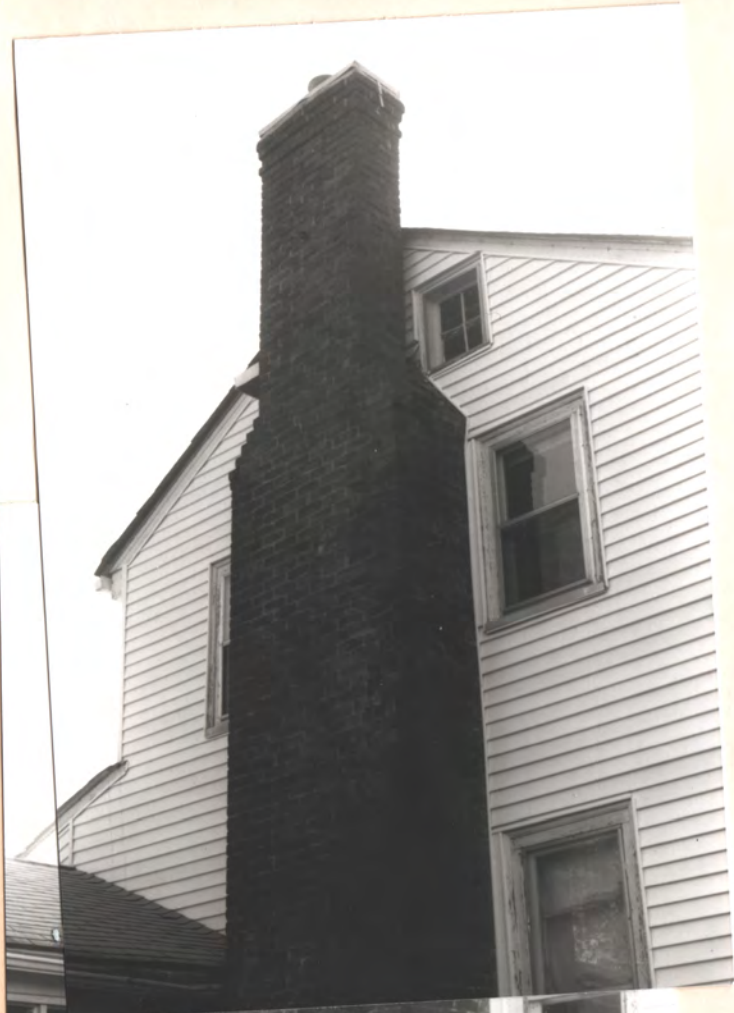
This "link" is 1950's  
per evidence of Dr. Gibbins' info

↑  
Vinyl  
Siding  
c. 1960

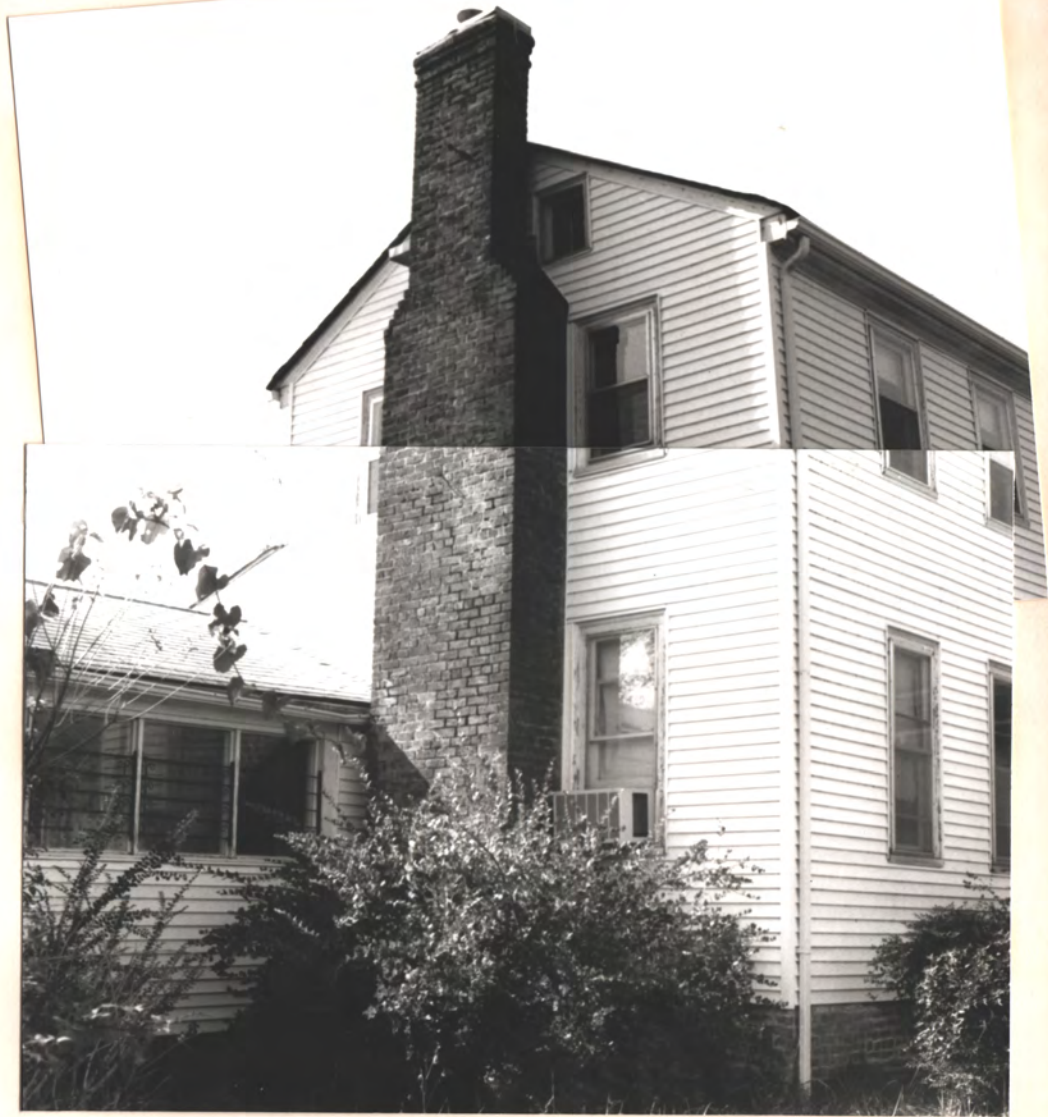
↑  
1950's  
"link"

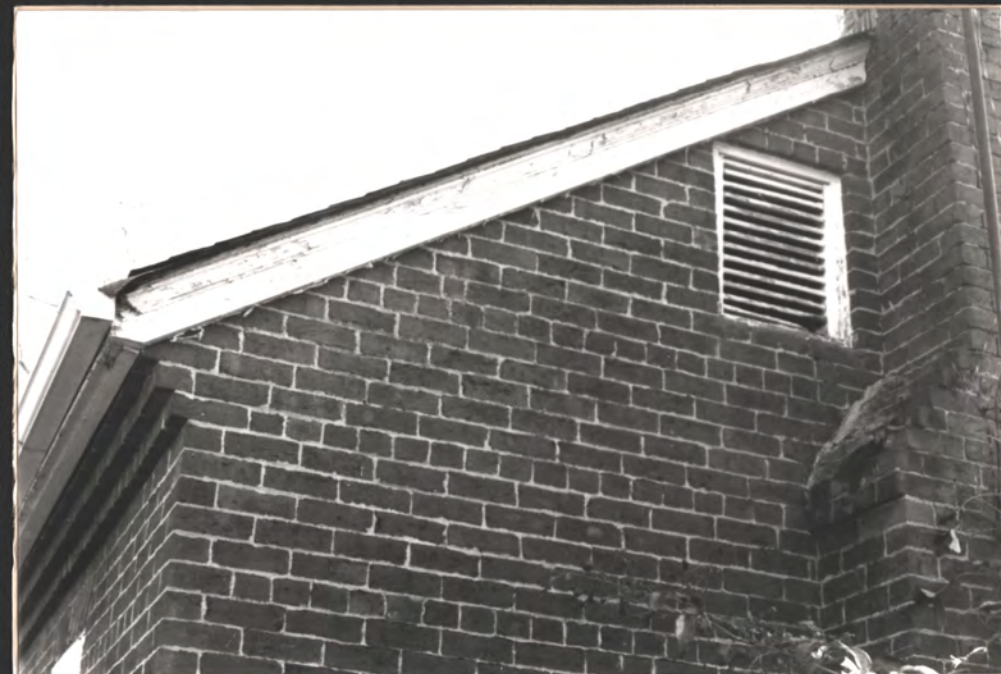
KIT.  
N.W.  
CORNER

taking  
crown  
mould  
= after  
1936  
(W49)

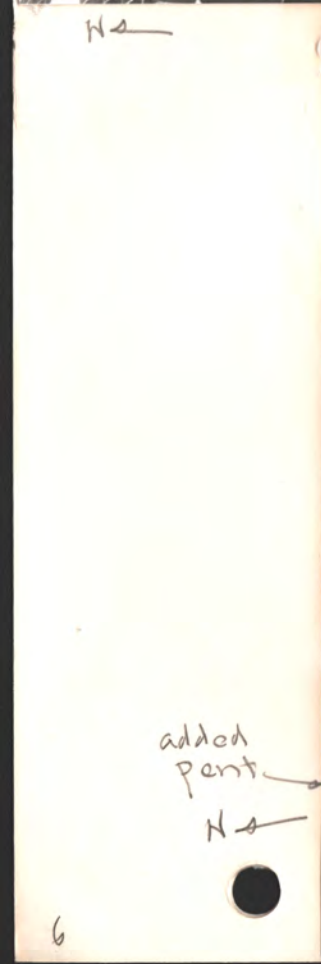
added  
pent  
→  
N  
→

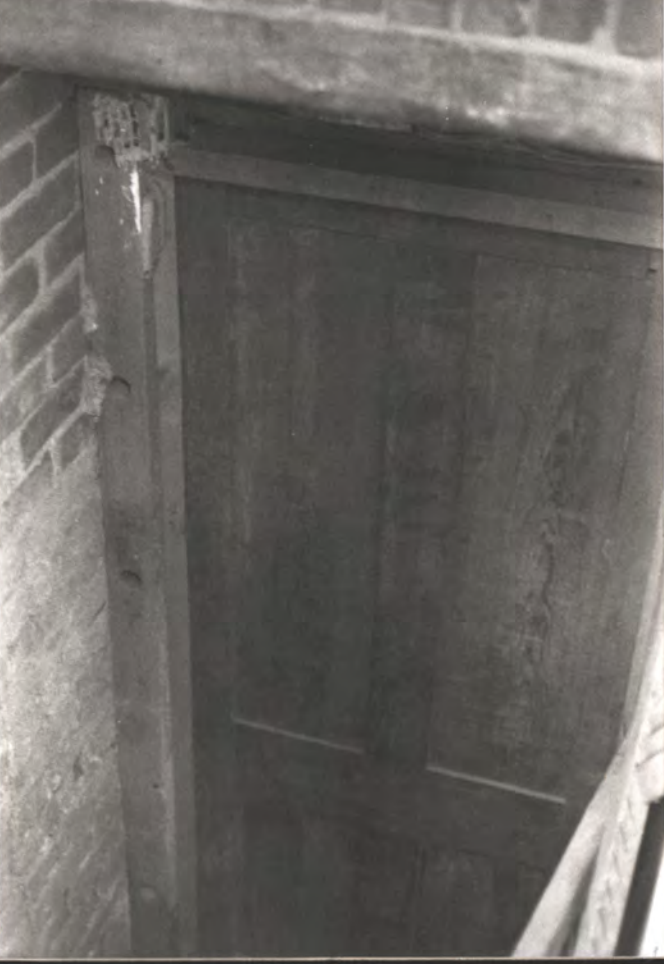
KK.  
N. Wall

← basement  
door from  
pent

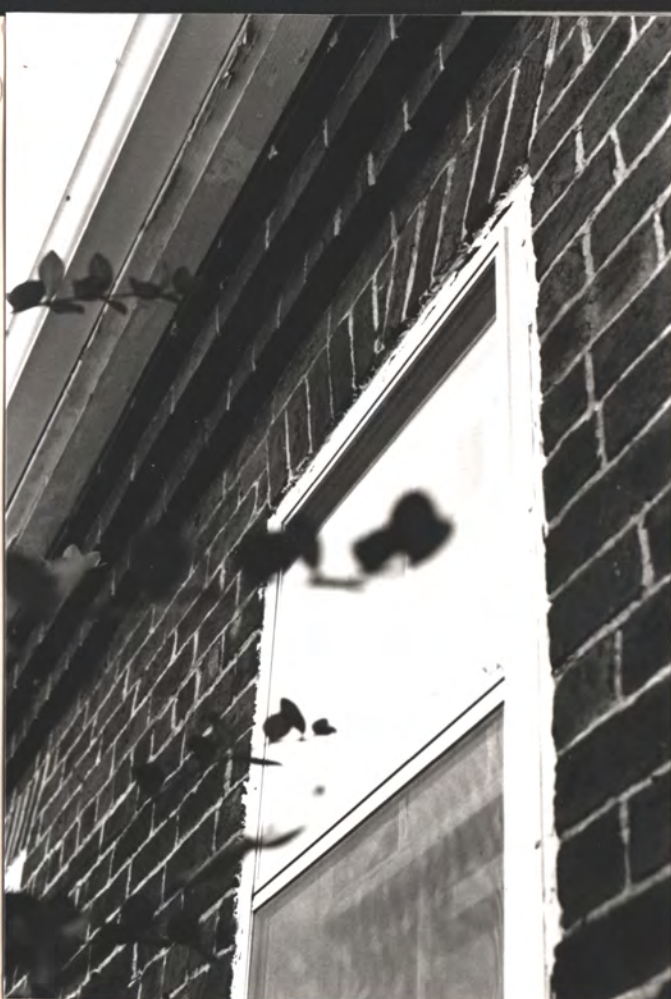
KK.  
N.  
Wall  
blast  
VENT  
(in masonry)

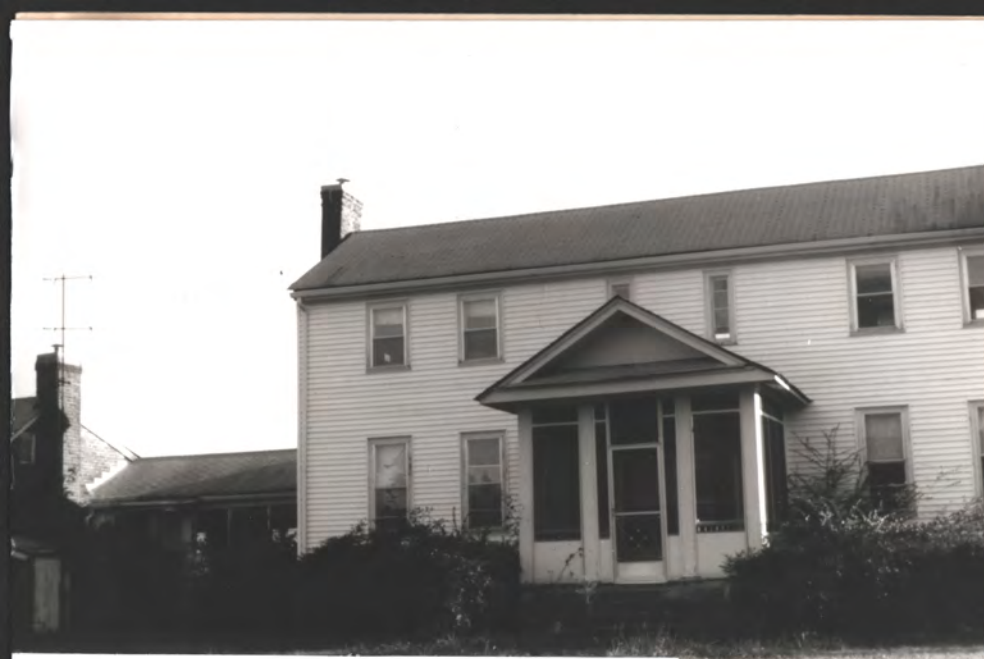
non-  
orig.  
porch  
(fl. struct  
↓ fl. =  
orig.)

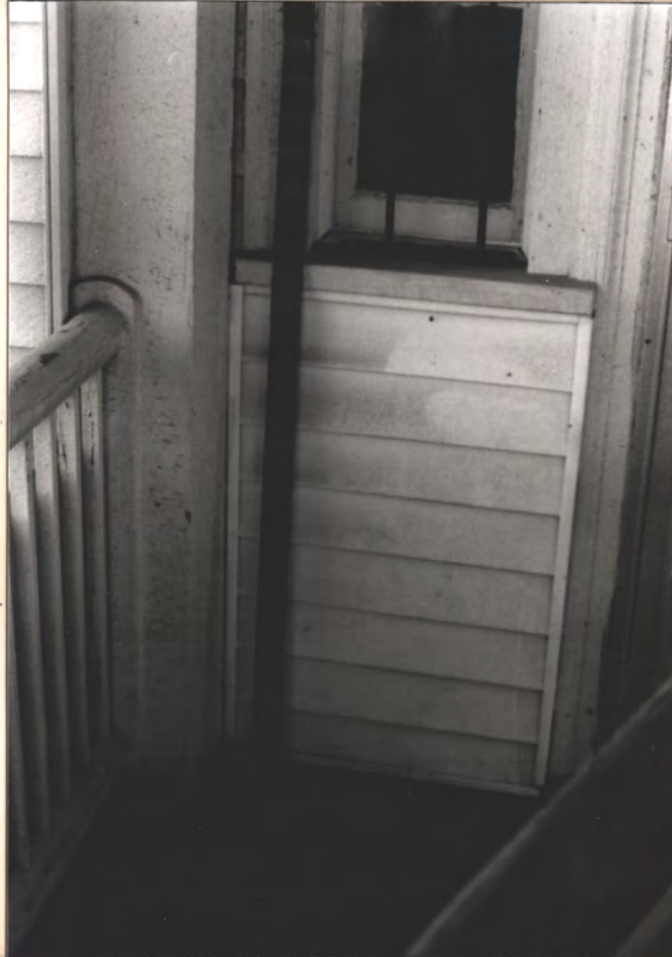
soffit could be  
orig.  
ck saw-marks  
on upper side

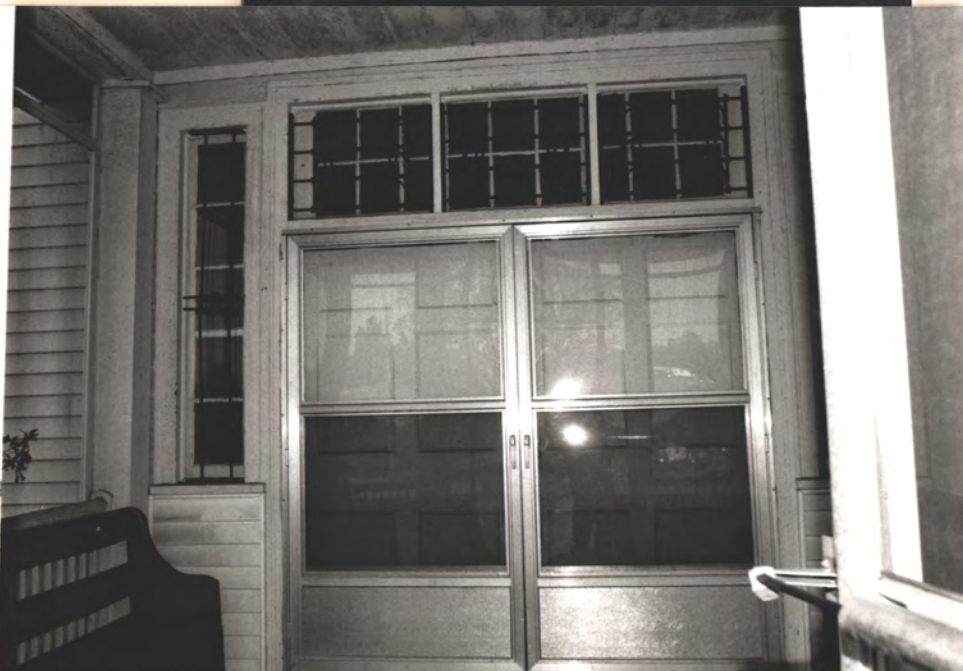
entry  
doors +  
"lights"  
= orig.

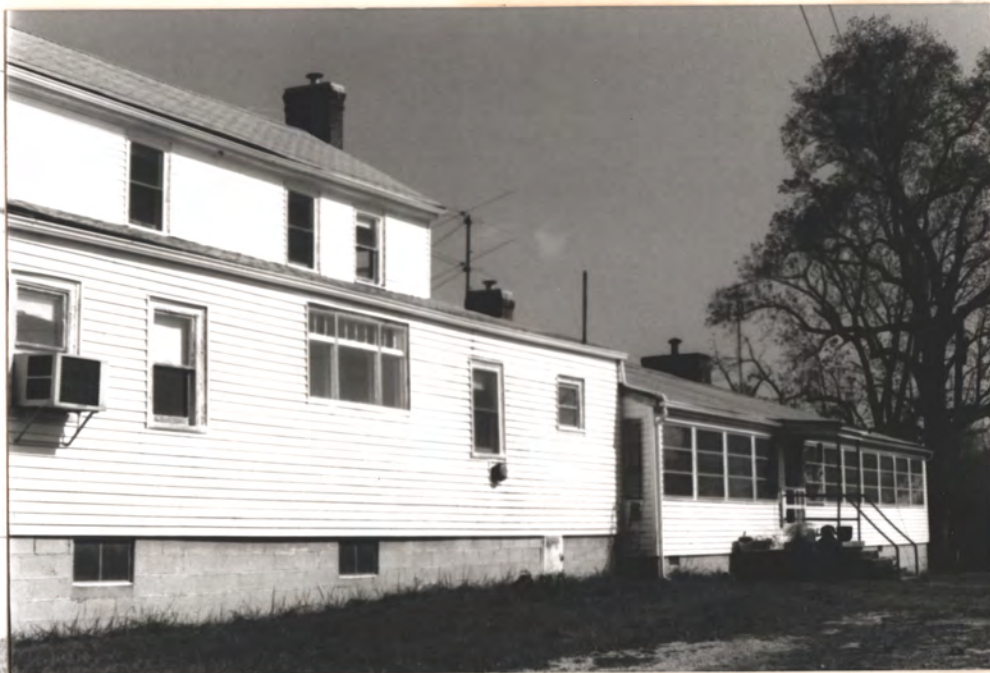
— orig. kit. behind 1950's add. —

rear shed  
= orig.

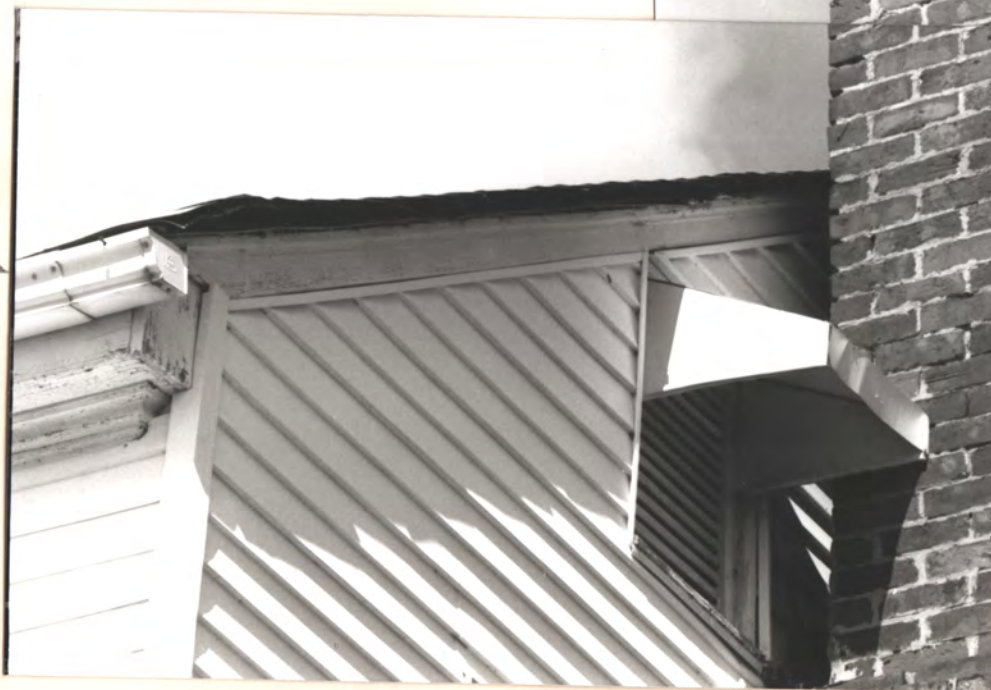
2ND FL. E. WALL

box cornice, crown of rake fascia  
appear original. Vinyl siding c. 1980

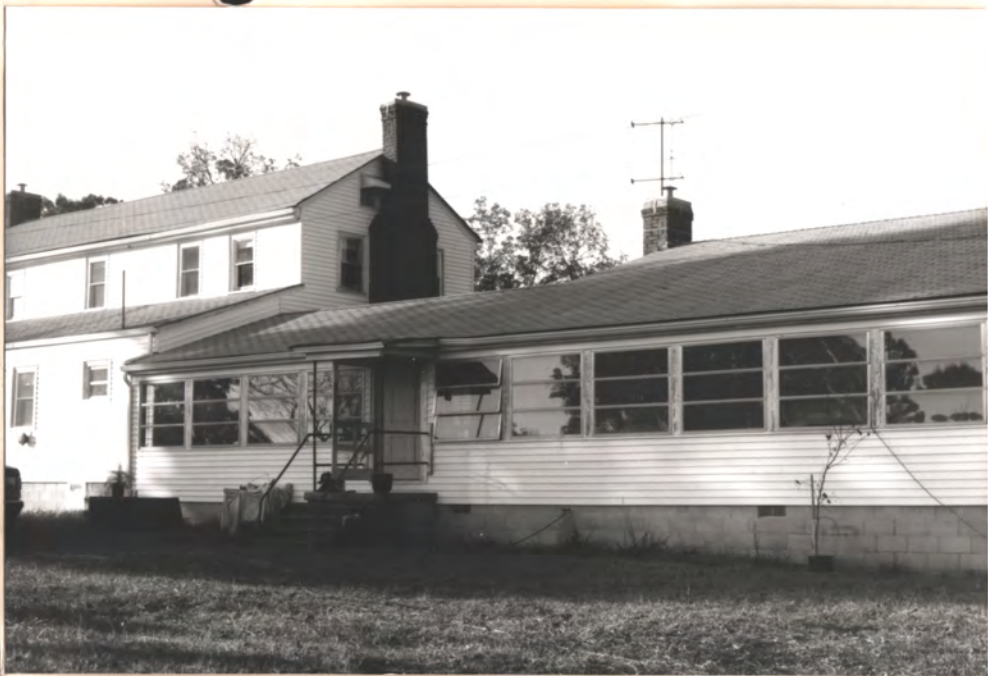
→ H 1950's "link"

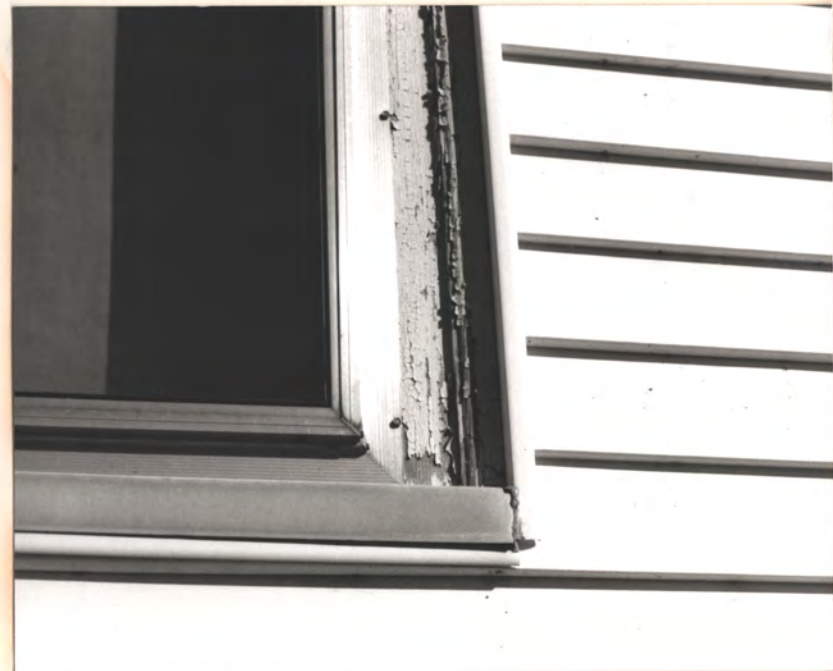
this   
 no projecting courses at hip = very unusual

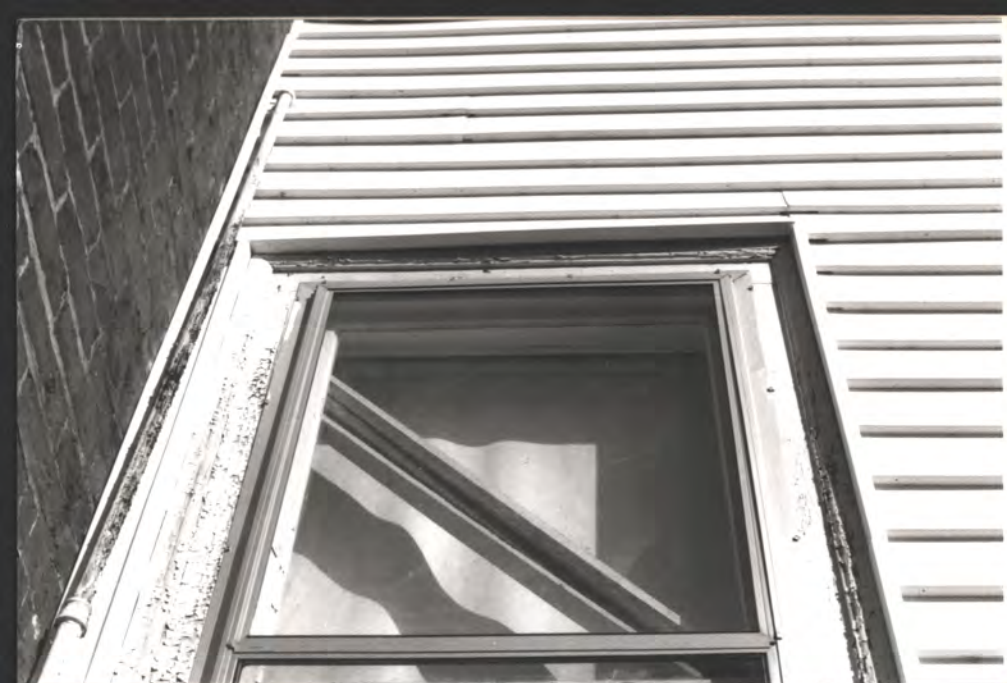
Poor "repainting". Compare w/ orig. photo at rt. + ps. 16.

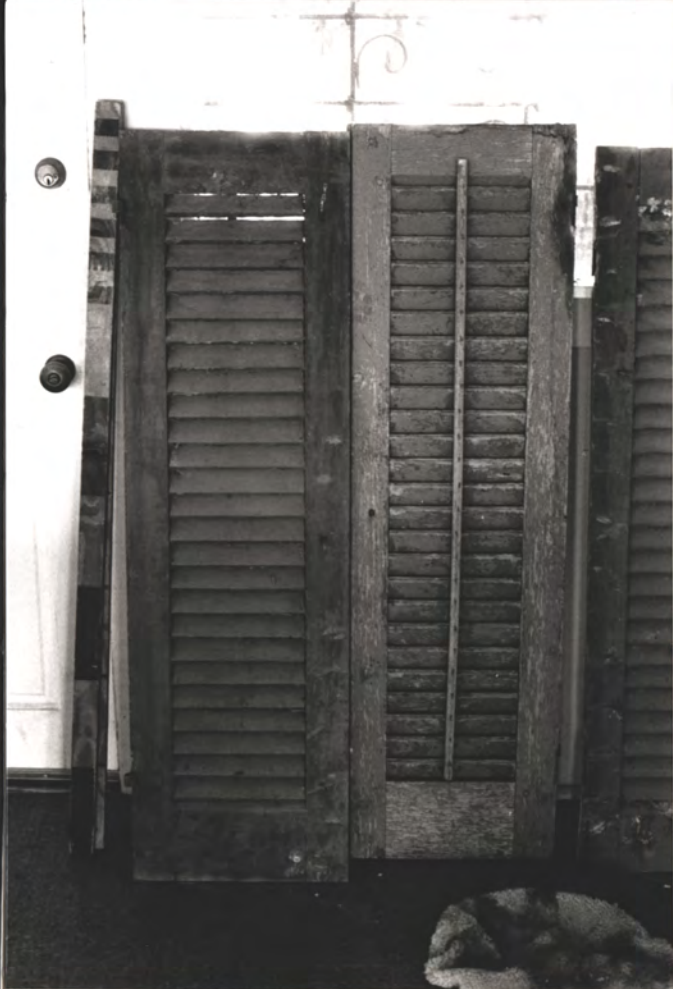
orig. blinds (open. of fixed blinds)  
See 1936 HABS photos

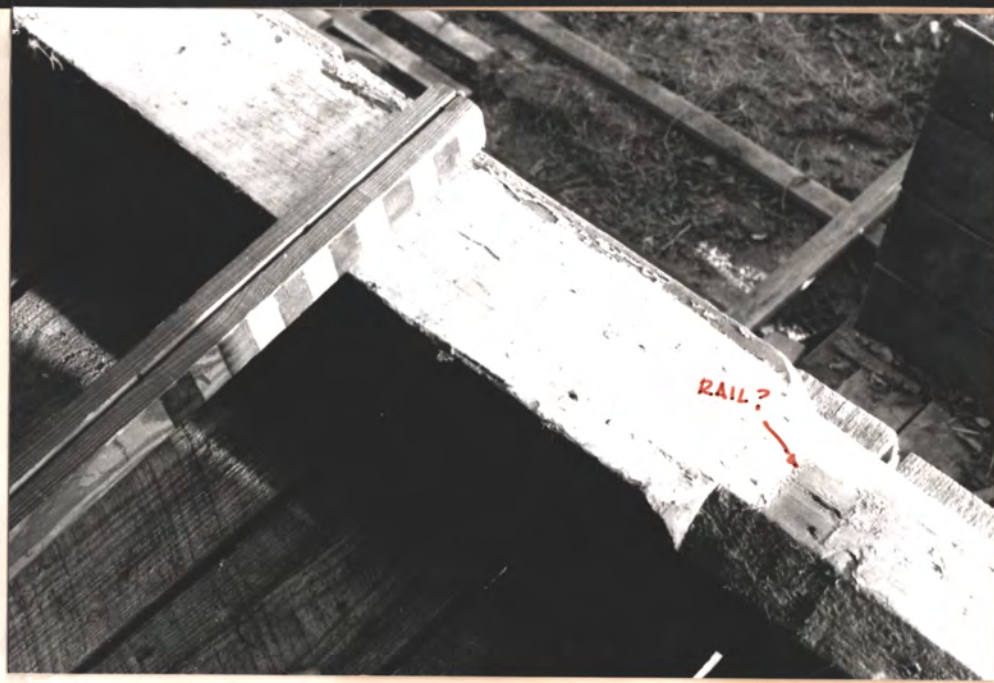
one orig. col. that was at the "hike" covered walk  
 (See 1936 HABS photos), now in barn loft, with  
 top rotted-off.

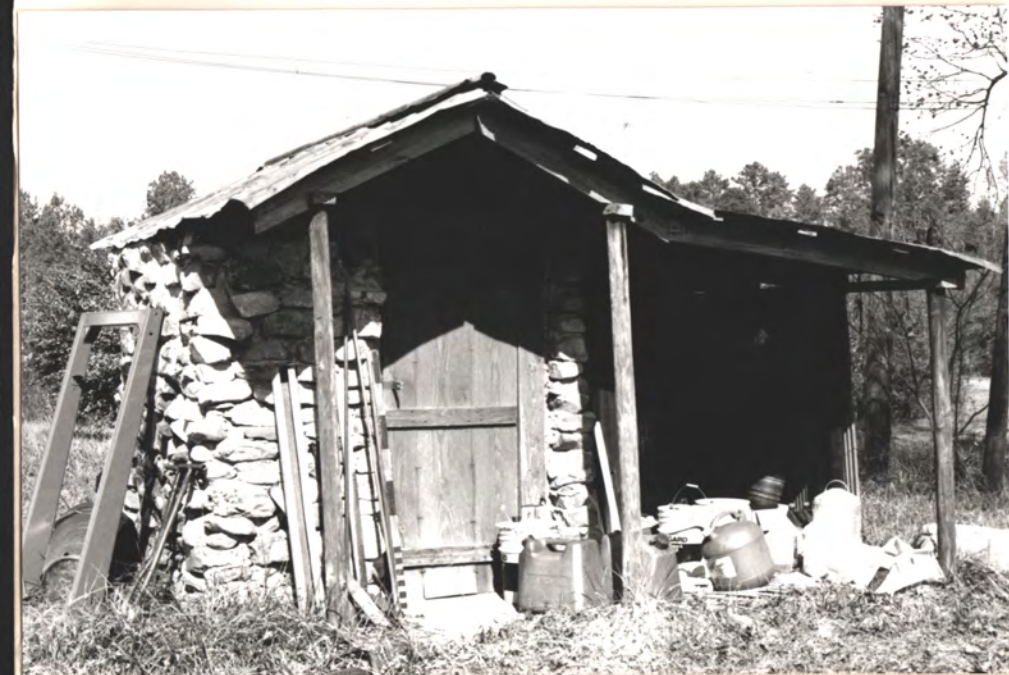
Modern shed, S.E. of kit.  
 Perhaps mid-20th century

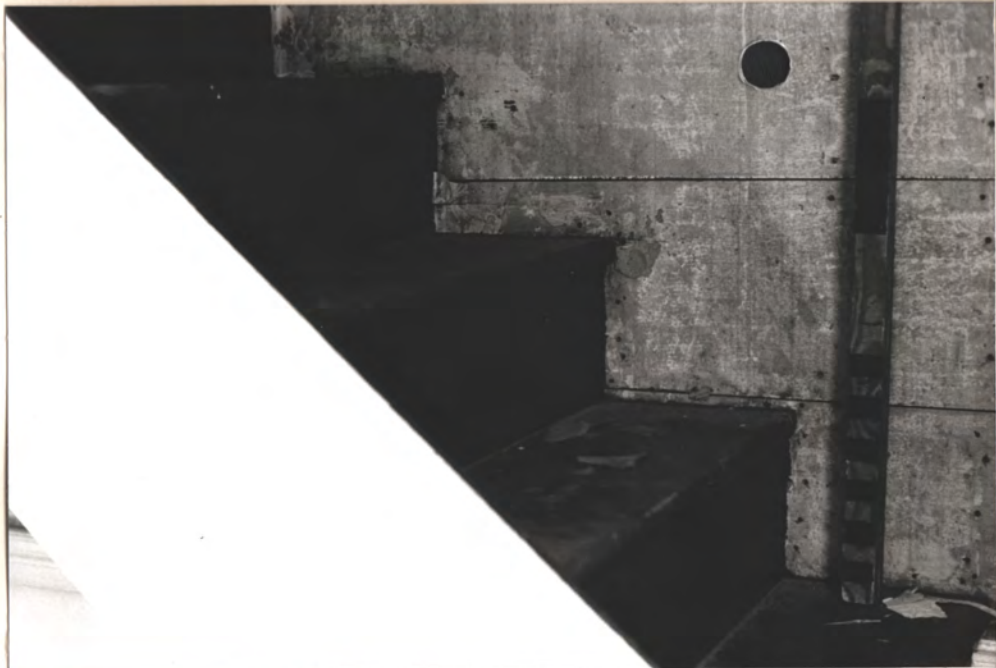
← See 1936 H&BBS  
photos for bd.  
walls. This is  
gypsum-board over  
the bd. walls, plus  
wallpaper

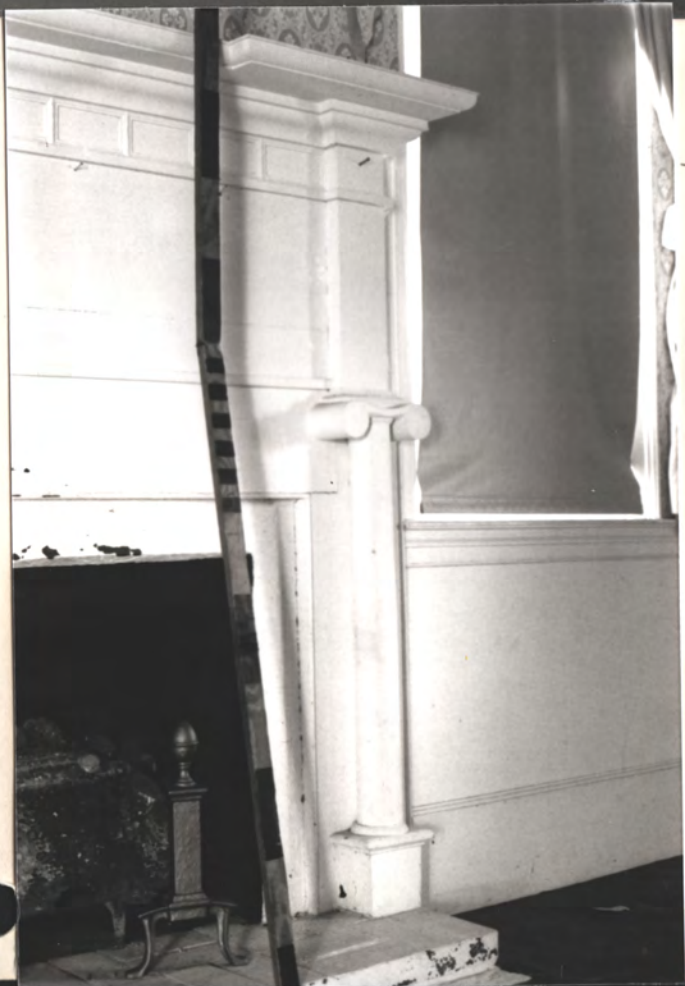
FIRST FL.  
N.W. Rm.

plaster,  
probably  
later

raised  
height  
= mod.  
(1950's?)

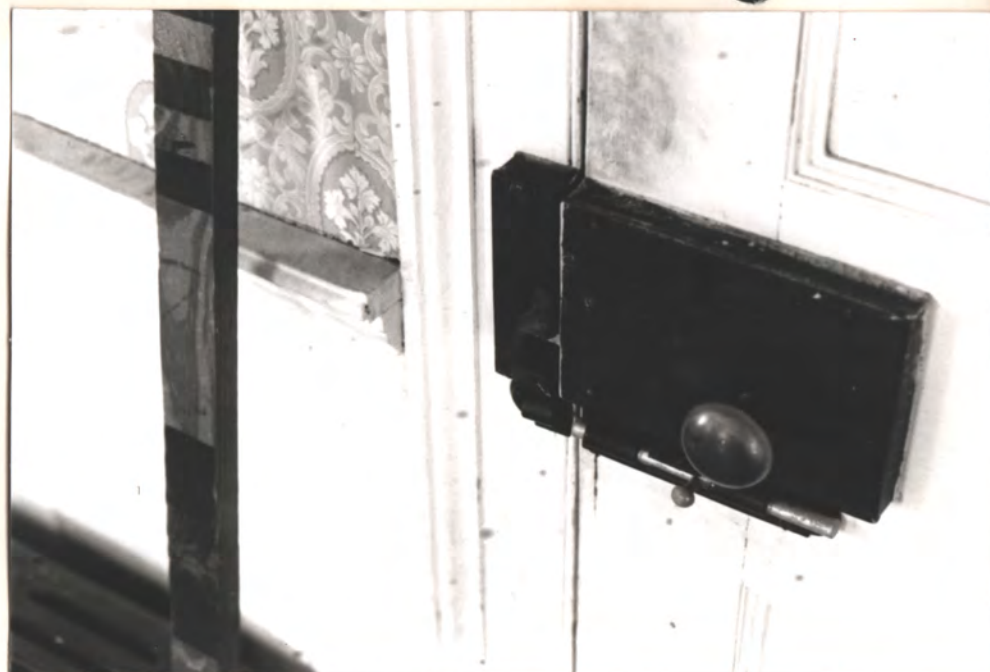
~~NW~~ EAST DOOR ("Carpenter" brand lock) = Fed.  
slide-bolt = mod.

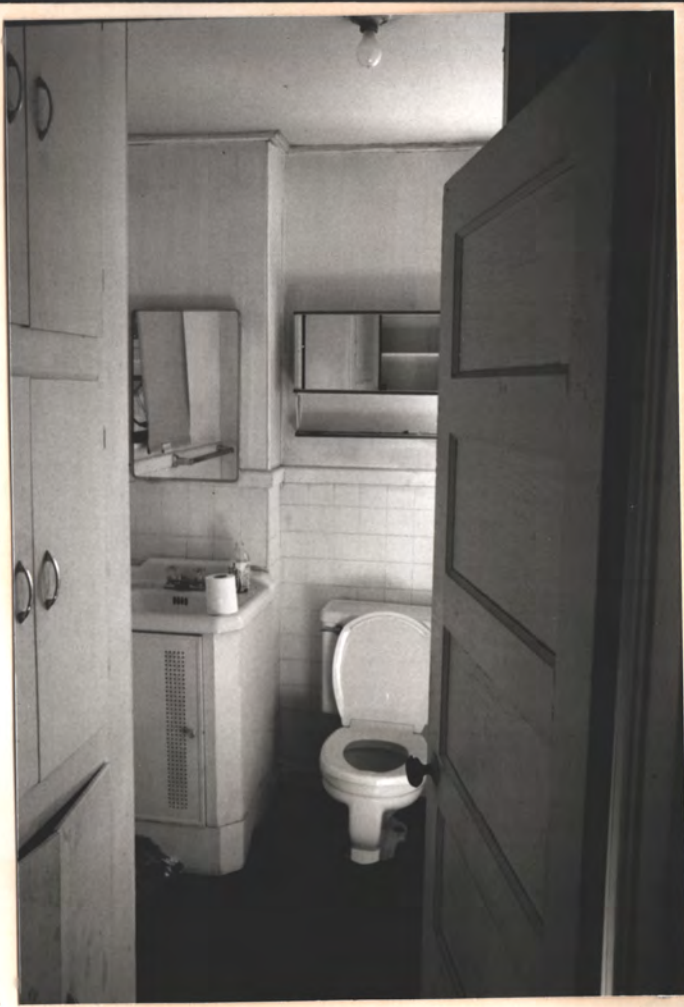
1ST FL. S.E.  
SHED Rm  
(cut into bath, closet etc)

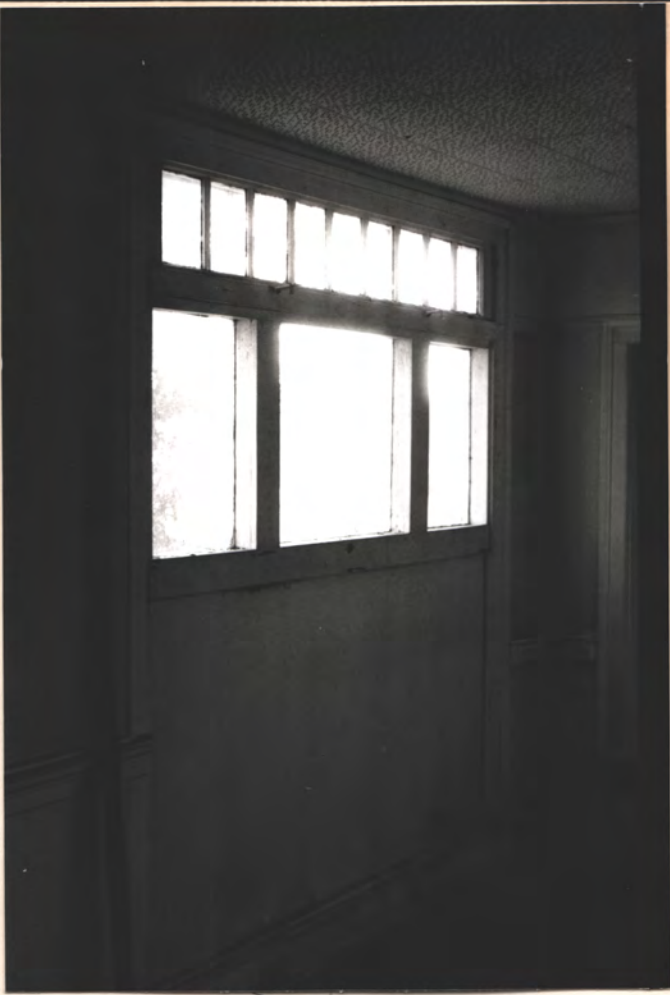
OR10.  
TRANSOM  
- See  
HABS

OR10. REAR  
ENTRY  
(see HABS  
photos)  
now closed  
(1950's?)

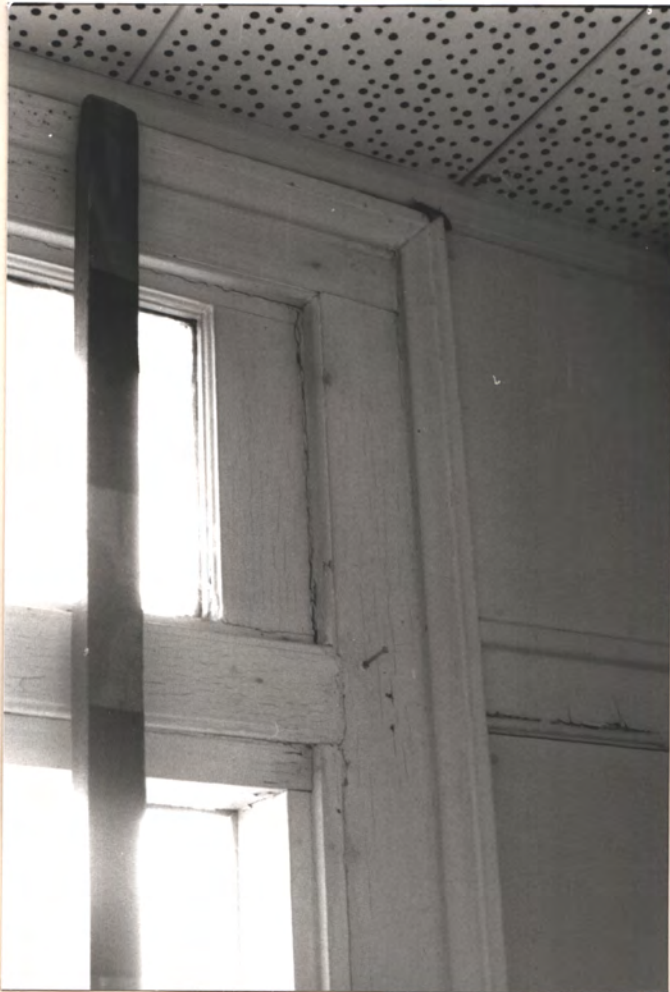
← c. 1950's  
Acous.  
tile
