## Borders-Blackmon House Offers Important Record of Slave Artistry

CIRCA 1840 BORDERS - BLACKMAN HSE, ANNISTON, AL.  
 H.A.B.S. RESTOR. + ADDN. 1990 DR. GEORGE & SUSAN GIBBS.  
 JONES & HERRIN, ARCHITECTS - H.P. JONES, F.A.I.A. - HUNTSVILLE, AL.

c.1840 Borders - Blackman Hse, Anniston, AL (HABS)  
after restoration in 1990 by Jones & Kerrin, Arch.  
Harrie P. Jones, FARA, Huntsville, AL  
Owner - Dr. George Gibbins, Anniston  
Photos H. Jones, June 1993

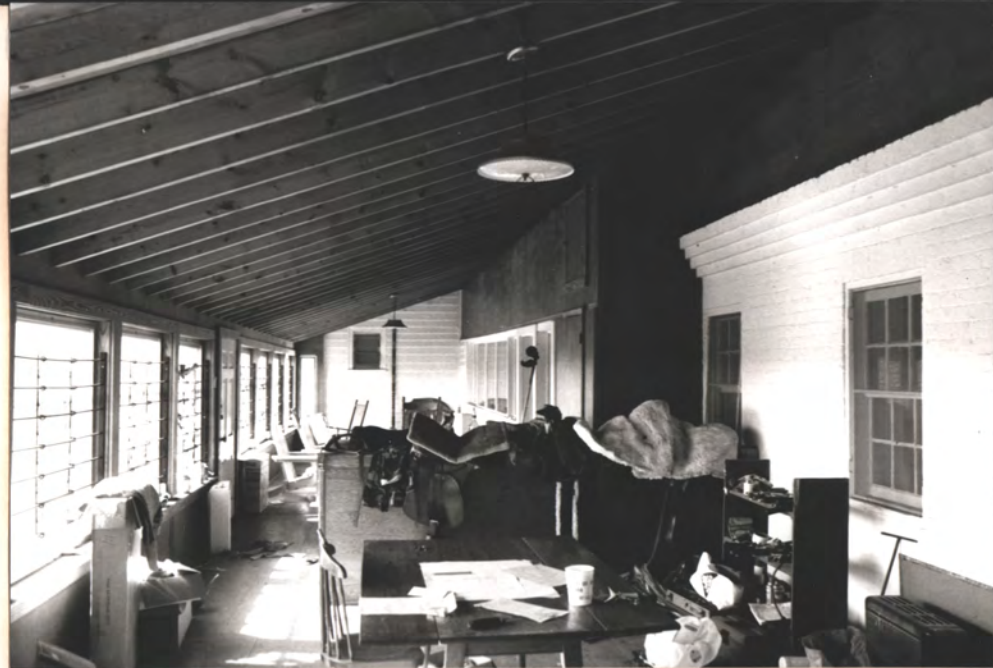
bricks = orig. ked.  
small

"LINK" - 1950's

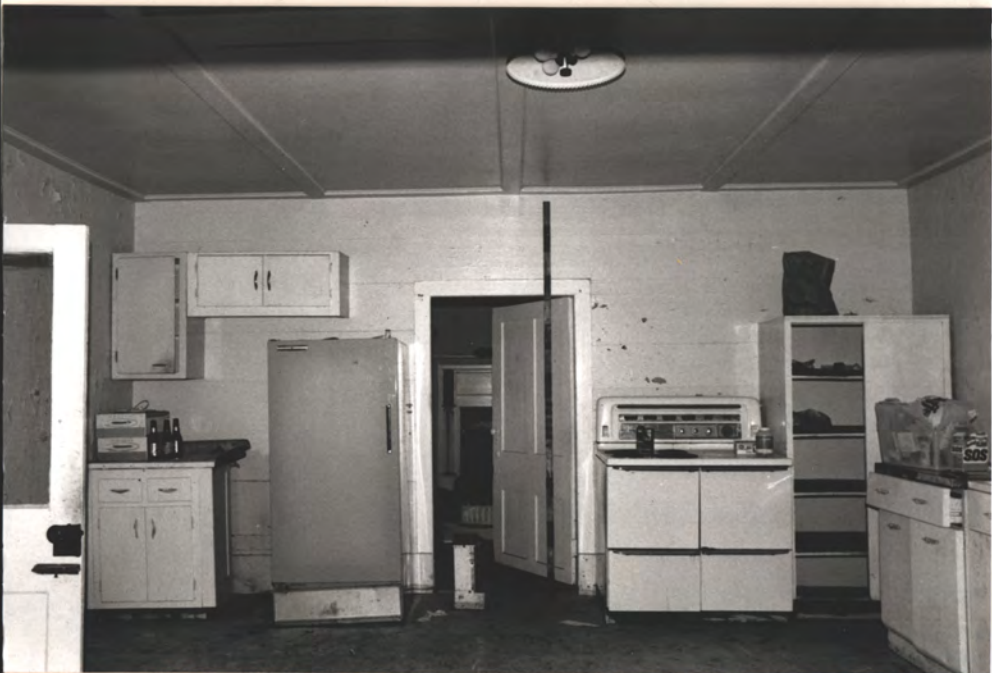
W. WALL → N

mod. cell. fin.

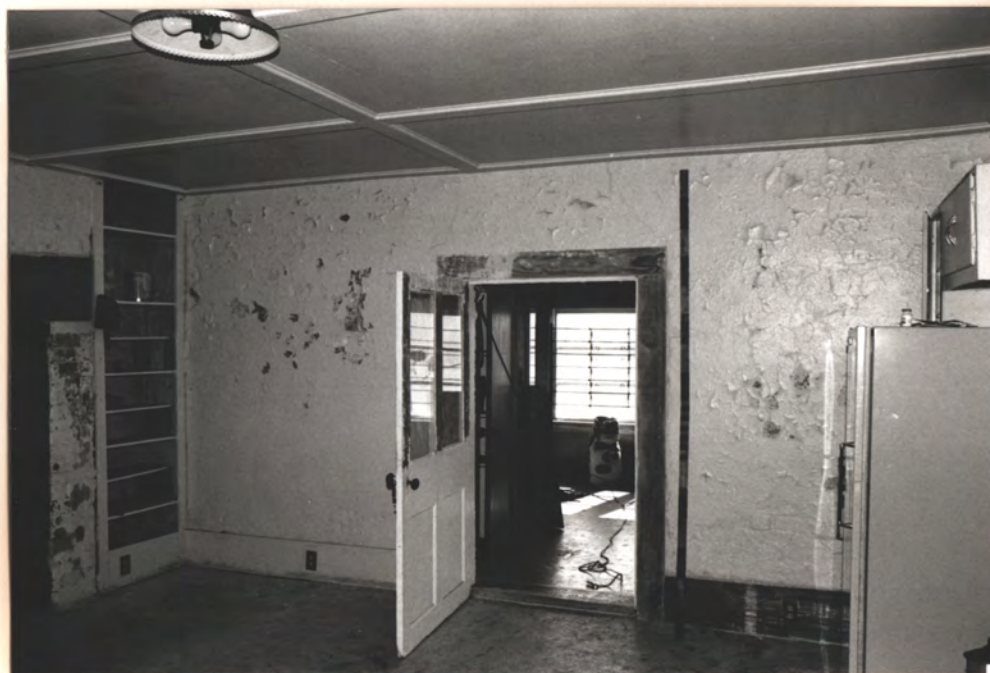
S. WALL → H

cem. fl.

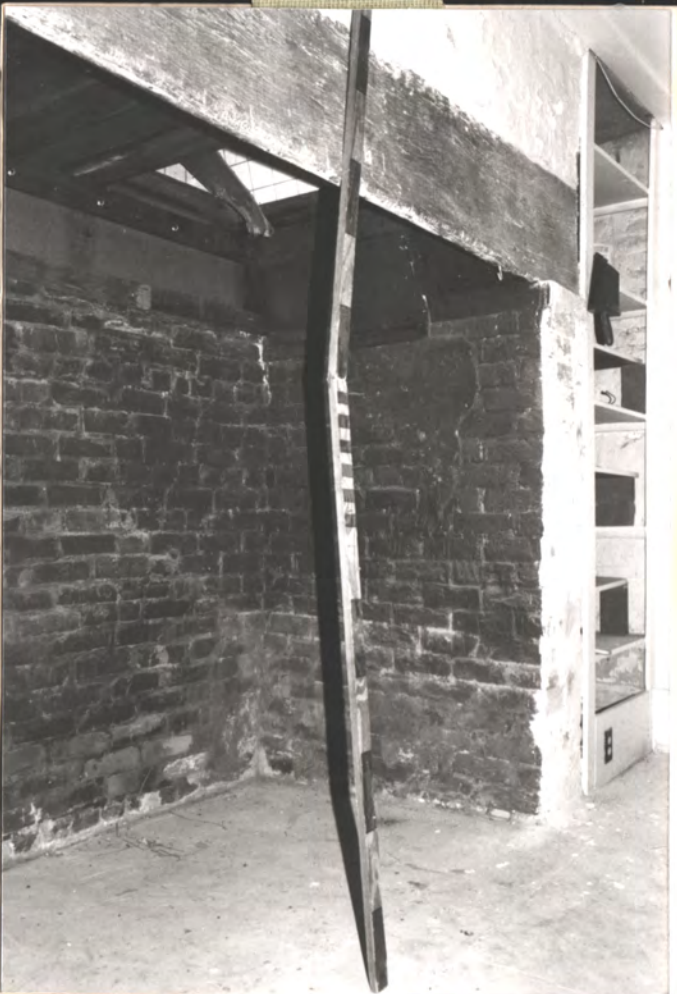
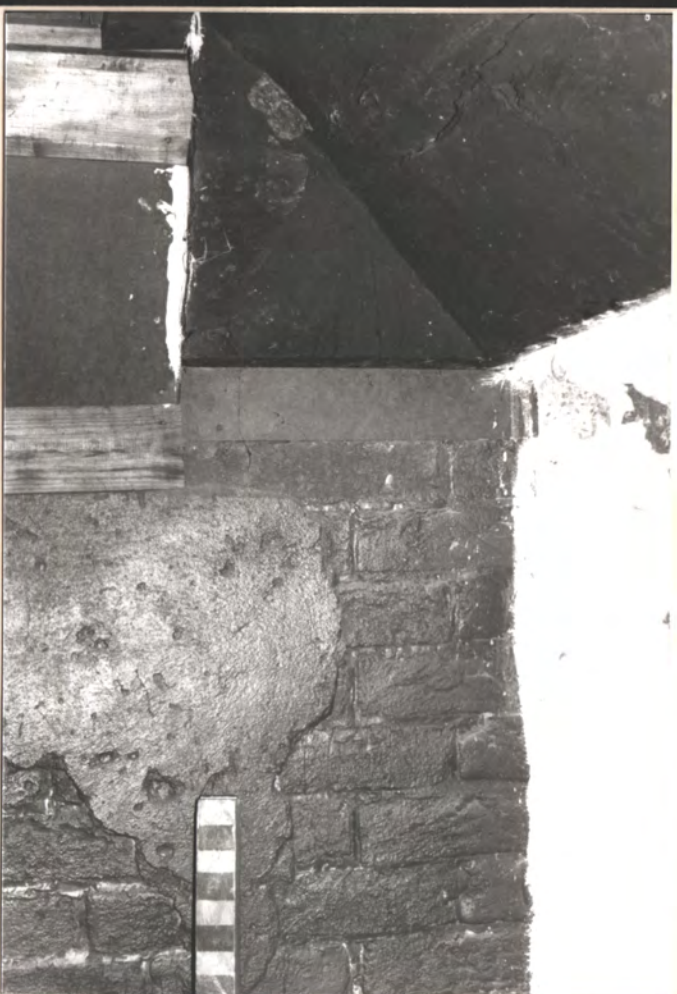
ORIG. COOKING FIREPLACE

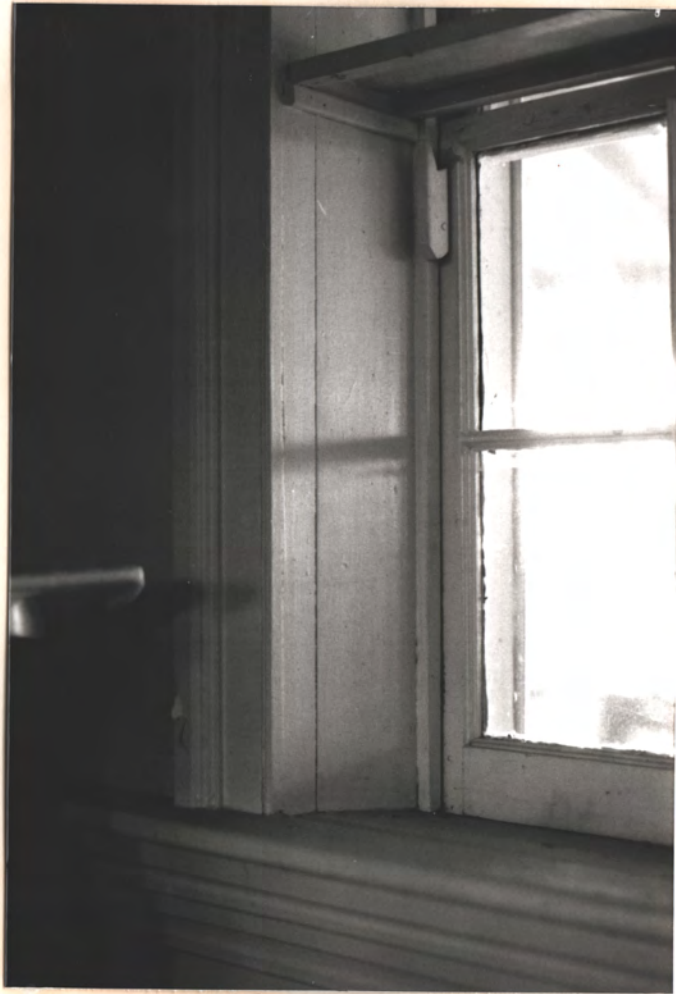
← this bottom sash only is Fed.  
 (S. wall, E sash, bottom half)

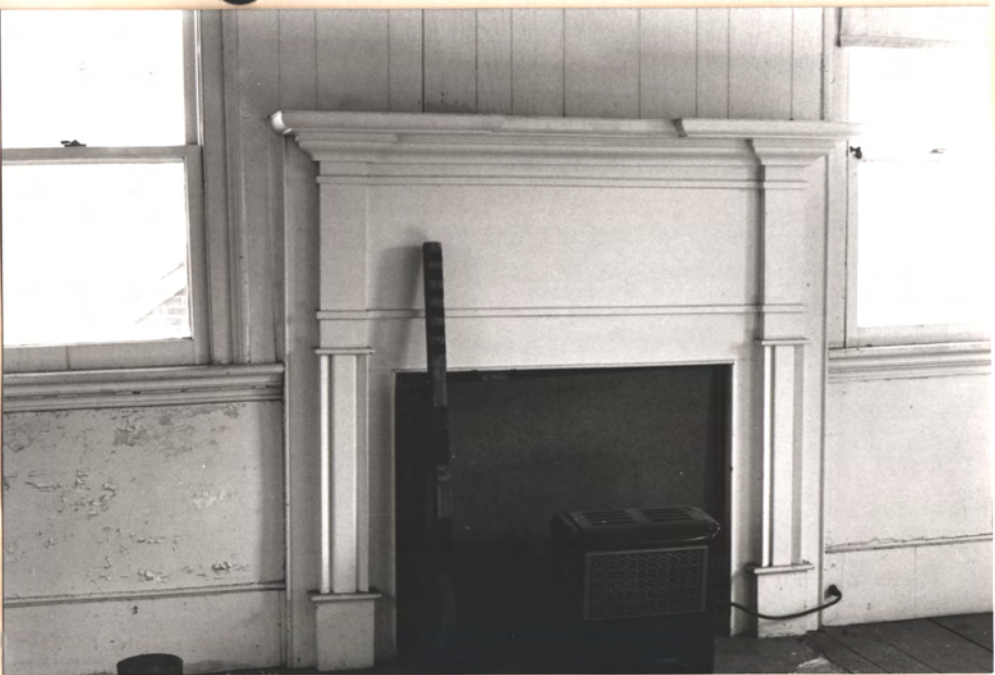
2ND FL. E. RM.

probably  
mod. gyp bd  
over plank  
dado (etc.)

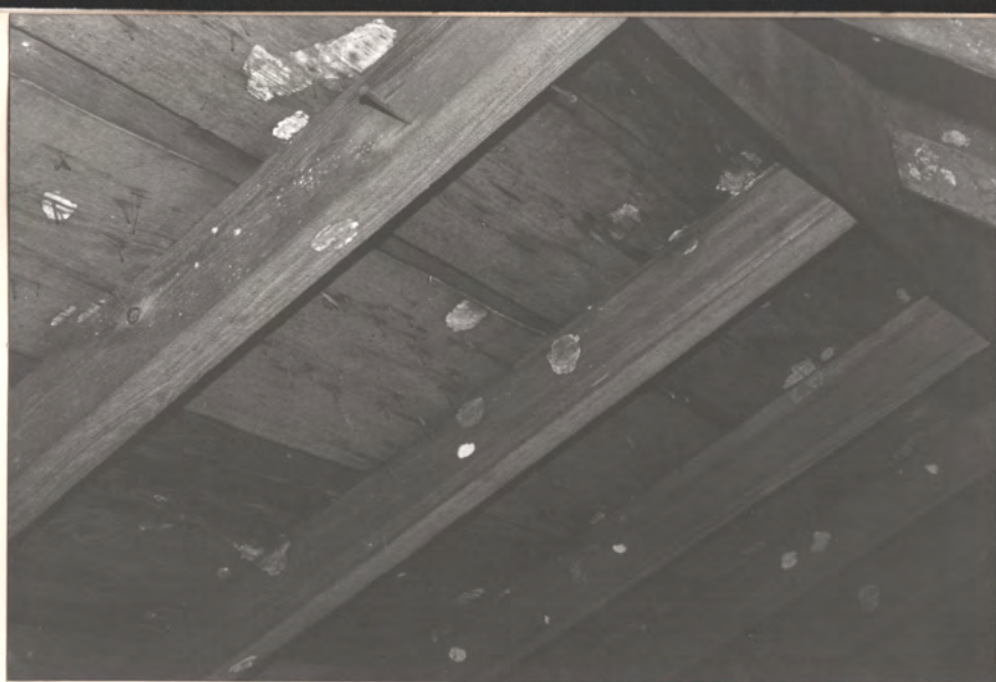
orig deck etc

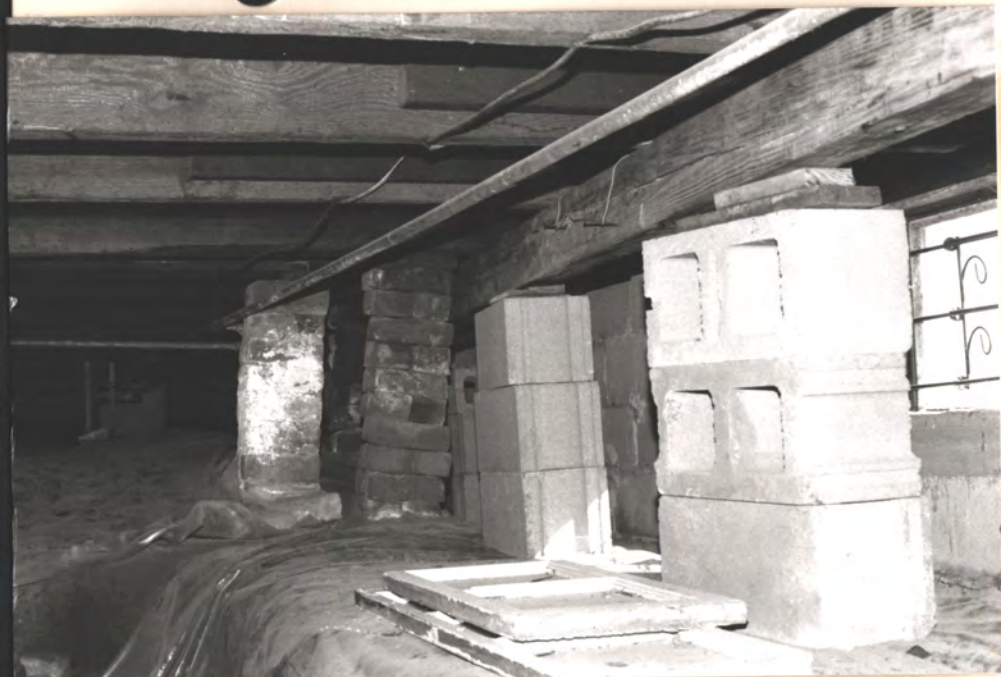
later props along S. wall

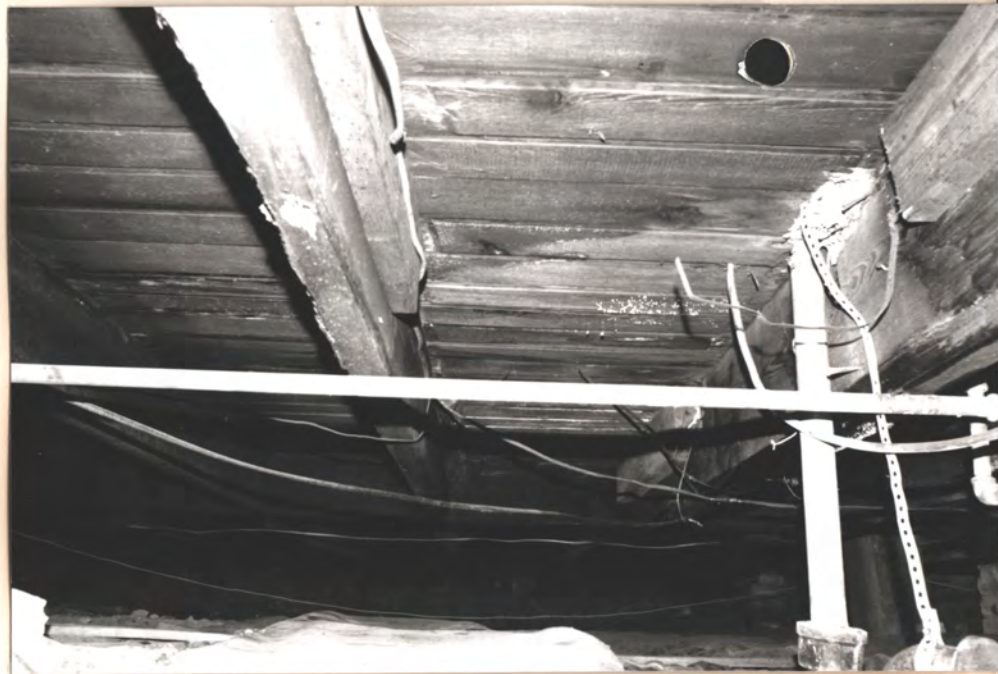
← sash-saw marks (top Fed.)

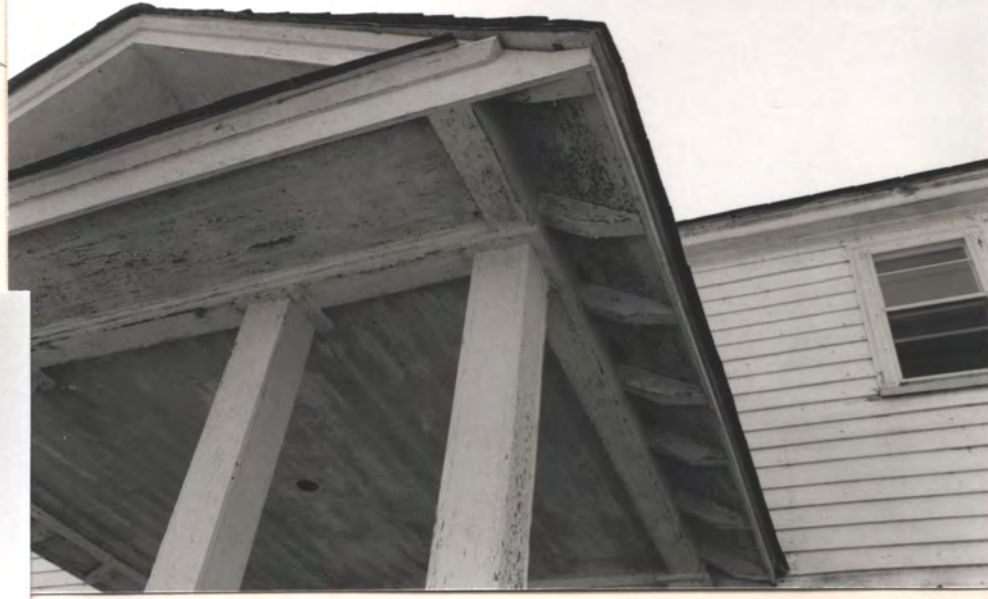
R corr steps = c. 1950's. Fl. + rail + col = c. 1840  
SLOPED ROOF c. 1850's

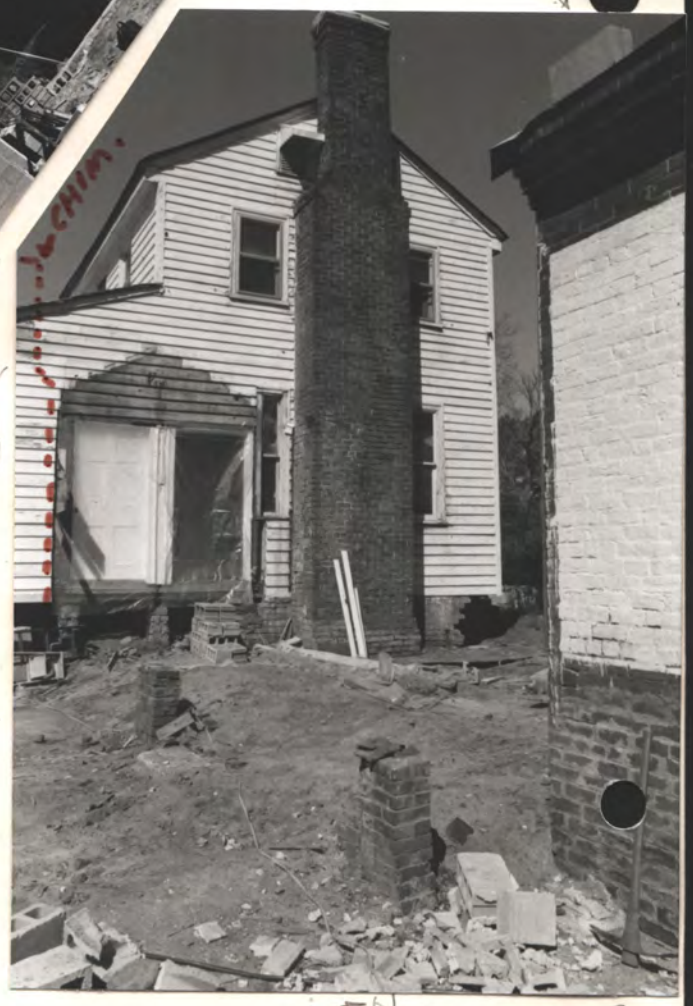
1950's finish being  
rebuilt w/ some blk  
& brick veneer.  
SAYS BRICK  
TIE BELTS - see Pg. 10  
SOURCE: WALK  
Trace of old, covered  
walk shown on 1934  
HABS photos  
ORIGINAL  
COV. WALK  
PIERS, WERE  
UNDER THE  
1950'S FM.

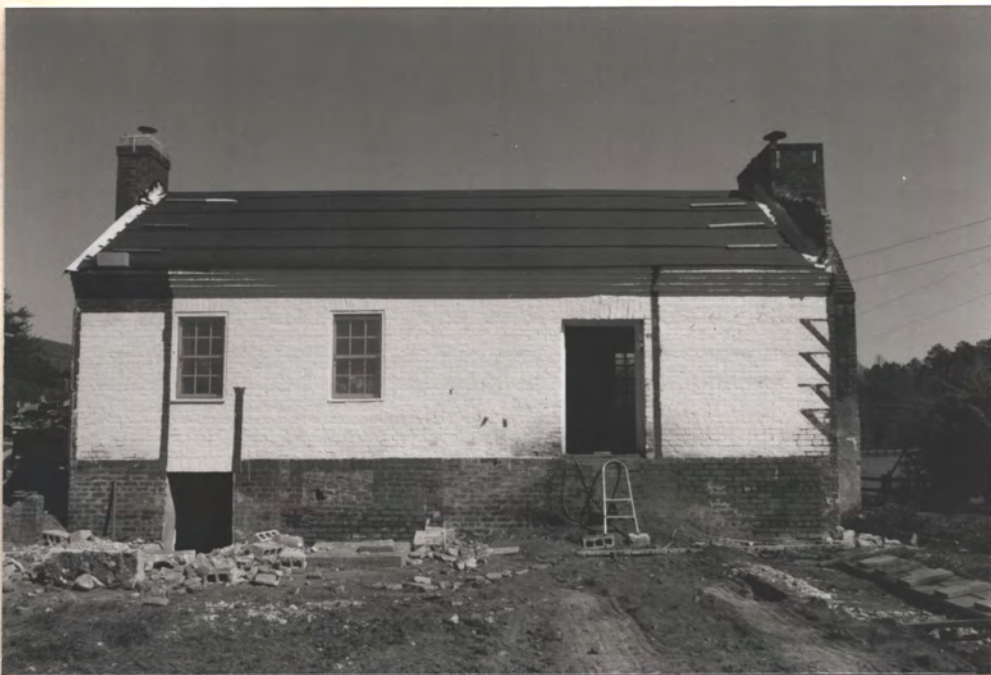
→ see WABS photos  
for step-gables,  
removed c. 1950

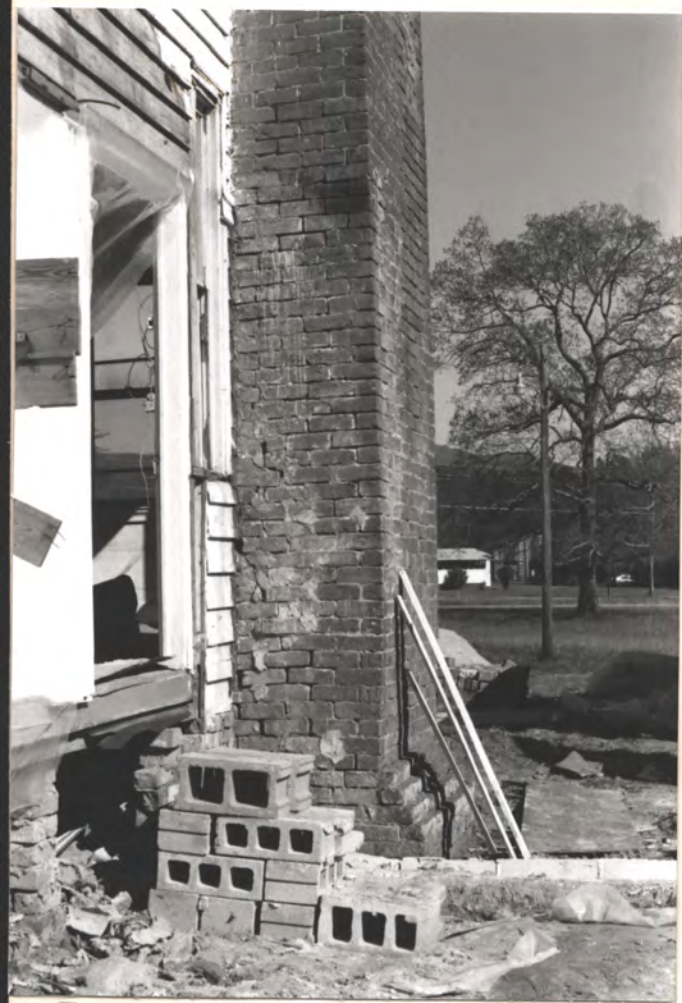
Heavily rotted (red.) Fram. under portico fl. → N

Note: The pent was added, but was an early addn

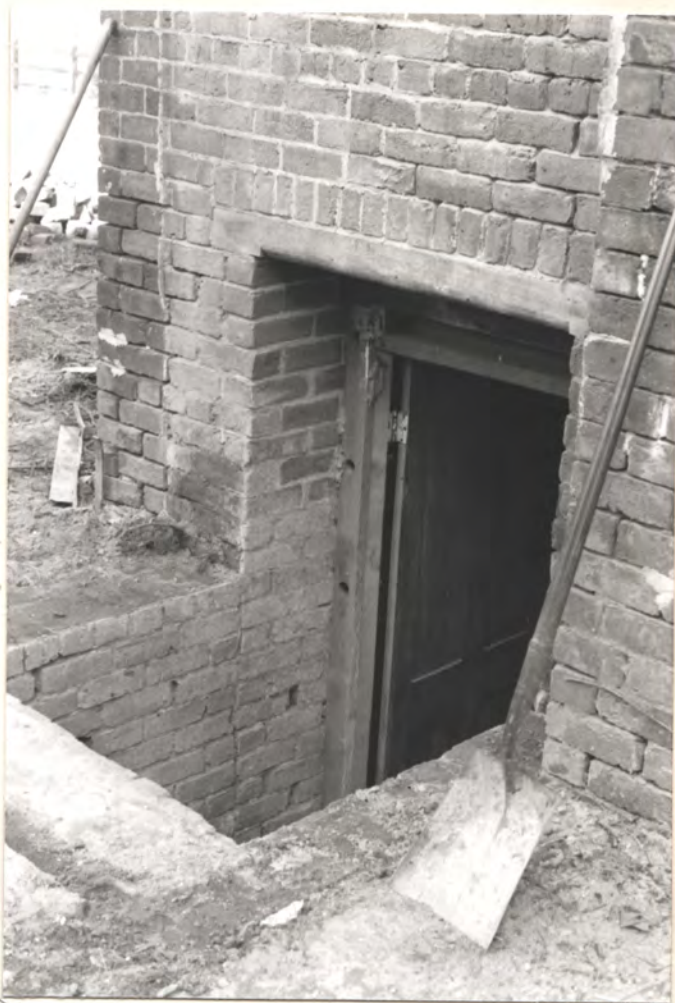
↓  
PENT ENTRY TO BSMNT. GONS. SEE HABS + 1980 photos

E. Chimney, Main Use, bad tech. cond. (bowed out)

Wet

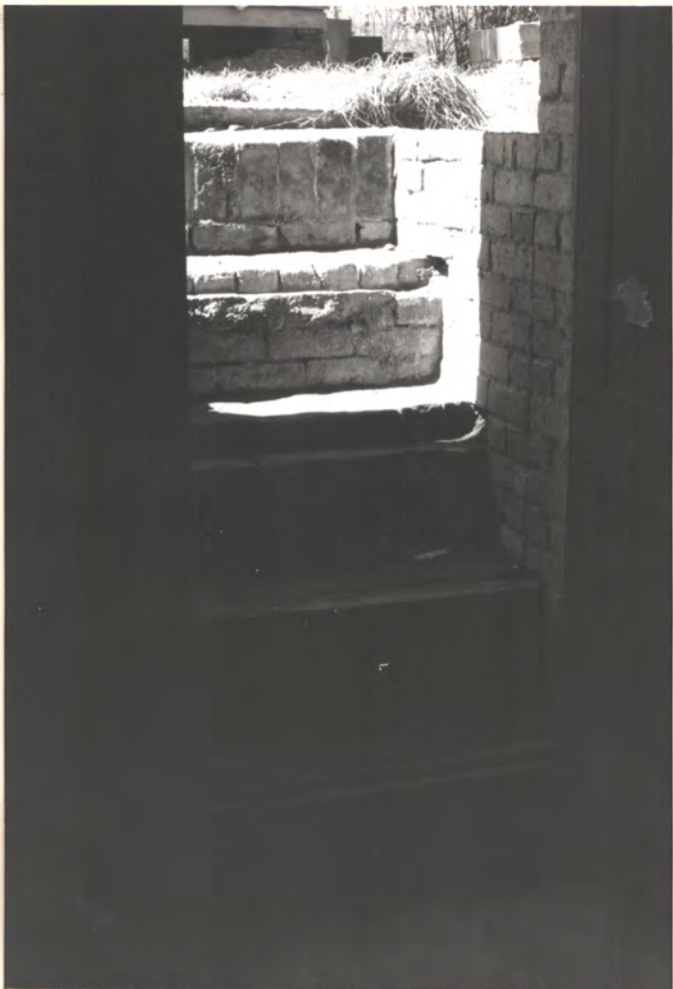
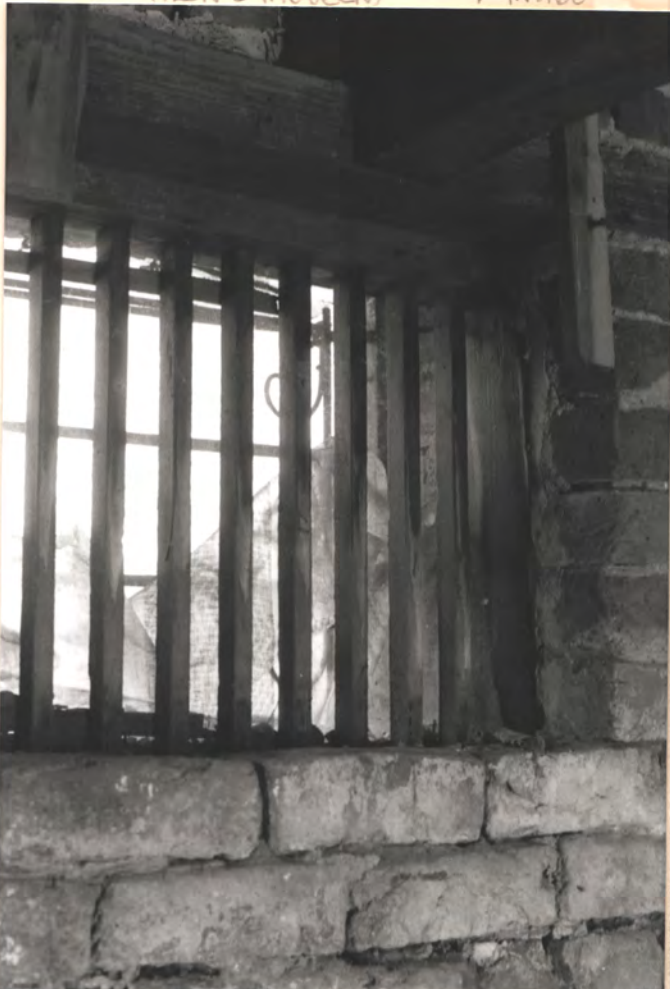
↳ BASEMENT VENT GRILLE (WOOD) (IRON = MODERN)

↳ OUTSIDE  
↳ INSIDE

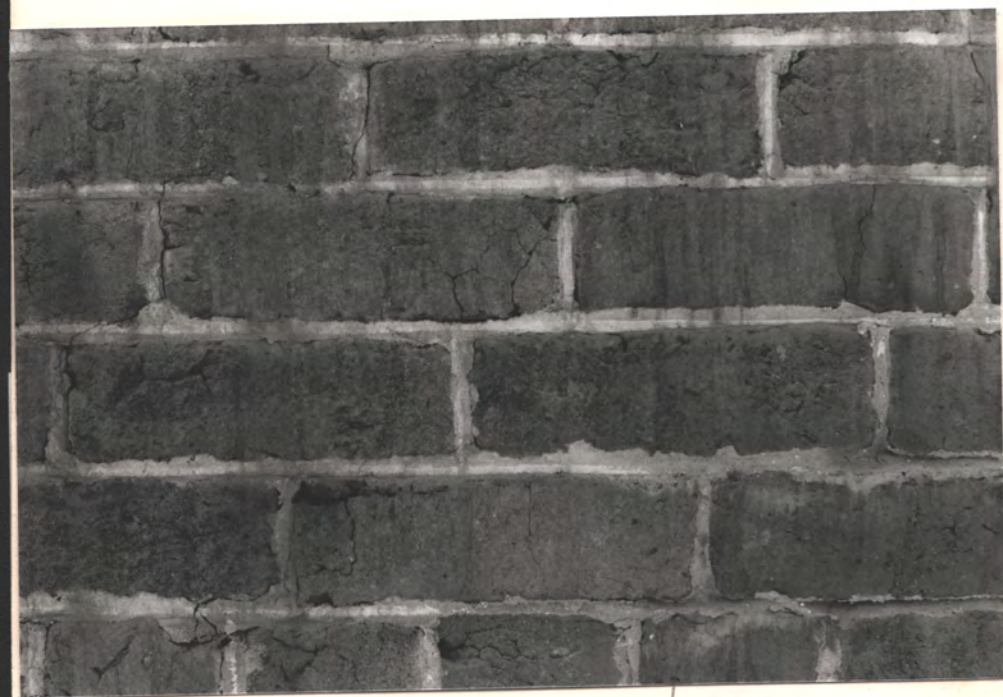
Brick that was under  
the pent roof & protected  
from weather.

Note the "periced" joints  
( $\pm 1/4"$  white paint stripes on  
jts) = typical of 1800-1860  
(Most has weathered off, but  
can usually be found under  
roof eaves etc)

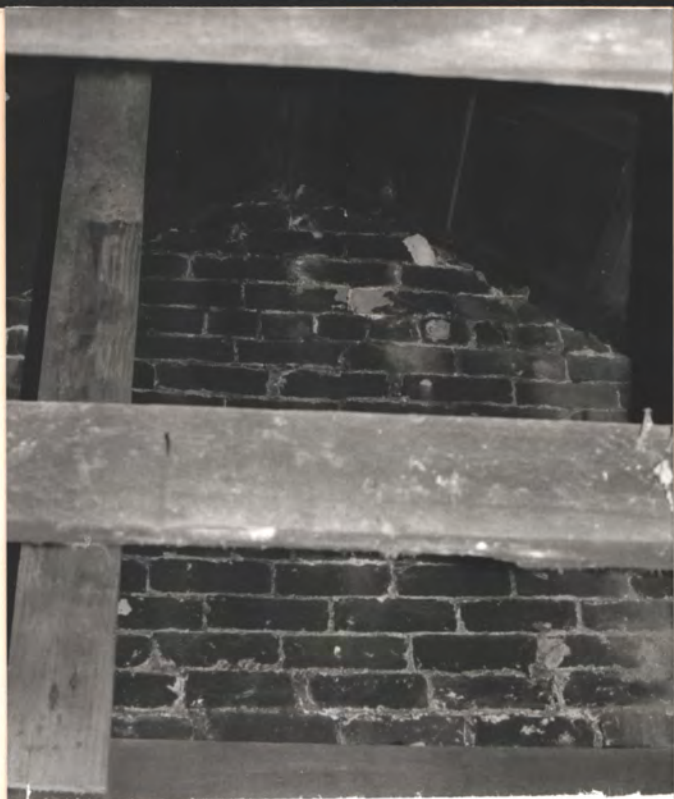
Note heavy soot. The Kit,  
apparently never had a coil,  
until the 20th c.

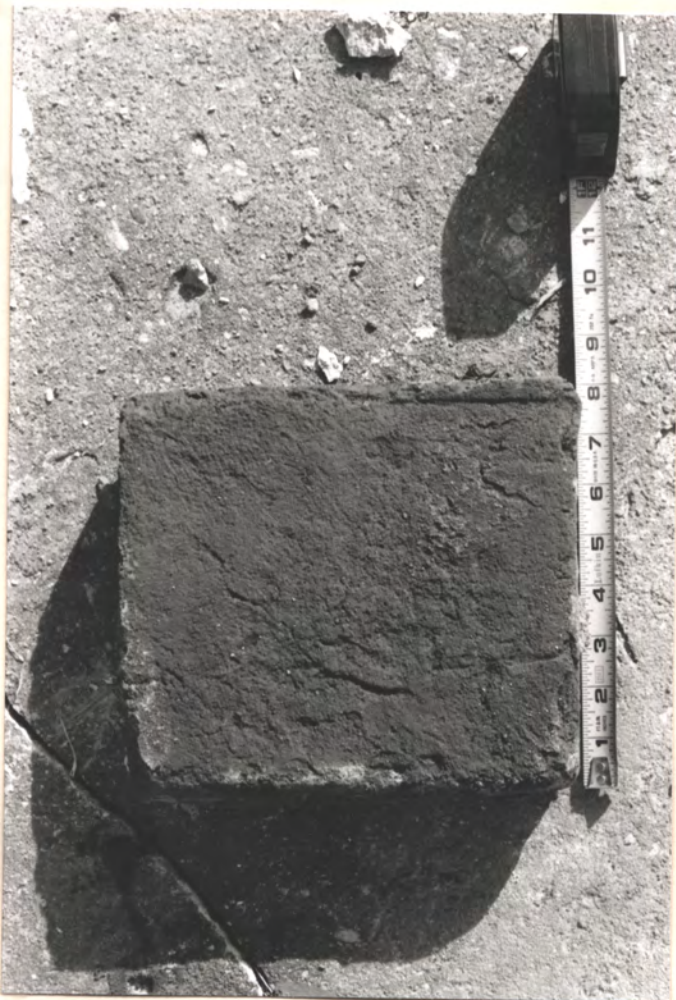
KIT's fl. brick, used as infill to  
build the modern steps at the portico.  
Apparently removed in the 20th c.

KIT fl. was  $\pm 2''$  core on south  
in 1989.

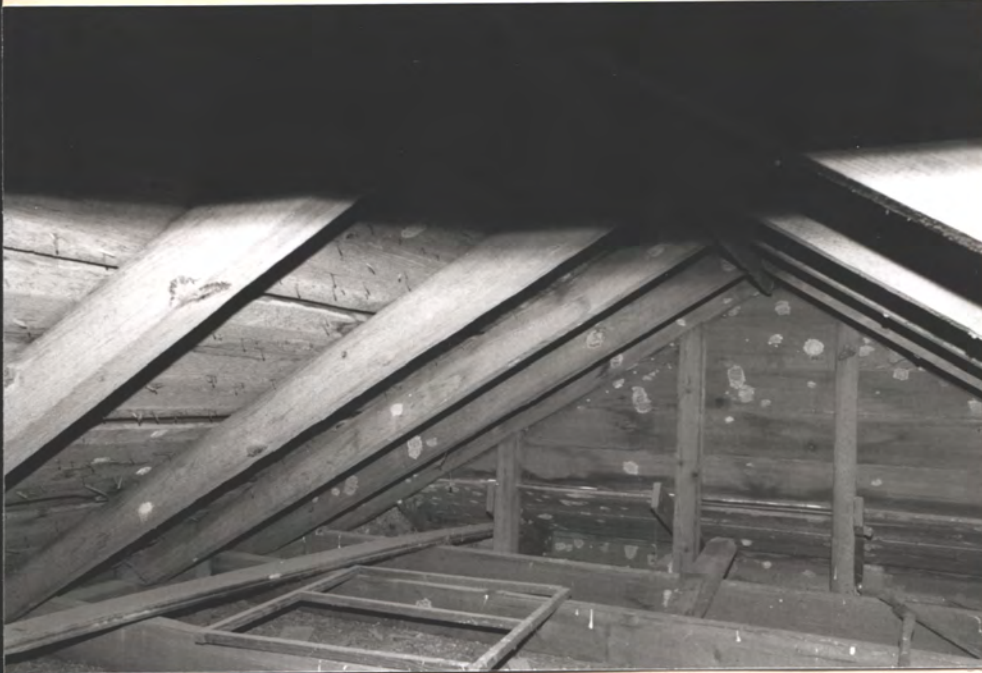
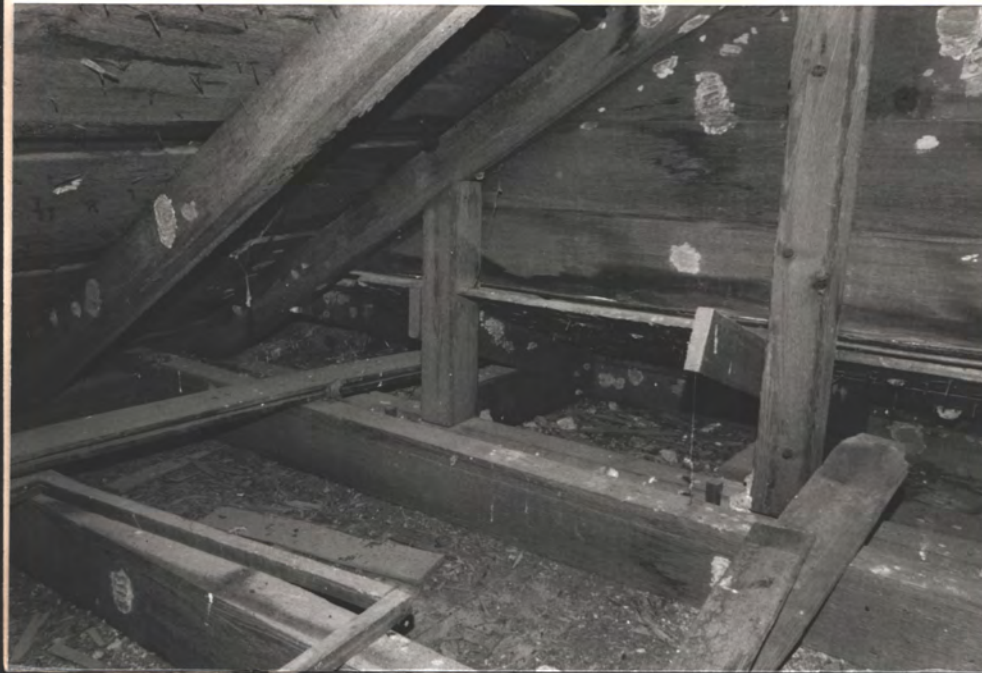
Portico attic.

All framing is thick  
& pit-sawn or sash-sawn  
indicating early 19th cent.

Therefore the pitched roof  
was apparently put on within  
5 to 15 years of the house's  
constr. Flat roof probably  
leaked.

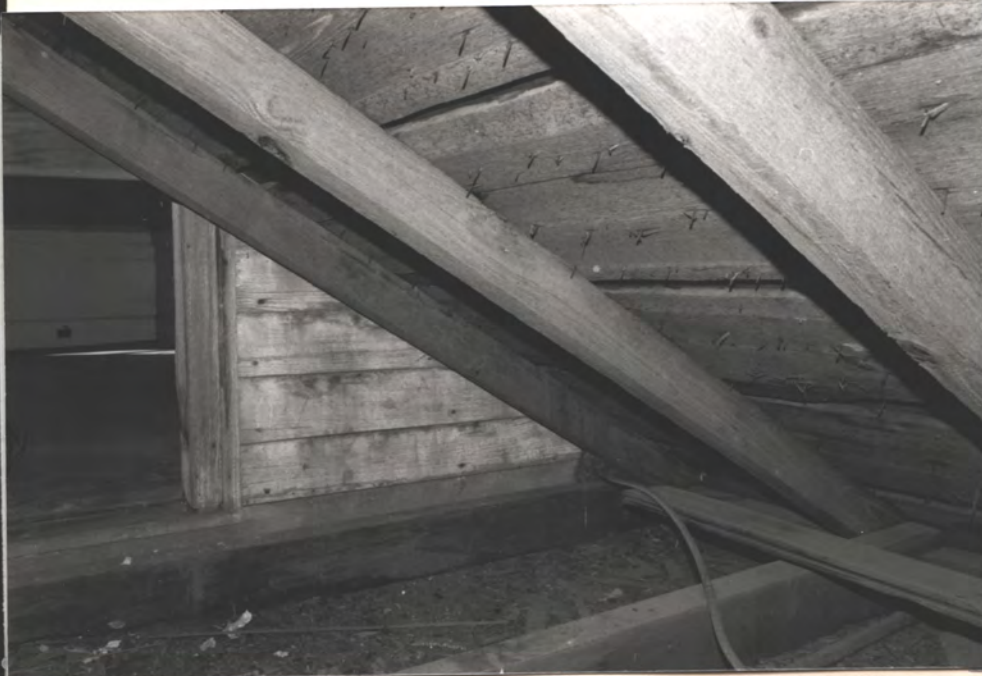
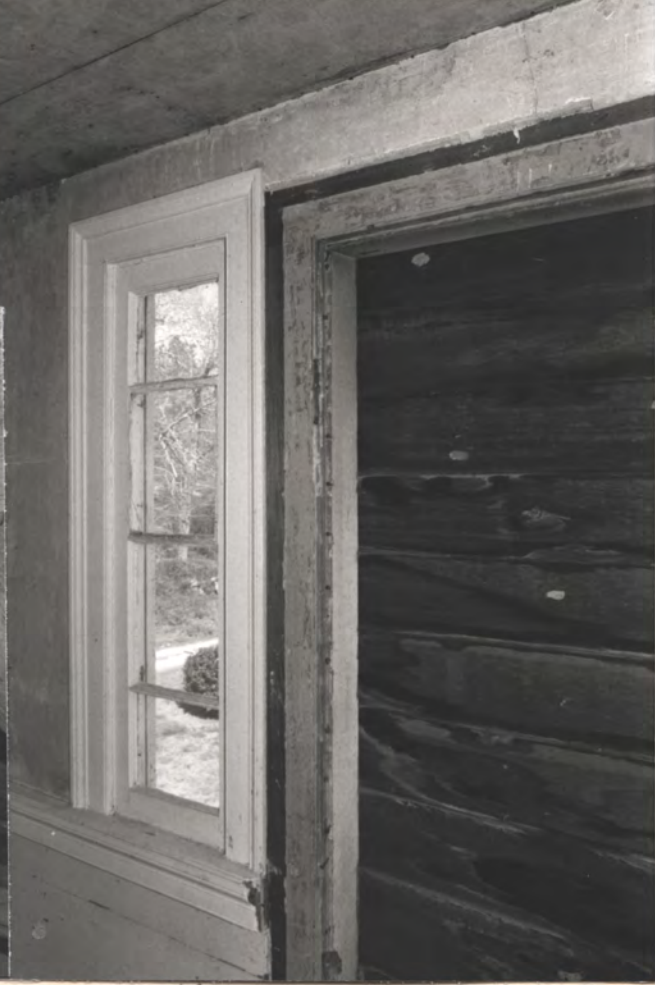
c.1845-65 framing & decking at slope  
 ↘

Door, originally an access  
 to the deck over the porch  
 ↘

Clapboards put over the  
 door to the deck  
 ↘

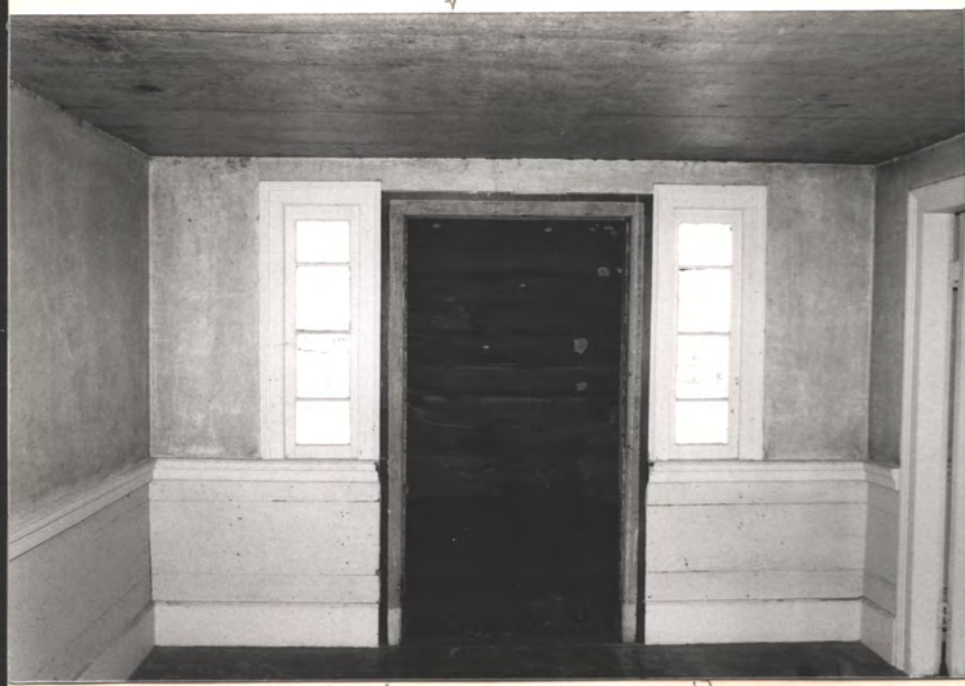
End of hall  
 N. Wall  
 Clapboards put over door  
 to c.1840 deck above porch.  
 (Bottom ± 30" in attic to open)

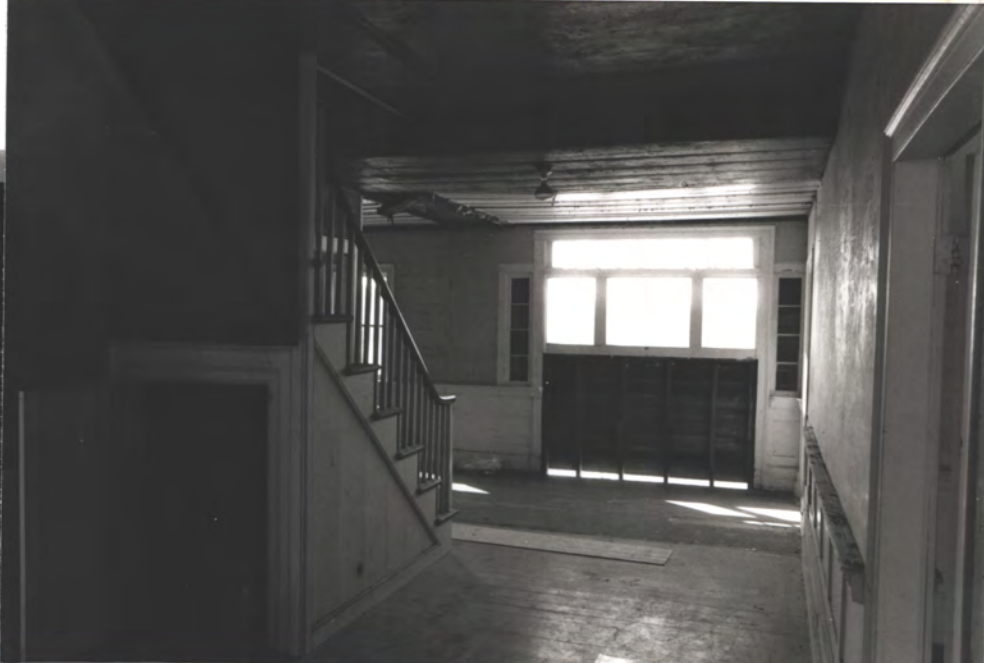
batters are moderns (c.1950's)

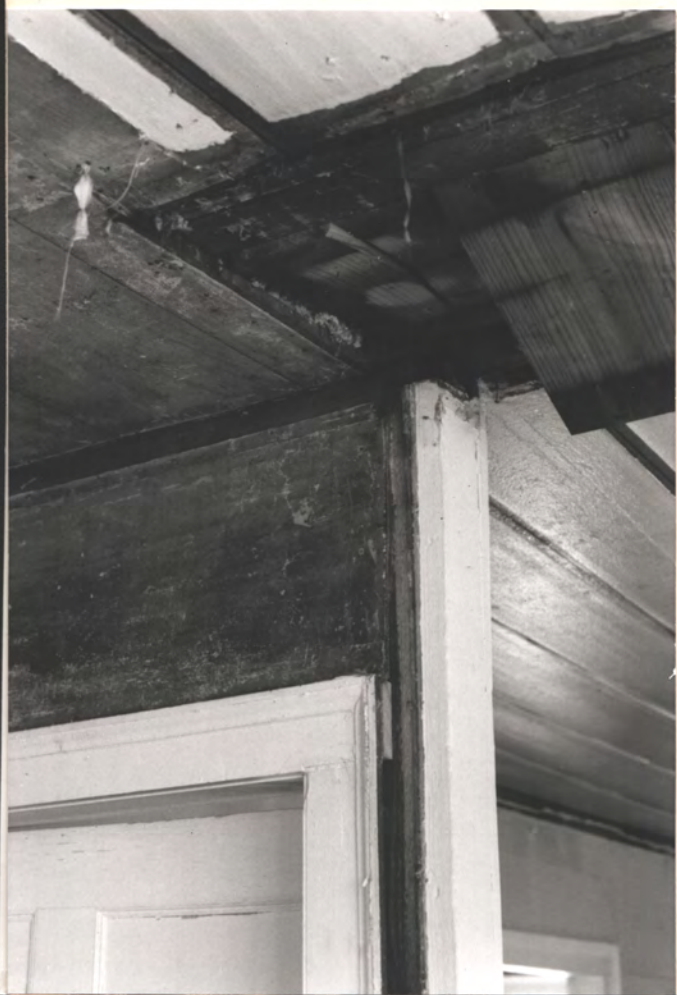
---  
T  
WALL  
TRACES  
↓  
---  
---

These bitterns were put on when the rock-wool  
 insul. was blown into the shed-rm attic,  
 probably 1950's. Moisture condensed in the insul.  
 ↓ bowed these ceil. boards. When insul. is not  
 above bd. cell. the boards aren't bowed.

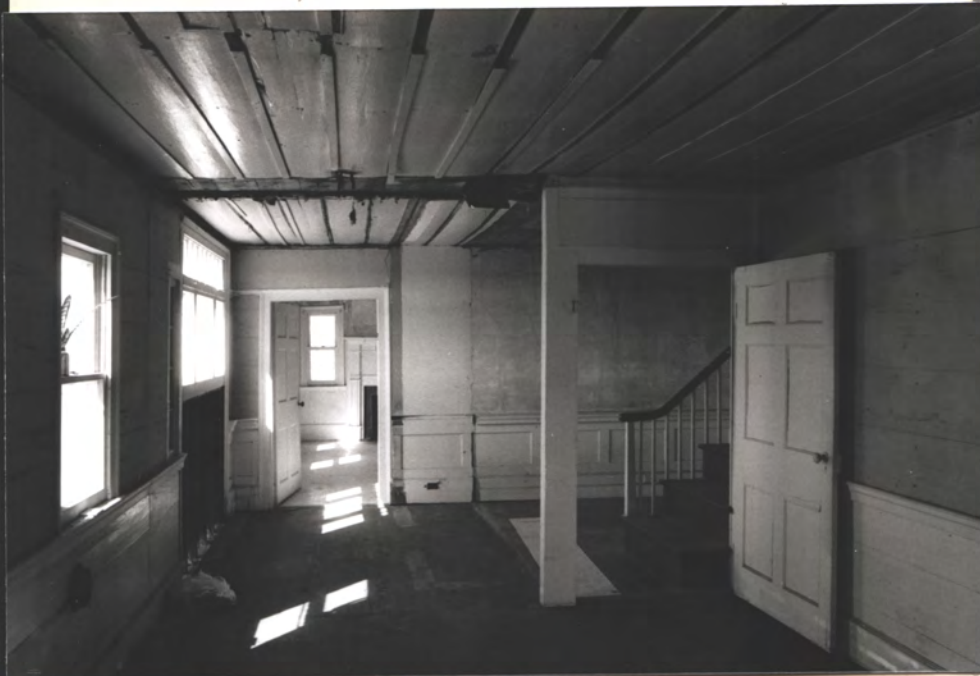
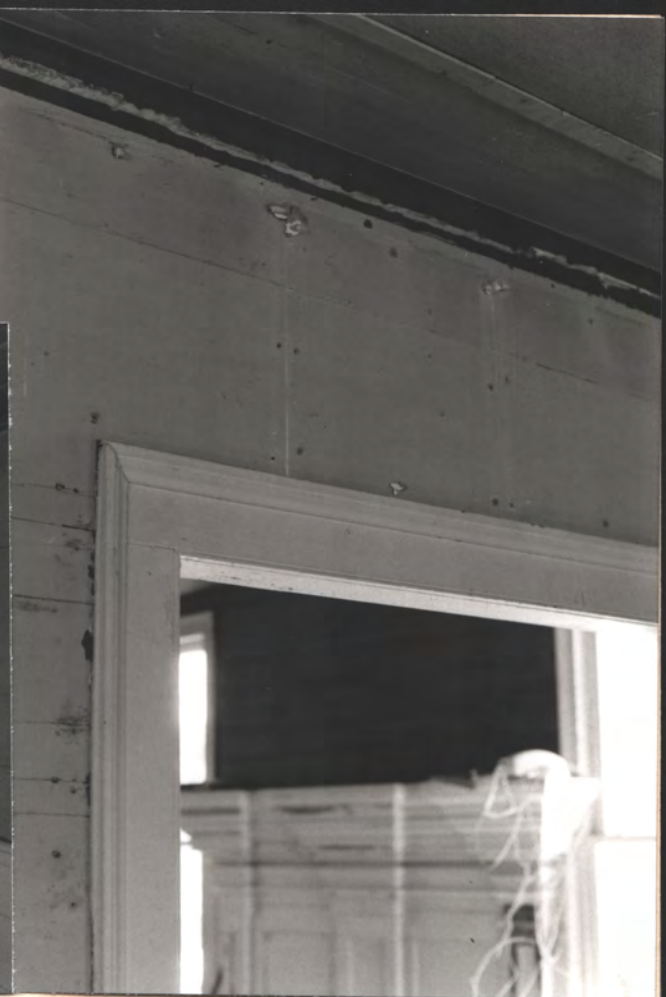
MISSING MOULD

→ N  
 ← CLOSET REMOVED c. 1950's  
 ORIGINAL (steps are finished on this edge)  
 N. door at SE, Rm, → N.E. Rm.

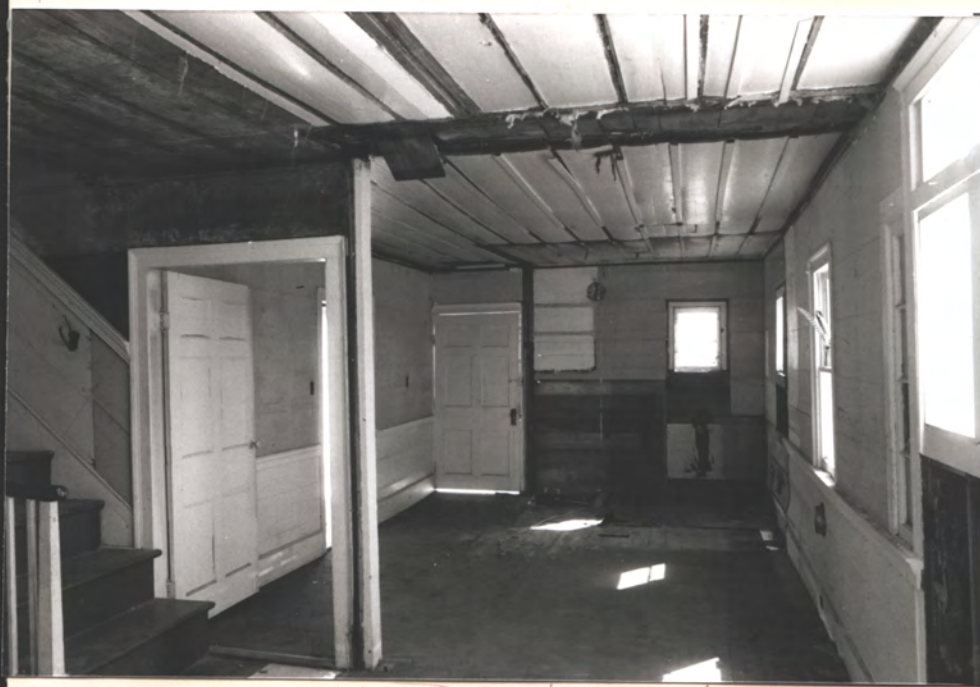
← N  
 --- CLOS. REMOVED c. 1950's ---

Wall trace just east  
 of rear entry sidelit,  
 about 18".

← trace of c.1840 class.

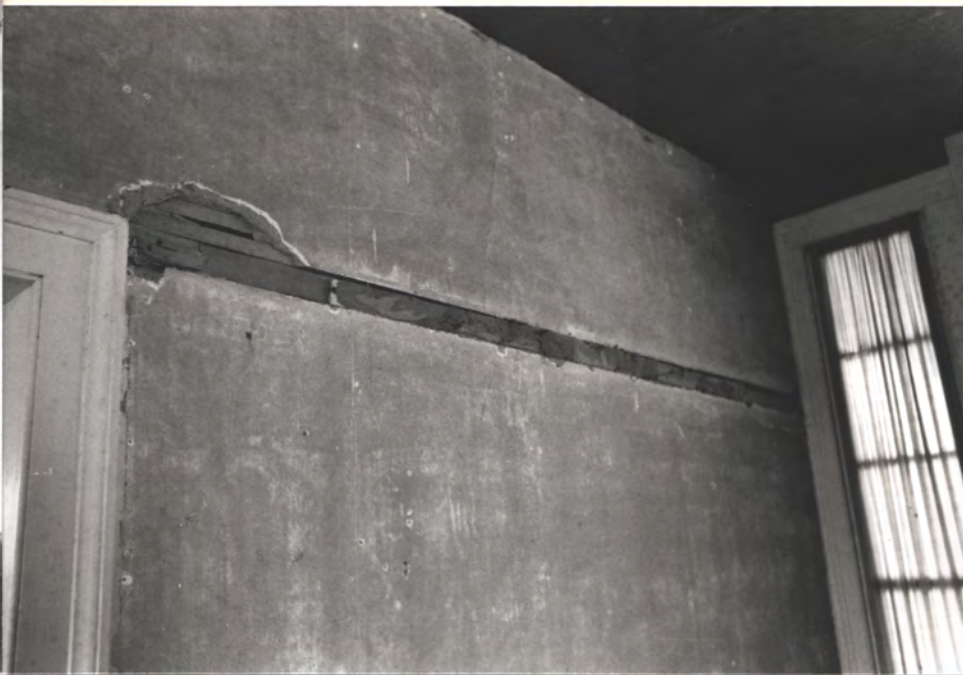
↑ patch where a hat-peg bd. originally was, based on the c.1830 Kelly Hse in Hsv.

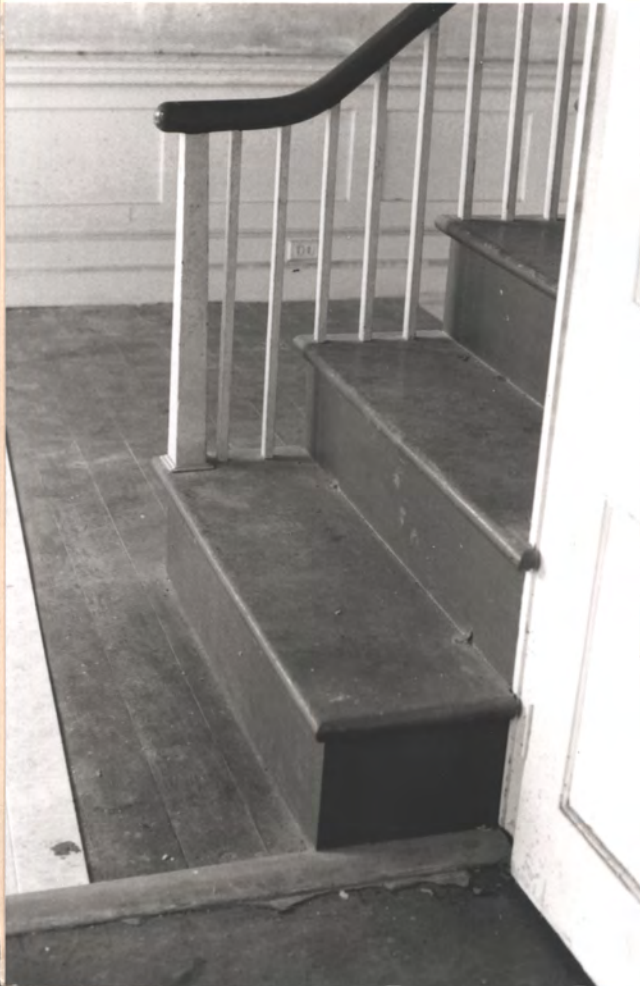
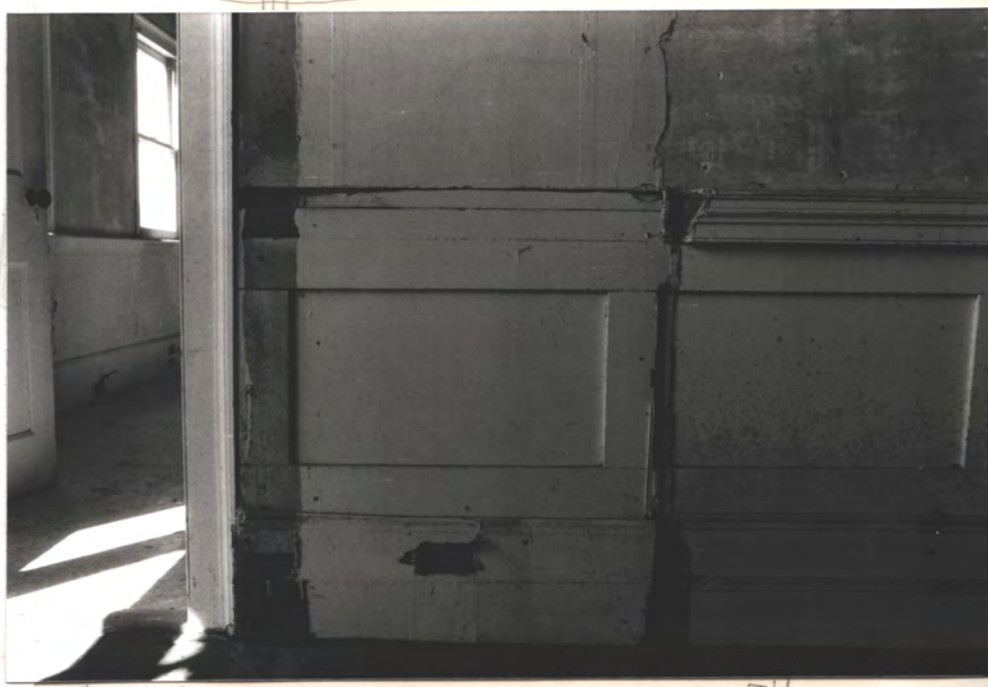
↑ DOOR TO SW. RM

c.1950's added wall for closet (see 1989 photos)

← finished stair edge proves this door was here originally. Is a Fort. Per. door
