## Borders-Blackmon House Offers Important Record of Slave Artistry

CIRCA 1840 BORDERS - BLACKMAN HSE, ANNISTON, AL.  
 H.A.B.S. RESTOR. + ADDN. 1990 DR. GEORGE & SUSAN GIBBS.  
 JONES & HERRIN, ARCHITECTS - H.P. JONES, F.A.I.A. - HUNTSVILLE, AL.

c.1840 Borders - Blackman Hse, Anniston, AL (HABS)  
after restoration in 1990 by Jones & Kerrin, Arch.  
Harrie P. Jones, FARA, Huntsville, AL  
Owner - Dr. George Gibbins, Anniston  
Photos H. Jones, June 1993

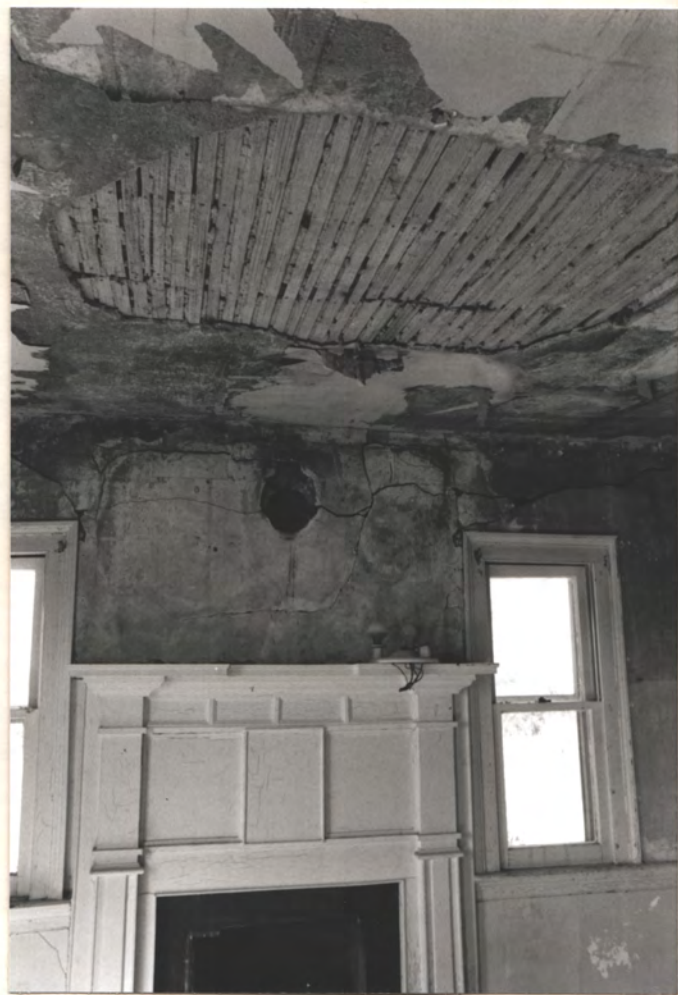
1st fl SW Rm.  
Hand-split lath

MISSING ORIG.  
MOULD (COPPER)

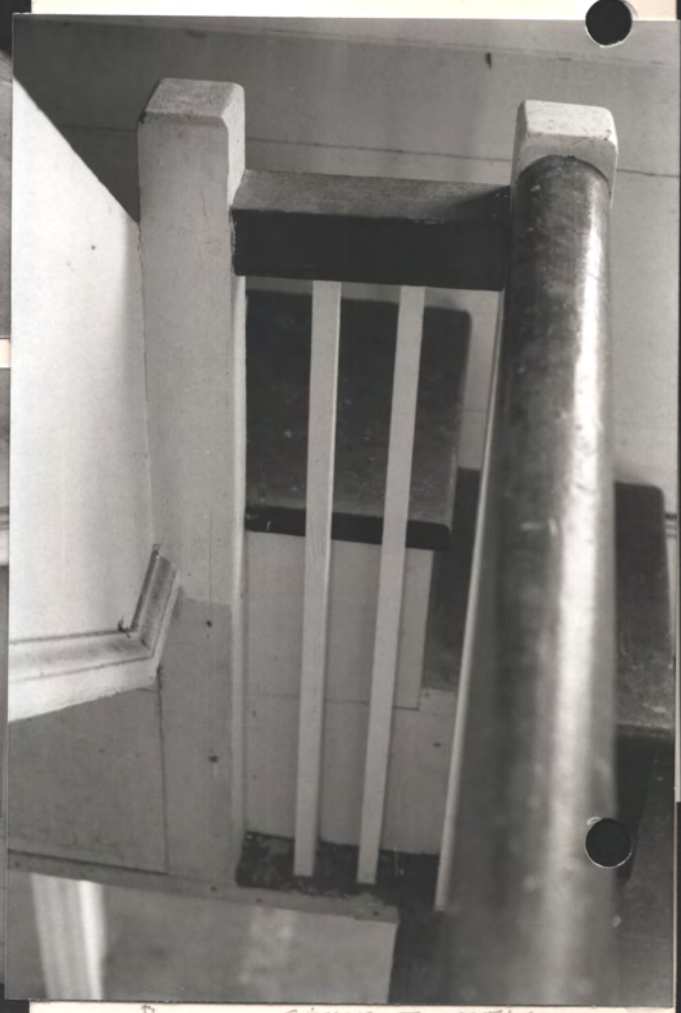
STAIR TO ATTIC ↓ N

loose c. 1840 chair rail  
 piece that was removed  
 when the c. 1950's closets  
 were installed in the  
 2nd fl. rooms

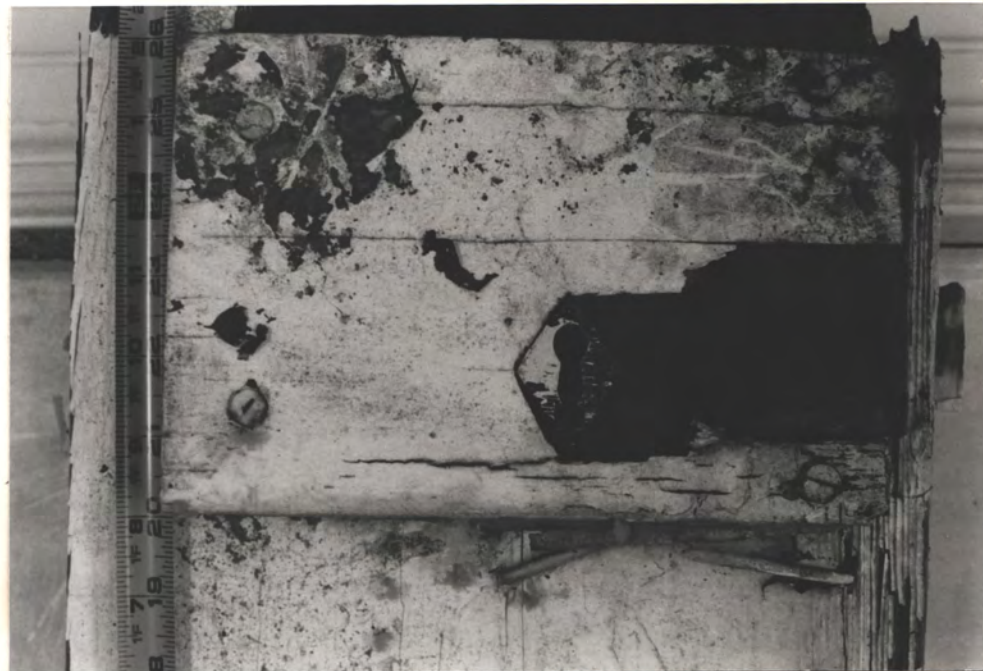
"STOCK LOCK"  
 (metal parts mtd. in a  
 wooden "stock" block).  
 Was on the basement  
 pent. door. Is an early  
 19th. c. type. Helps  
 indicate the pent was early

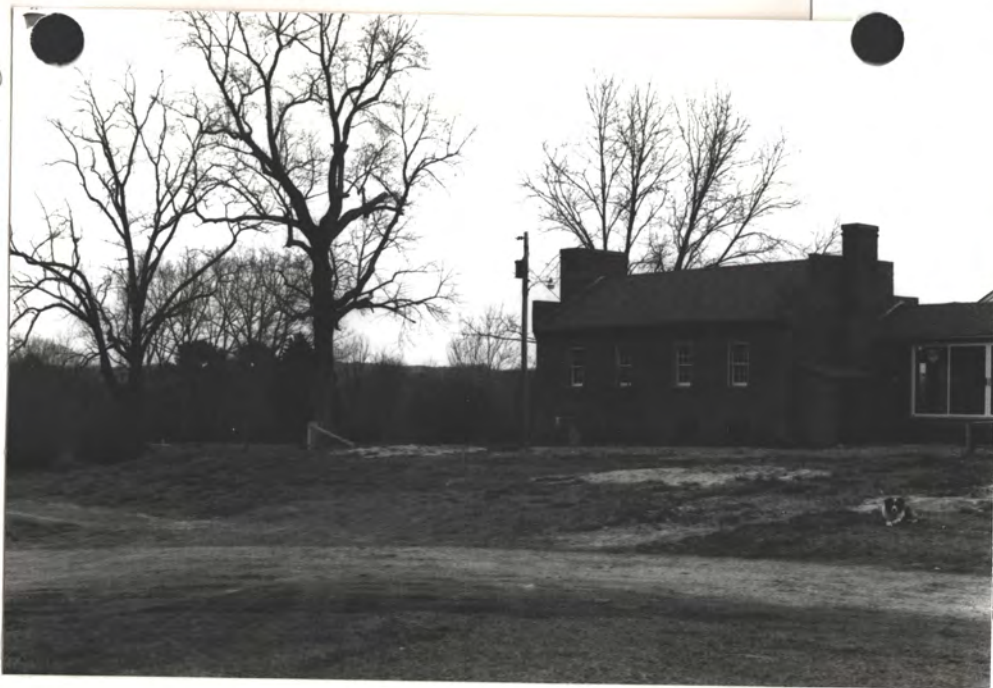
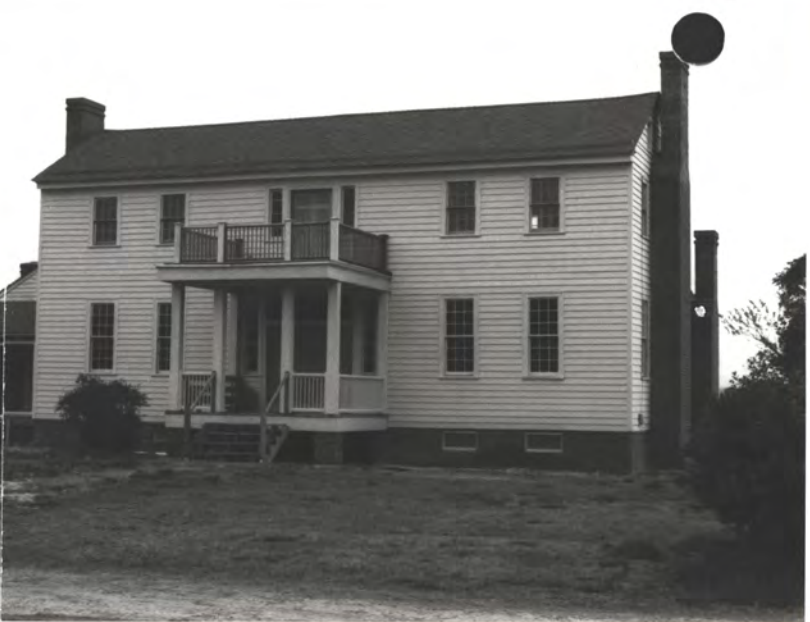
Rebuilt orig. crow-step parapet gables

glazed walk is recreated Fed Period open cov. walk (widened). Glass to be cov. w/ lattice  
 Wide front overhang is not per hist. evidence

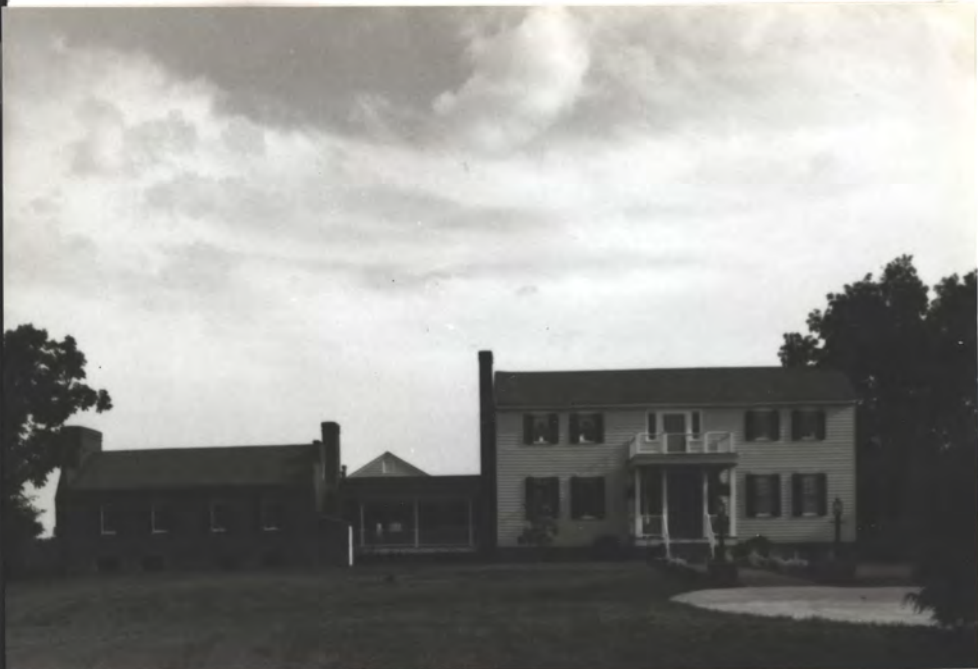
brick step-gables put back on  
kit bldg. per 1930's HABS photos

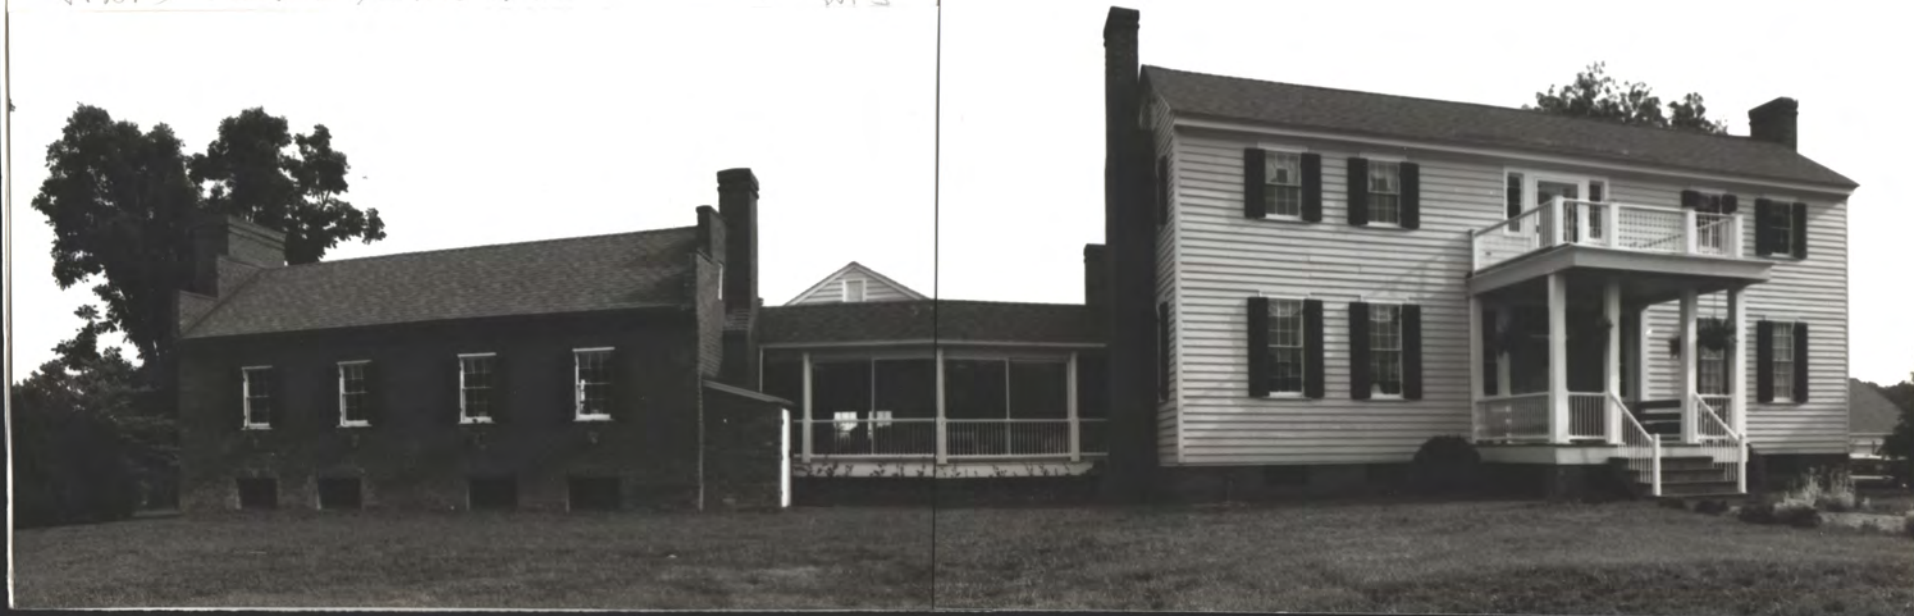
6/6 of 9/9 photos put back per 1930's HABS photos  
Also blinds put back per HABS if a few swimmers found in barn.  
Vinyl siding removed.

Owner  
left dark  
controversy  
on =  
not original  
front  
correct

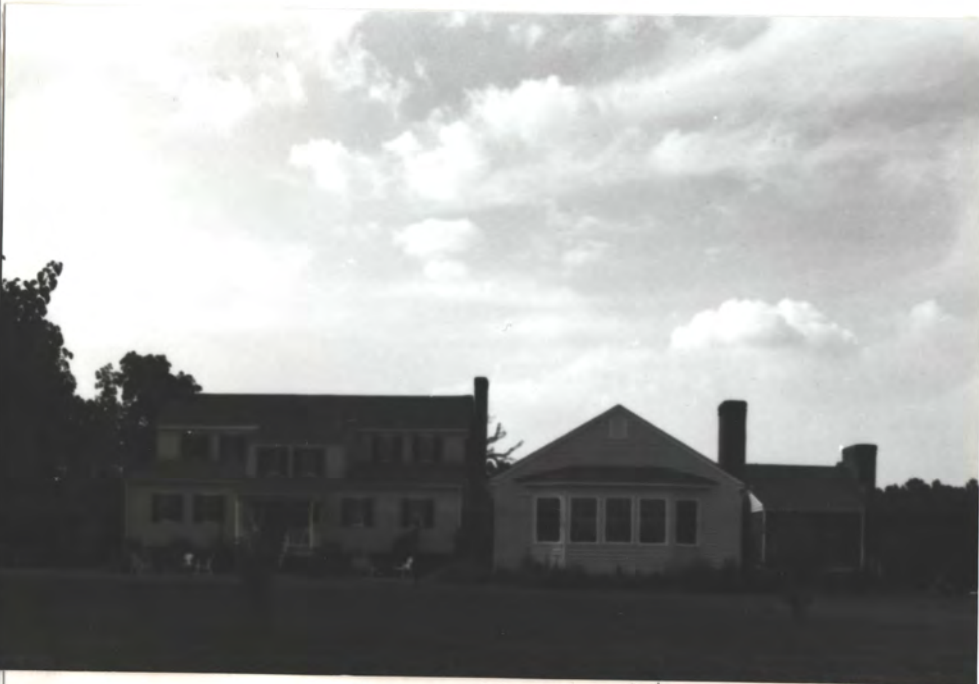
Gallery put back per 1930's  
H&B photos, w/ plate of behind  
later gable removed from  
porch per 5th  
evidence

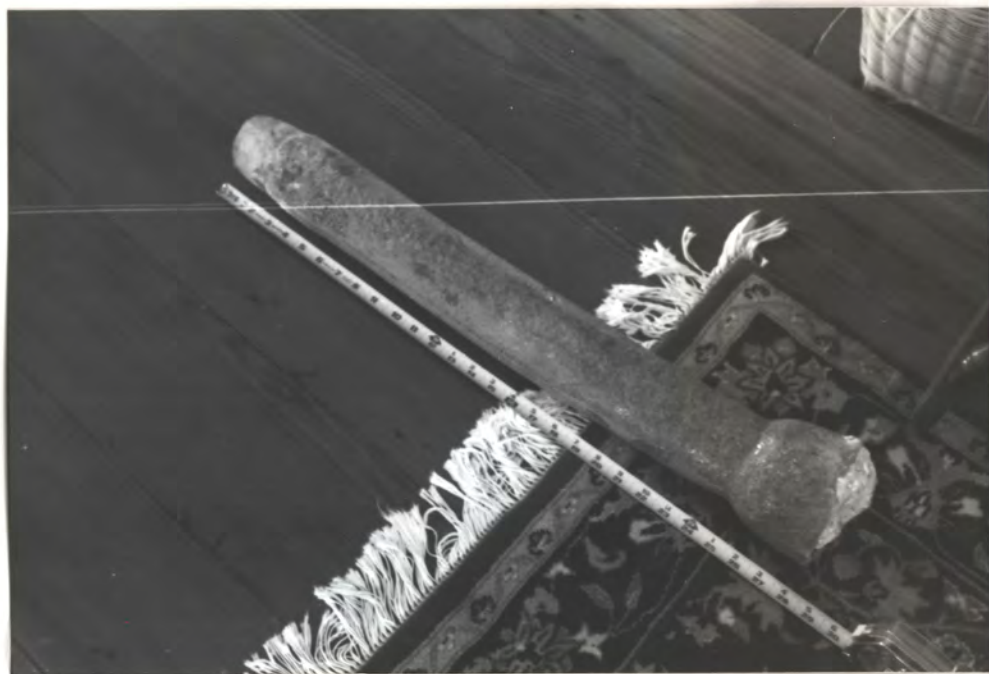
Water  
line  
1840-1860

Gray-green glazed ceramic 2"  $\phi$  (I.D.) water line  
mentioned in Border's memoirs. Ran  $\pm 1/4$  mile  
from spring on hill to the north. It's section  
w/ lime mortar. Date? probably 1840-1860

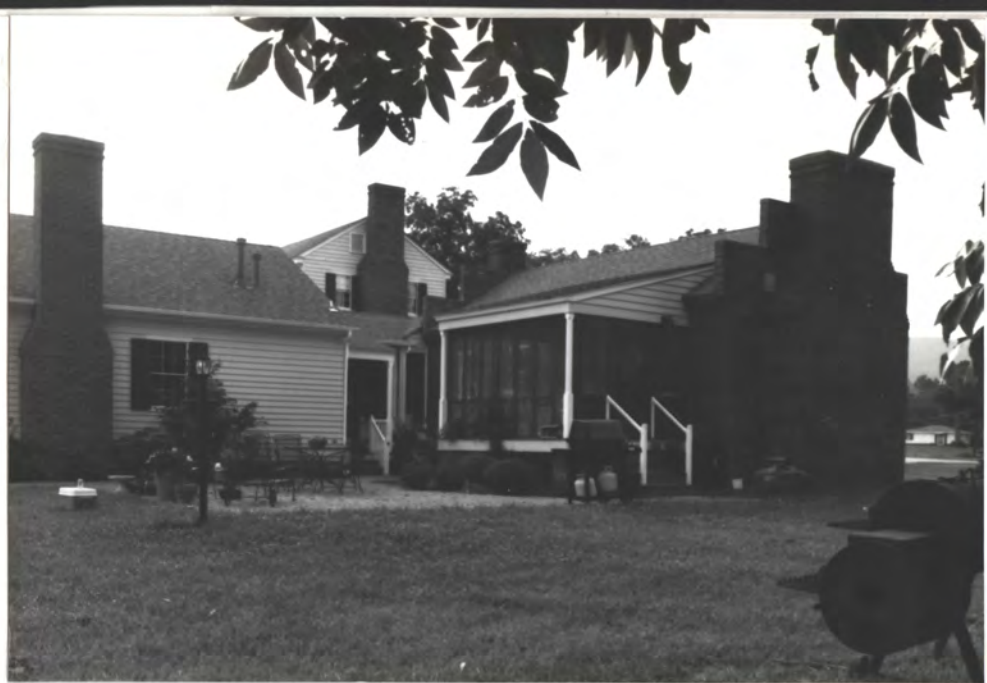
1990 Den ← \* Orig. Din./Kitch →  
 Step-gather rebuilt  
 per 1930's HABS photos

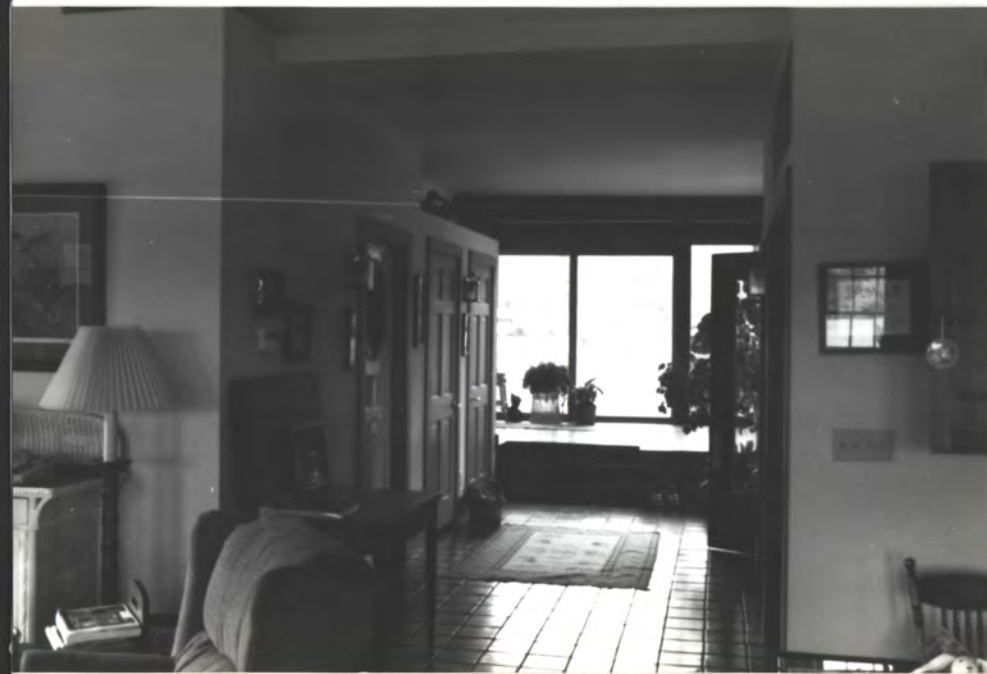
Looking S. into 1990 addition room (by AD) from the link - passage
