**ST. MICHAEL'S AND ALL ANGELS CHURCH
(EPISCOPAL)**

ANNISTON, ALABAMA

PROJECT NO. 93049

PRESERVATION & RESTORATION PRELIMINARY OUTLINE NOTES

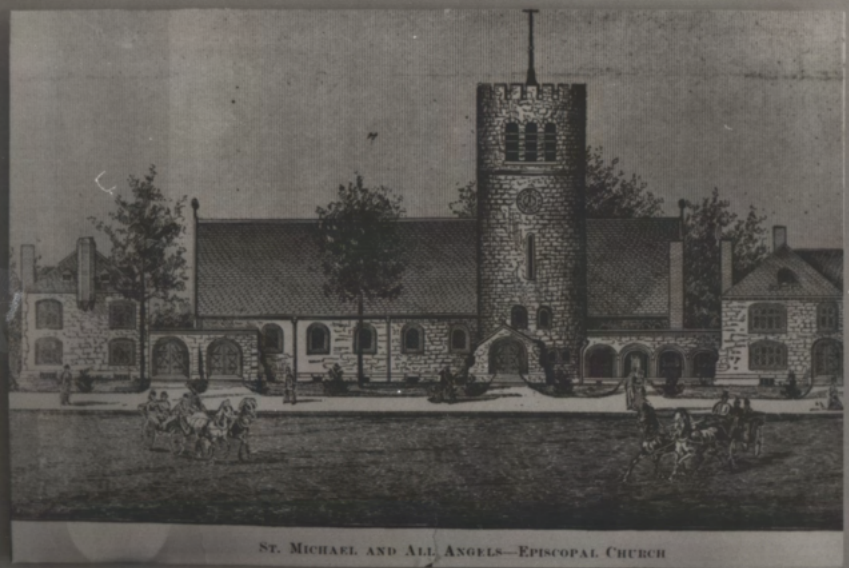
Said to be orig. architect's drawing.
Note ROUND tower shown, SQUARE tower built.

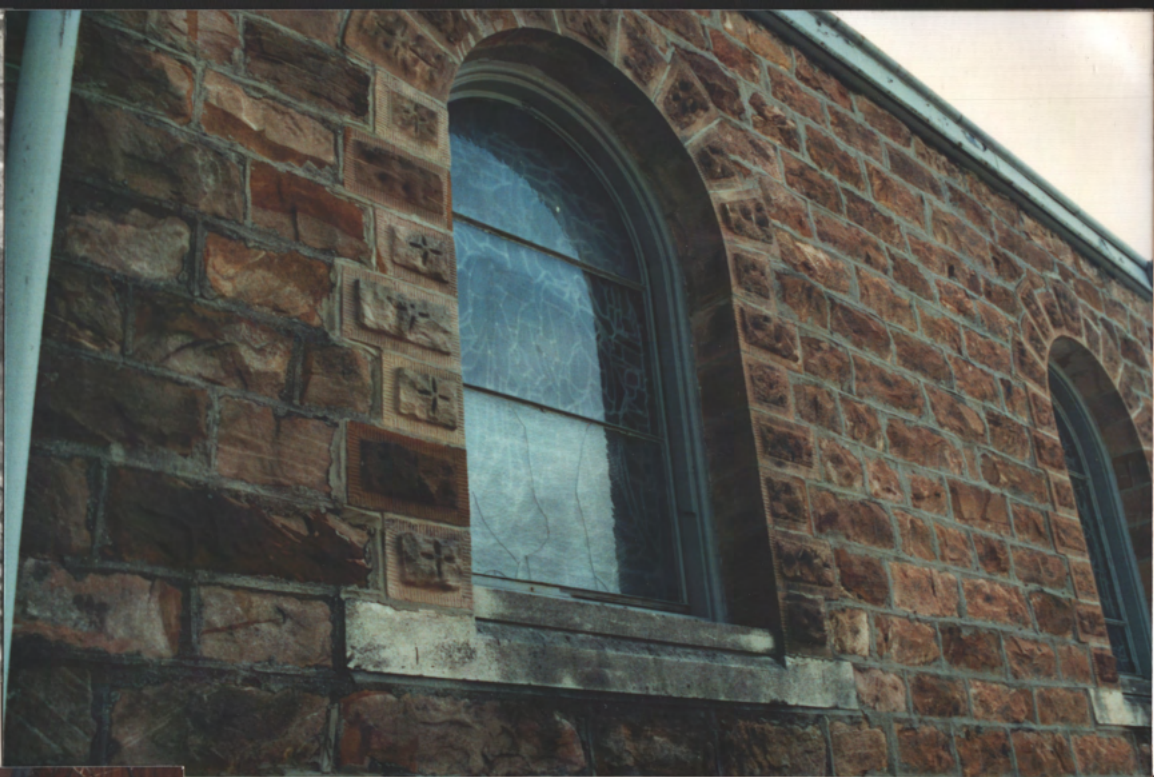
Vent buried by later fill. Congrats w/ arch. domg. post
N. Central wall → N

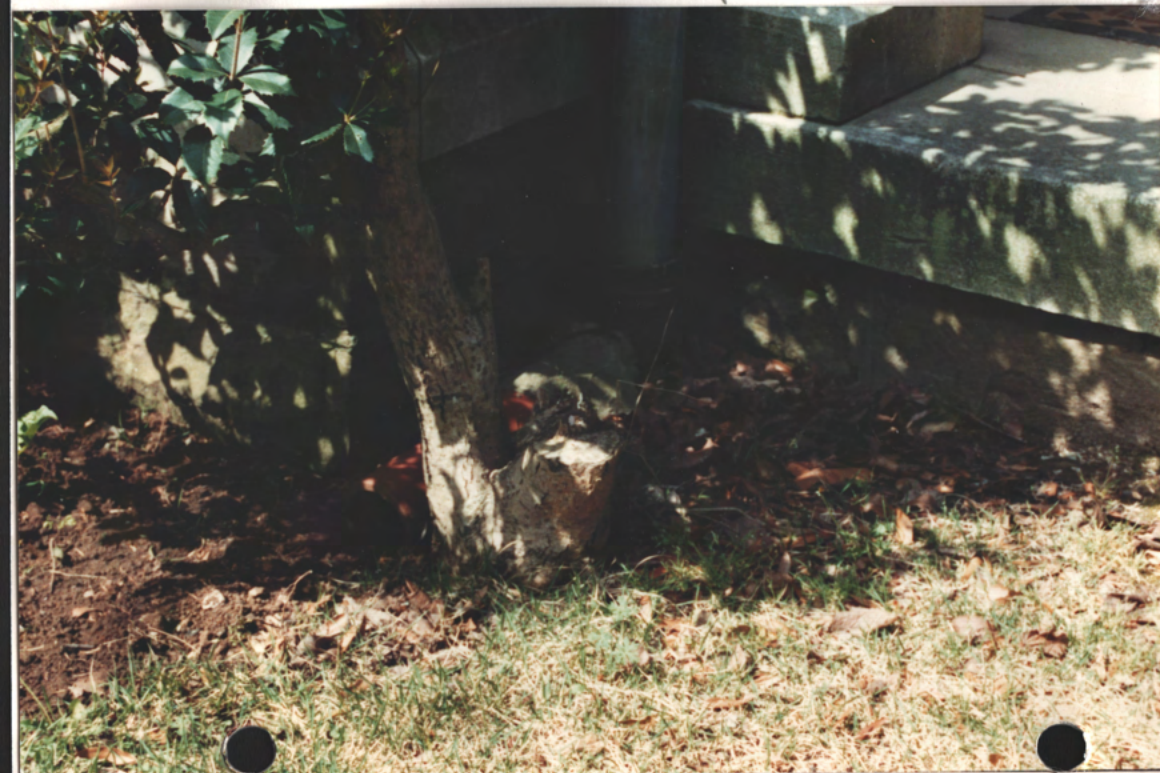
Loc. 7

E.D.S. drains on finding thence into Grand Spire

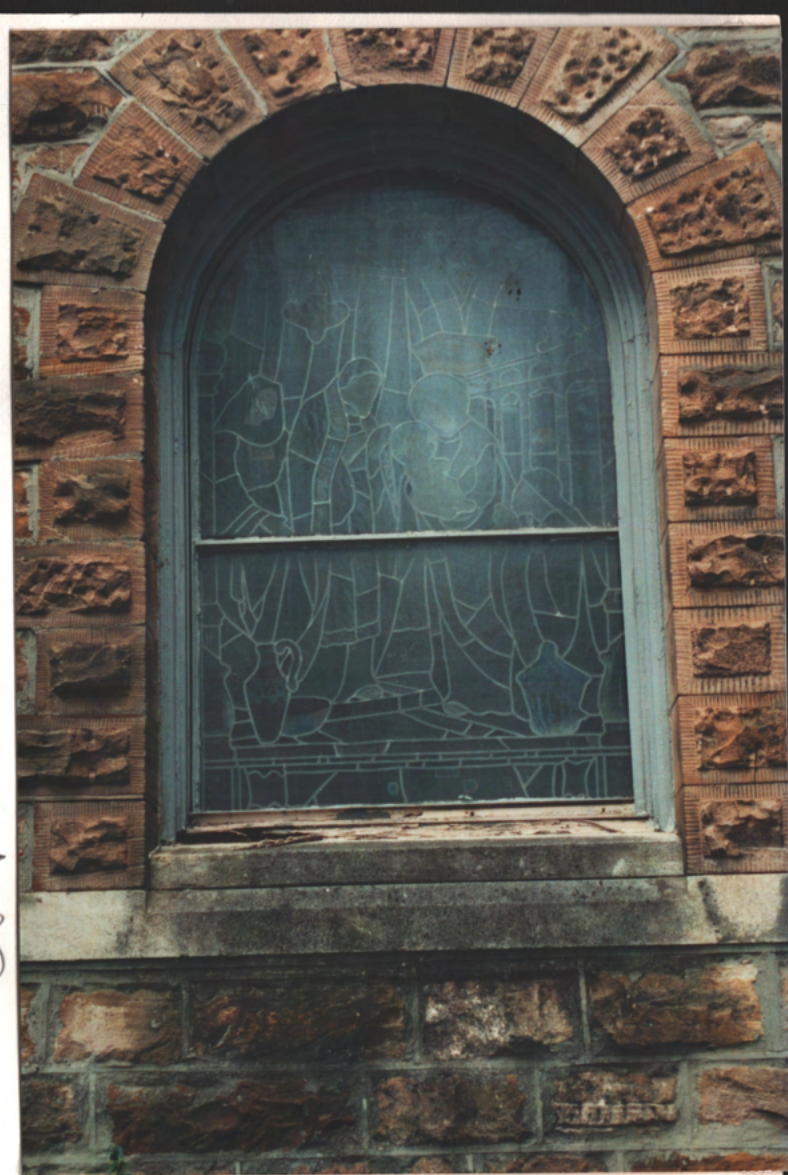
Loc. 7

rotted →
Sib
(very few
apparent)

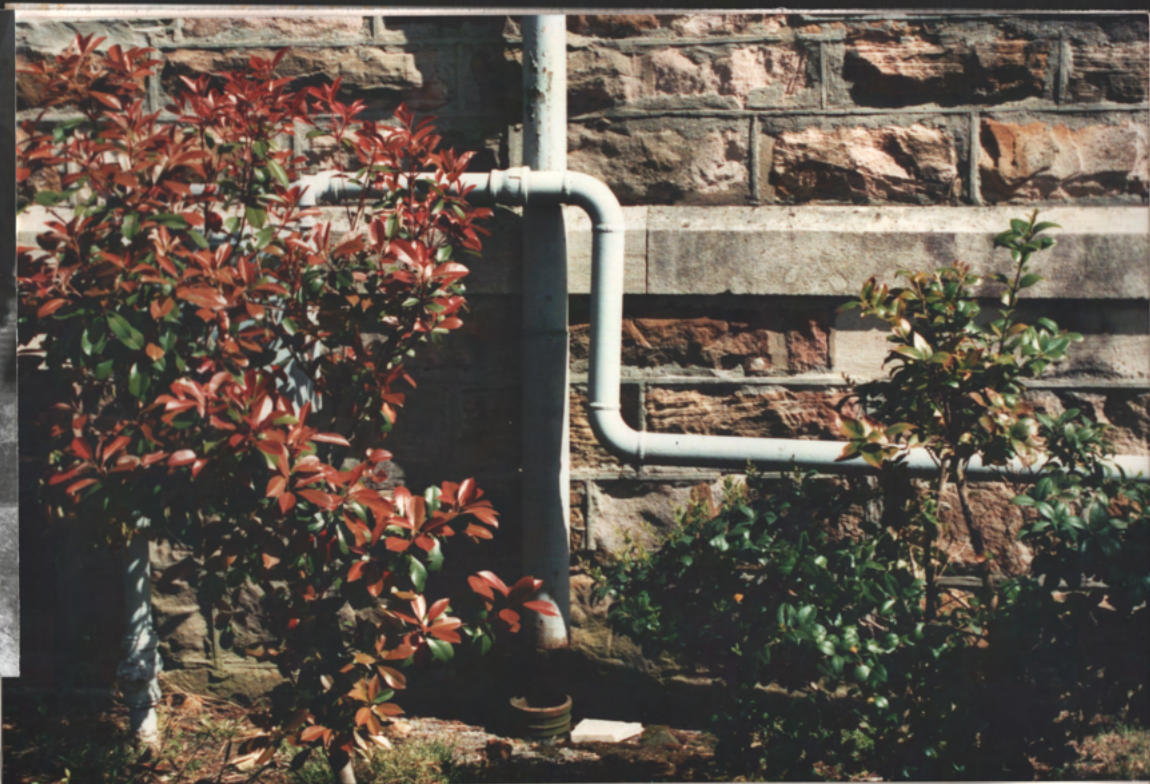
† drain spout not joined to
C.I. storm drain
Loc.?

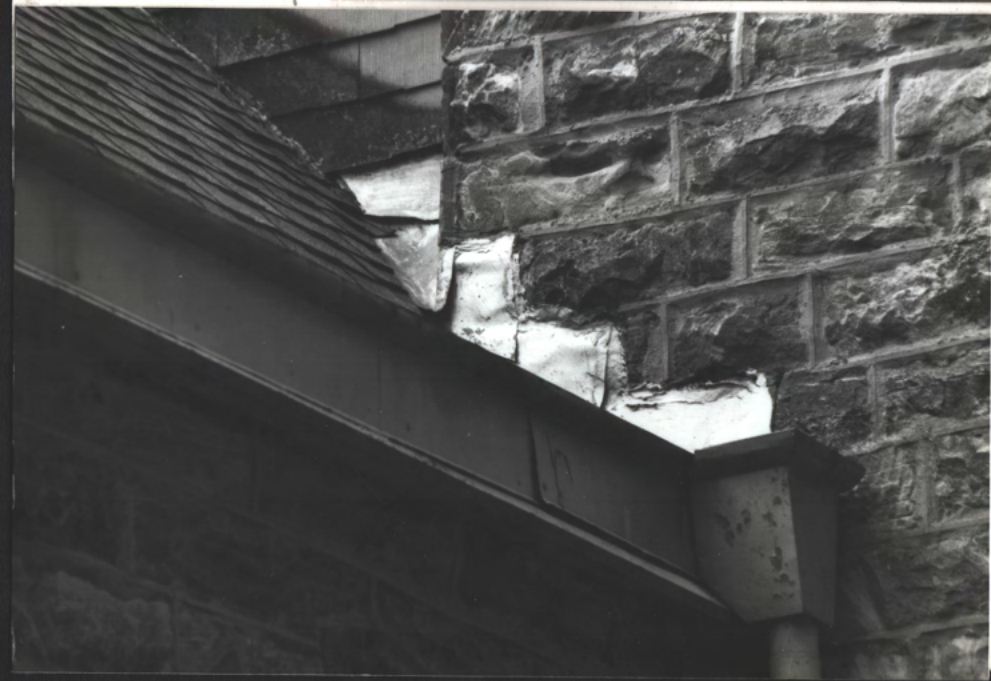
PN Tower south face,
about 20' up
(telephoto)

←
White streaks
are oxidized
"sealant" put
in cracks
years ago

Hard Portland
cem. put in
±20 years ago
(not good).
Gray color.

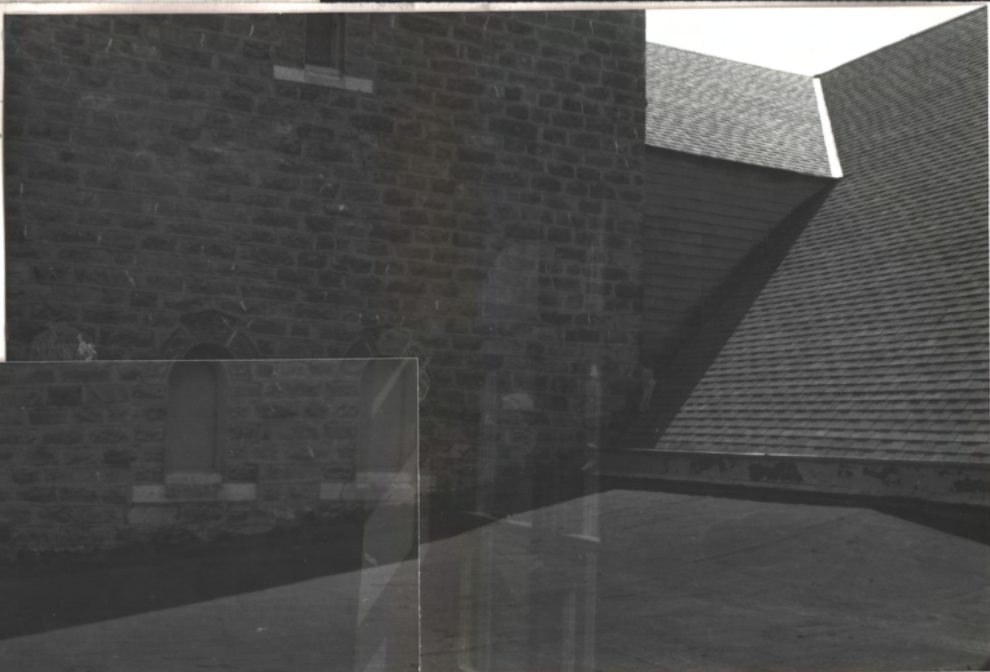
Tower
N. fac.

"Crickets" shed
(later?) w/
con. asbestos tile
on walls

Grp timberline asphalt
shingles (not shed)
SHEET.
(CARRIAGE)
ROOF

Orig. roof = gray slate
(found pieces in attic)

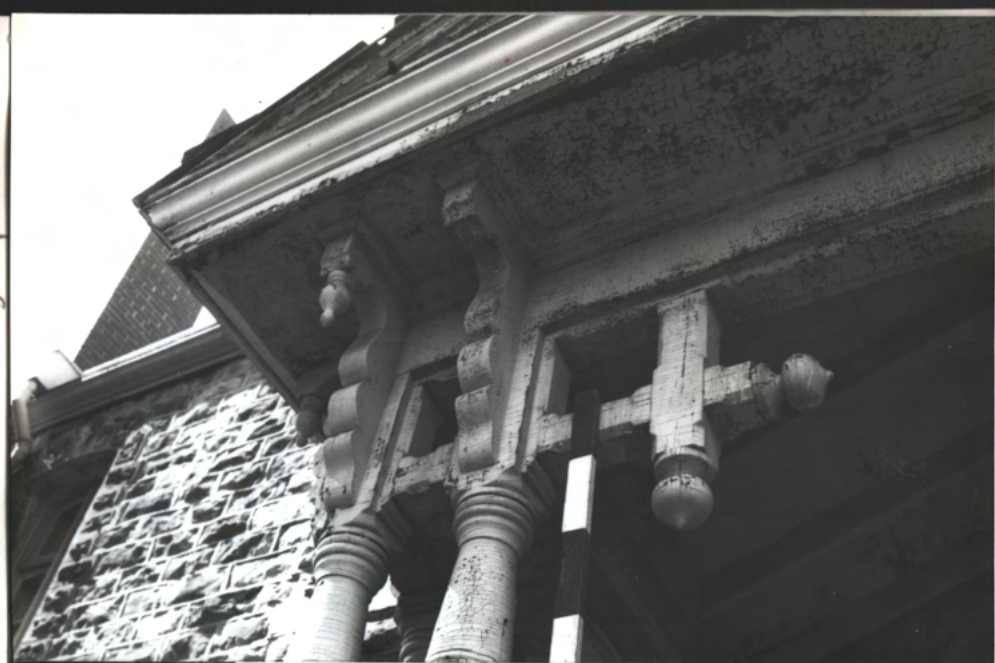
Horiz. mould is modern (WP45)

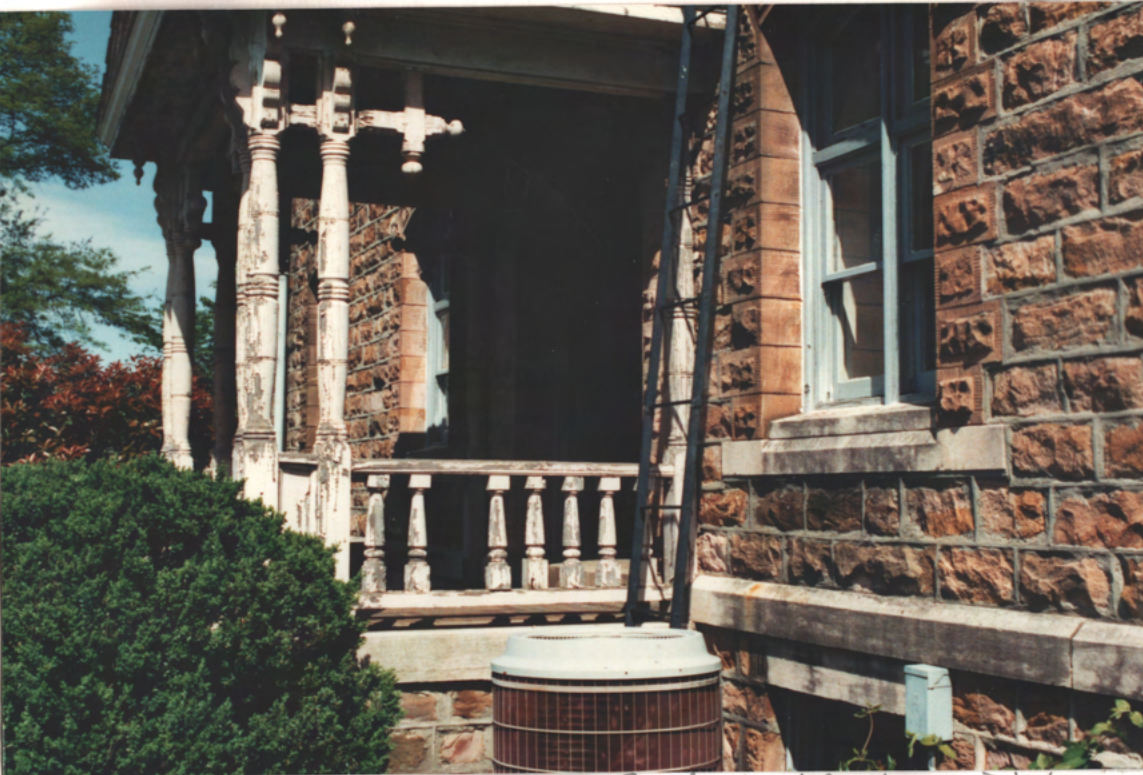
Raker-Mould = 1880 (copying exact profile)

Horiz. Mould = modern WP45

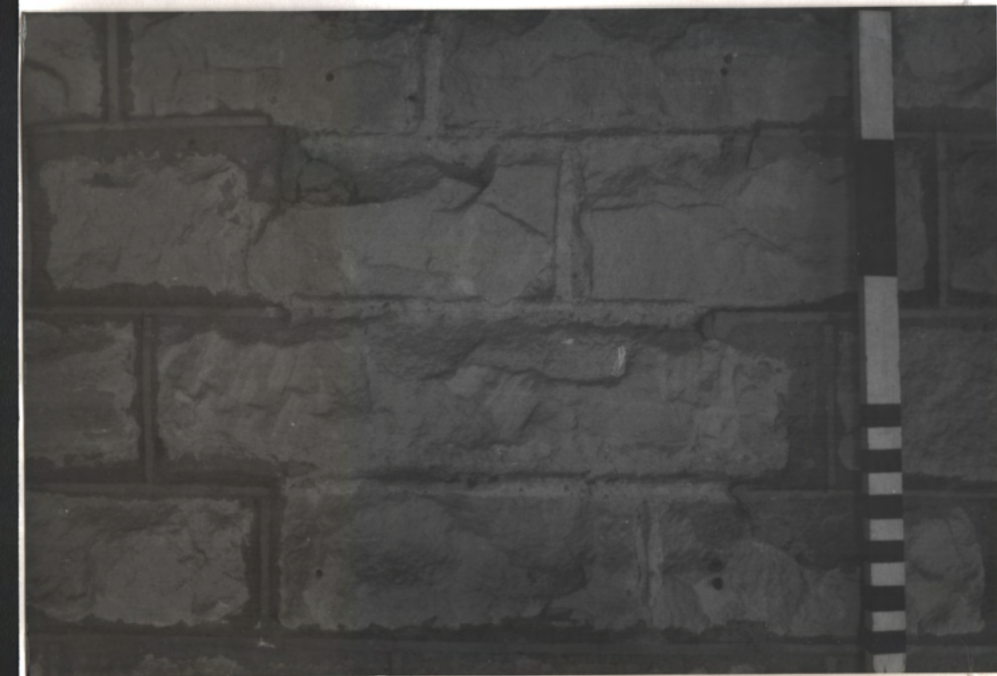
↑ not due to leaks in flat roof above + NW

PN
 LM. mortar = original lt. buff color
 lime mortar.
 Dark mortar = c. 1960
 portland cem.

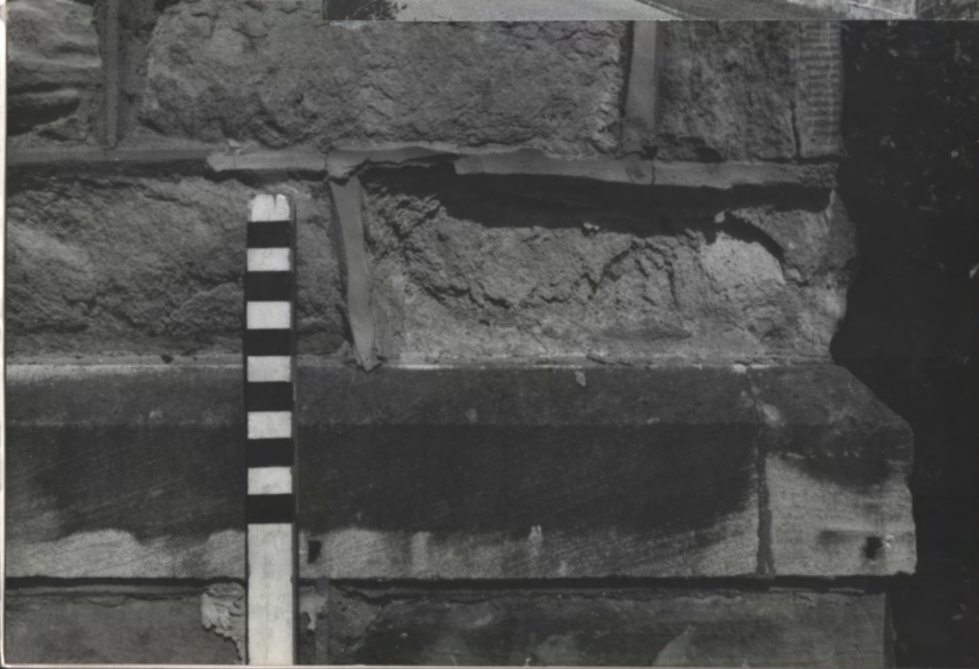
At S.W.
Corner:
entire face of
stone spalled
1/2" ± 1/2" deep

old cer. elect. insulators
on rake-fascia

plant growing at top of portland jt.

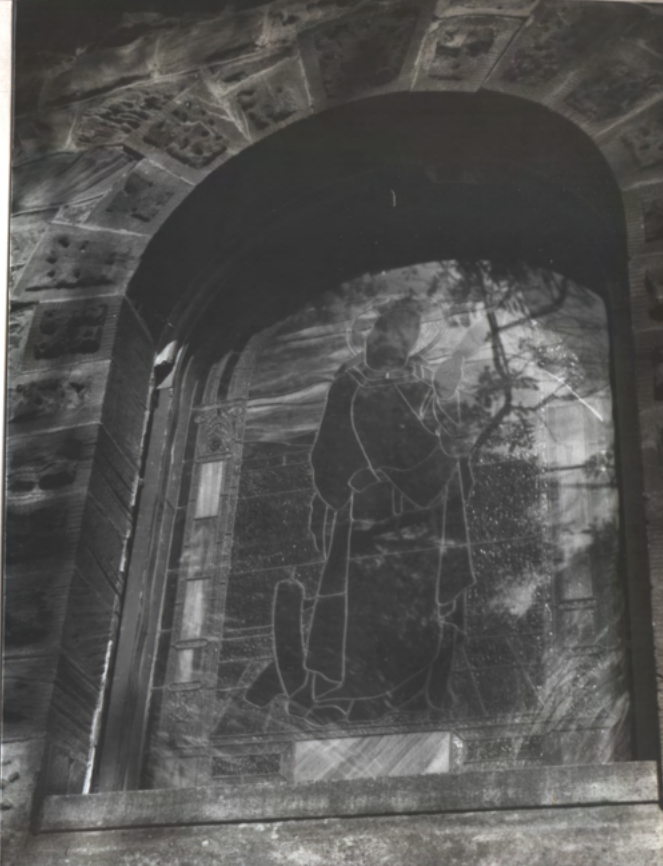
→
→
SACT,
W. WALL
WINDOW
→ bsmnt
scuttle

No Surt. wall:
DSmt
Scuttle (cracked)
± 3/4" crack
admits water

→
Note
stone
slipped
3/4" ±

→
Note
rotted
trim &
patched
jams

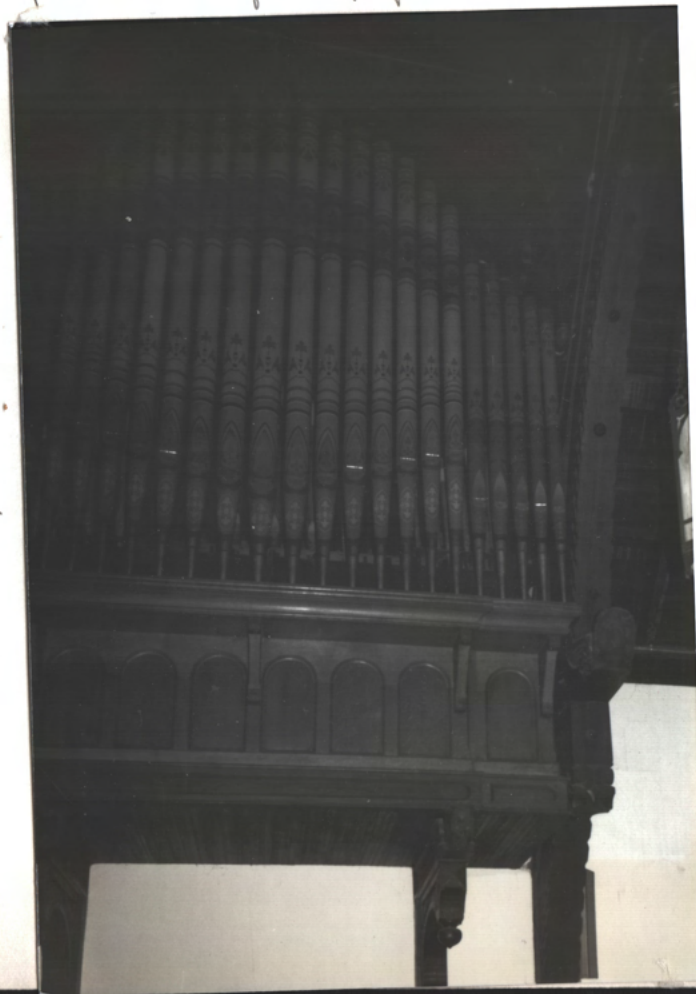
Painted organ pipes, W. side

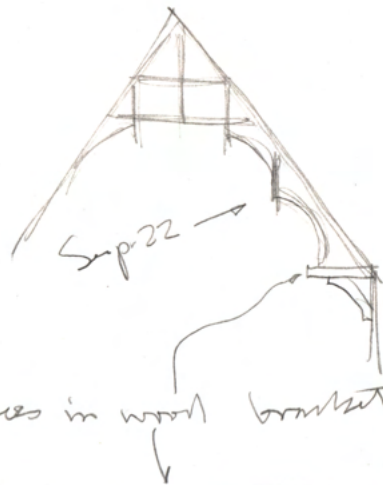
Curved faces in wood brackets
