Karsner - Kennedy Hse
 Florence
 1828

Kayama - Kennedy House, 1829

Re: 1825 Karsner House, Florence, AL / A87060

Re: Karsner House, Project No. 87060

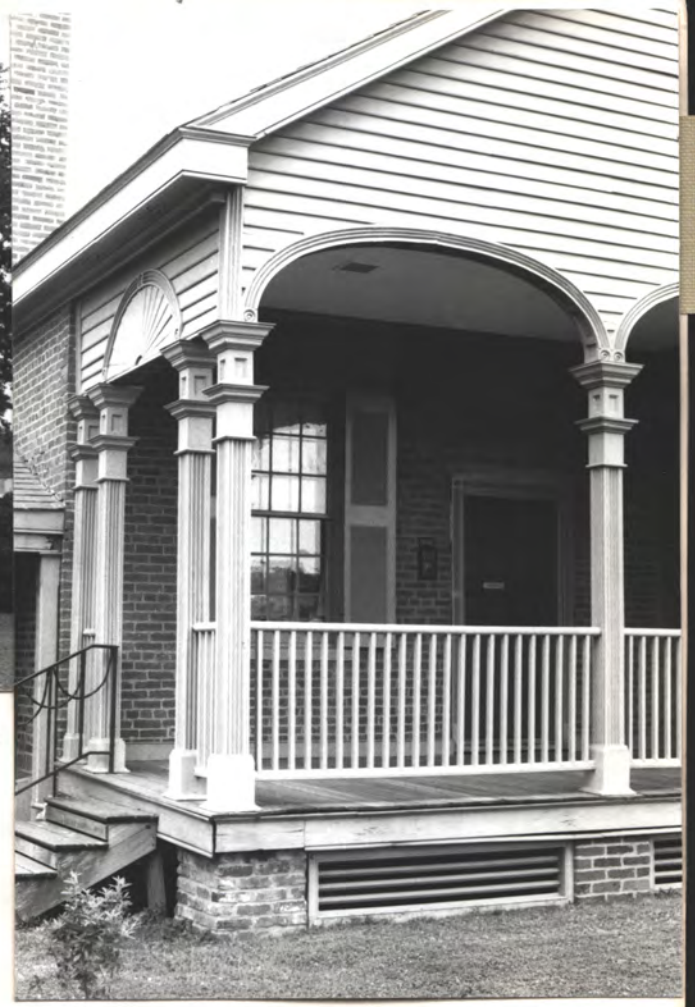
Before restor. in 1970's by Doug Fuller, Arch., Decatur/Hantsell
 "bungalow" remodel, 1920's
 note that the 1825 brick wall is bulged by this time

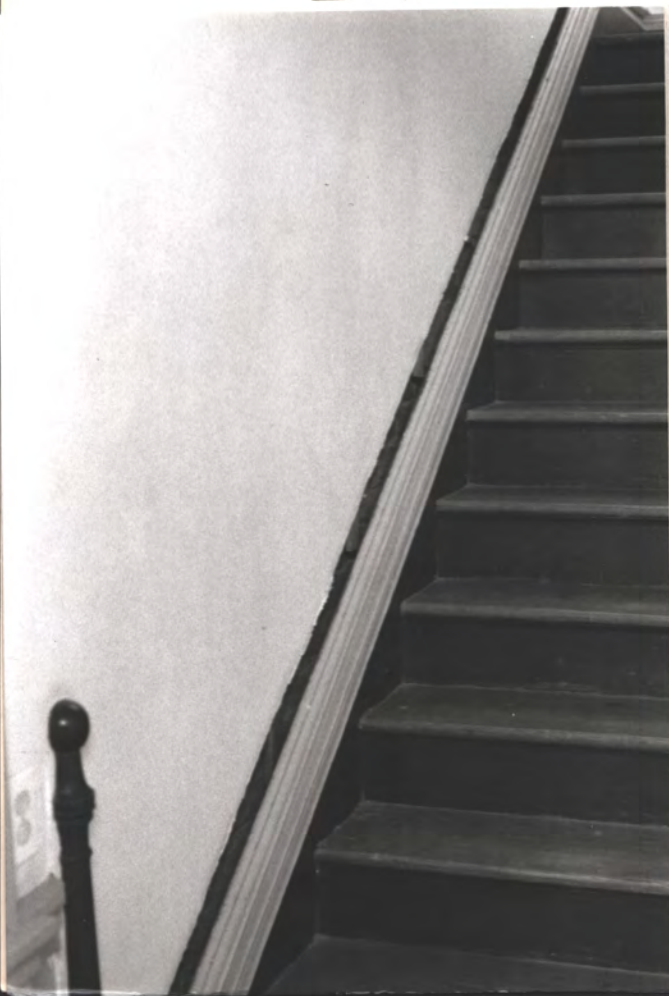
1 1/2" ± GAP DUE TO WALL
MOVING (BELLING) SOUTH
STAIR BASE

I feel the sensible thing is to not attempt to straighten the wall, since the bulge is not obvious to the ordinary observer. Where the inner wall has pulled away from the stair trim I would scribe a neat, flat 1x filler strip and insert it to fill the crack. Verify adequate bearing at the floor joists at both floors.

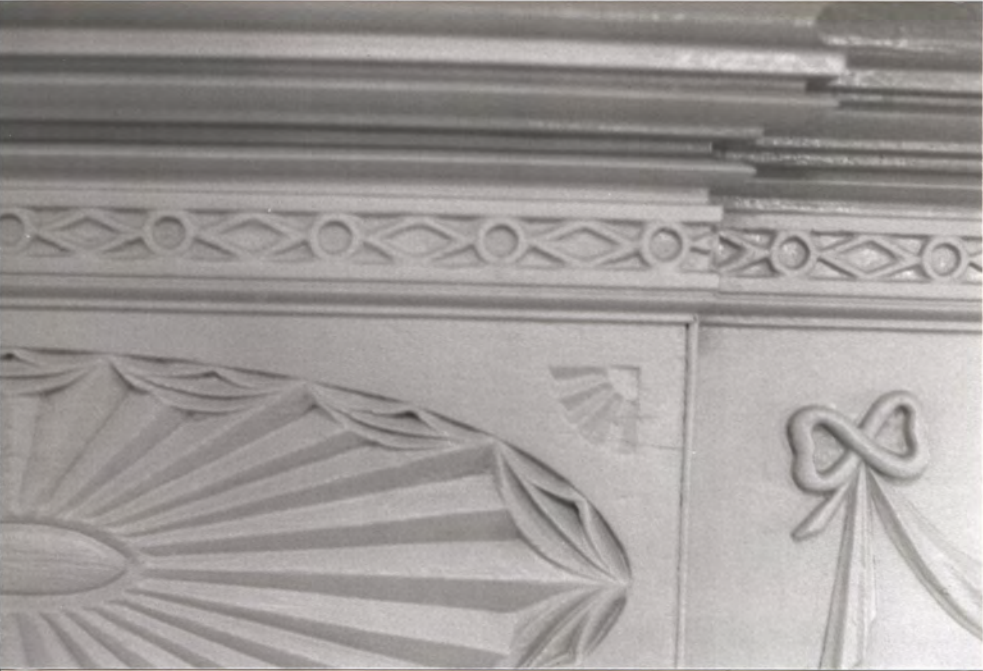
Parlor Mantel
 (very nice)
 "Surround" should be plastered.
 Herring pattern not correct
 Should be →

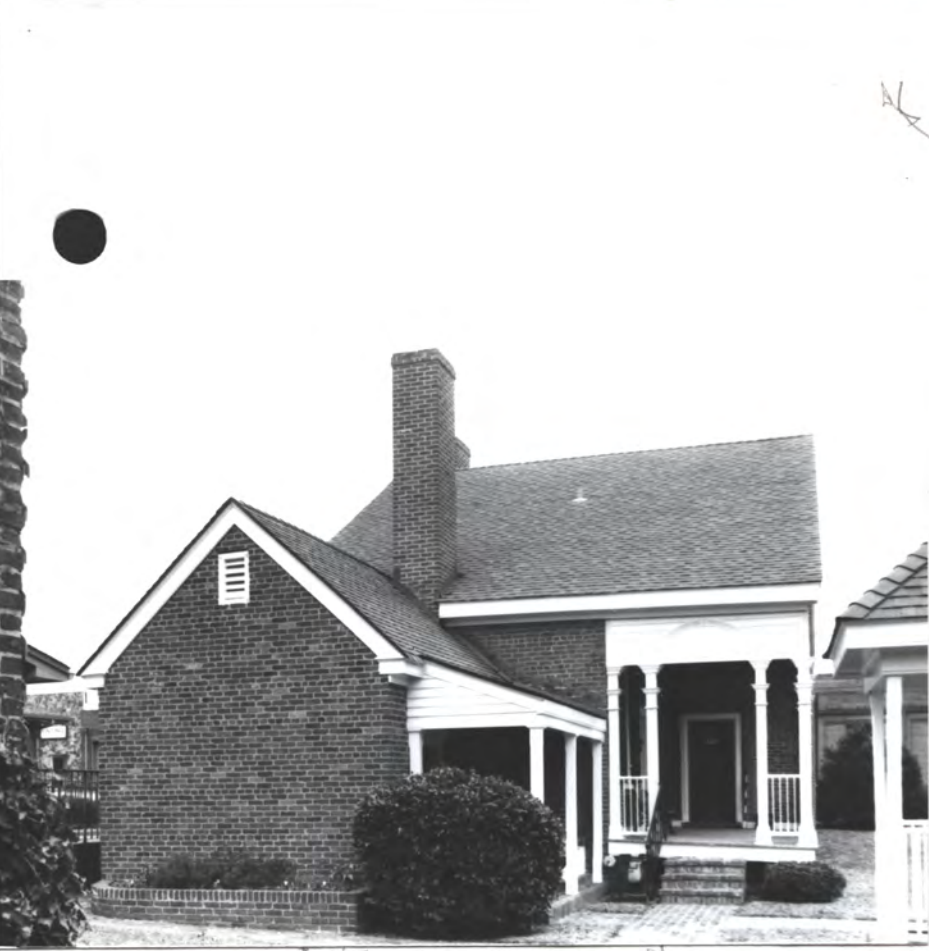
brick was sandblasted in 1970's,
 + Poor repointing (wide, shaggy joints)

Window to be added here in 1995 work

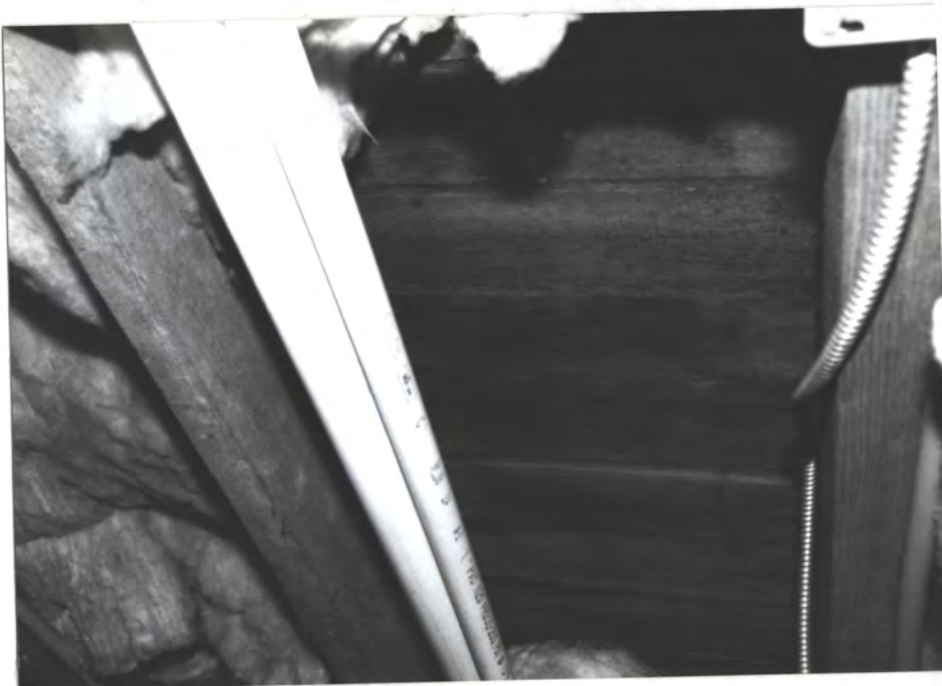
BSMT 7,
Looking up

Note
Sash saw
marks on
bottom of
fl. joists
(typical of
1800-1860)

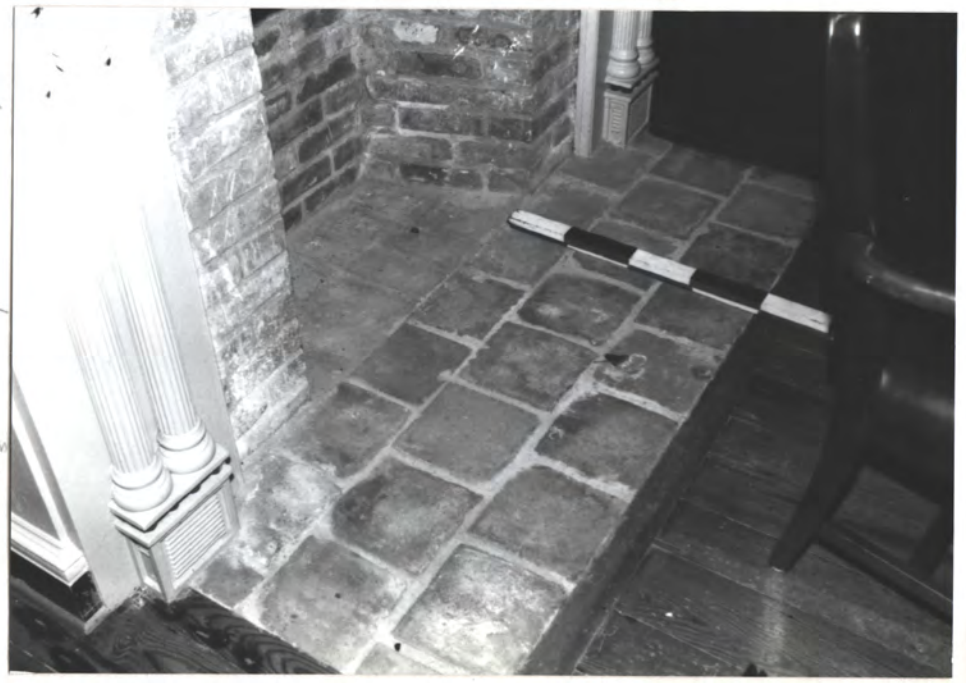
Parlor hearth (sq. bricks should not have "mortar joints")

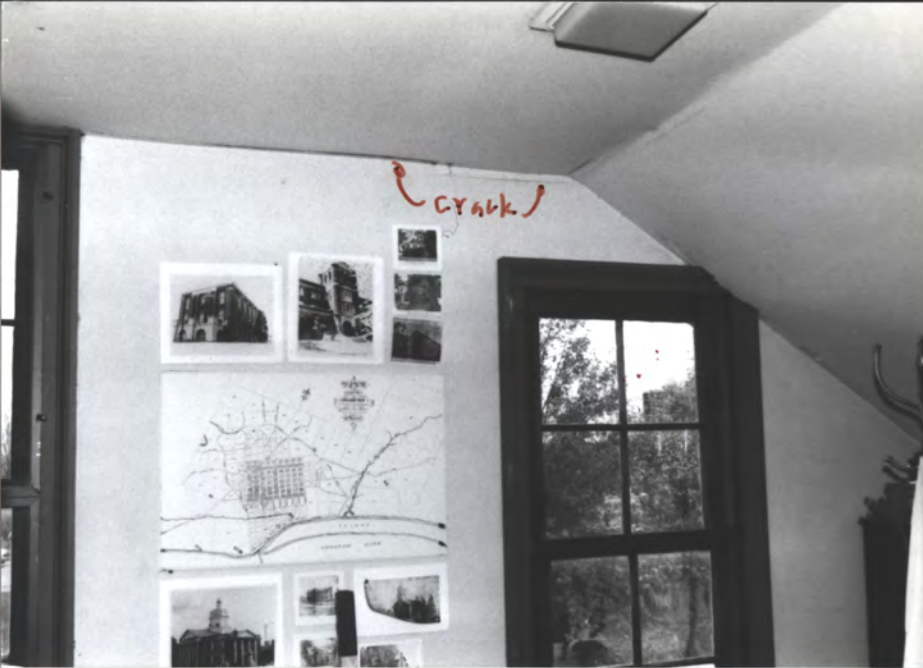
FL. 2 N.E. FRONT B.R.

crack

ALL 1976
SURF. =
~ 1976
gypsum
board
(Dry Wall)

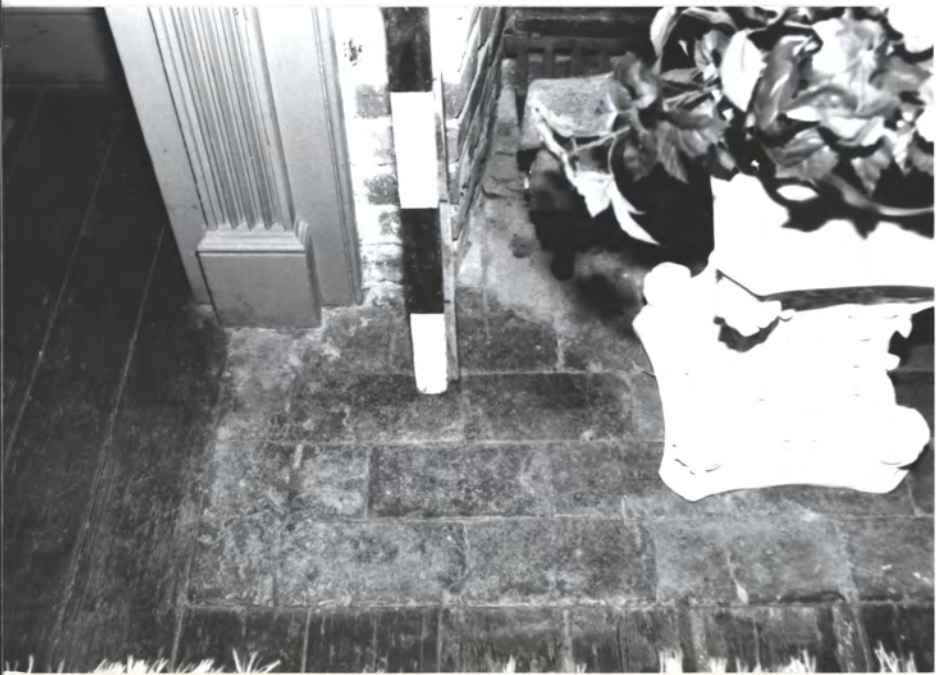
FL. 2
N.W. Rm

Original
brick
hearth,
tight butt jts
no mortar

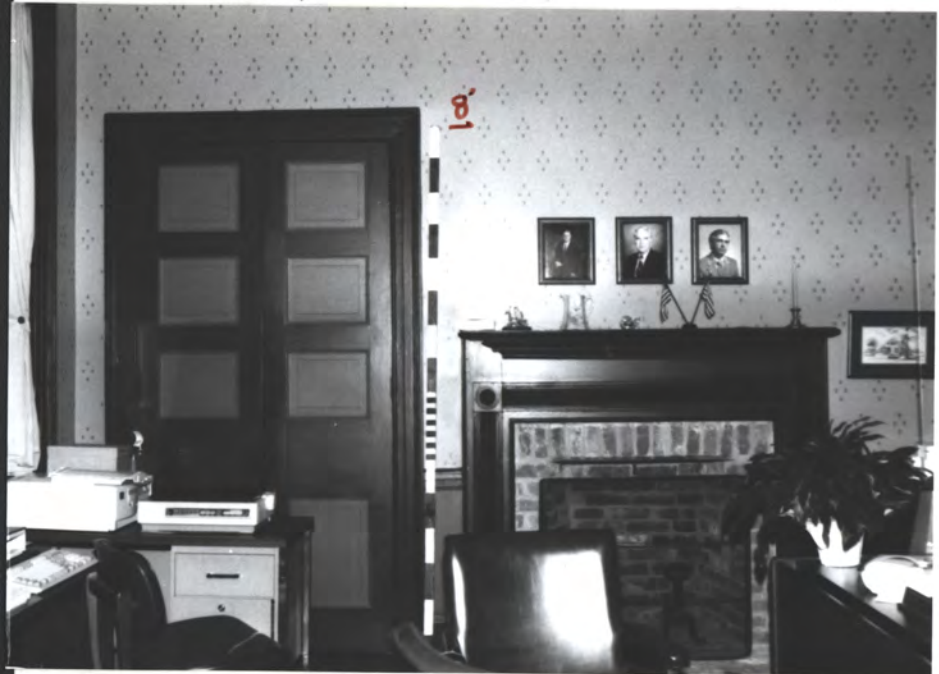
class. (orig.)

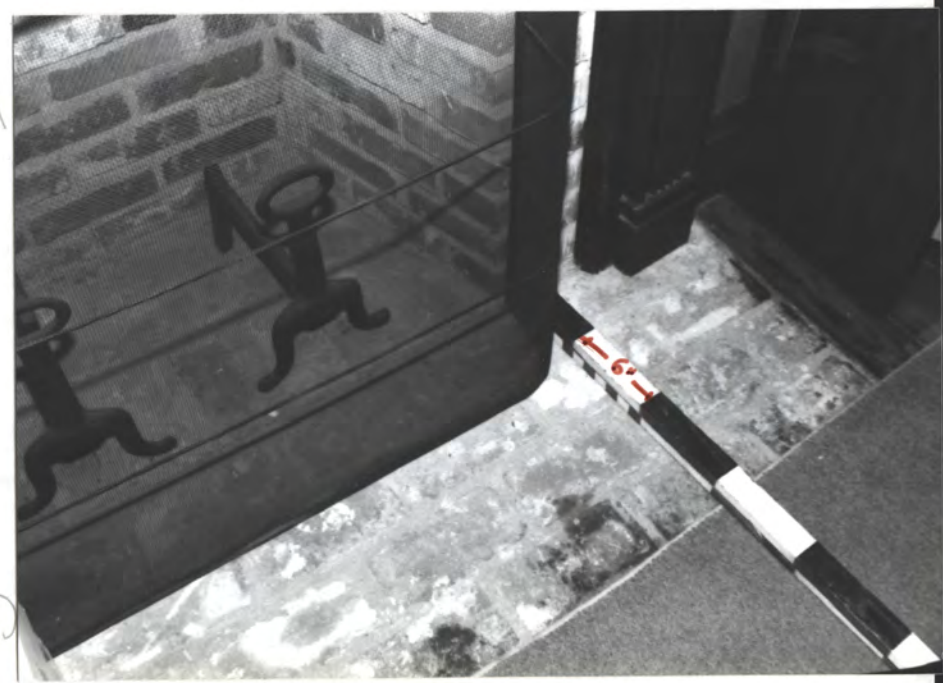
FL. 1 DW. RM. (w. y. porch)

F.p. surround
should be
plastered.
Hearth =
incorrect
pattern &
should not
have wide
marker ribs
(should be
butted tight
w/ no marker)
