**ARCHITECTURAL COLLECTION
OF
HARVIE P. JONES, F.A.I.A.**

BOOK 49

**1940 Rosenbaum Hse.
Florence,
AL**

Milly Wright **FRANK LLOYD WRIGHT ROSENBAUM HOUSE FOUNDATION PROJECT**

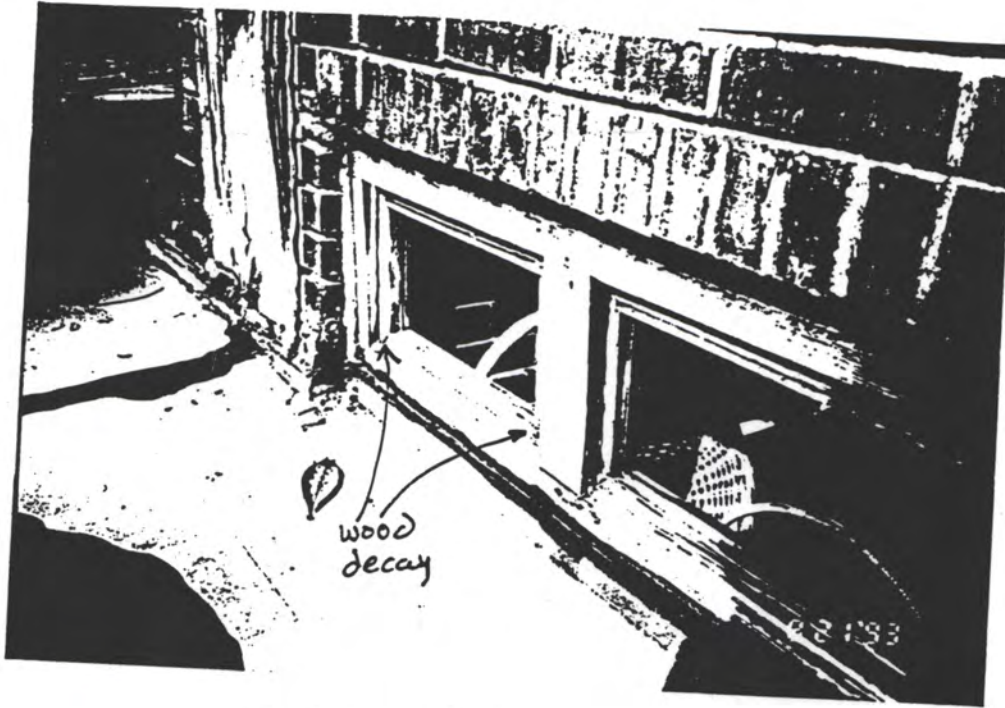
FIG. 10

As usual with older houses, the exterior grade level has been built up higher than originally intended causing potential water, rot, and termite problems at the base of the exterior board and batten walls. There are signs of wood decay at the plywood trim at clearstory windows (Fig. 9), various window frames (Fig. 10), and door frames (Fig. 11). While cypress is highly resistant to decay and termites, it is not equivalent to pressure treated wood that is used today. Also, the exterior brick needs to be cleaned.

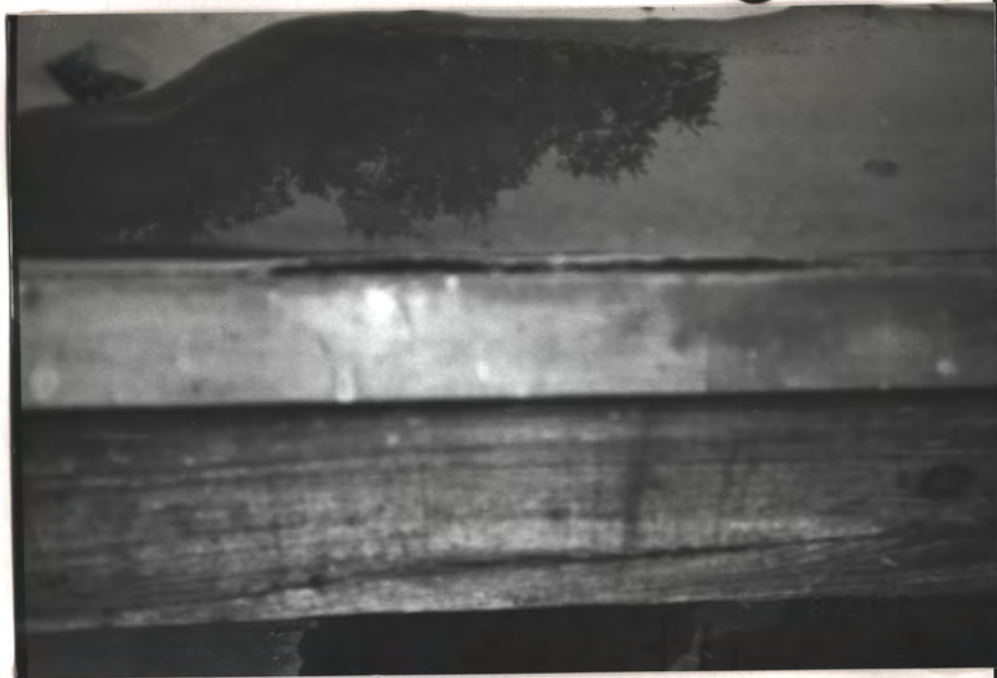
peeled canvas topping edge at roof (numerous)
(Built-up roof is under canvas.
Painted canvas is only for south - color.)

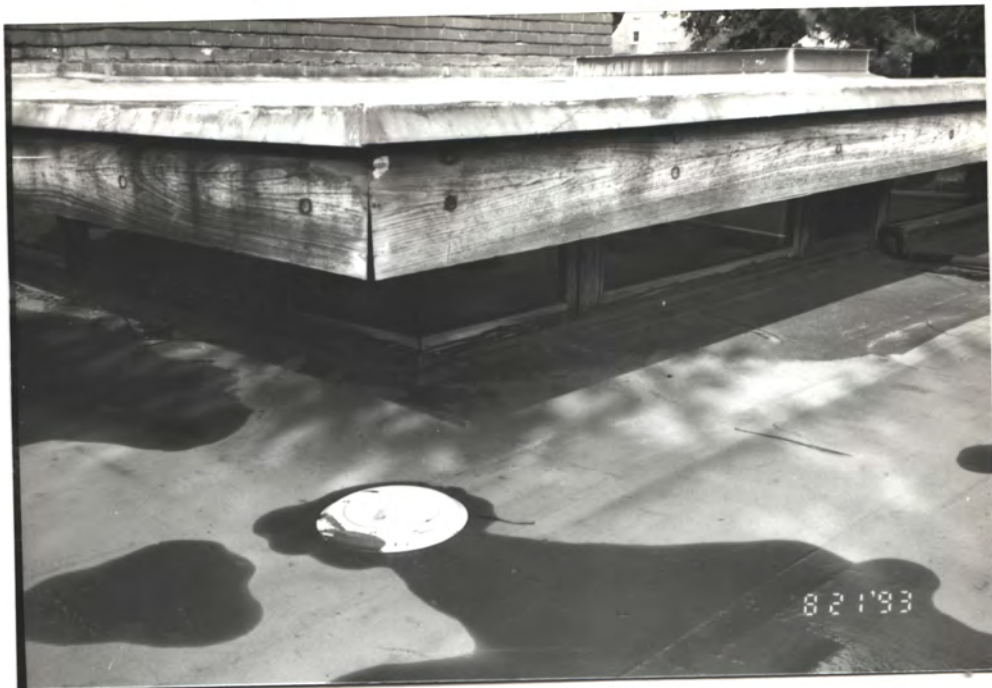
FIG. 7

The cantilevered eaves are sagging at various locations around the house (Fig. 4, 5, & 6). The fascia board that was added in the 1968 renovation has become separated and warped at numerous locations (Fig. 7). It was originally attached with glue. The fascia at the east wall of the '48 addition at the courtyard is decayed badly and covered with plastic at this time.

↳ c. 1967 copper scupper (top.)

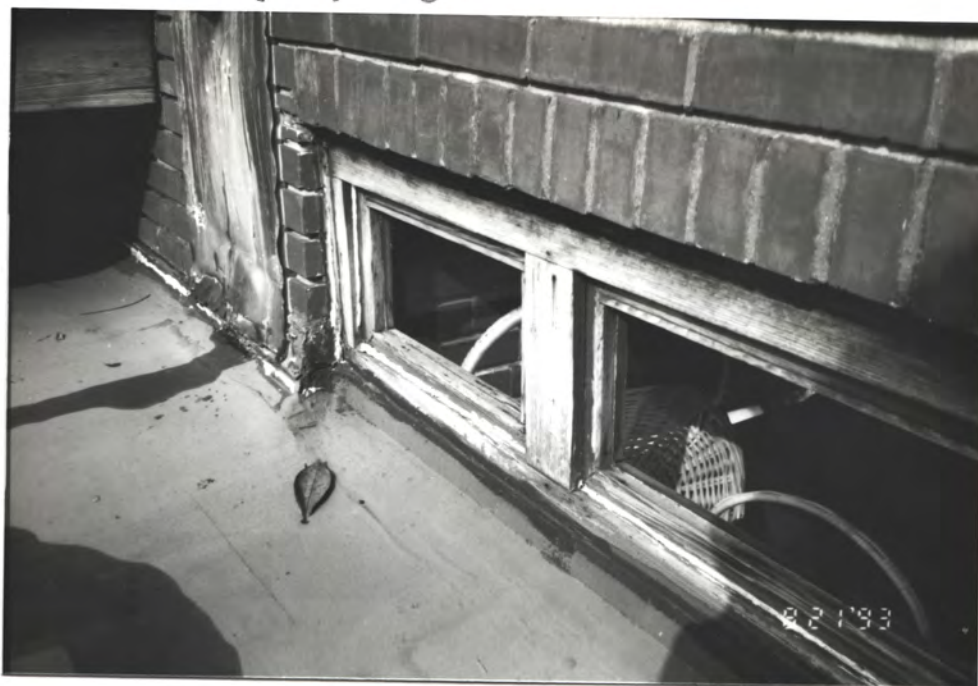
FIG. 9

← Overstory
at 2nd
150
S.W.M.

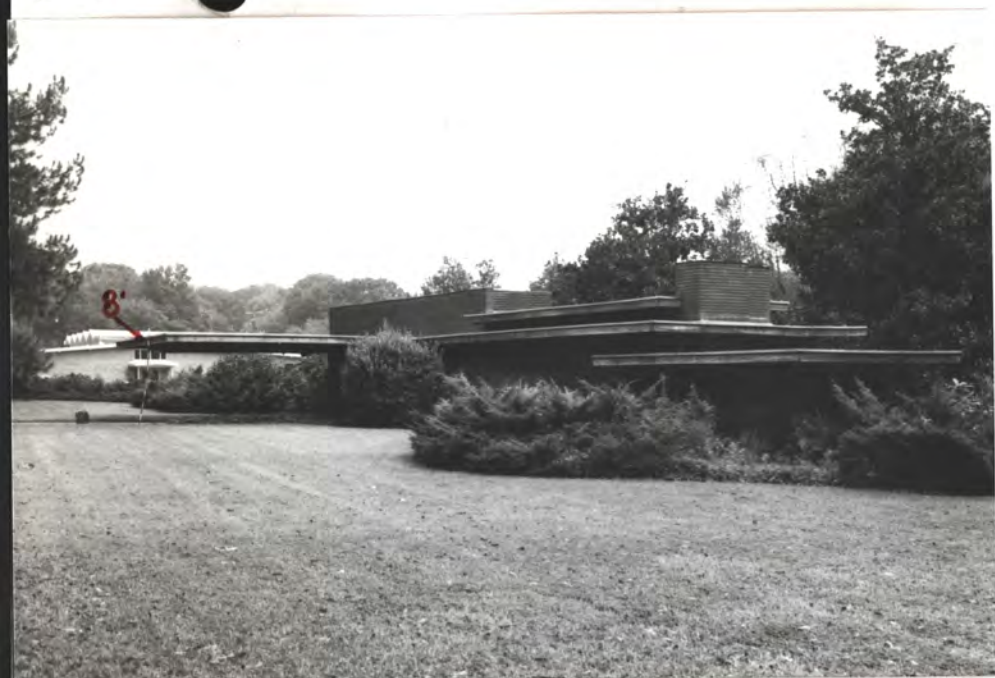
N ← CHAPEL → L.R. → Study →

note roof defect →

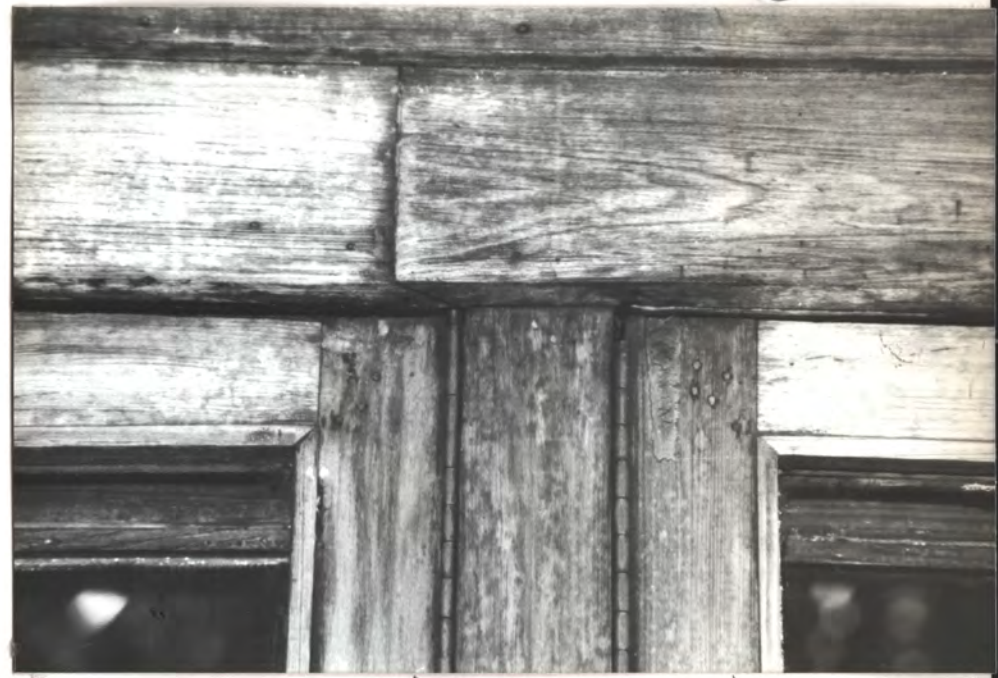
↑ deflection at top

L. R. - S. W. M French Windows (typical)
brass piano hinges

↑ nail-patches at top

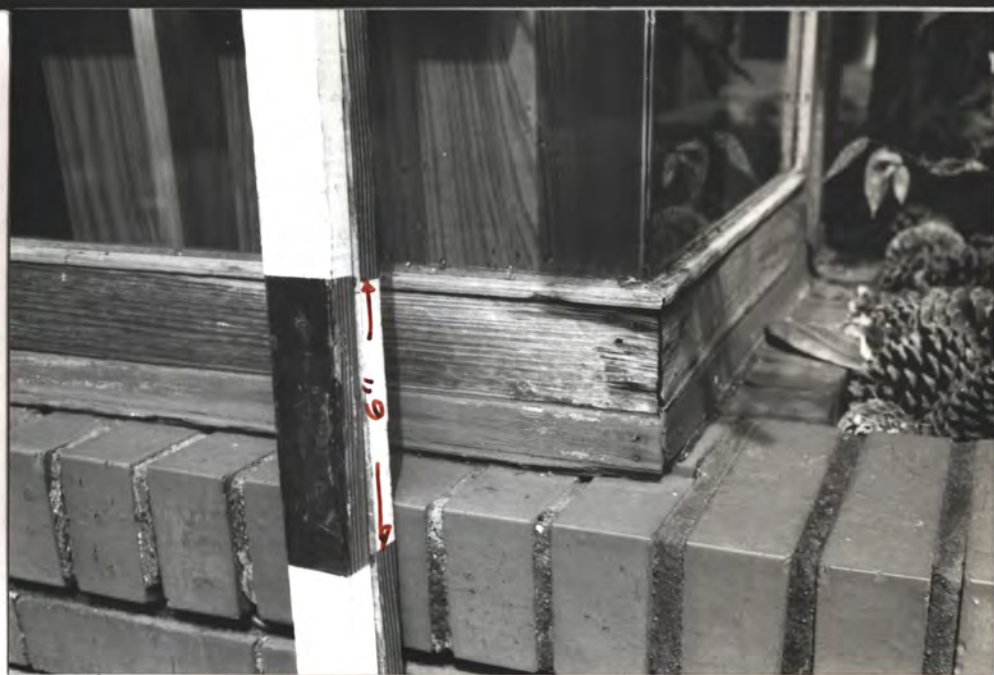
N ←

rot ↗ ↑ S.W. Corner at
Din. Rm

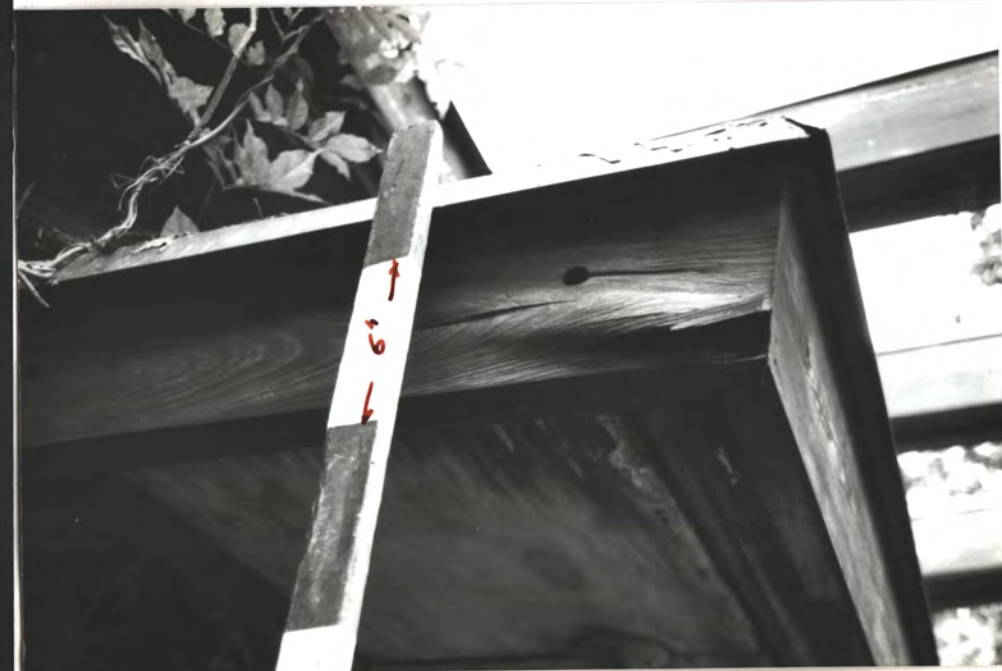
IMPR balcony
 * → c. 1948 Guest Rm
 Rm by EBW
 N → Sag ± 4°

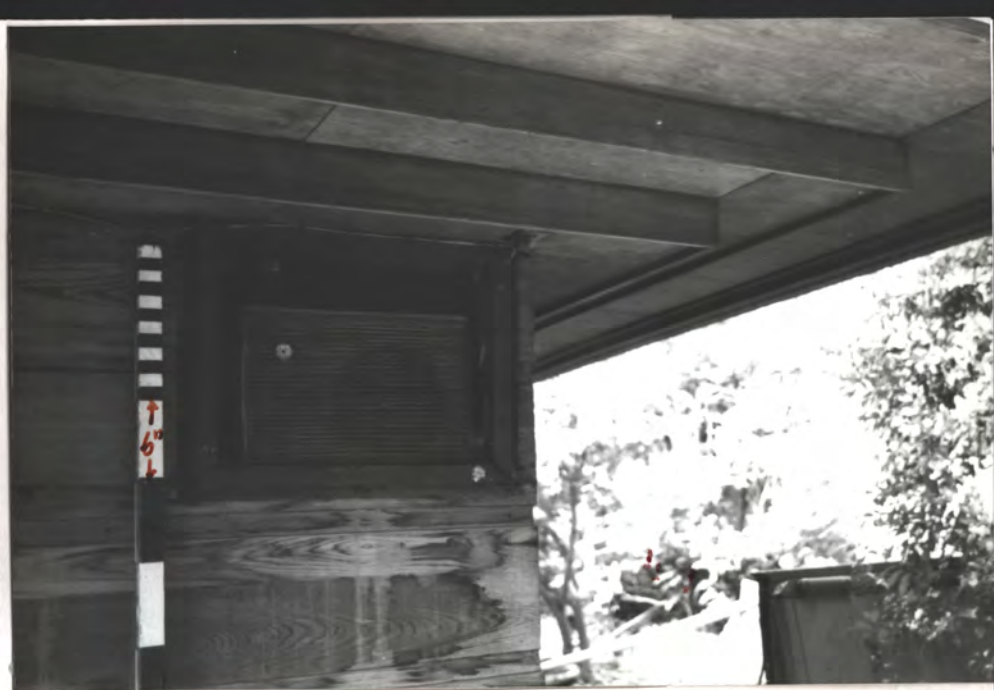
Sag ± 4° Prot
 S. eave at Guest Rm Rm.

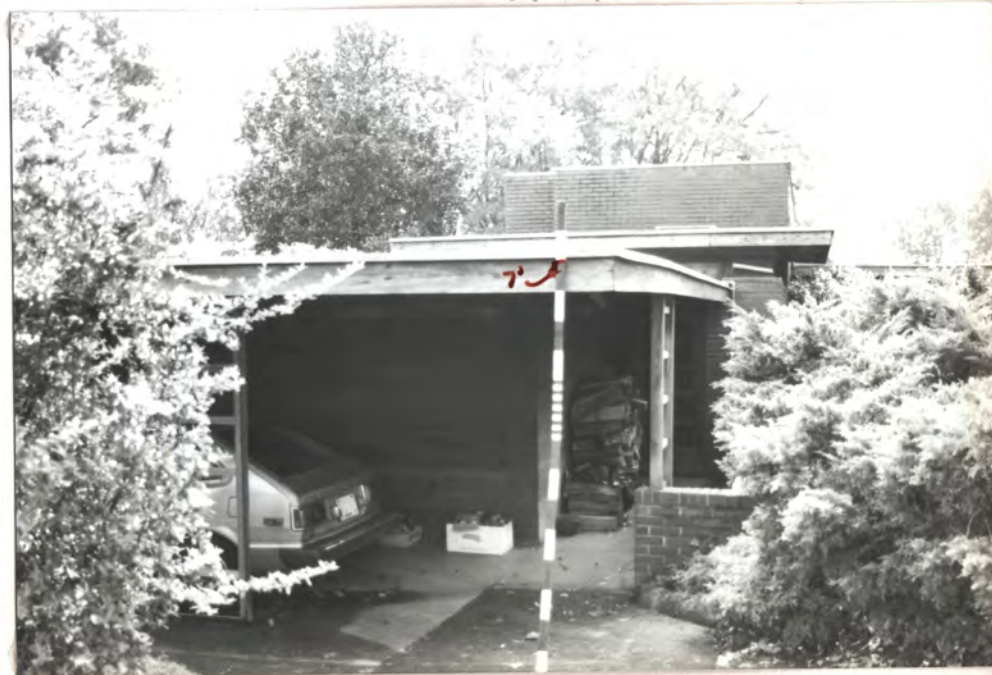
1948 erect carport (trellis added later, c. 1968, when roof deflected) - per Mrs. R.

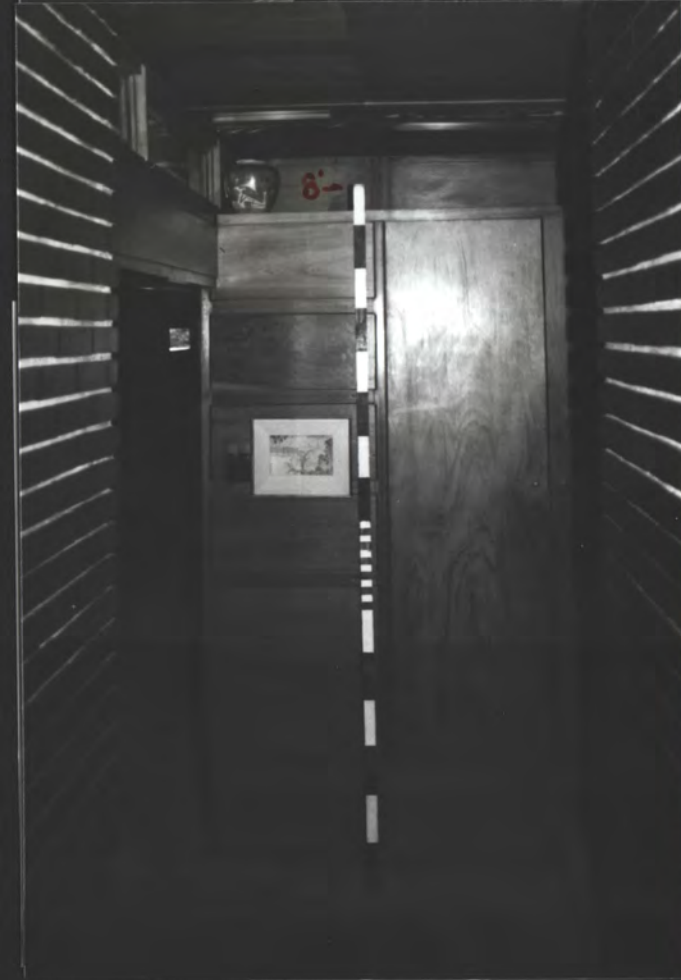
→ white is efflorescence,
behind late polyurethane sealer
on brick (mistake)

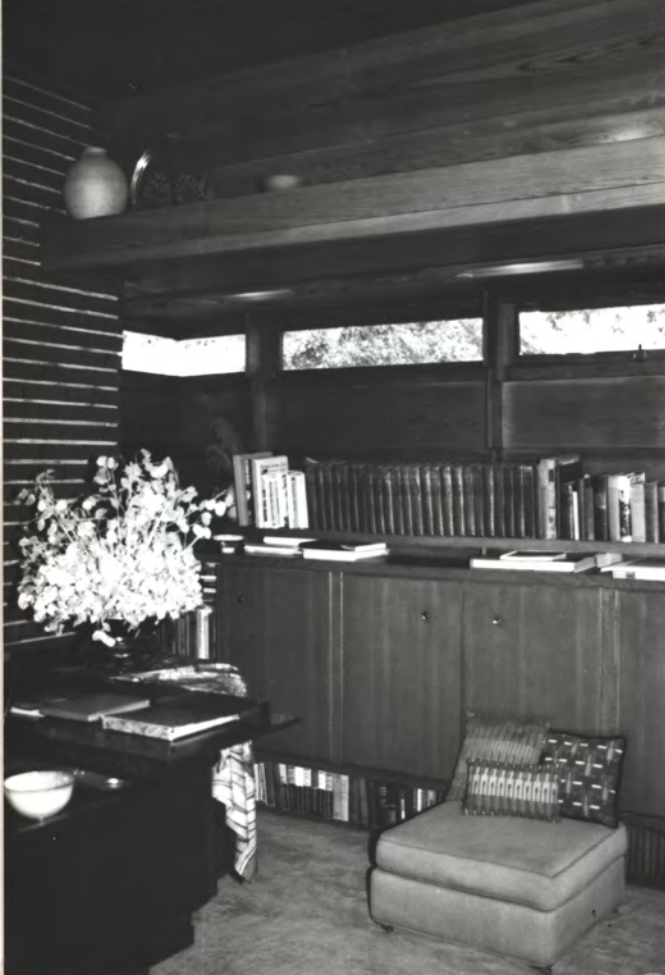
store. cabinets added later,
not by Taliesin (was shivs)

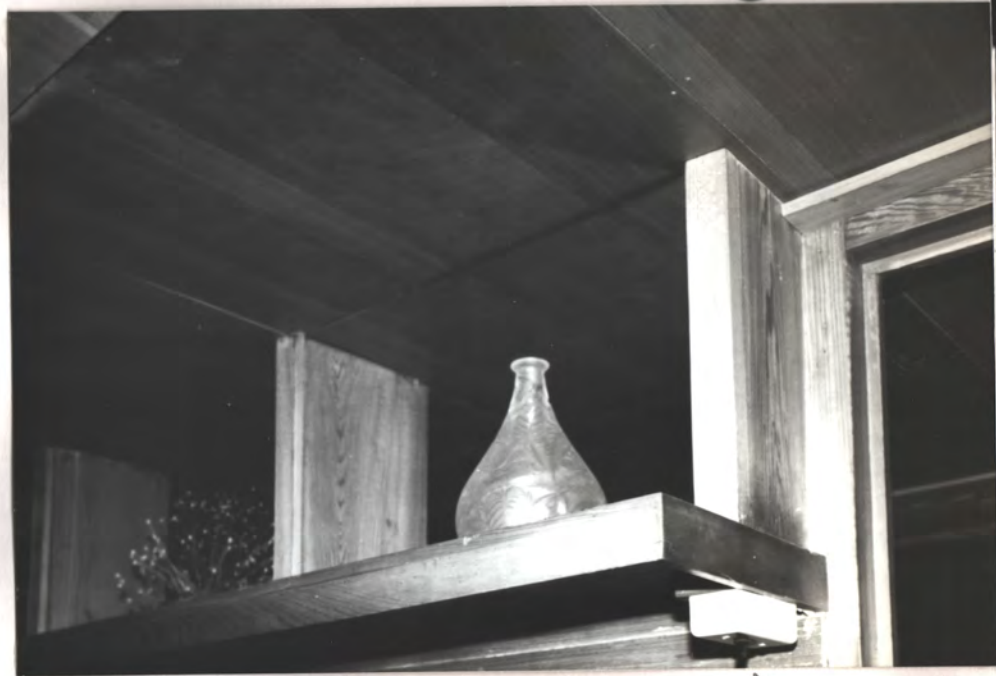
↑ added glass at transom
between 1948 din. area
& 1940 hall (was open,
but noisy, per Mrs R.)

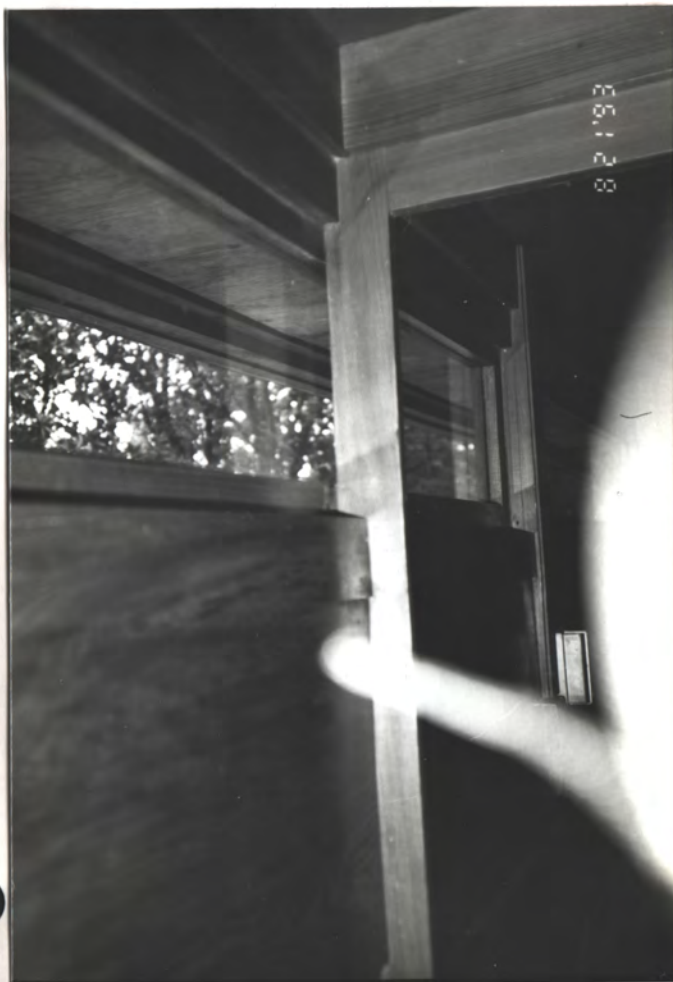
Door / window
intersection at
1940 hall &
MBR door?
(verify)

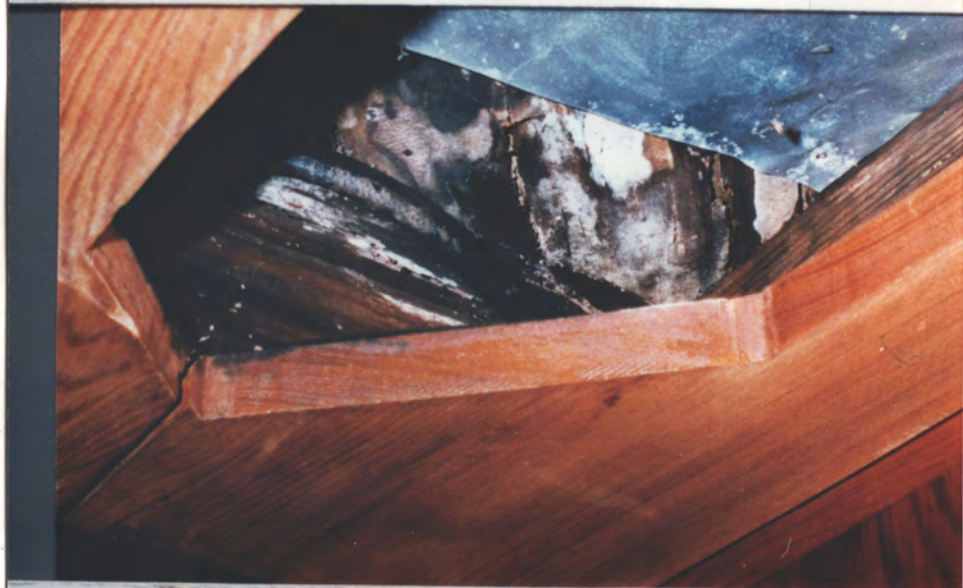
E. wall ceil, at lt. panel contact

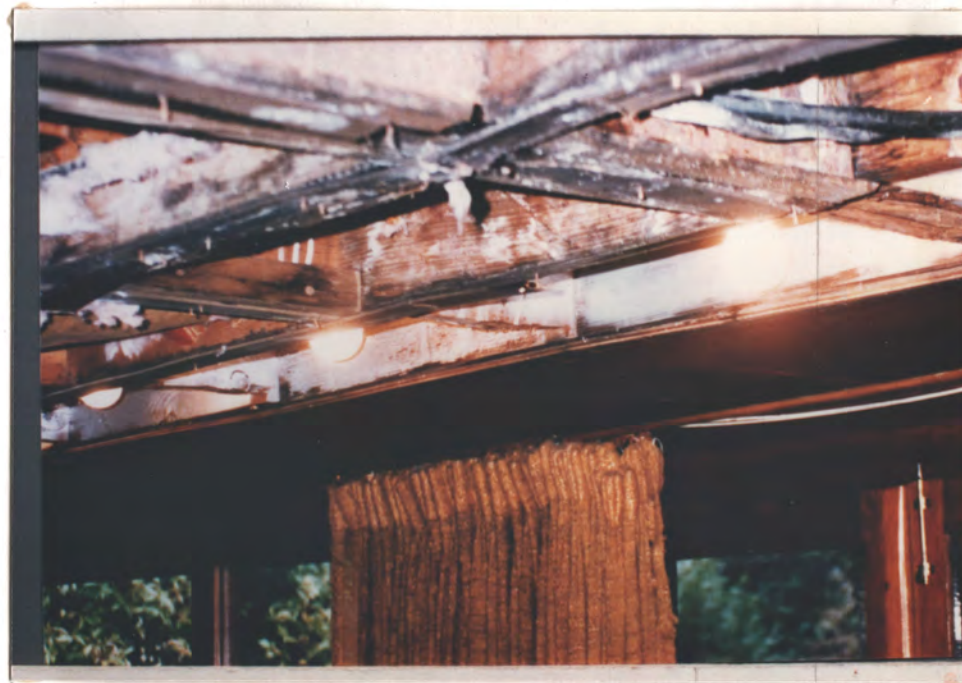
← N.E. Wing, bkfst. area

E. Hall, terminals of rot
