JONES & HERRIN

June 28, 1994

ALTO BUILDING HUNTSVILLE DEPOT HUNTSVILLE, AL DECEMBER, 1980 PROJECT # 80.031 (AMERICAN LEGION BLDG.)

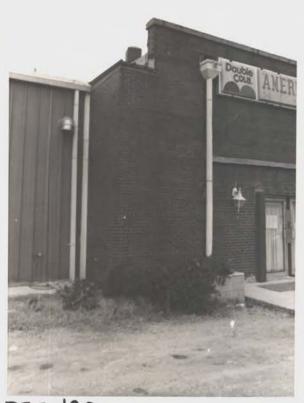
South FACE 1 METAL BLOG - BRICK BUILDING JOINT

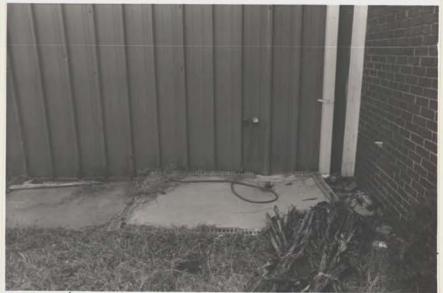
SOUTH FACE 1 METAL BLDG. SHOWING GARBAGE CAN WASH

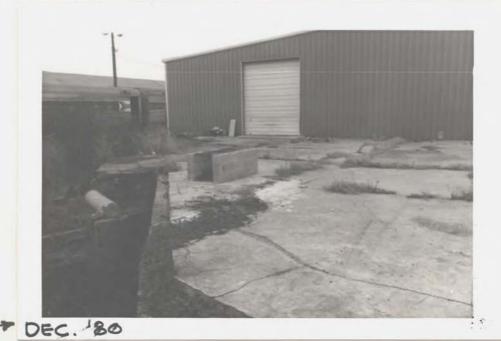
WEST FACE AT DRAINAGE TUNNEL

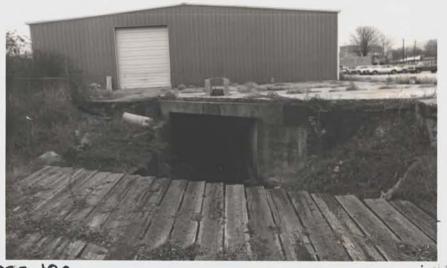
WEST FACE AT DRAINAGE TUNNEL

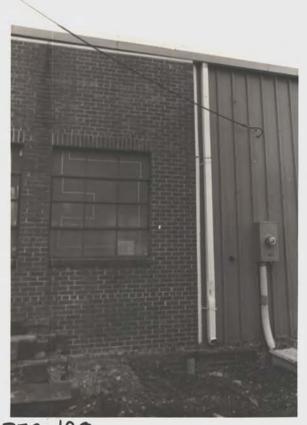
NORTH FACE 1 METAL BLDG. - BRICK BLDG. JOINT

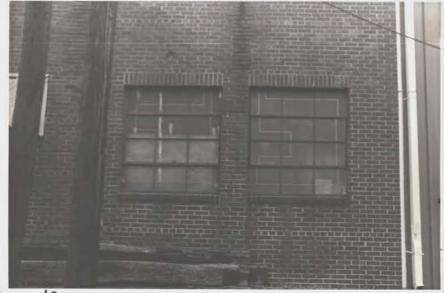
NORTH FACE AT STORAGE RM. WINDOWS

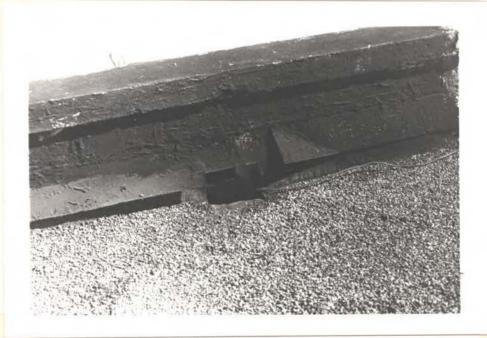
South Well

Metal roof

Roof vents

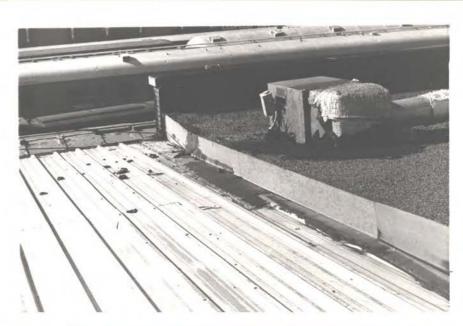
Flashing detail @ connection of built-up root of metal root.

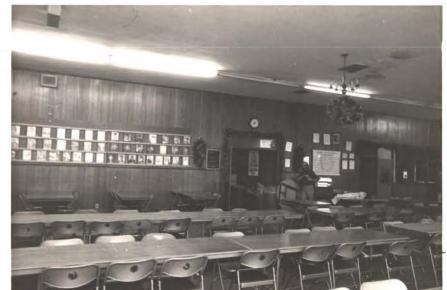
Looking South.

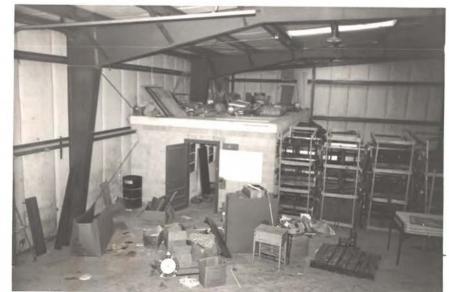
METAL BLDG. LOOKING SOUTH-WEST MASONRY PARTITIONED ROOM AT PHOTO CENTER

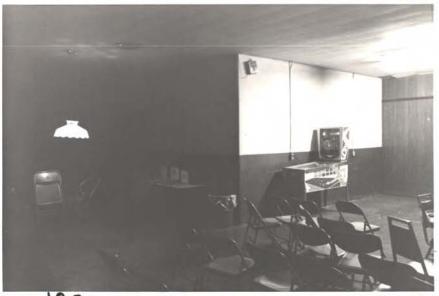
RECREATION Rm.
LOOKING NORTH-EAST
OUTSIDE CORNER OF
SAFE @ PHOTO CENTER
