Re: Church of the Nativity Administration Office
Project No. 95075

Re: Circa 1870 Building at 208 Eustis Avenue
(Church of the Nativity Administration Building)
Project No. 95075

NATIVITY ADMINISTRATION BUILDING
PROJECT NO. 95078

CHURCH OF THE NATIVITY ADMIN. BLDG.

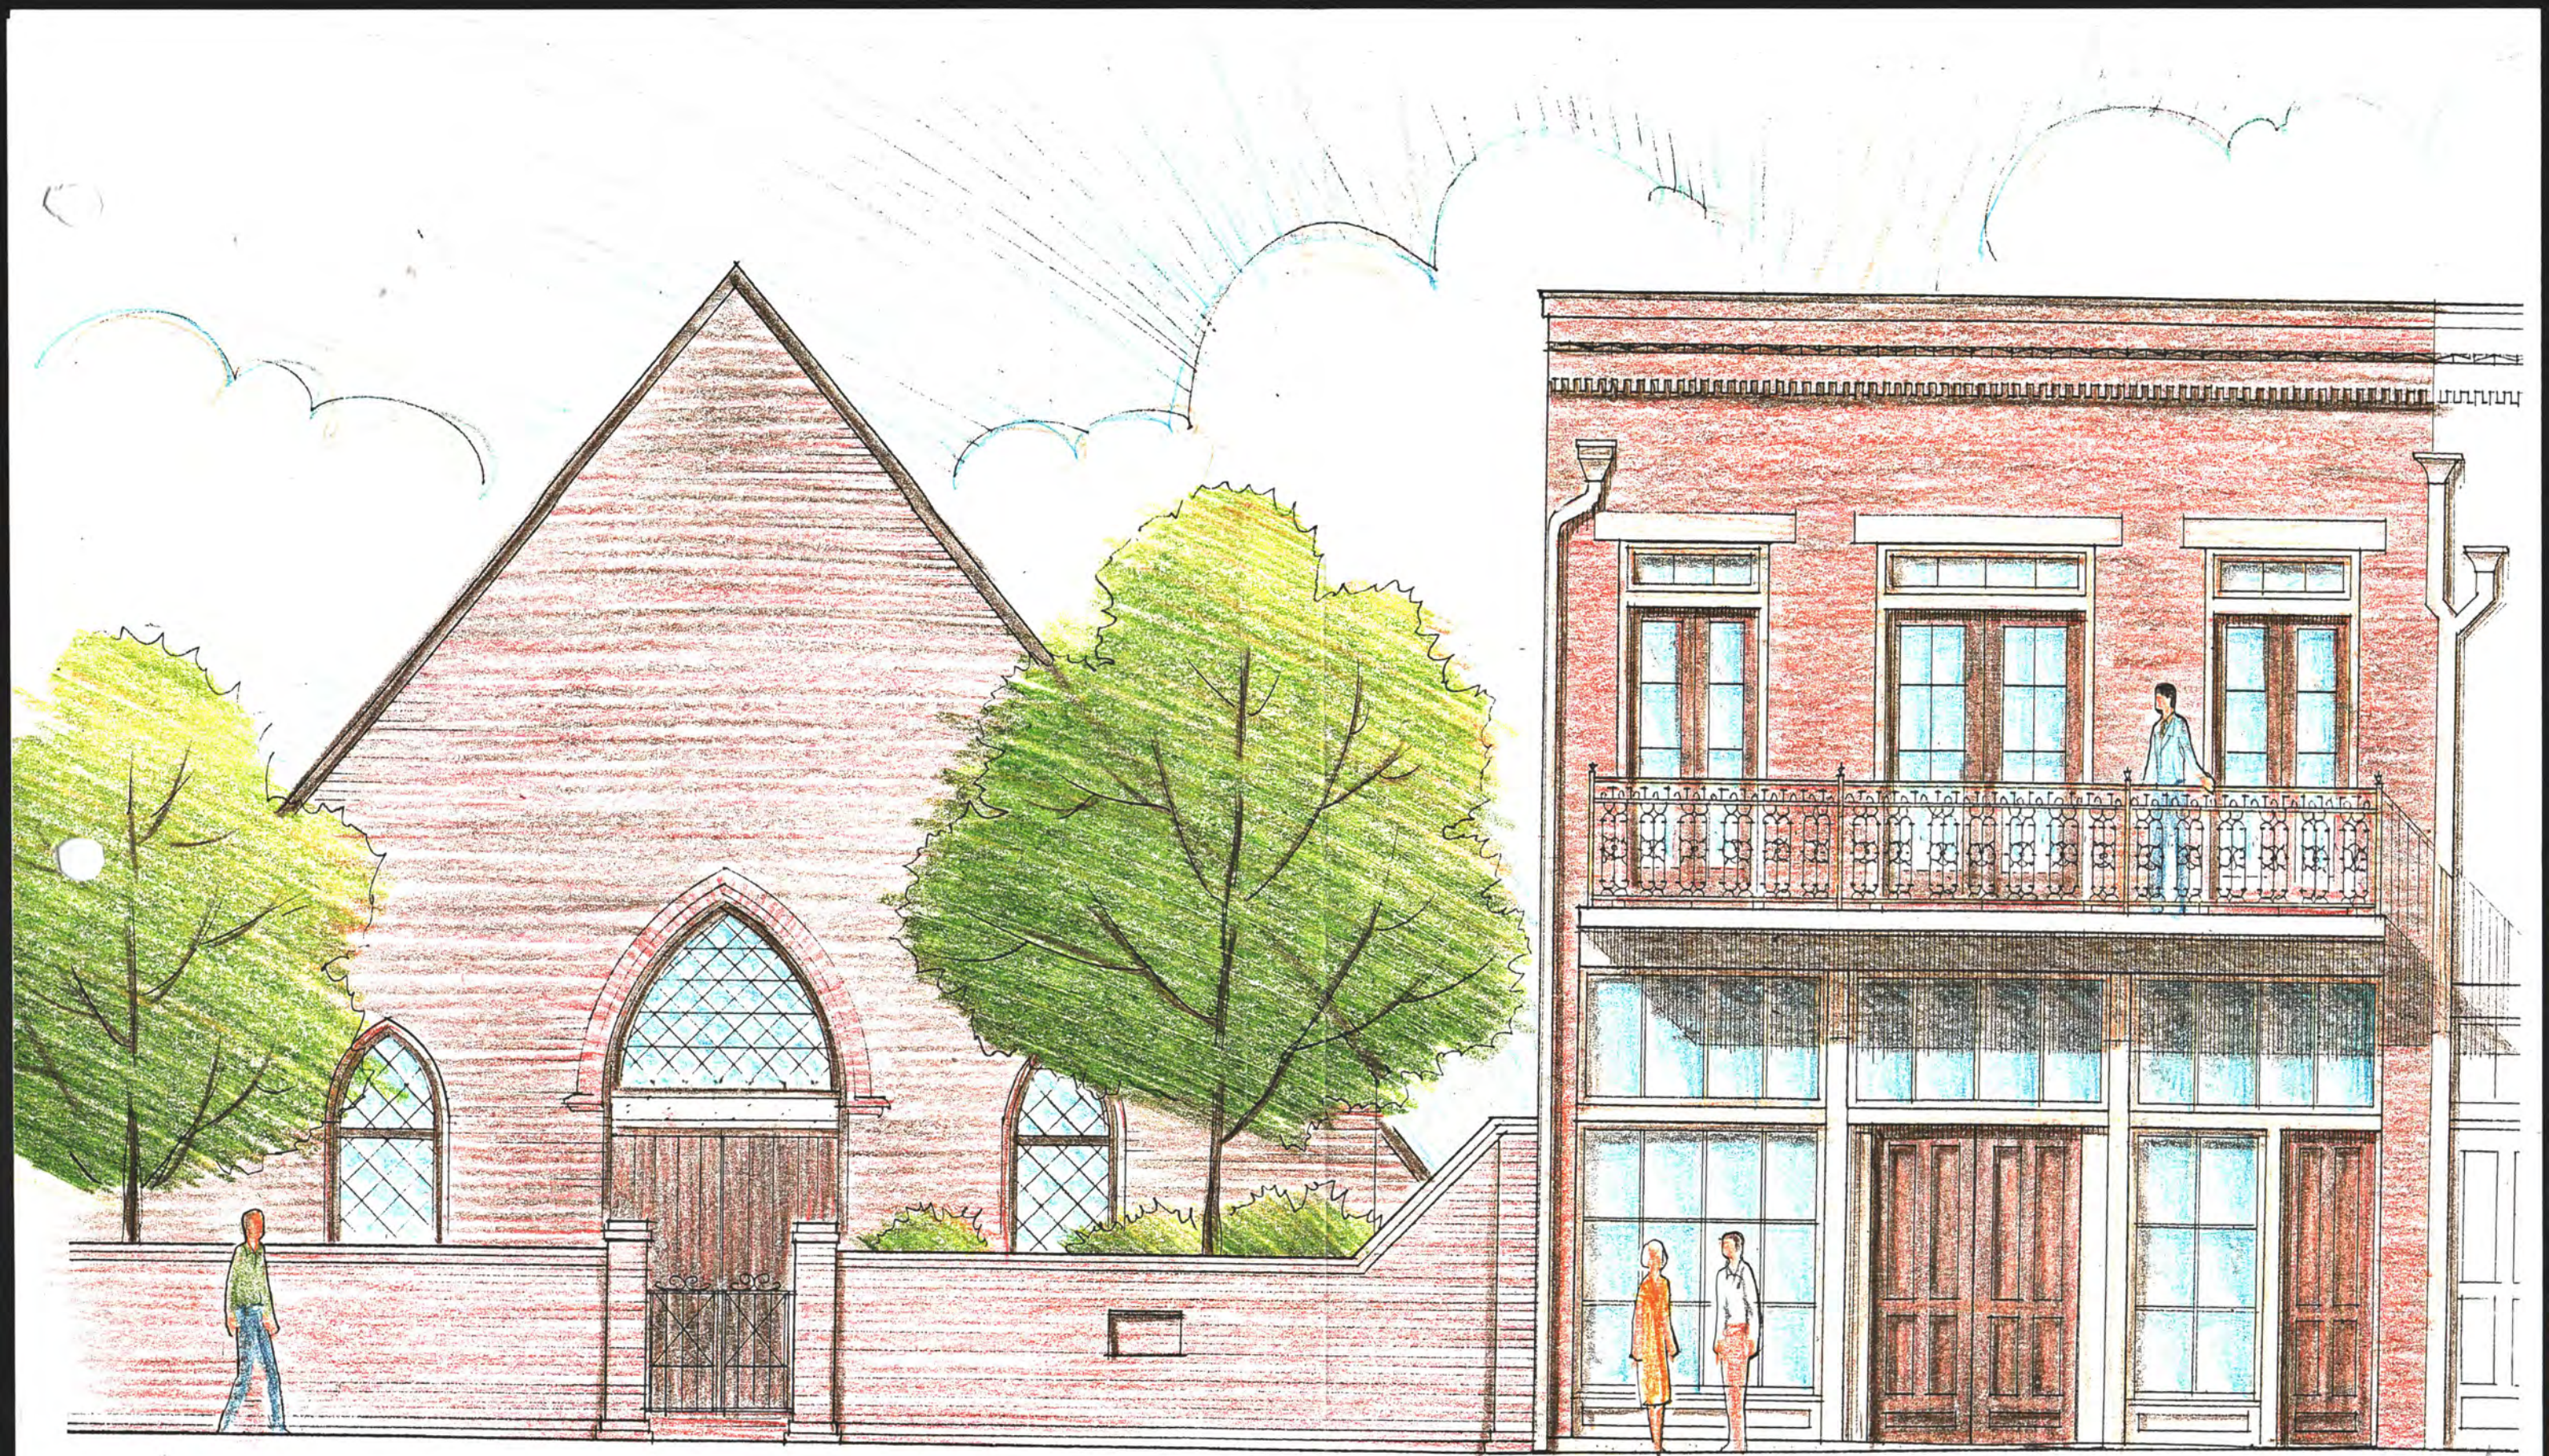
RESTORED PER 1898 SAUBORN MAP, EVIDENCES
AT SITE (BALCONY BOLTS, WINDOW TRACKS ETC.)
& 1950 PARTIAL PHOTO.

BALCONY RAIL SAME AS WAS ON DENTLER BLDG.
JONES & HERZIN, ARCHITECTS / INTERIOR DESIGN

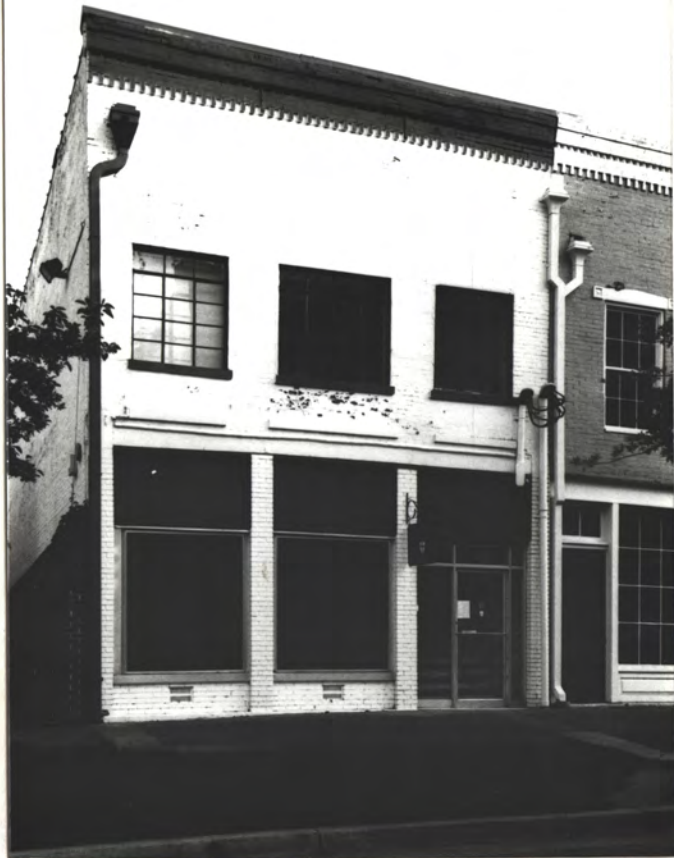
ORIG.
LIGHTS

ORIG. DRINGS

ORIG.
SILL

← 1860's
bldg.
restored
1980's by
JAH
HJ

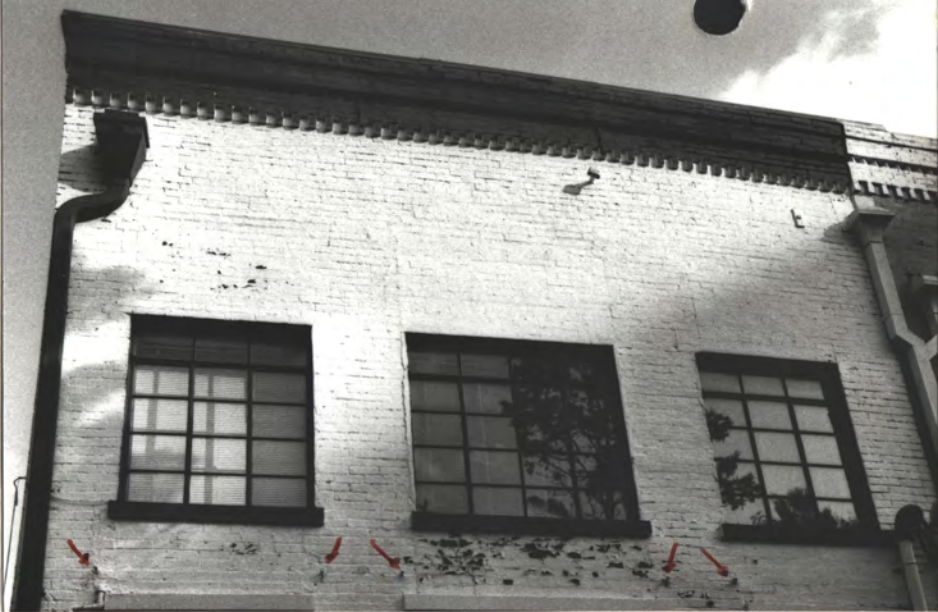
Circa 1870's bldg. owned by Episcopal Ch. of the Nativity
(windows of storefront = c. 1950's remodeling)
S. Side Eustis St. between Franklin & Groce Sts.
Huntsville AL photos May 1995 Harris B. James FWD
for restoration - James J. Herrin, Arch. + June '95 (p. 3-7)

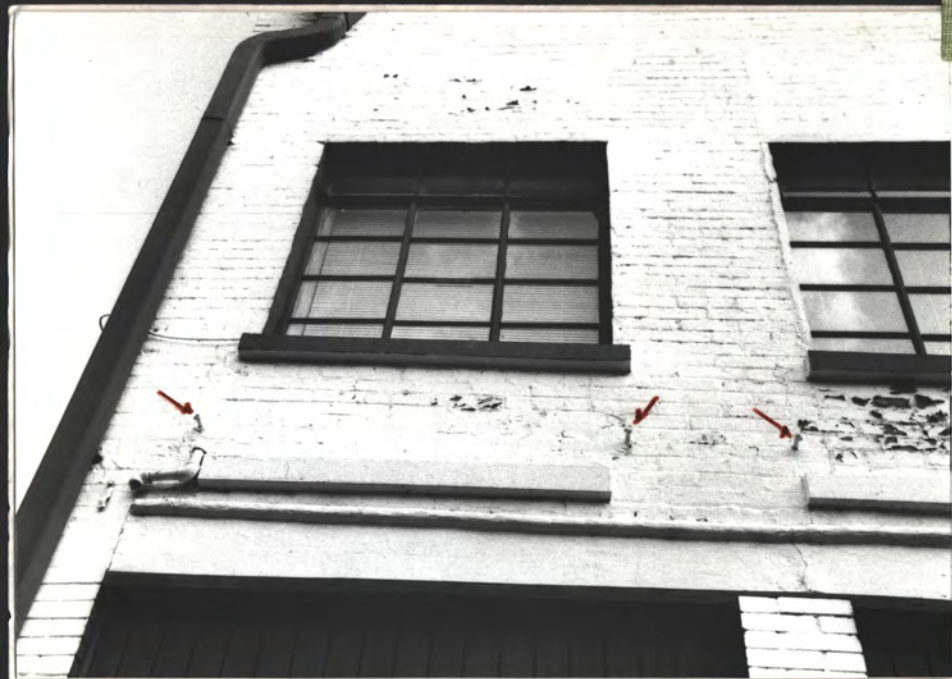
c. 1950's
steel
windows
much
shorter
than orig

bolts may
be for
balcony
rail
(?)

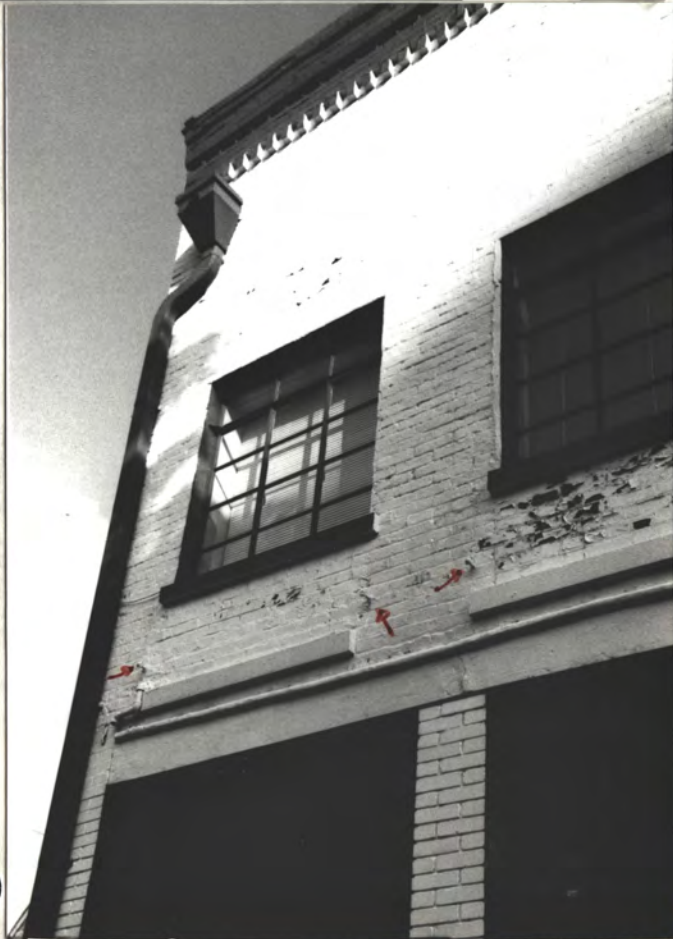
orig.
sills

c. 1950's
removable

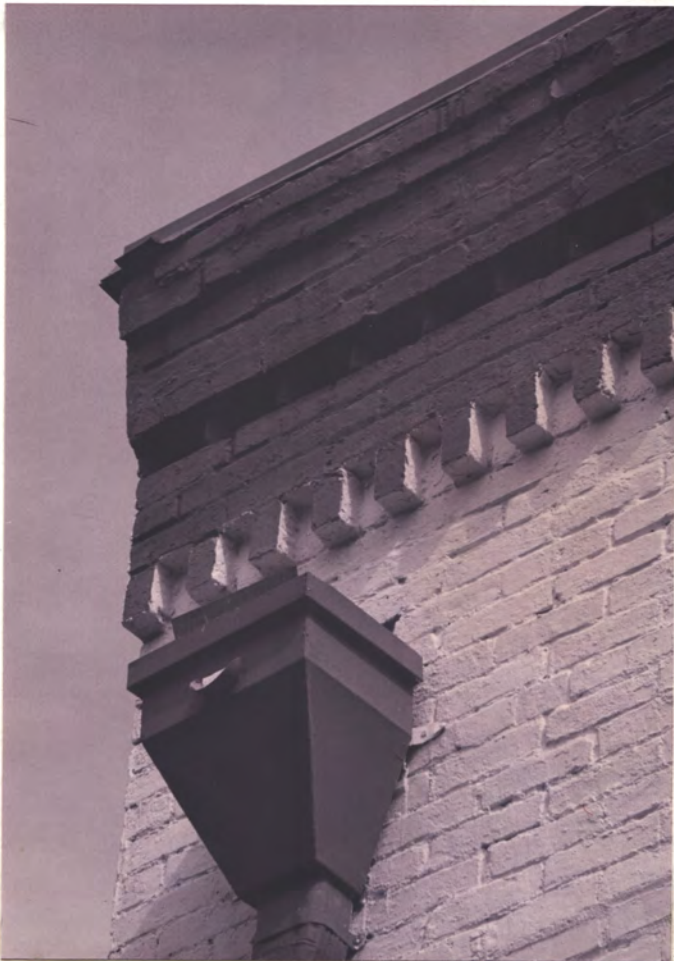
modern
shimmet
suggested

Dentler
Bldg.
demol.
c. 1950
for Ridley
Wall
Epis. Ch.
Admin.
Bldg.

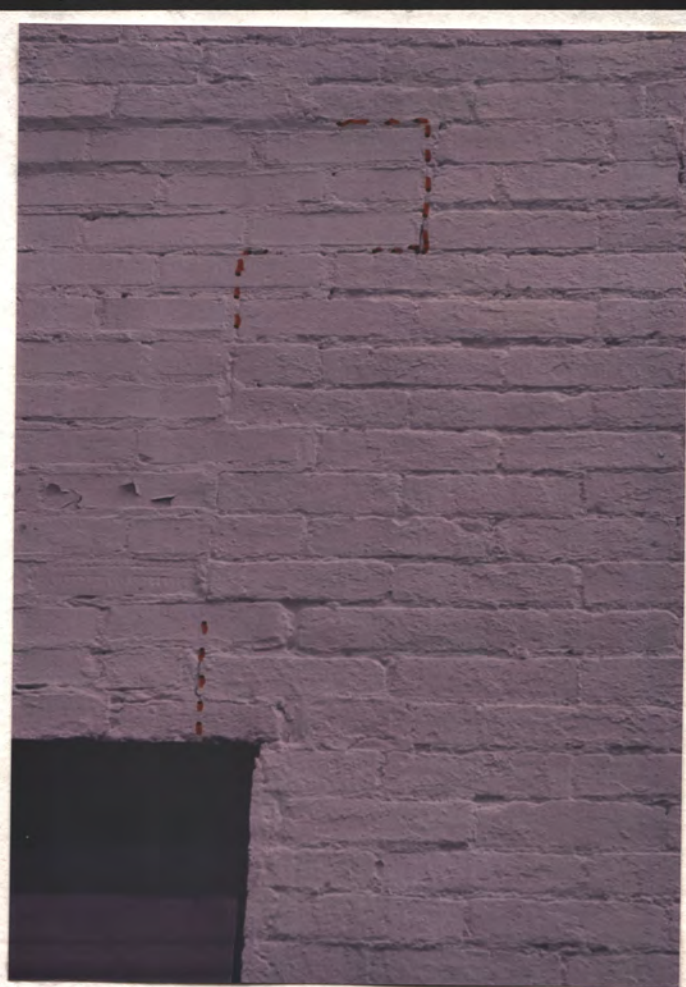
Top Left (east) sash head

orig. lintel
trace

orig. jamb
trace

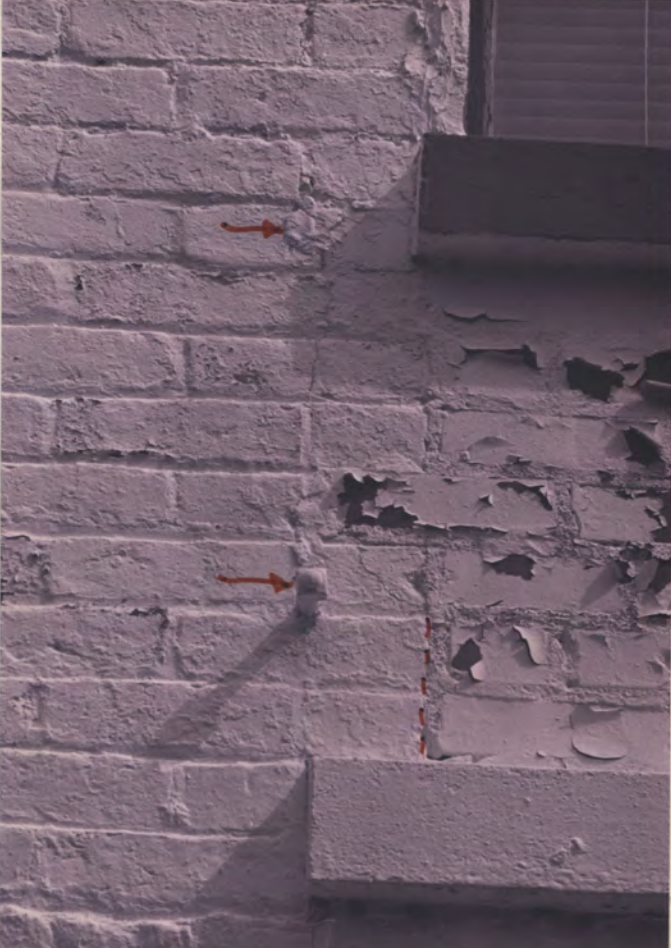
c. 1960
sim

orig.
sim

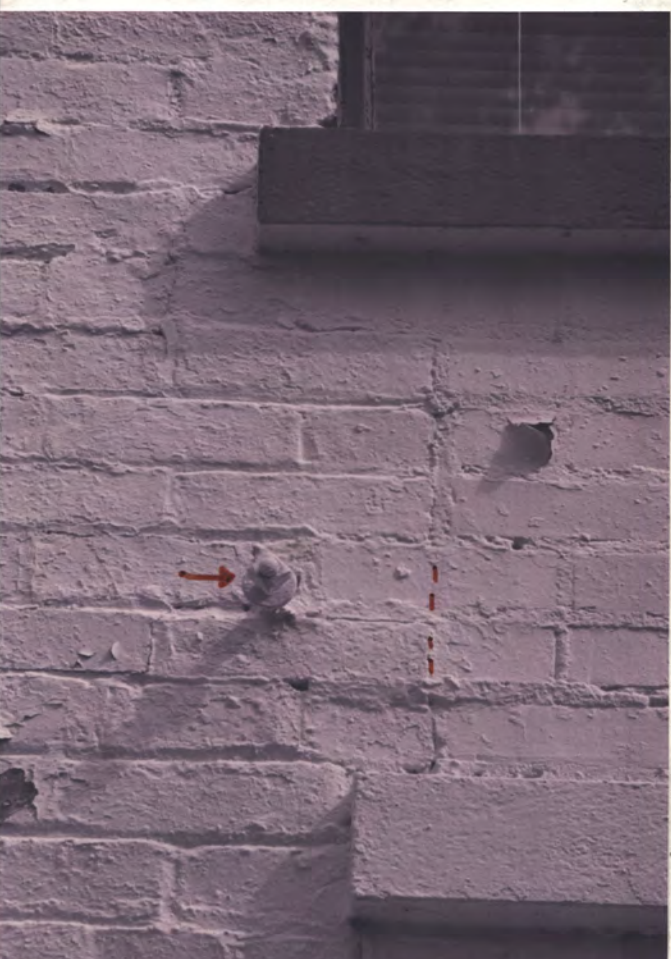
c. 1960
sim

orig.
sim

→ orig. balcony rail met. anchor or filled hole
: Top Pt. (West) South sim
: original jumbo track

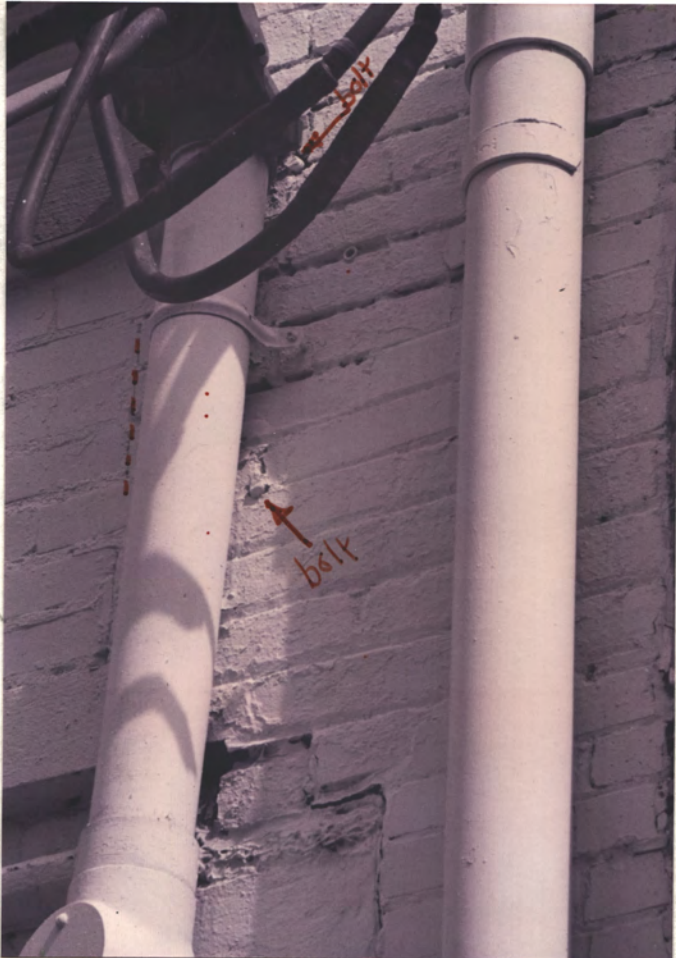
c. 1960
SWM

orig sil

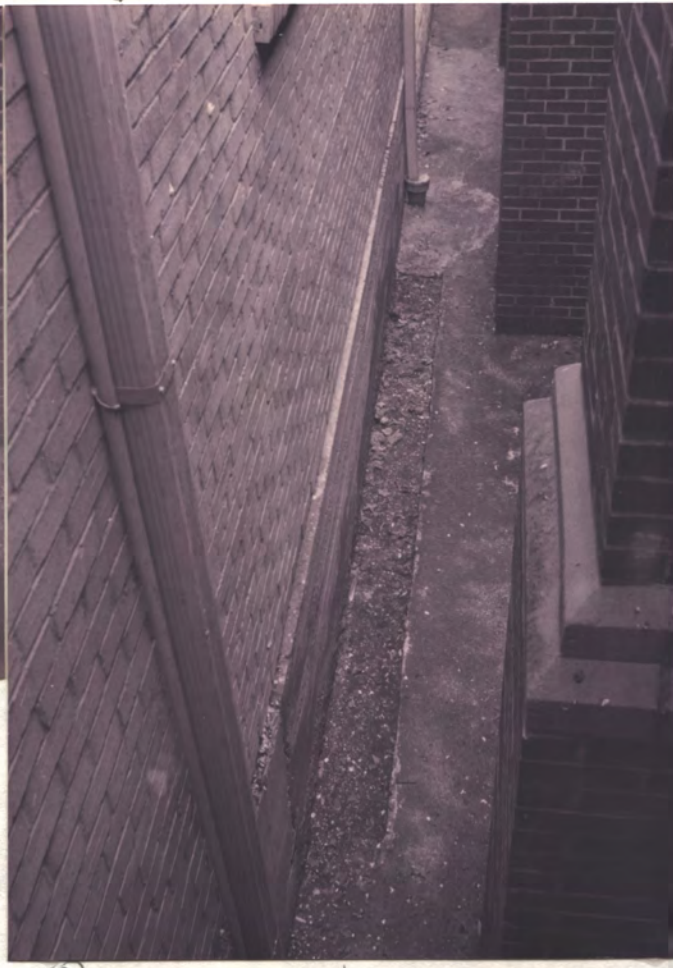
③

mod. T-1-11 ply.
pried up to see under

c.1950 brick
cols. at front
are hollow, ∴
c.1868 cols
were removed
in c.1950!

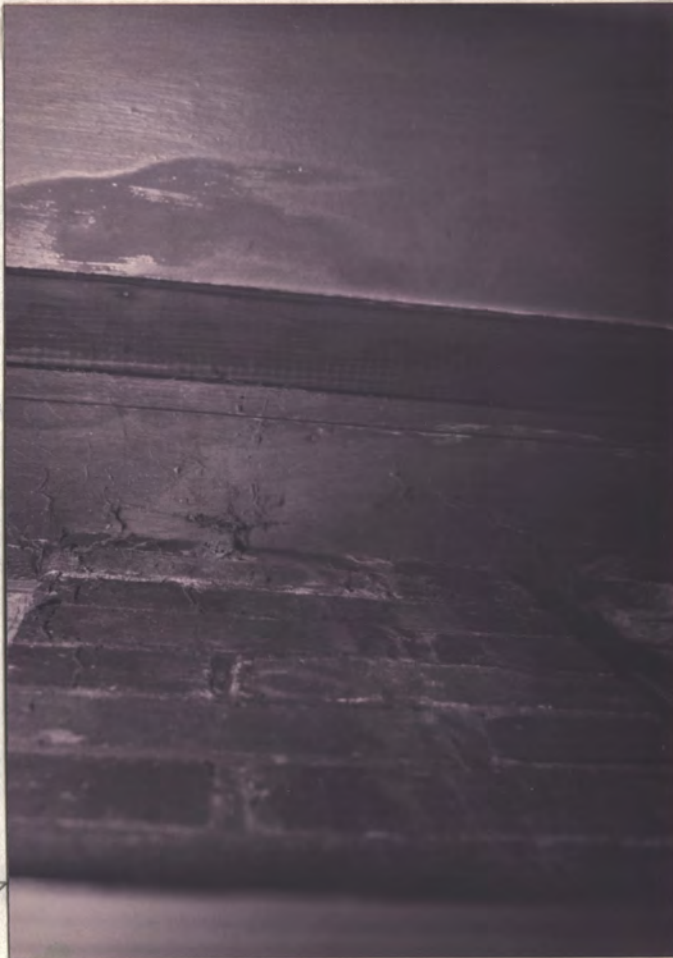
c.1920
corrugated
1x4 battens
ceil.
1x4 T & G
above it
c.1868
classroom
head (brown
paint)
apparent trace
of c.1868 col
(no paint)

c.1950 sill

c.1950
brick spandrel

c.1950 brick col.

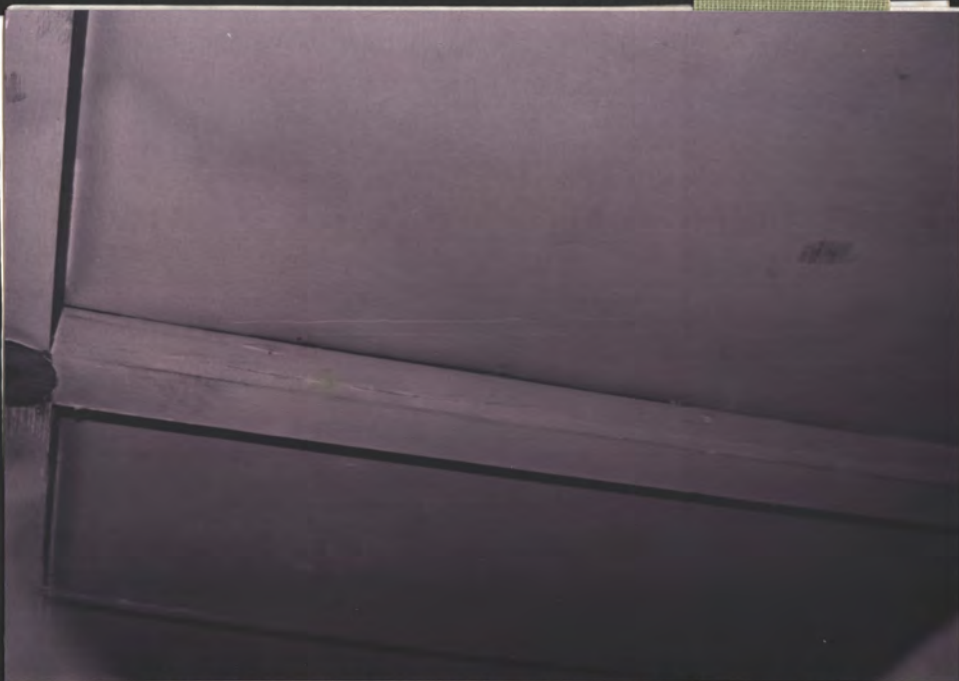
← 4x4
battens
here.
Why?

← c.1920's 1 1/4" corrugated ceil. + 4x4 (here only) battens
above W. rm., S. of stair, fl. 1

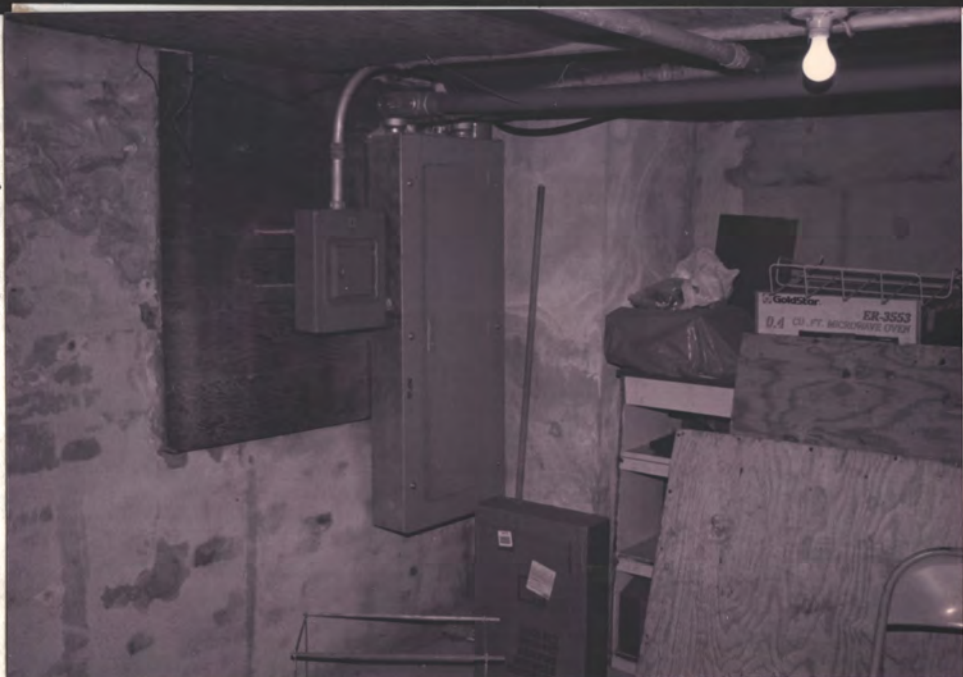
← Bsmnt N. Rm.
N. Rm.,
start fl.,
modern joists
& flooring
± 20' N.-S.

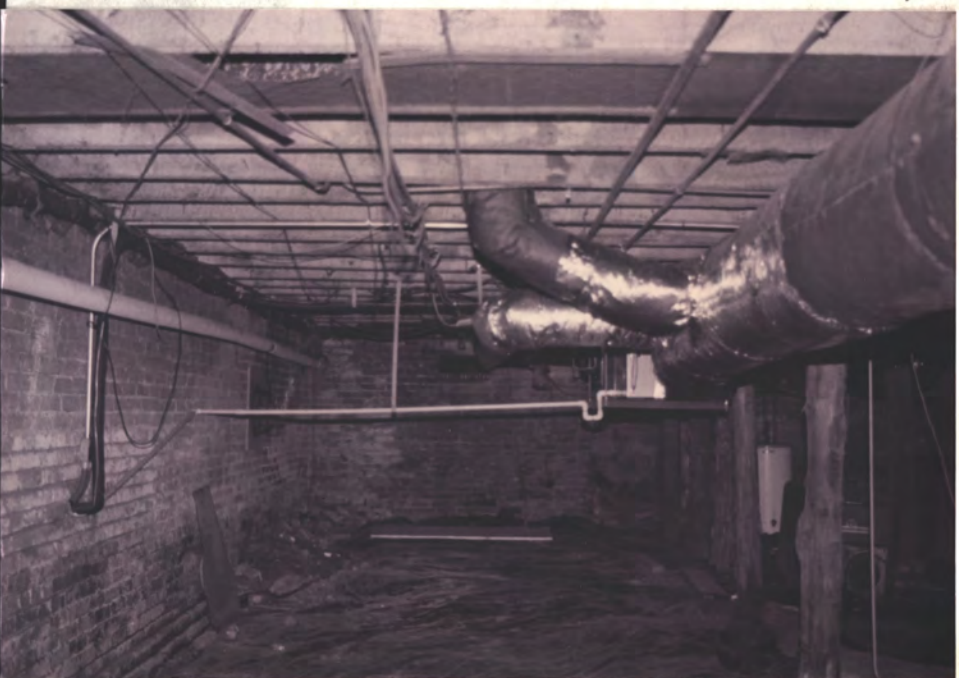
c.1868
± 2 1/2" x 12"
joists
± 18" o.c.,
Robert Sumner

later
props

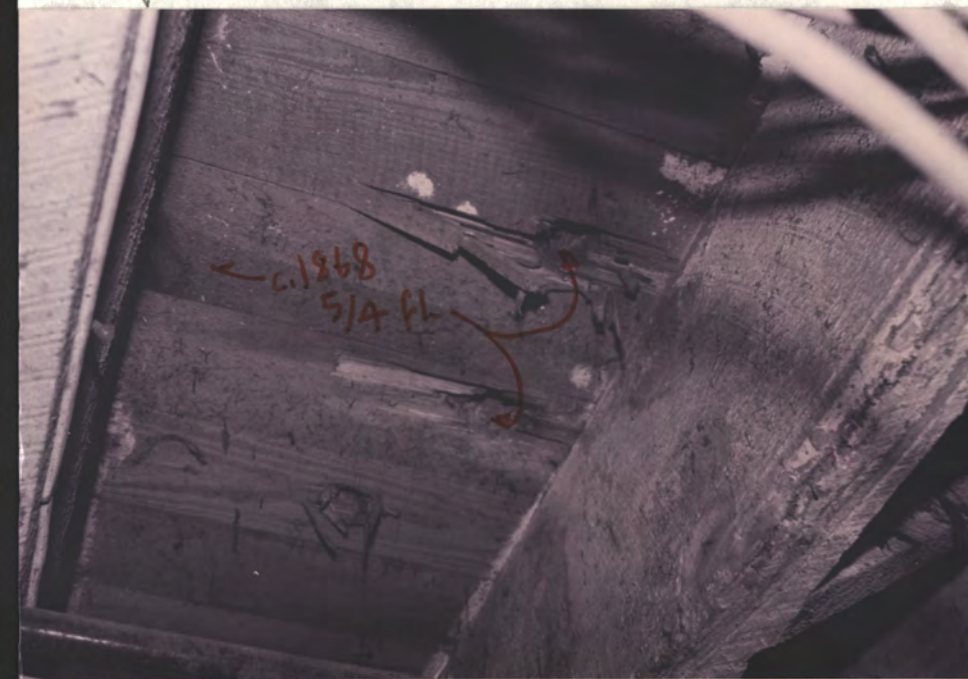
c. 1868
5/4 fl.

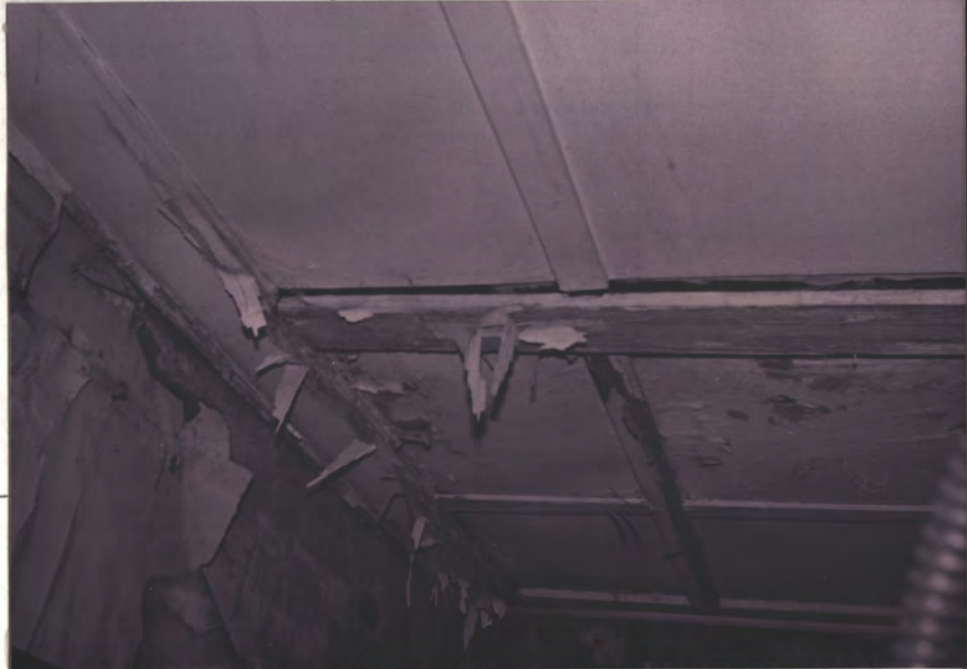
Mod. thin wtd. fl (c. 1910-20) over
c. 1868 - 5/4" x 6" - 4" fl., dense pin
at Fl. 2 N. Rm., N. W. M. (Rector's No.)

FL. 2 Ceil. & Fl.

c. 1920's charbonned 1/4" ceil.
+ 1x4 battens (c. 1868 wood
1x4 ceil. is above it)

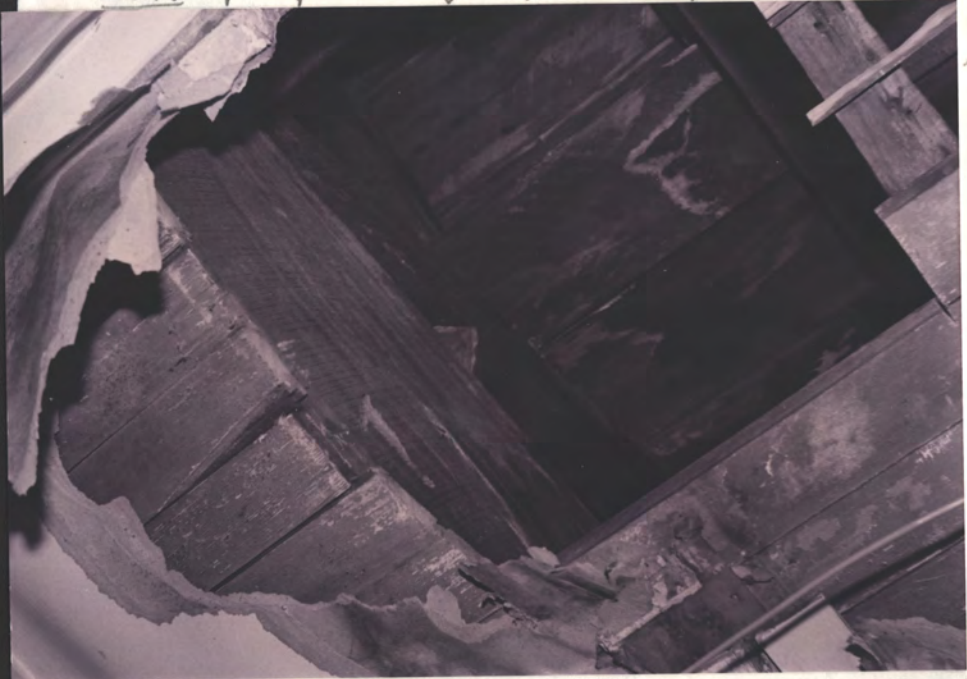
no plaster
key traces
on joist
bottoms

c. 1868
Rafters

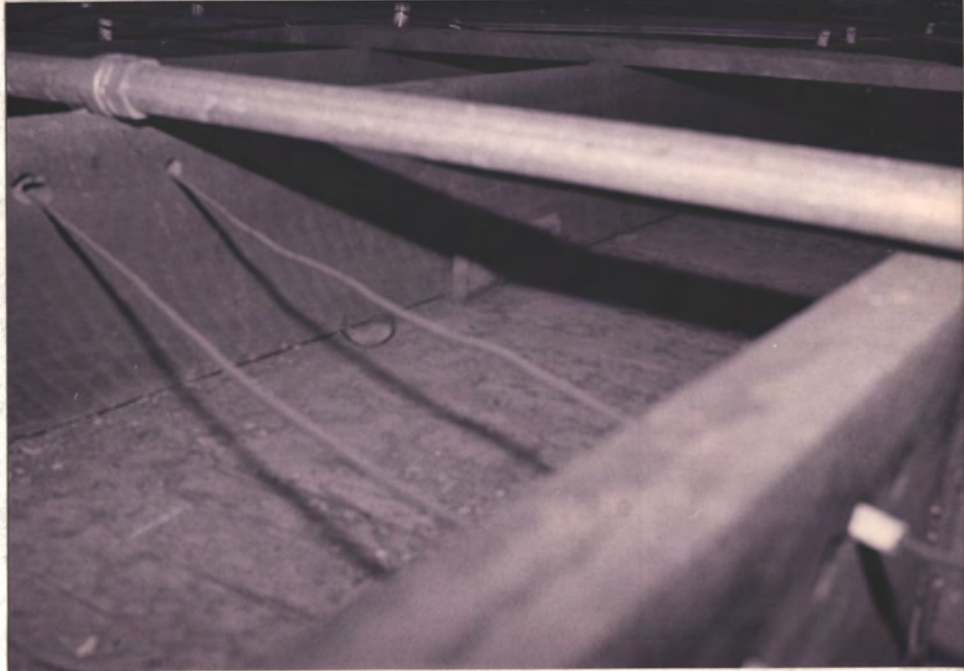
c. 1868 rotary sawn cell
 joist ± 18" o.c.

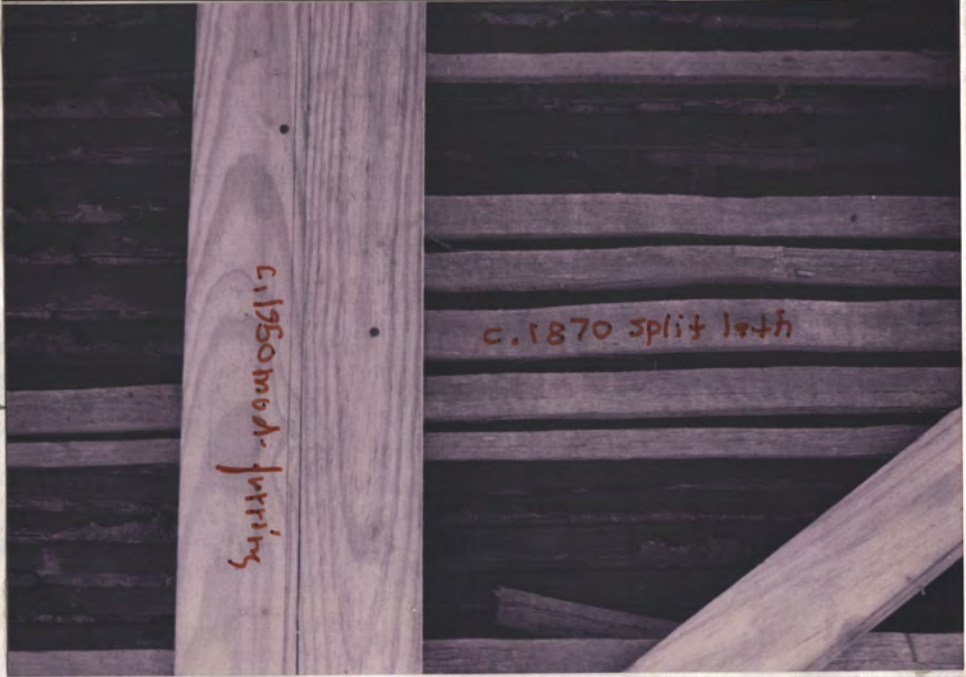
Original photo w/ 1950 vinyl cover
 (c.1870 part'n of E. side of stair - hand-split white oak plank, semi-rem'd photo.)
 (typical until c.1880 when rotary sawn plank became common)

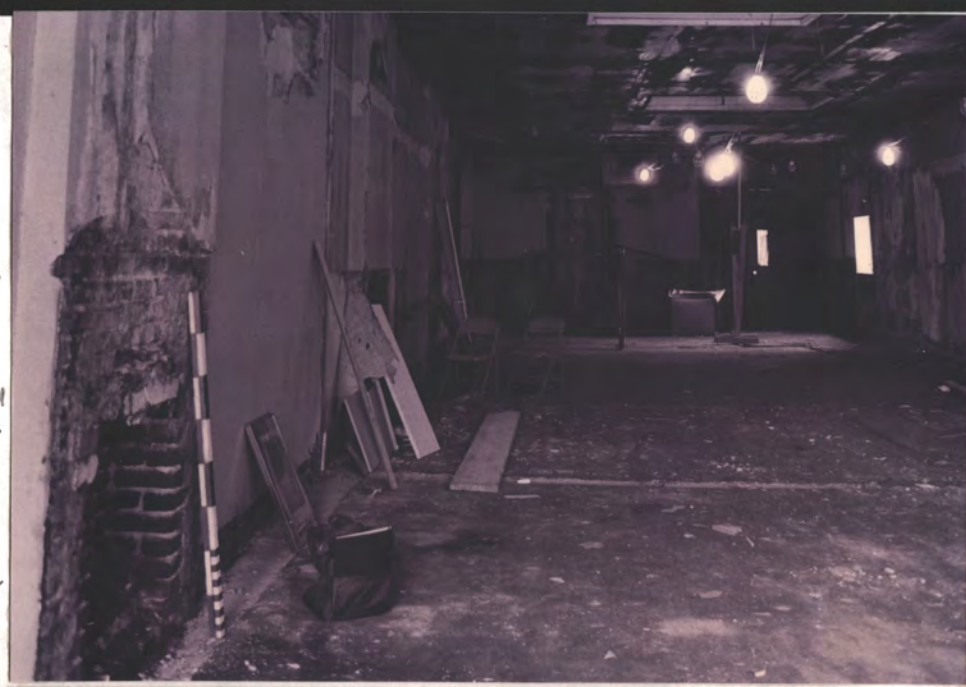
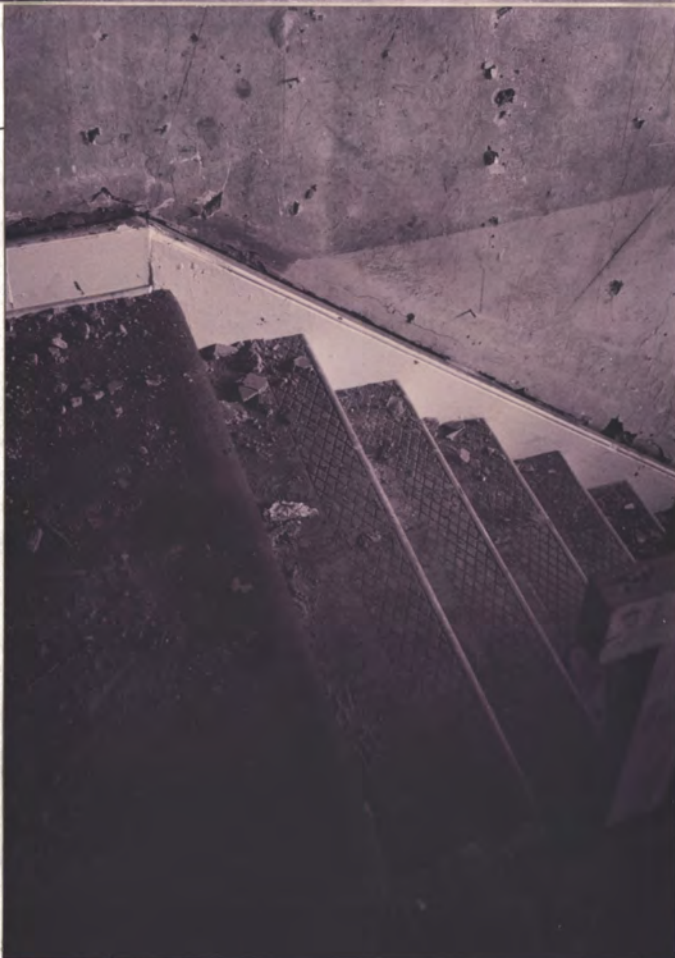
original
c.1870
wood-burn
fireplaces
(3 ea.)

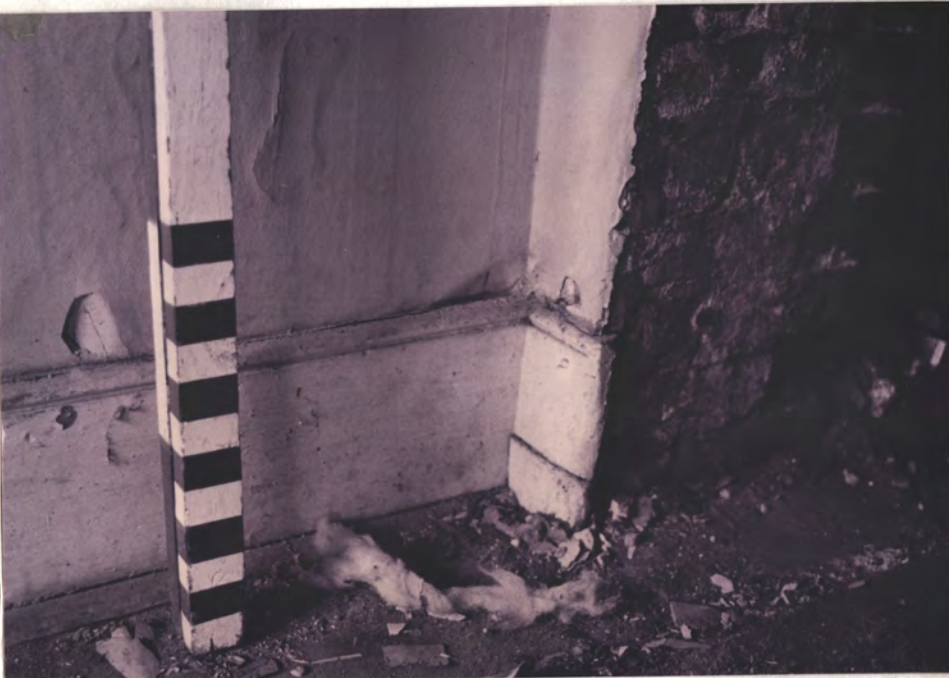
NORTH c.1870 fireplace, for burning wood (all wood, no modif. for coal)

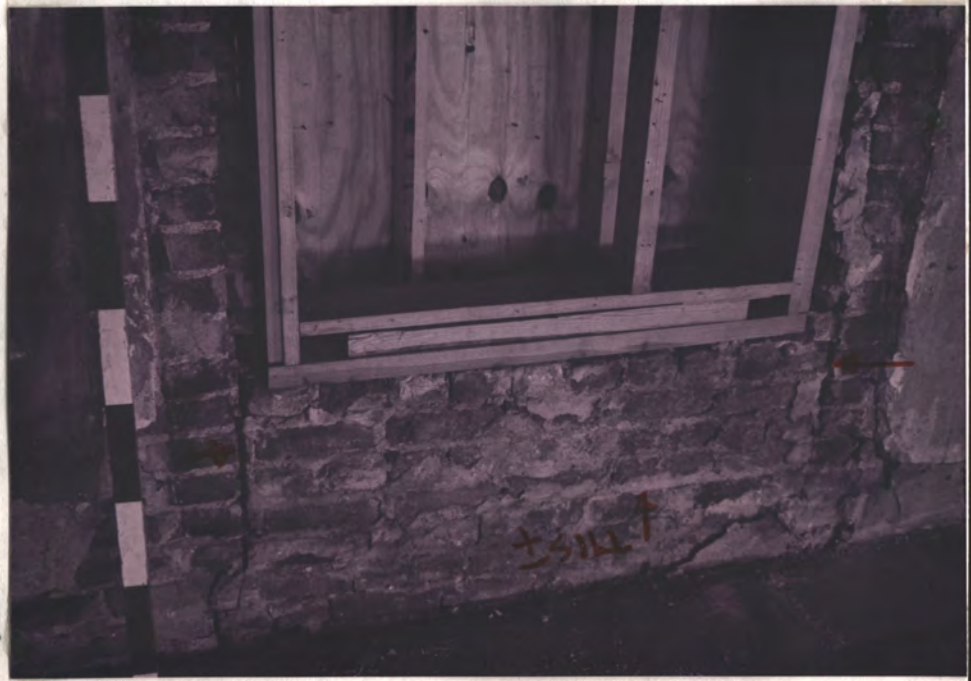
S. Wall, E. window open; later made smaller as brickwork - in here

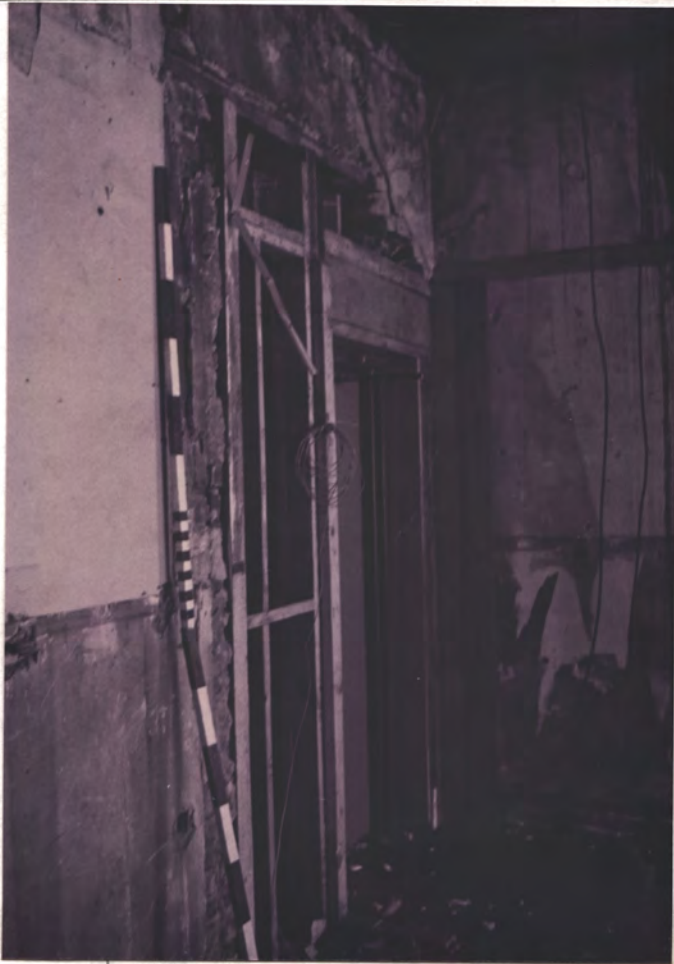
S.W. of M, W. Window (modif. c. 1975 for address by Tom Jones, Arthur)

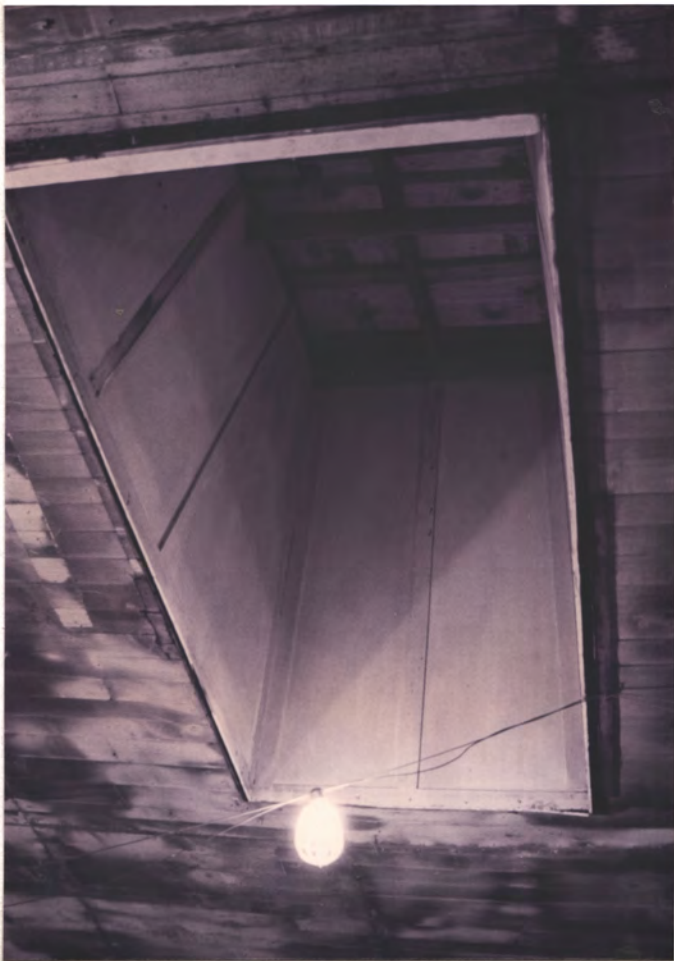
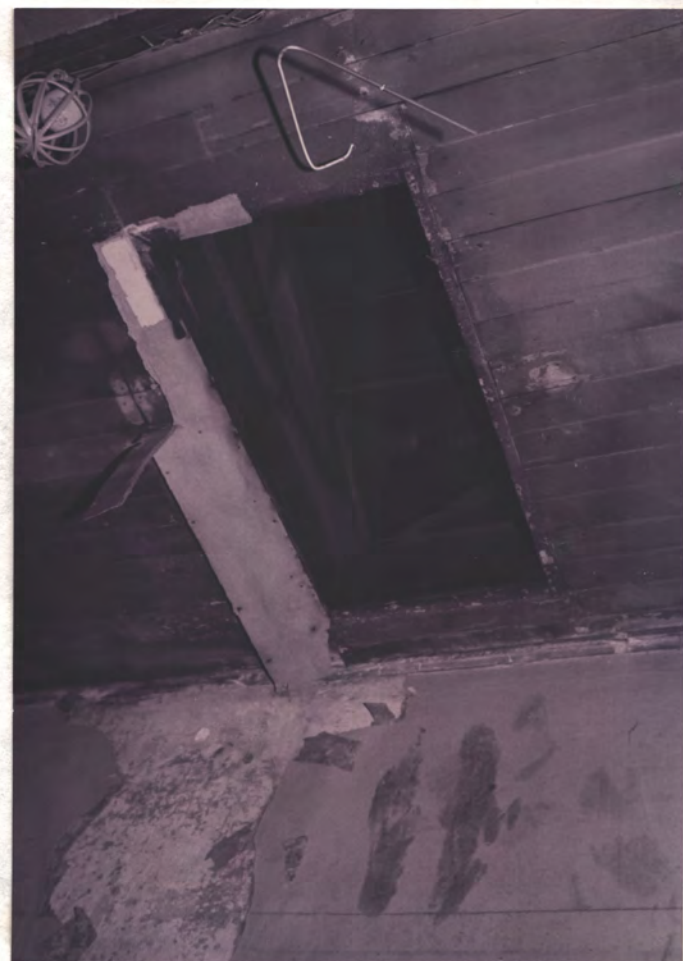
5 of 6
Later skylit, probably put in after 1872 when Dentler Bldg. blocked the windows

Orig. Attic access

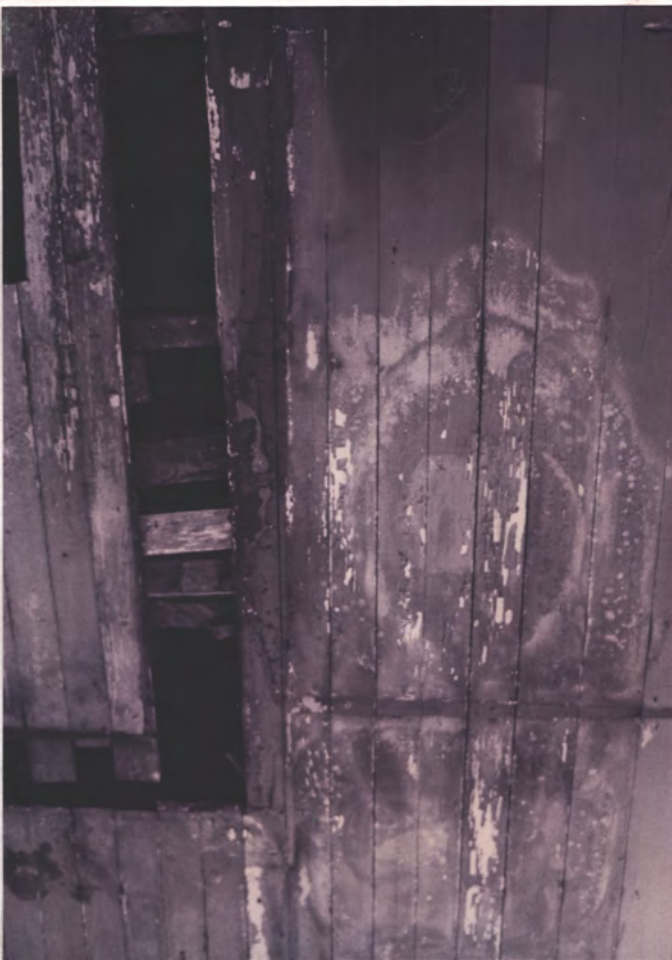
Call trace of orig. stud - pattern. (some patterns were vert. 5/4 x 6-7 & 6.)

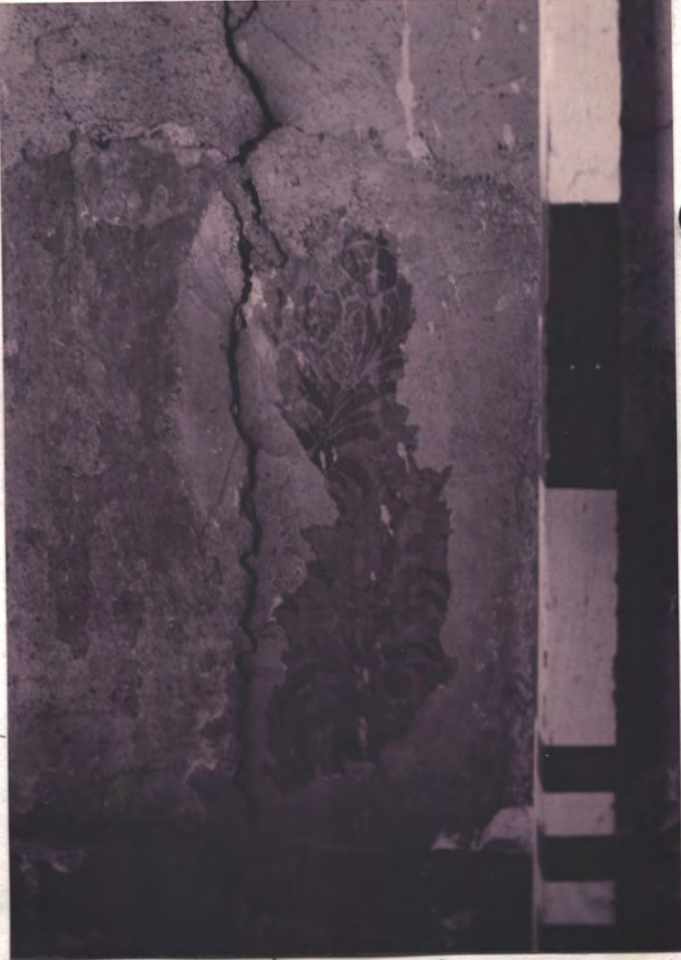
lowest wallpaper pattern, now brownish. At S. end of blk., fl. 2, E. of W. wall

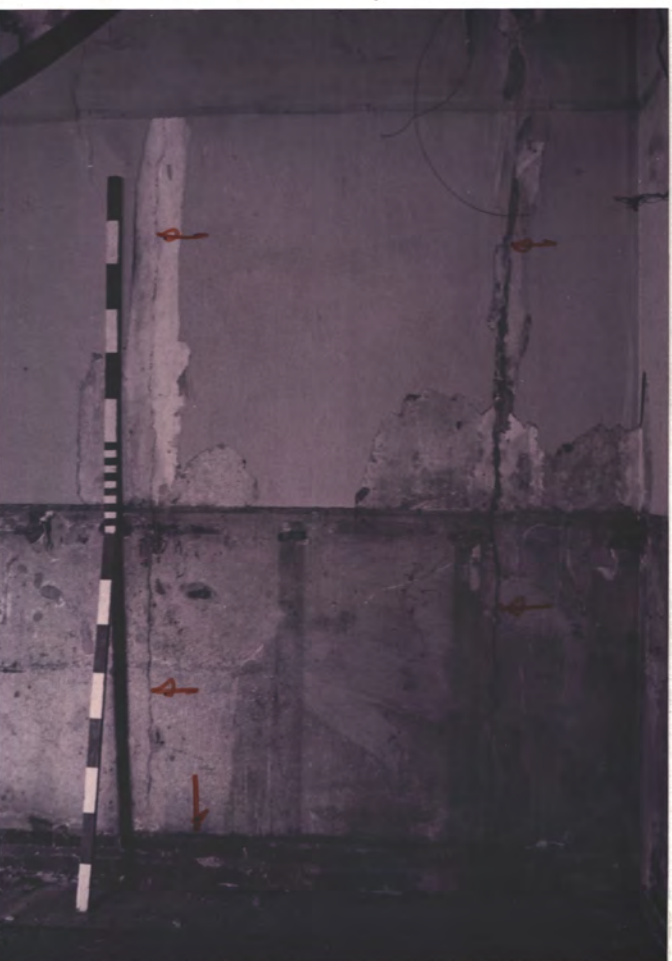
orig. E. wall
window
bricked up
when 1872
Dentler
blk. was
built against
this wall
(very tall
windows)
