Re: Church of the Nativity Administration Office
Project No. 95075

Re: Circa 1870 Building at 208 Eustis Avenue
(Church of the Nativity Administration Building)
Project No. 95075

NATIVITY ADMINISTRATION BUILDING
PROJECT NO. 95078

CHURCH OF THE NATIVITY ADMIN. BLDG.

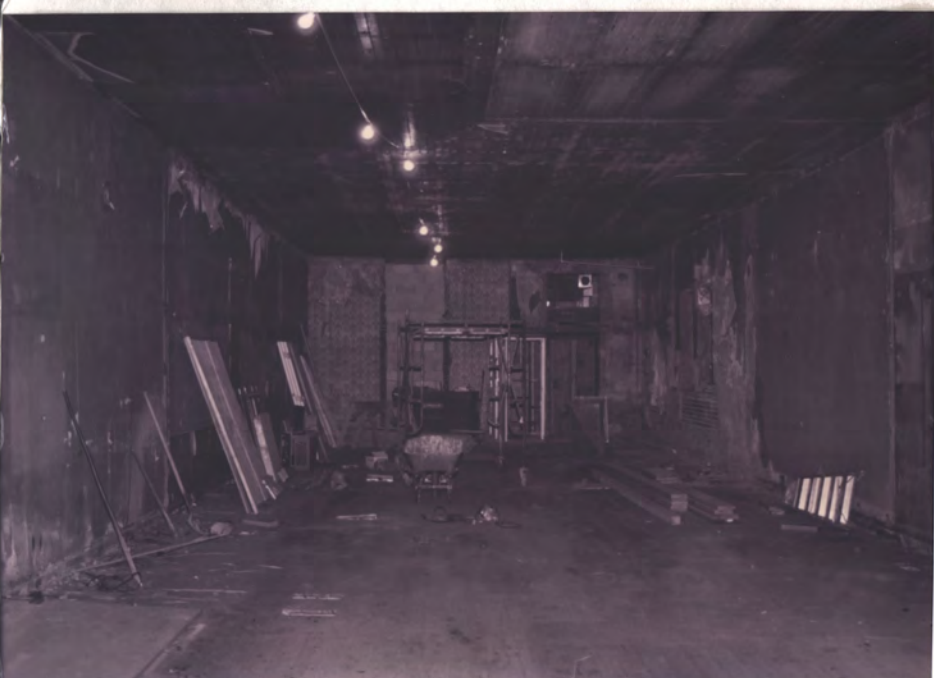
fl. 1
S. Room
wall

orig. flhs
in orig.
window

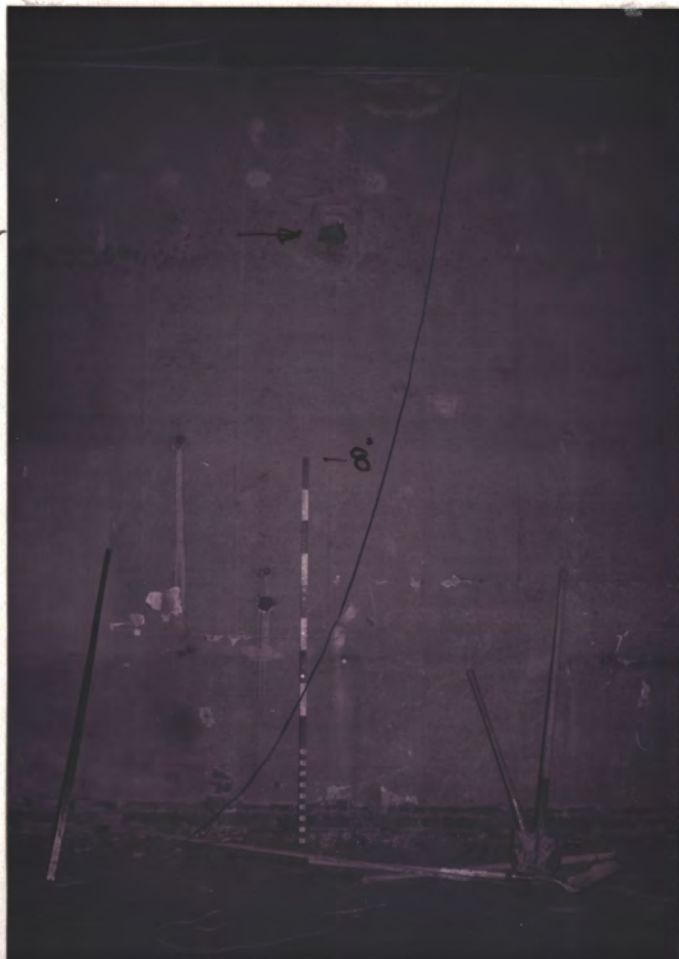
Fl. 1
c. 1870 stove-
thimble
at ± 13' h.
on E. wall
(3 m this wall)

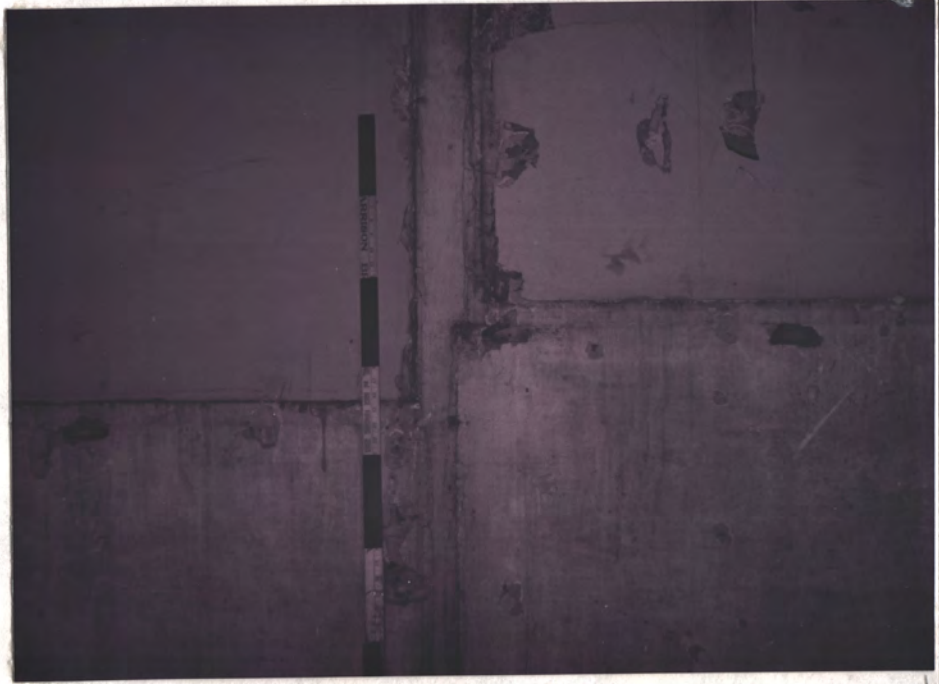
FL. 2, W. WALL
at head of orig. stairs

Wainscot trace. Nth wood railer - blocks
built into brick - plaster wall

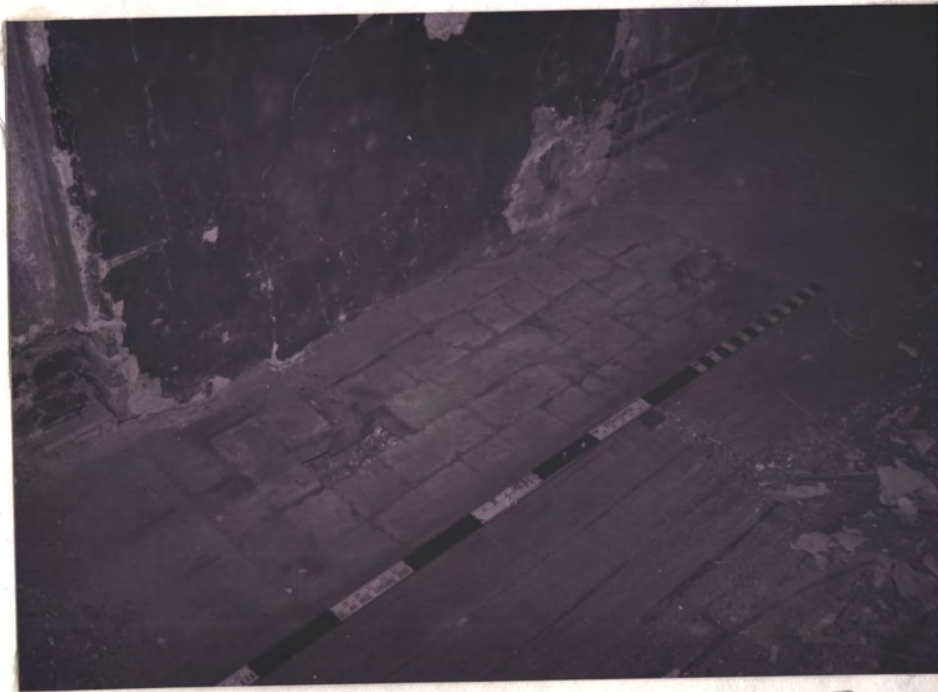
orig. heads in TYPICAL 1800-1880 pattern
 for base of Comm. Vitz

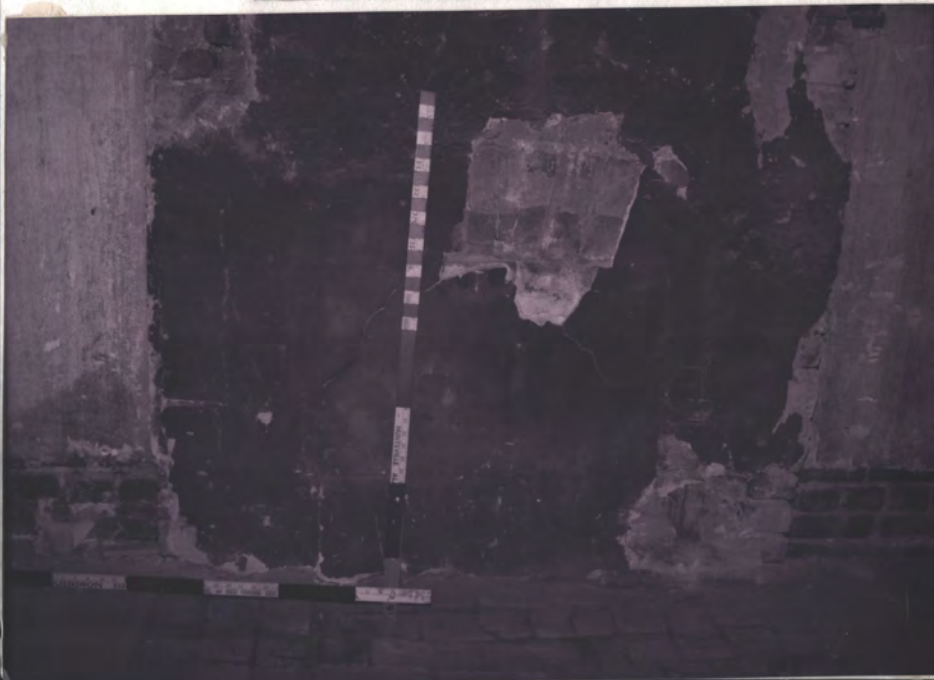
This will
 hopefully be
 restored, to be
 at head of
 1996-7 stairs.
 Mounted to be
 from 1881
 Bernstein also
 at 110 Stark
 St.
 (Italianate,
 small)

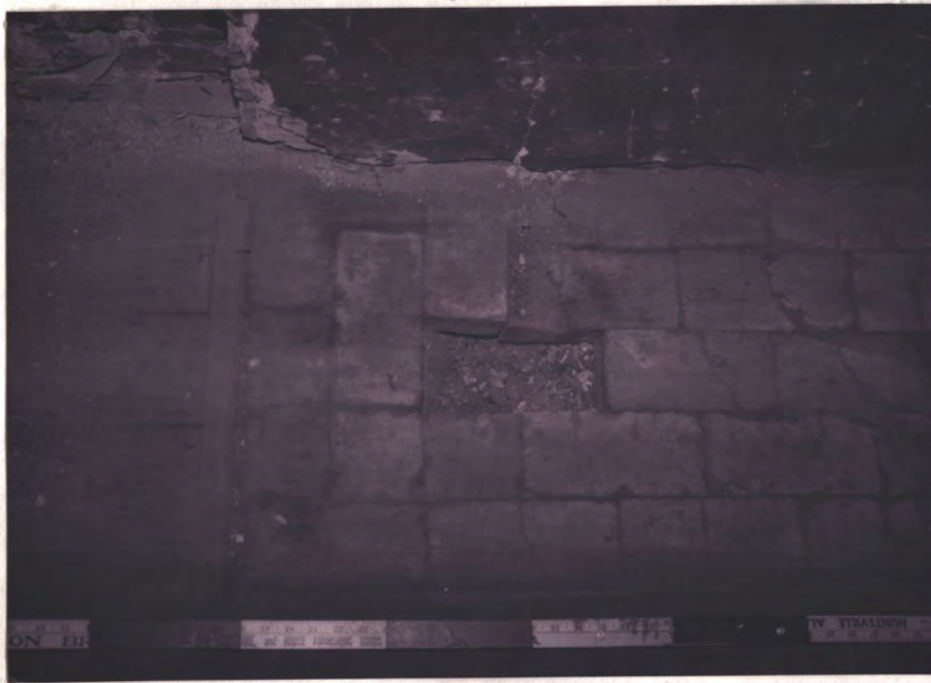
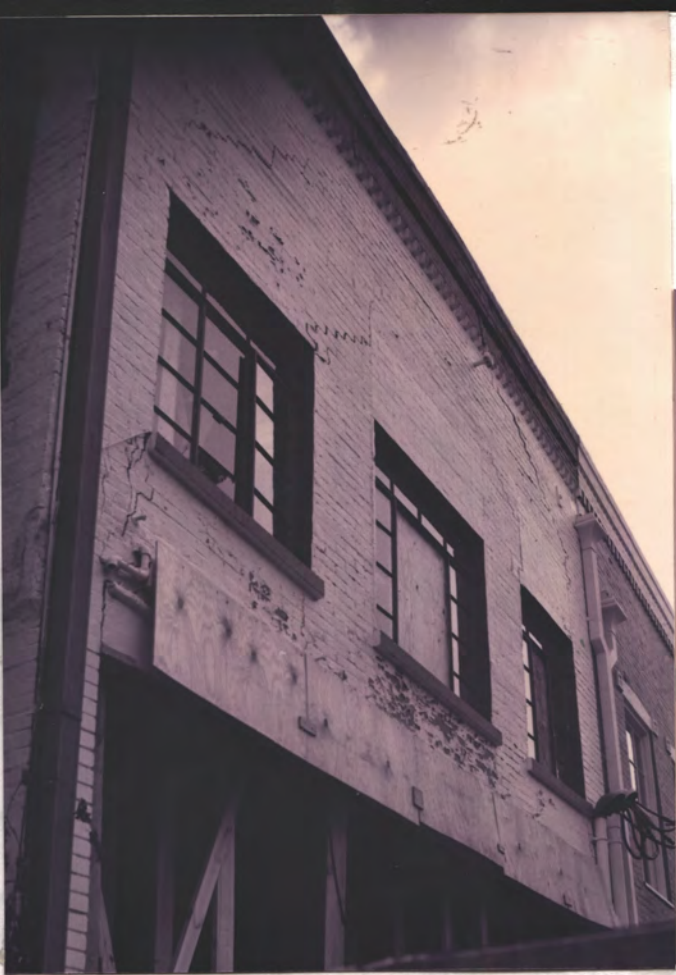
Wall not resupported securely before
1950's cols were removed. Dropped $\pm 3''$ & cracked

Note cracks & $\pm 3''$ sag in wall

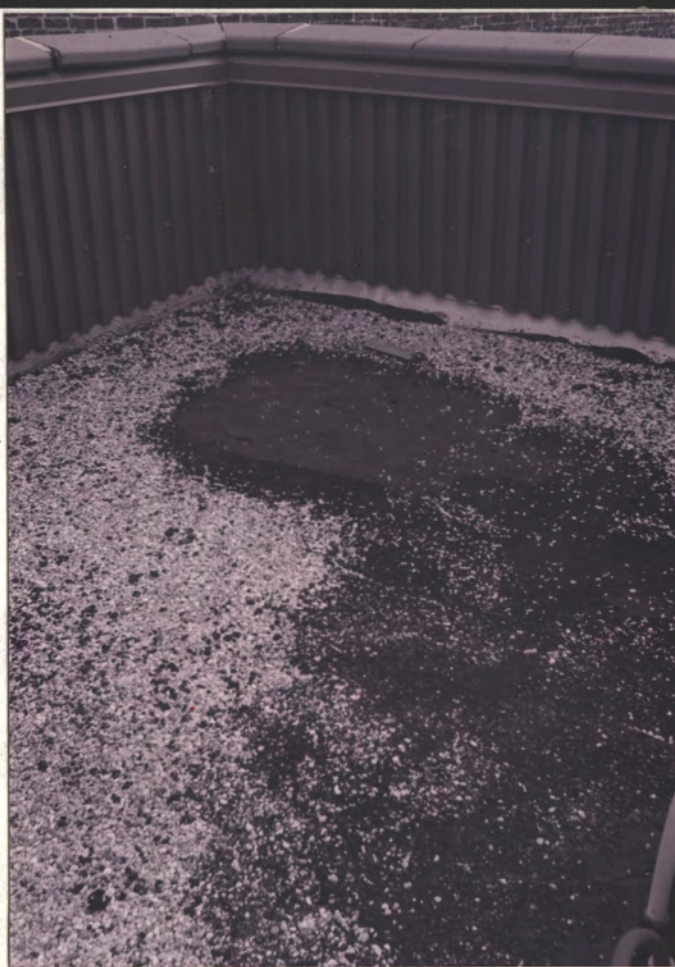
aggregate
blows off
bit. felt
at S.W. corner

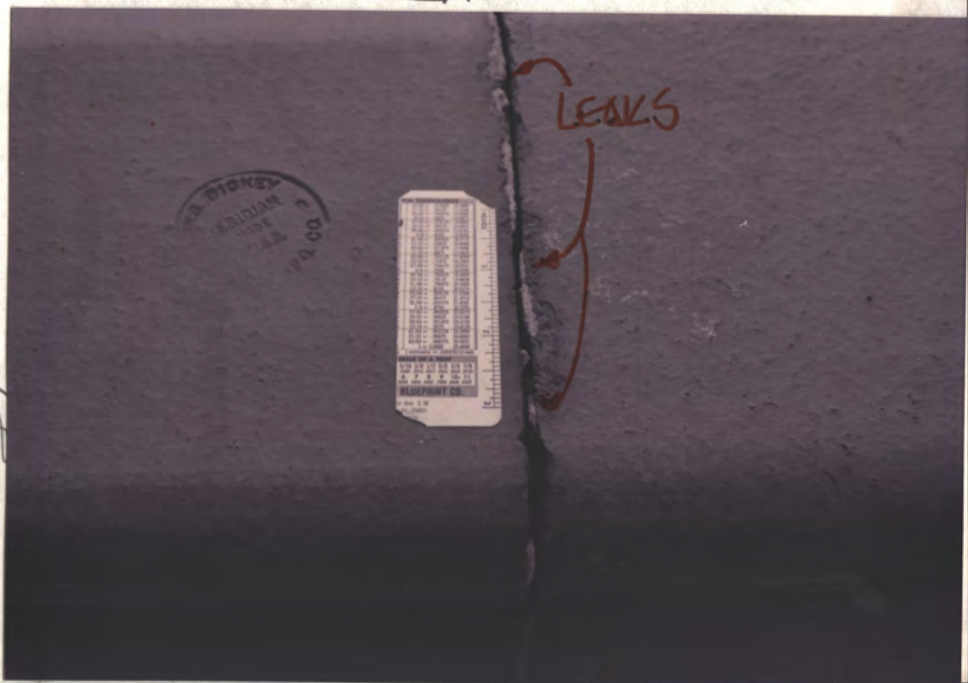
8. The 1970's terra-cotta caps at the 1970's south building parapets have butt joints, with cracked mortar, and all leak down into the masonry parapets, behind the aluminum sheets that are on the concealed side of the parapets. These joints should be permanently flashed (not just sealed) in some manner. HJ photos due +/- 22 September.

1970's
terra
cotta
cuping
caps
(butt jts.)
not
water proof

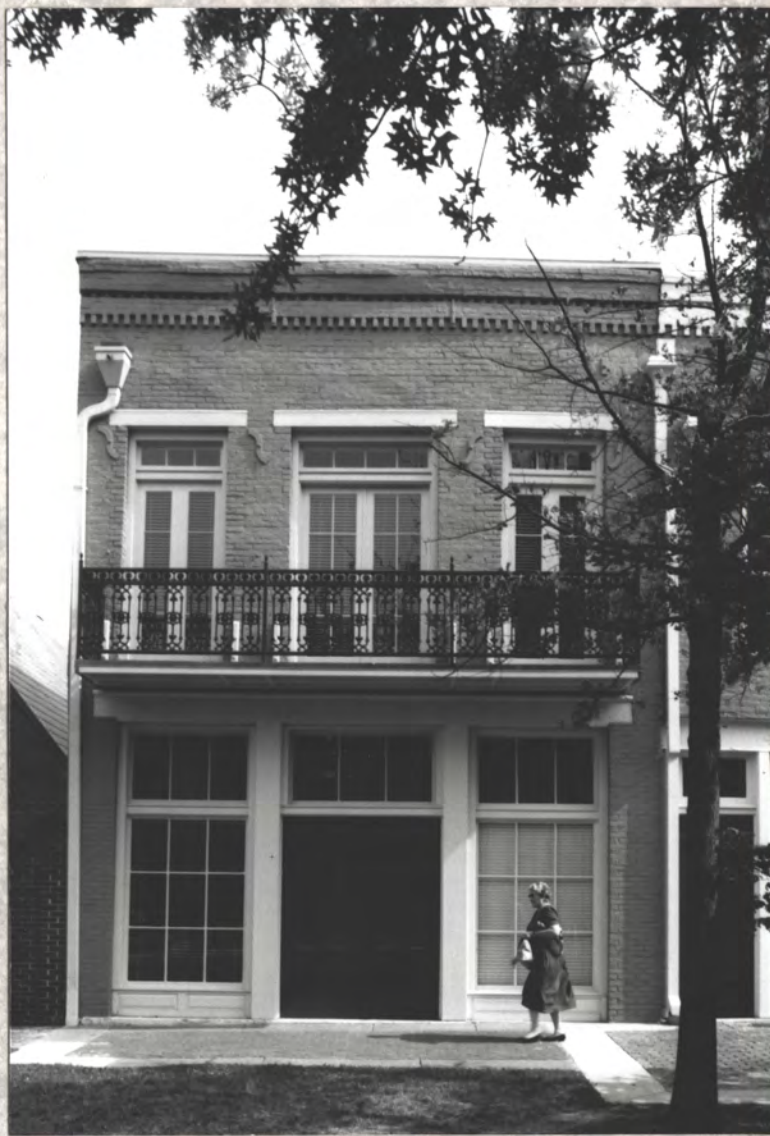
208 Eustis Ave., c.1870 per hist. photos & maps

photos Sept. 1997 H. Jones after ext. restor. & int. remodel. - J.H. Arth., H. Jones (ext. & lobby), L. Bantio (IP)

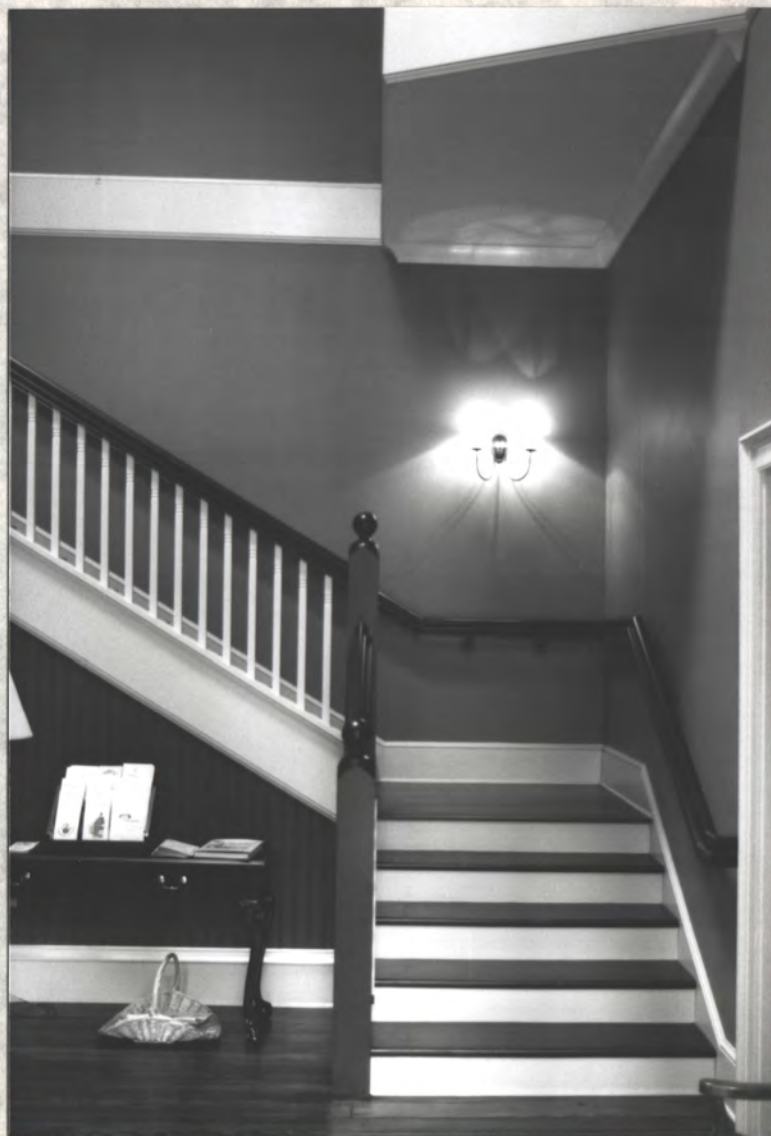
Lobby.
 Fl. = orig.,
 heart pine
 Stair & trim
 doors based on
 1870 exa bl'gs.
 in HV Lib.

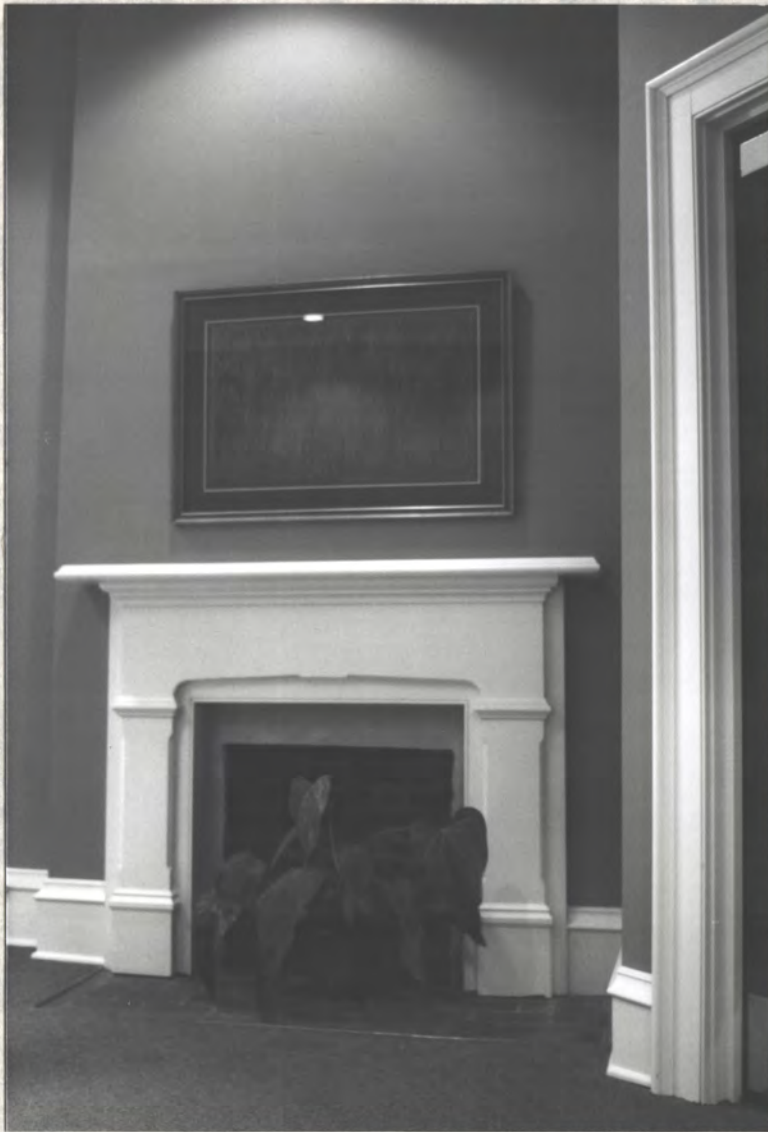
Orig. Fireplace repaired, at fl. 2 E. wall
at top of stairs.
Mantel is from c. 1881 Bernstein Hse, 110 Steele St.
(had been given to Hv. Hist. Fndn. when by builder)

new Stair at fl. 2, HJ design
per c. 1870 example
