**ARCHITECTURAL COLLECTION
OF
HARVIE P. JONES, F.A.I.A.**

BOOK 42

1840's - 50's
Solomon DeBow
Log Hse, Madison Co., Al.

Photos April 1993
Harrie P. Jones, FAIA
Huntsville

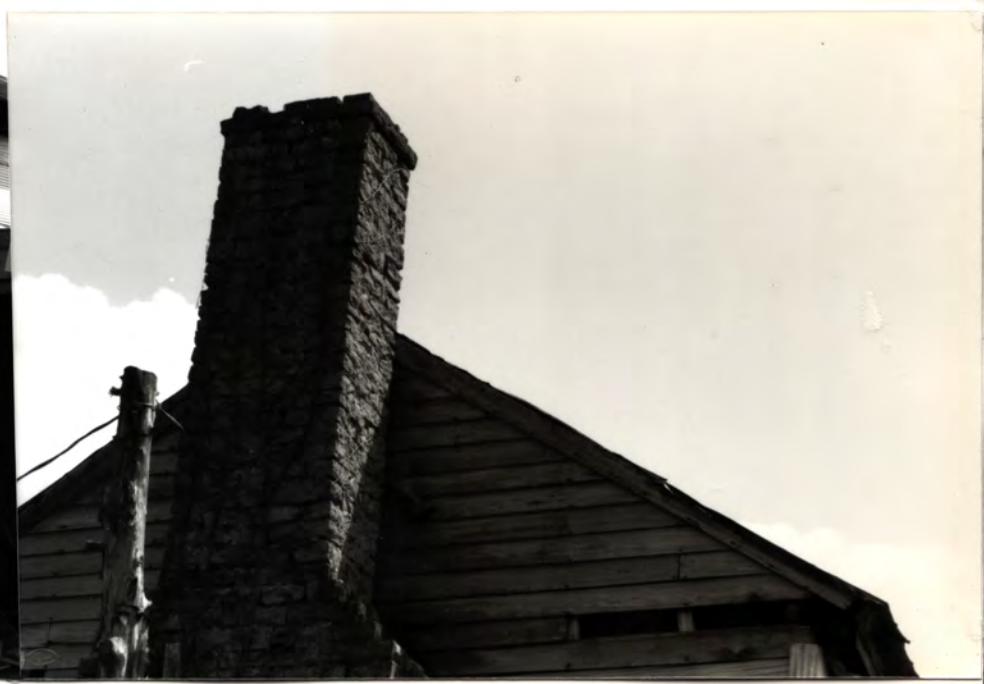
NORTH WALL

Upper part of flue stands clear of wall by $\pm 6''$ (fire safety provision) typical of 19th. c. frame const.

Mod. galv. stl. 5-rib roof

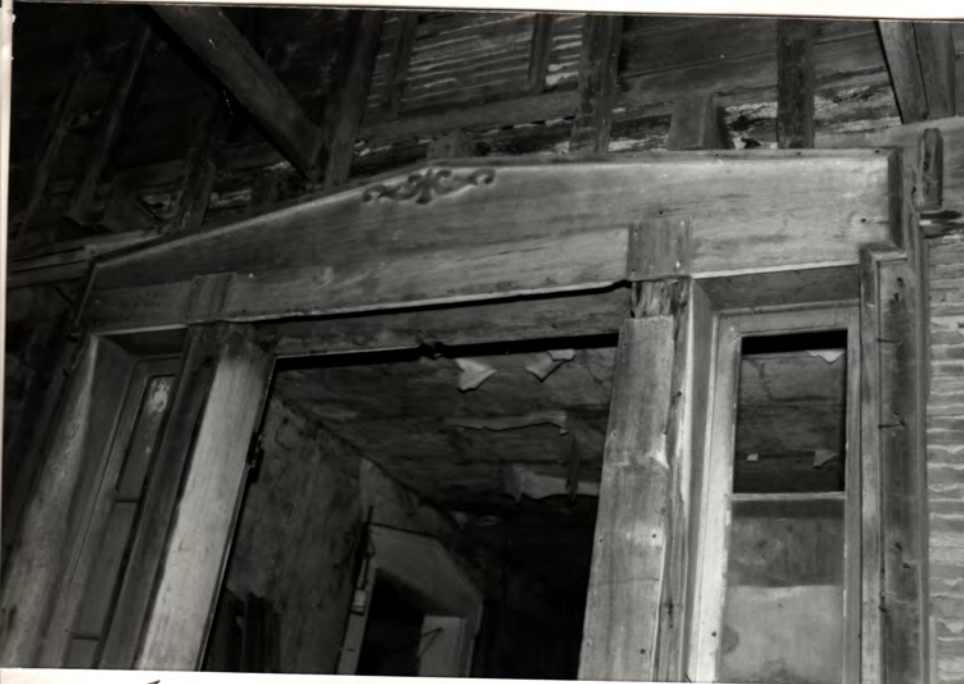
Scroll at frame top may be Vic.
but could be original to this
Greek Revival frame (?) Remove & verify.

Note no logs by entry
ENTRY SIDE → NO LOGS ← ENTRY RM.

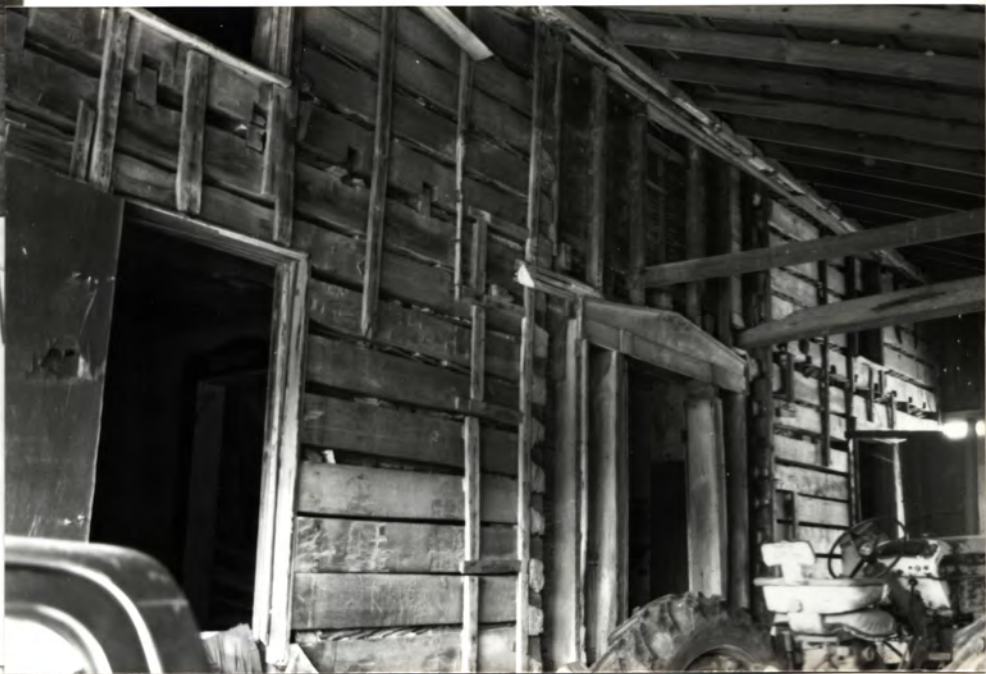
REAR
WEST
WALL
wide
banded
joint
T & S
siding
indicates
this was
covered
by a
porch

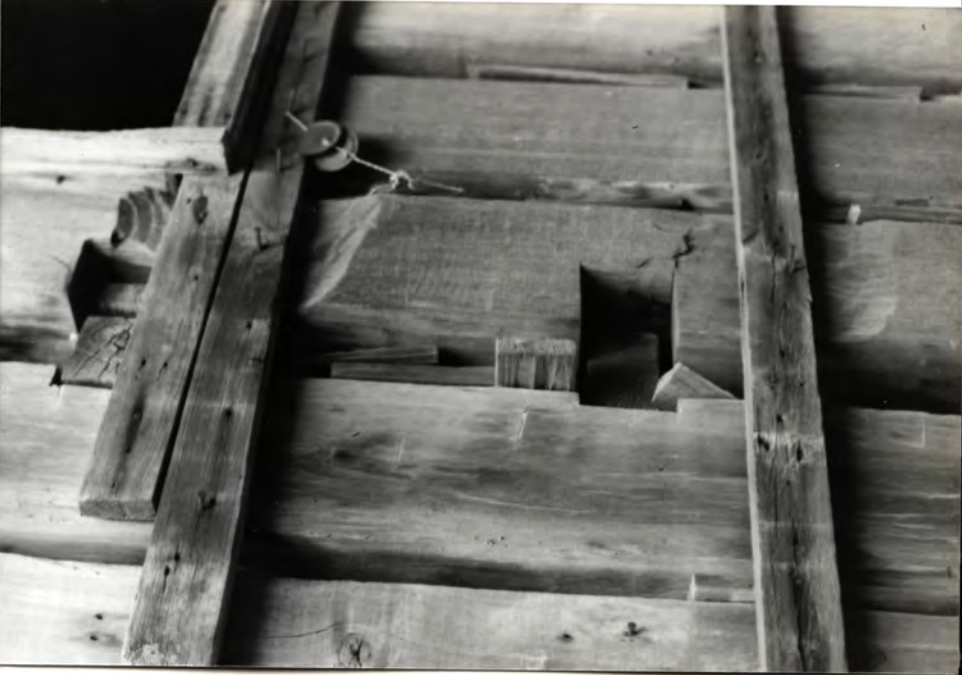
EAST FRONT WALL

NOTE - unweathered log faces indicate the house was clapboarded either originally or shortly after completion

→ N Most faces = pit-sawn, some hewn faces (very unusual in "log" bldgs.)

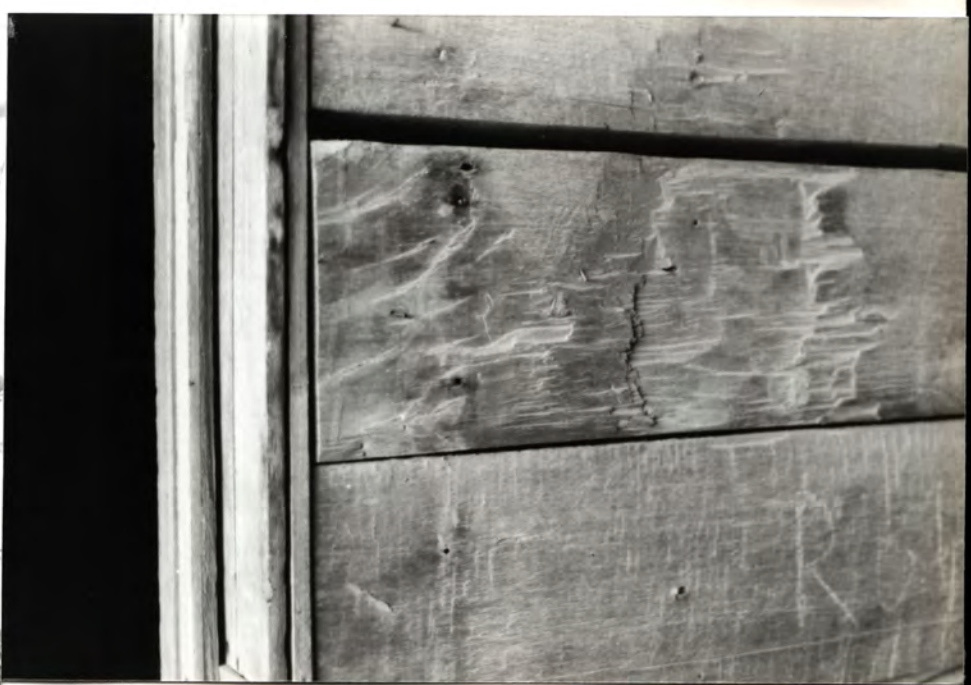
pit-sawn "logs" (slabs) w/ some hewn faces → N

half-dovetail notch

N.E. CORNER, FL 1 (exposed to blowing rain. Note weathering here mhp)

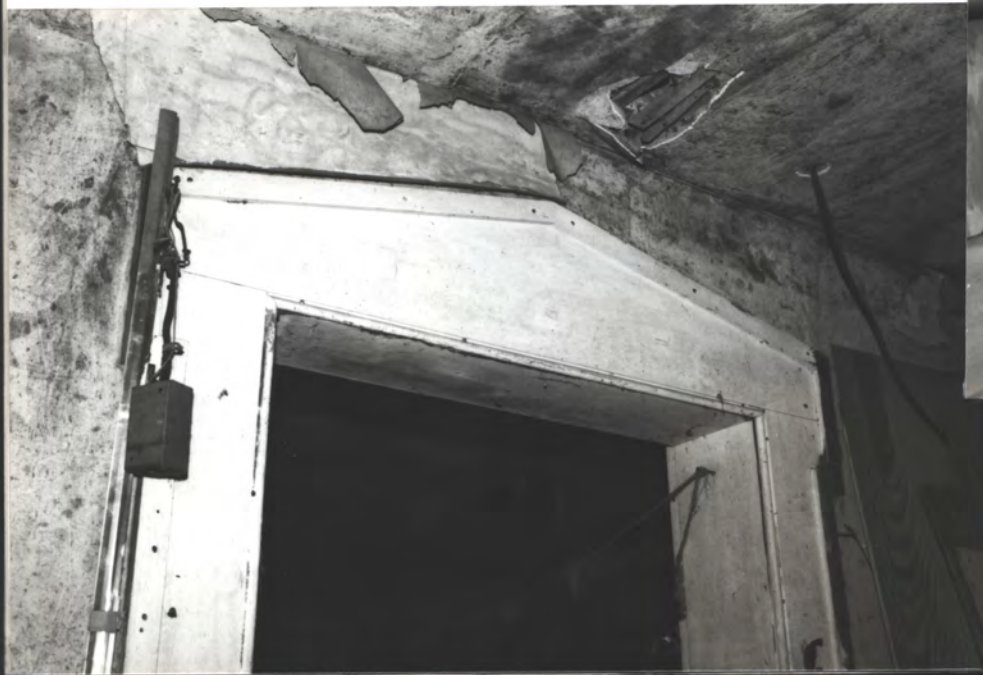
HALL, FL. 1
DOOR TO S. RM,

hole in wall for orig. rail. →
Baluster tenon-studs are still in fl.
 about 5" o.c.

← banded base ← plaster on w/d. lath (hand-split)

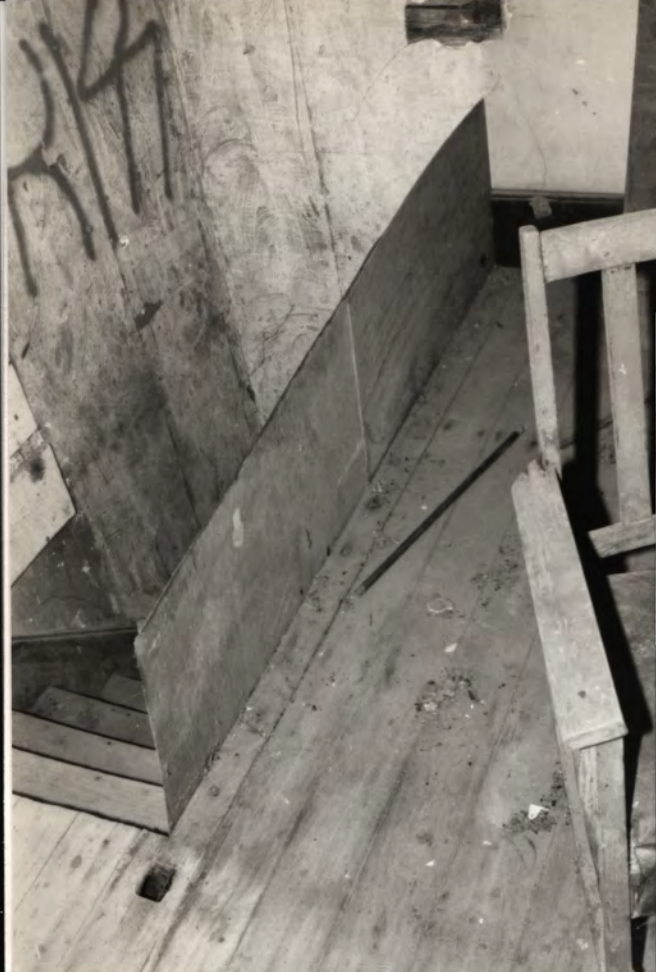
← mortise in wall for orig. rail

thin ply. "rail"

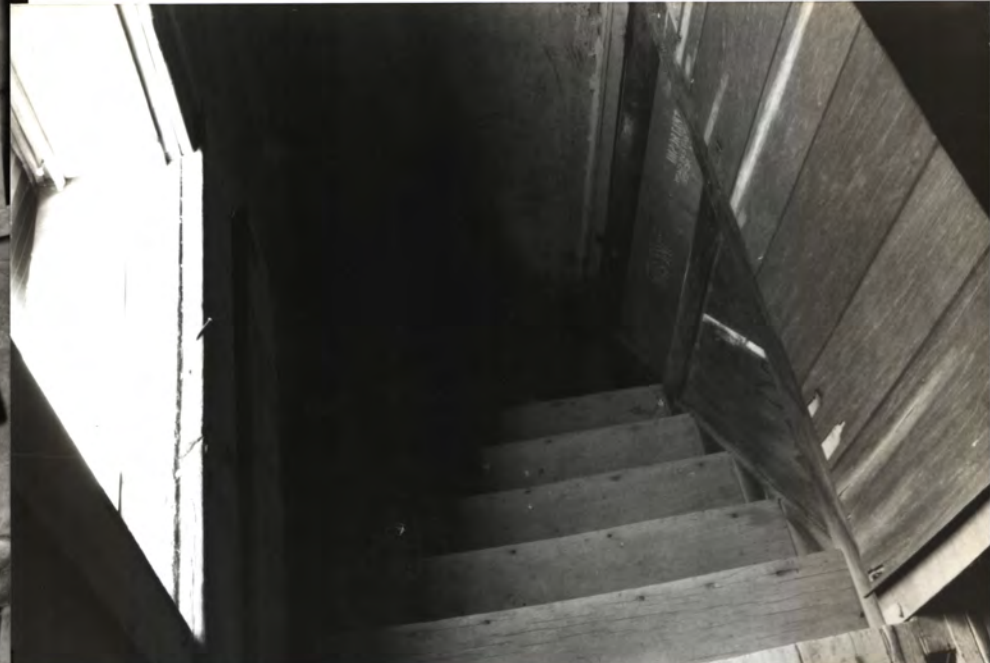
↑ mortise for orig. newel post
 ↑ mortises 15" oc. for balusters (thin ply. "rail" now)

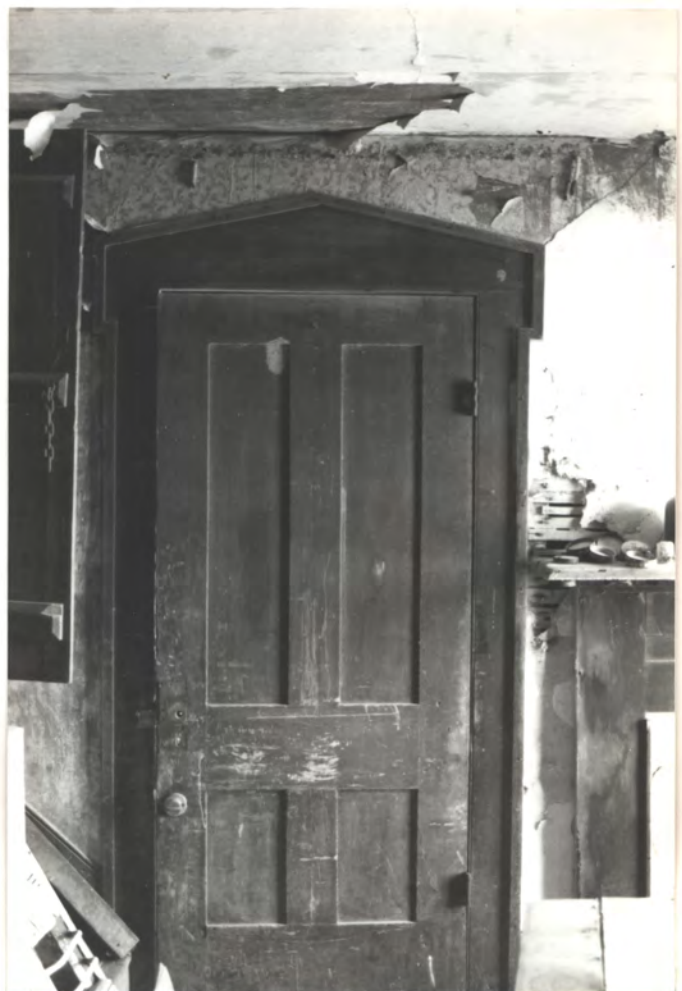
loose mantel ↘

W. Door to back porch ↗ N

cast-iron "fast-pin" (one pc.) hinge
= original

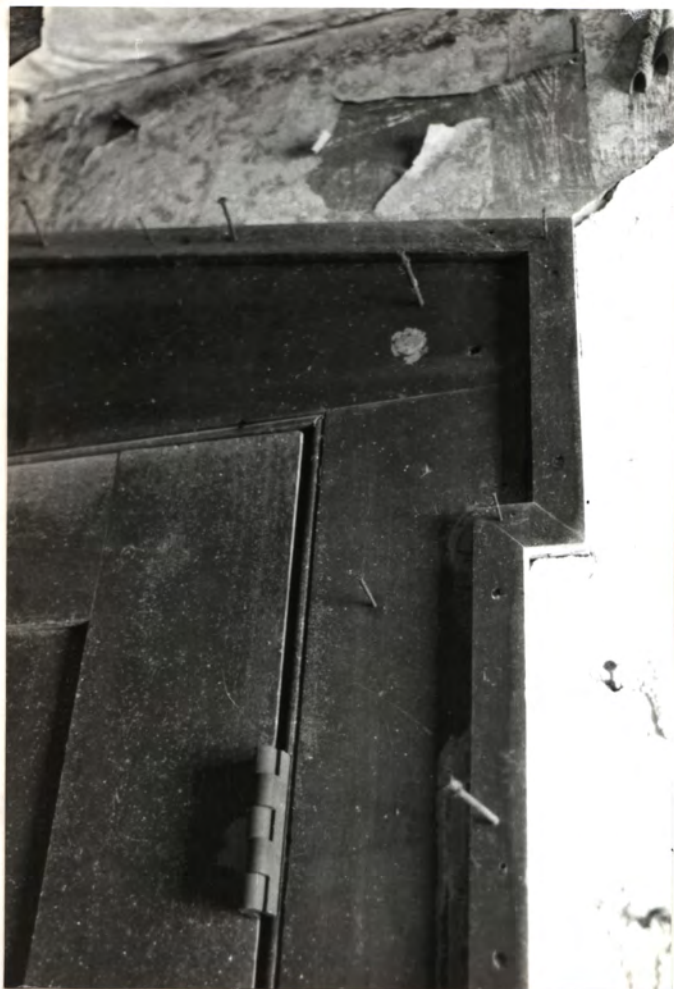
N.R.M., W. DOOR TO PORCH
(INT. SIDE) = ORIGINAL

traces of 2 previous
locks, 1840-50 proportions

"Greek
eay"

plaster
on wd,
lath

mod,
nails
for
pegs

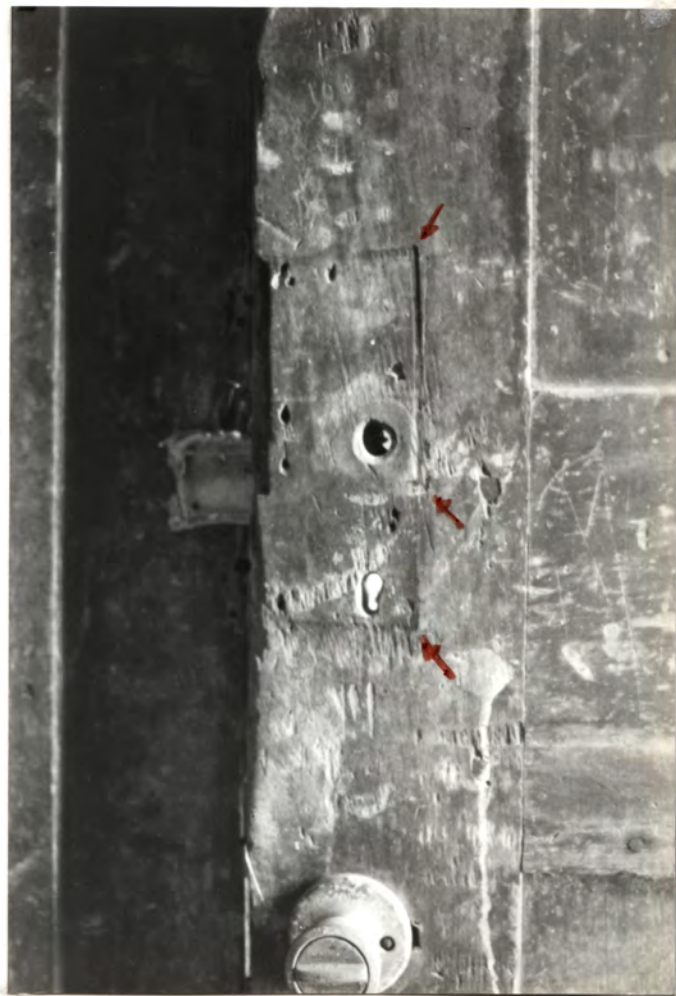
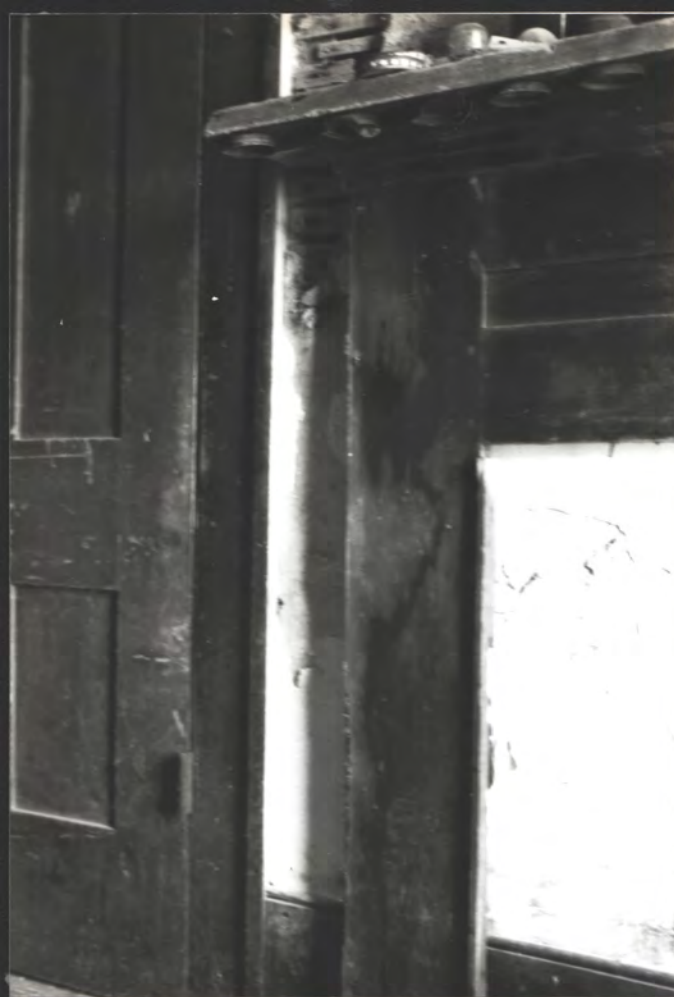
+N
 loose
 Greek revival style mantel, on W. wall
 of Fl. 1 N. Rm. (same design as mantel
 in Fl. 2 S. Rm., see p. 21)
 (Sax-lids = moderns, for screws etc. stor. in jars)

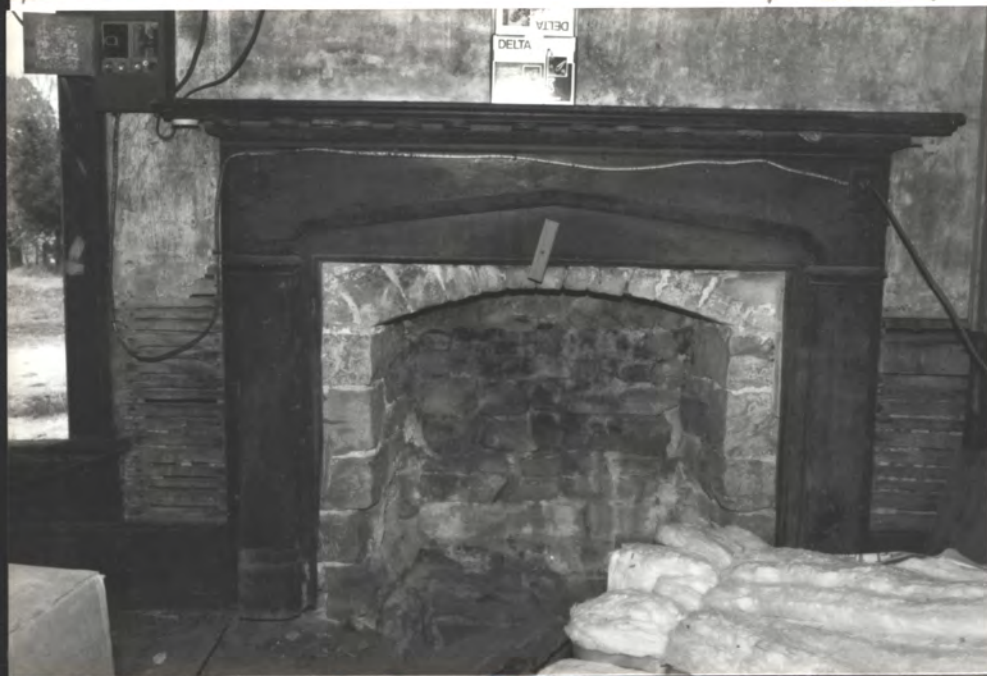
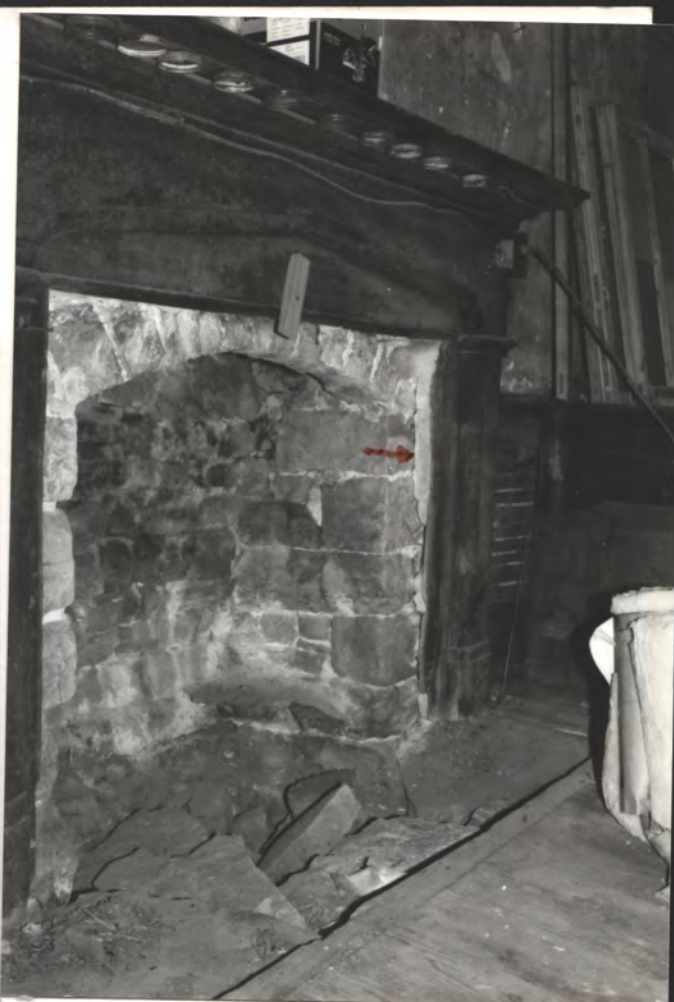
Italianate mantel, Fl. 1 No. Bm.
presumably a later modernization of
(would have to remove to verify)

note plaster remnants
on stone surround.
(typically plastered)

perhaps late 1850's or 1870's

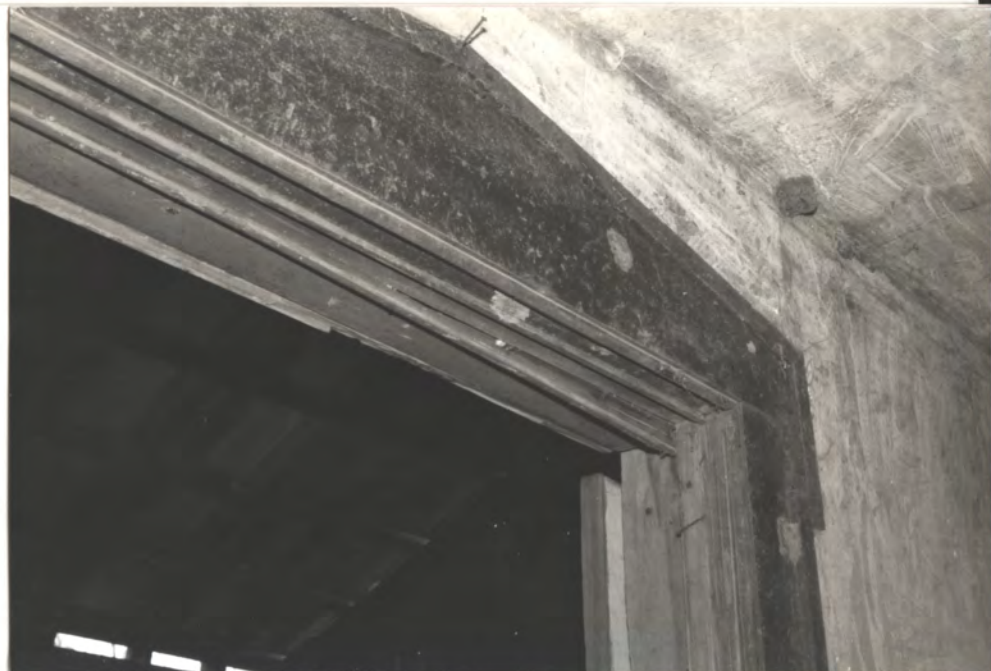
E. FRONT WINDOW FRAME
(all sashes gone)

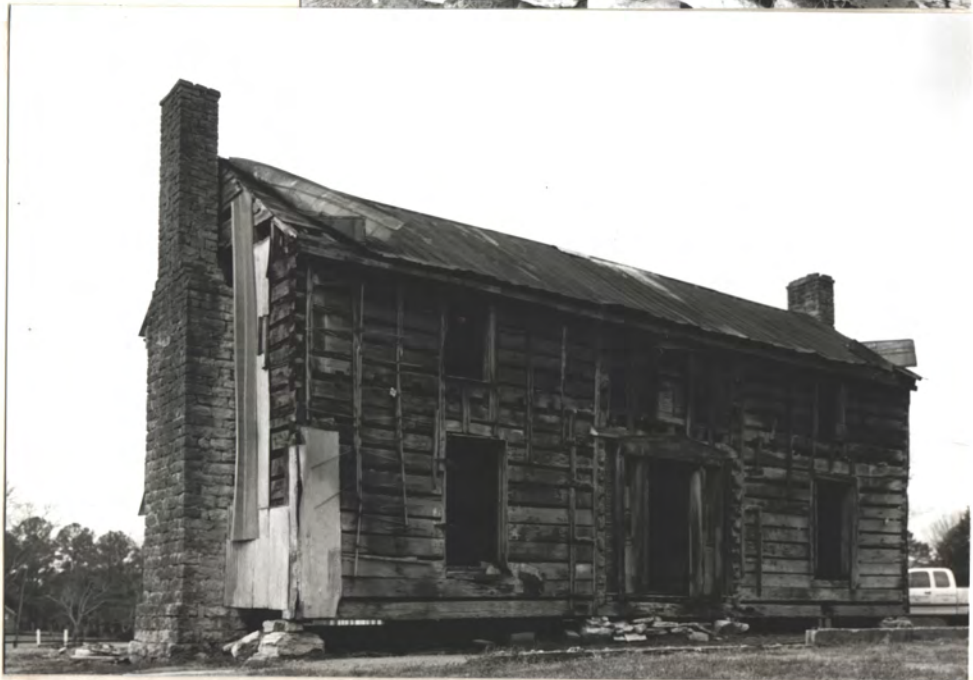
1997 Storm damaged. the modern shed

note 2
 marks in
 SIM photo
 for front porch

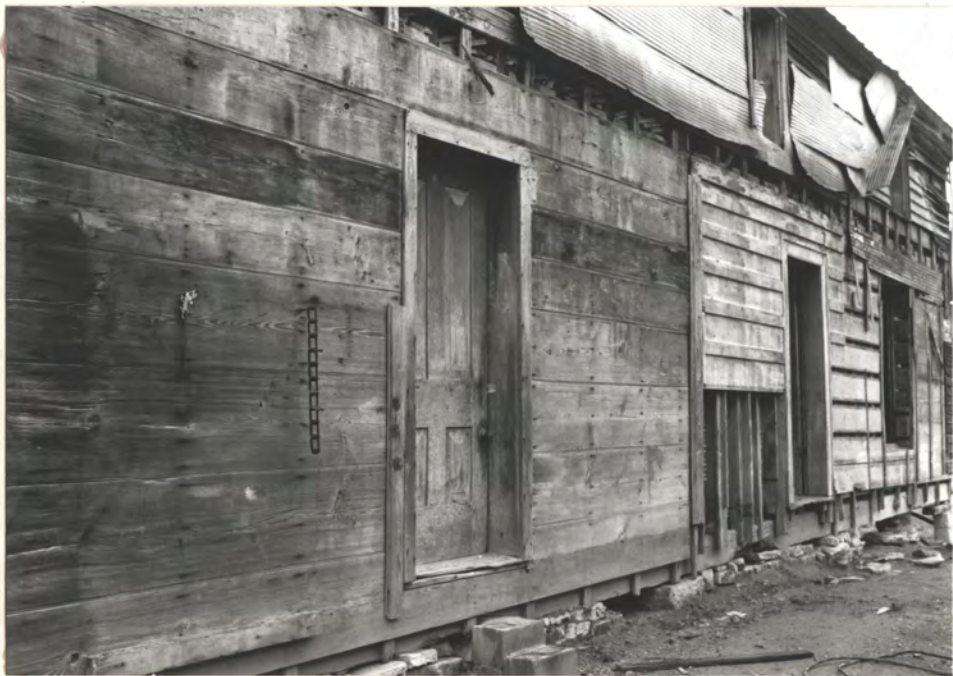
2000
HS

note 2 patterns of siding,
apparently in rms or under a
porch

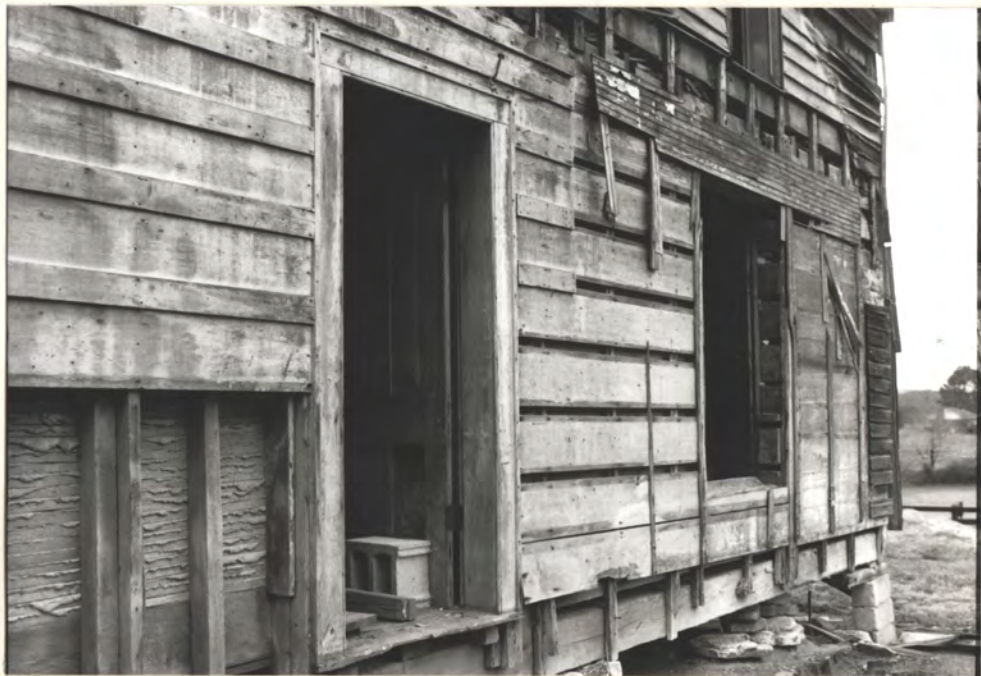
HS

batters removed

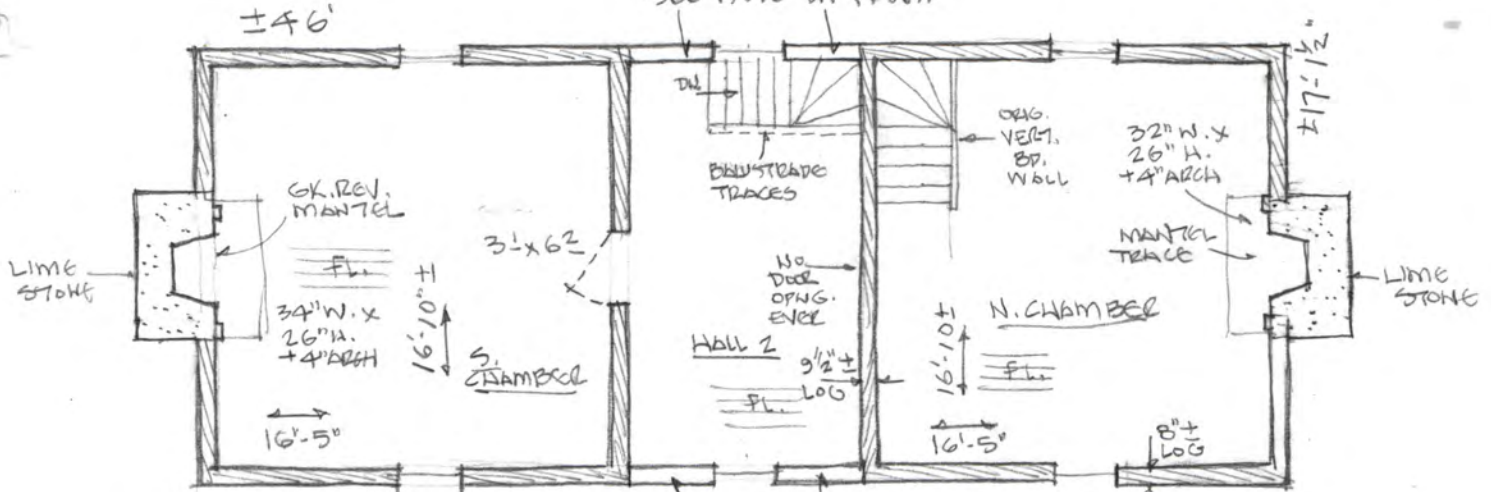
FL. 2
1/8" = 1' ±
24" x 32" H. SILL
7" H. TYPICAL FL. 2

no logs here (originally open?)

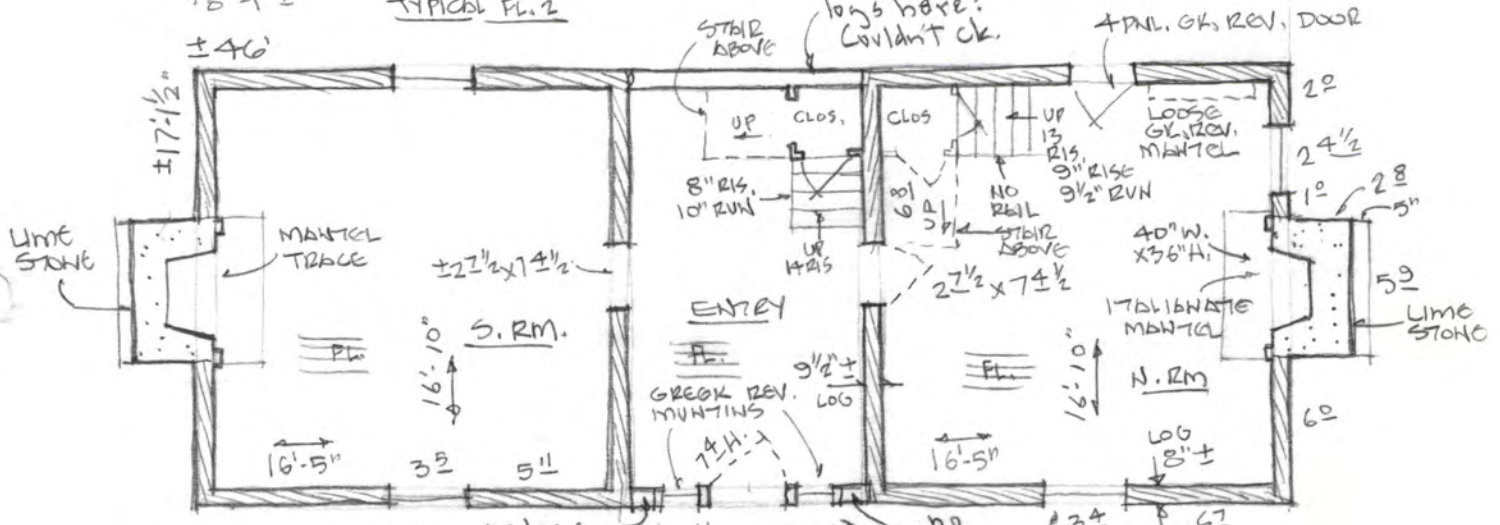
FL. 1 1/8" = 1' ±

no logs

SILL-13
HT-63
TYPICAL - FL. 1 EAST WALL

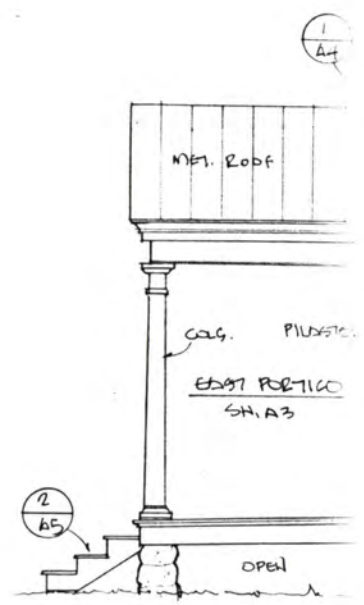
EAST FRONT

MORTISES IN SILL FOR C. 1860 PORCH
NOTE!

ALL SASHES GONG EXCEPT ENTRY SIDINGS. SEE 12:1 SASH SCHED.

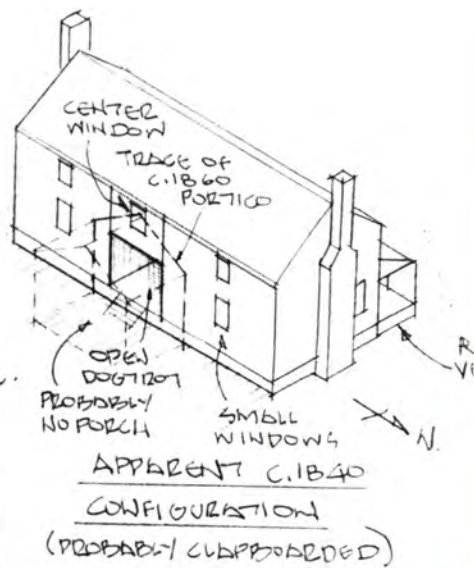
This later portico covered the original left center east window as shown
