Re: Inscho Residence (Hagan House, Mooresville)
Project No. 95125

Re: Inscho Residence
Project No. 95125

FEDERAL PERIOD + ADDNS.
IRVING-HOBAN-INSCHIO HOUSE
MADRIDVILLE, AL.
1986, 1995
JONES & HEERIN, ARCHITECTS
ANNHURSTVILLE, AL.
ARVIE P. JONES, F.A.I.A.

HAGAN HSE, MARTINSVILLE, VA.
EARLY 1800'S + LATE 1800'S ADD. & INT. REMOD.
+ C. 1960'S N. WING
photos June 1995 by Wally Insko, new owner,
for add'n's & renov. by Jones & Herin, Arch
Huntsville (Harvie P. Jones F.A.I.A.)

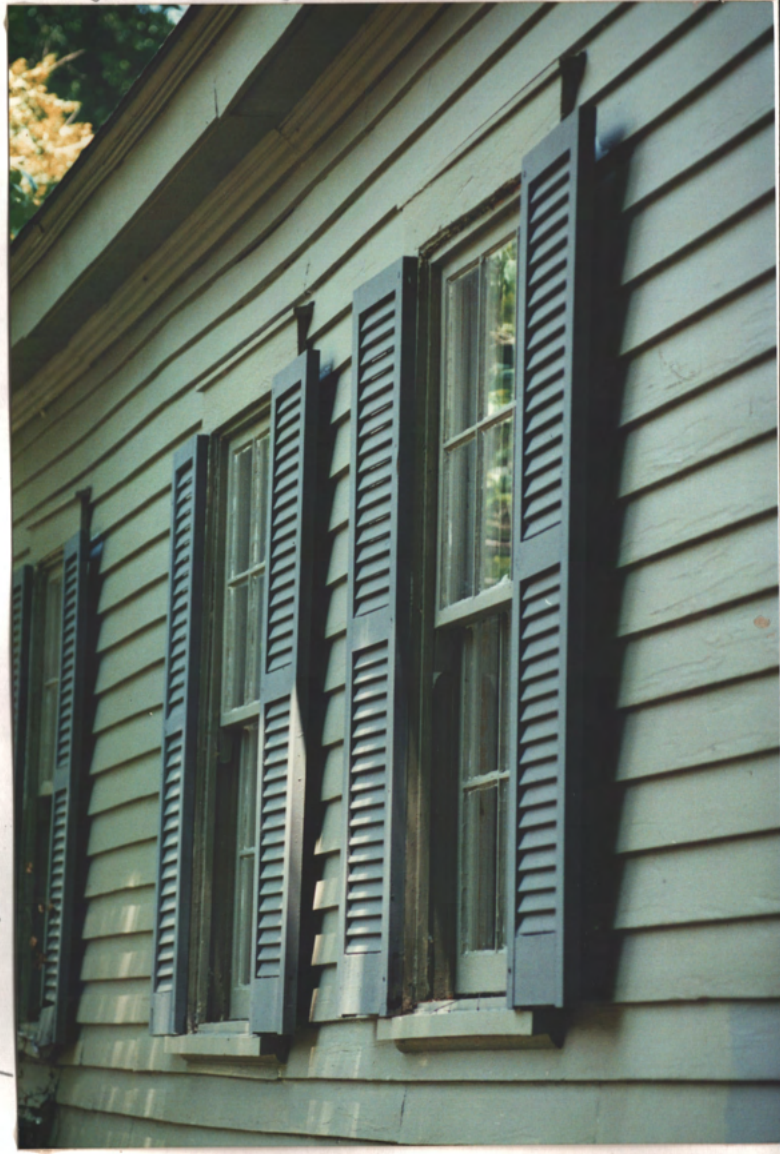
old blinds, burlap, nailed to wall
(all incorrect)

originally open breeze way

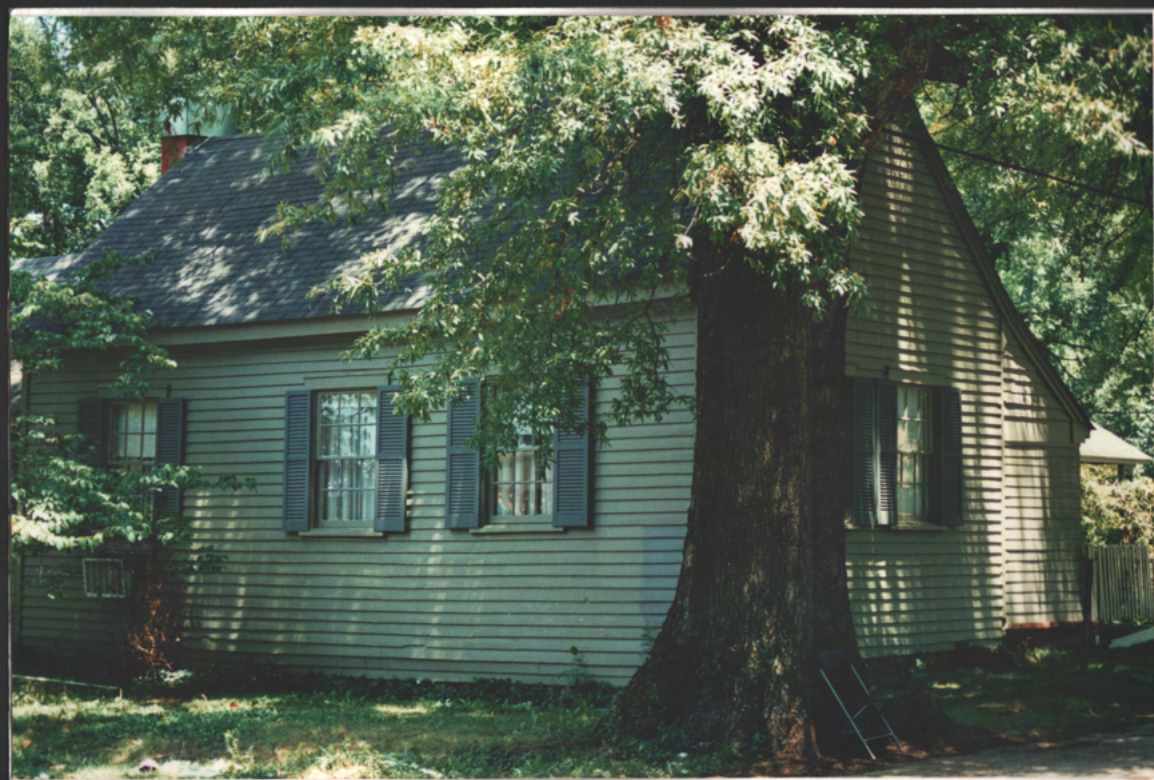
↳ was probably the front door

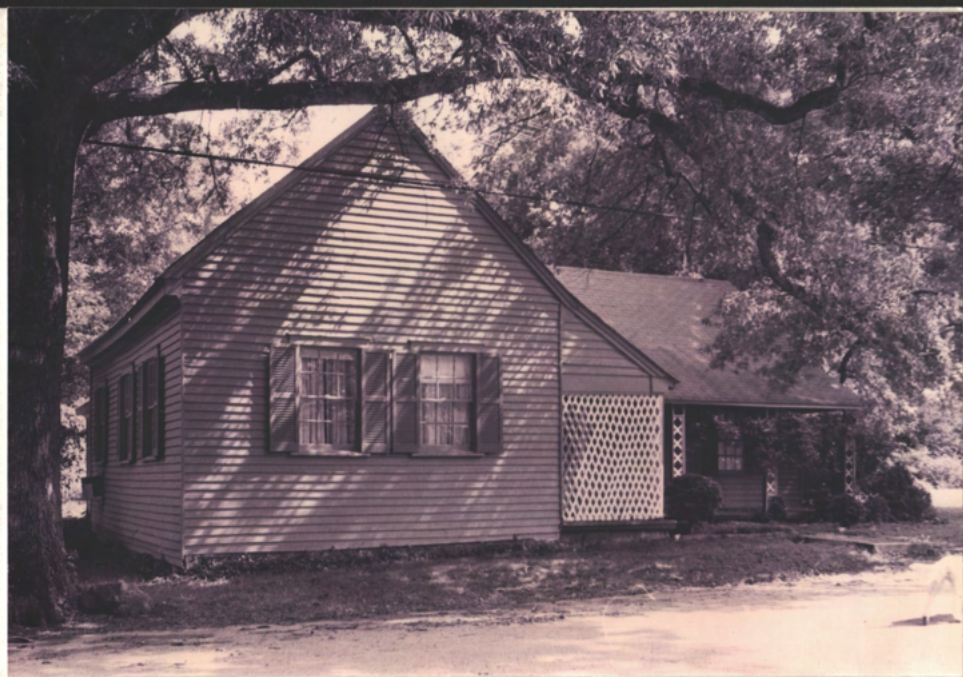
This cent. window was the front door, per an old resident of per several practices in Hall & Parlor plans.

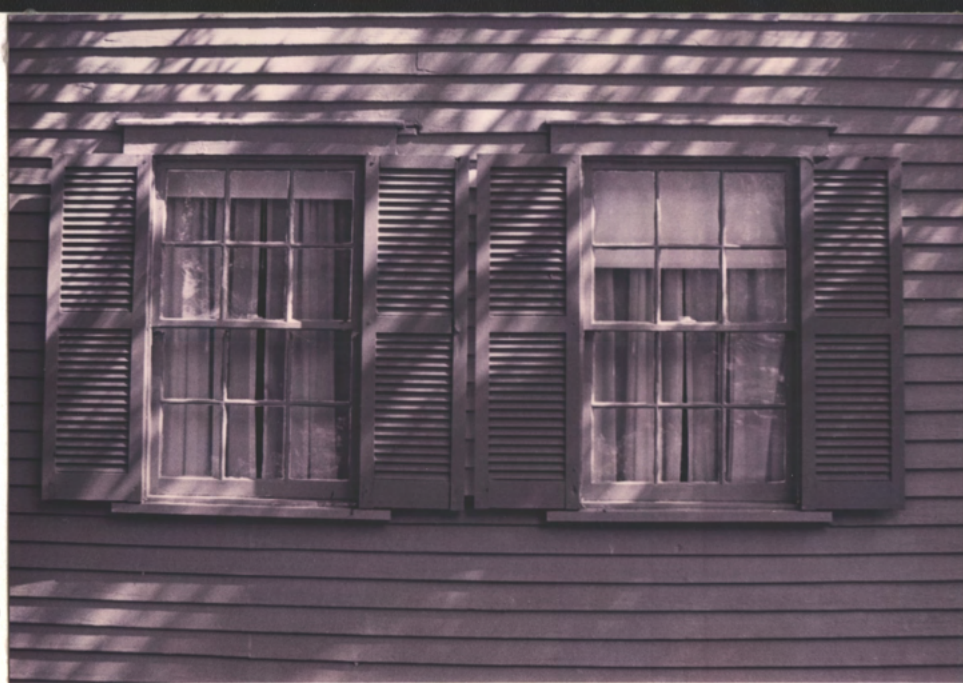
20th c. blinds & shutters (AM)

← Fed.
Tapered &
beaded
rake -
fascia

← Vic.
Chap.
(rotary
Sawmill
mt. side)

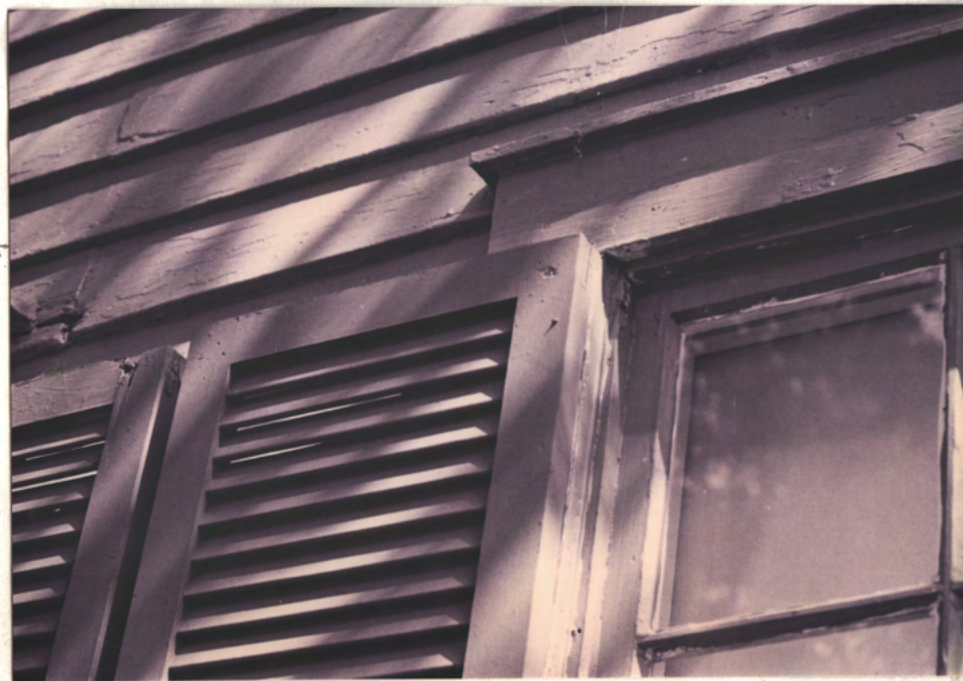
c. 1960 fake blinds
nailed backwards
(to wall)

20th c. shutters

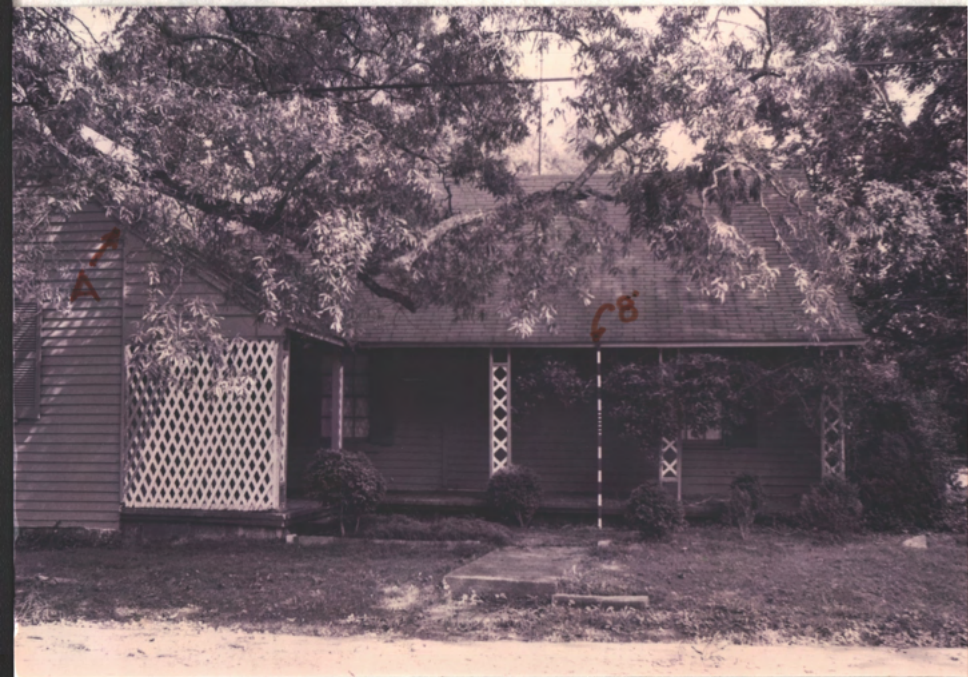
Wall trim indicates
orig. breezeway

Feb. bordered tapered fascia

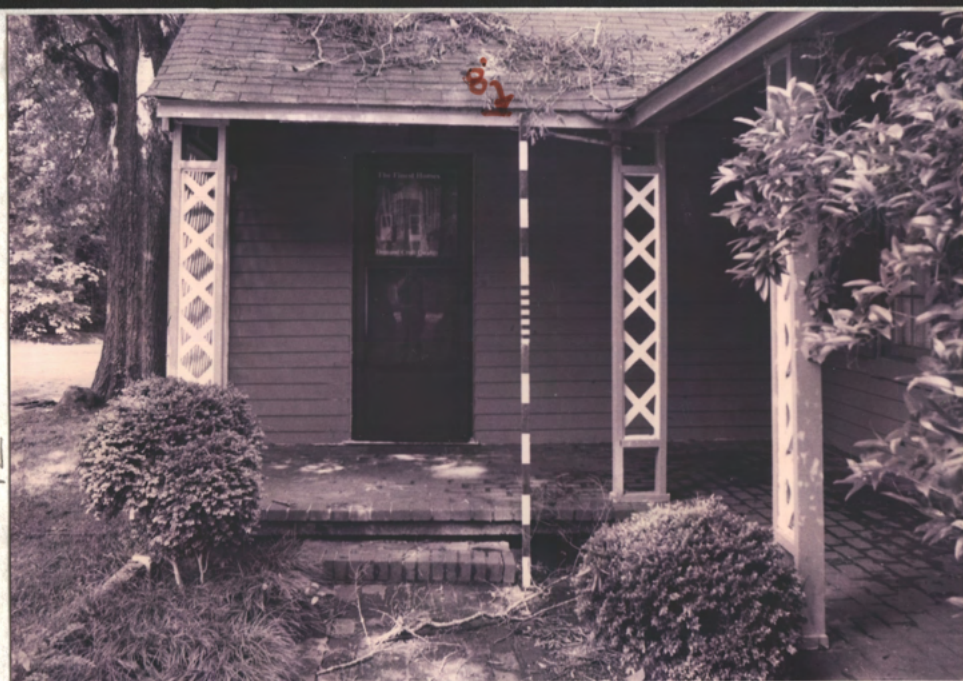
Brick W.
looks c. 1960

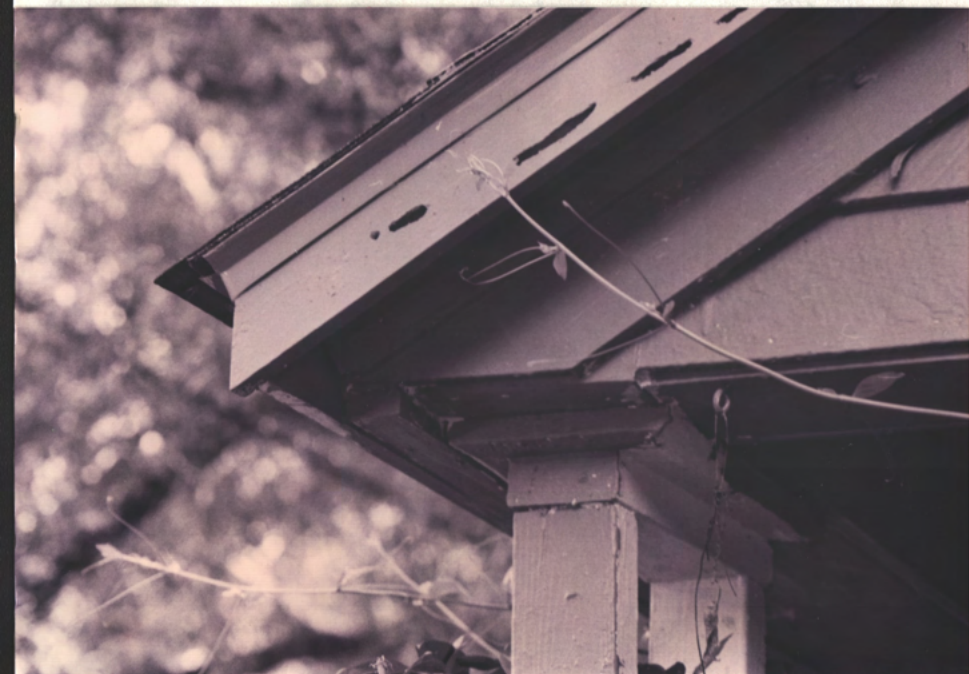
S.E. corner of Vic. veranda →

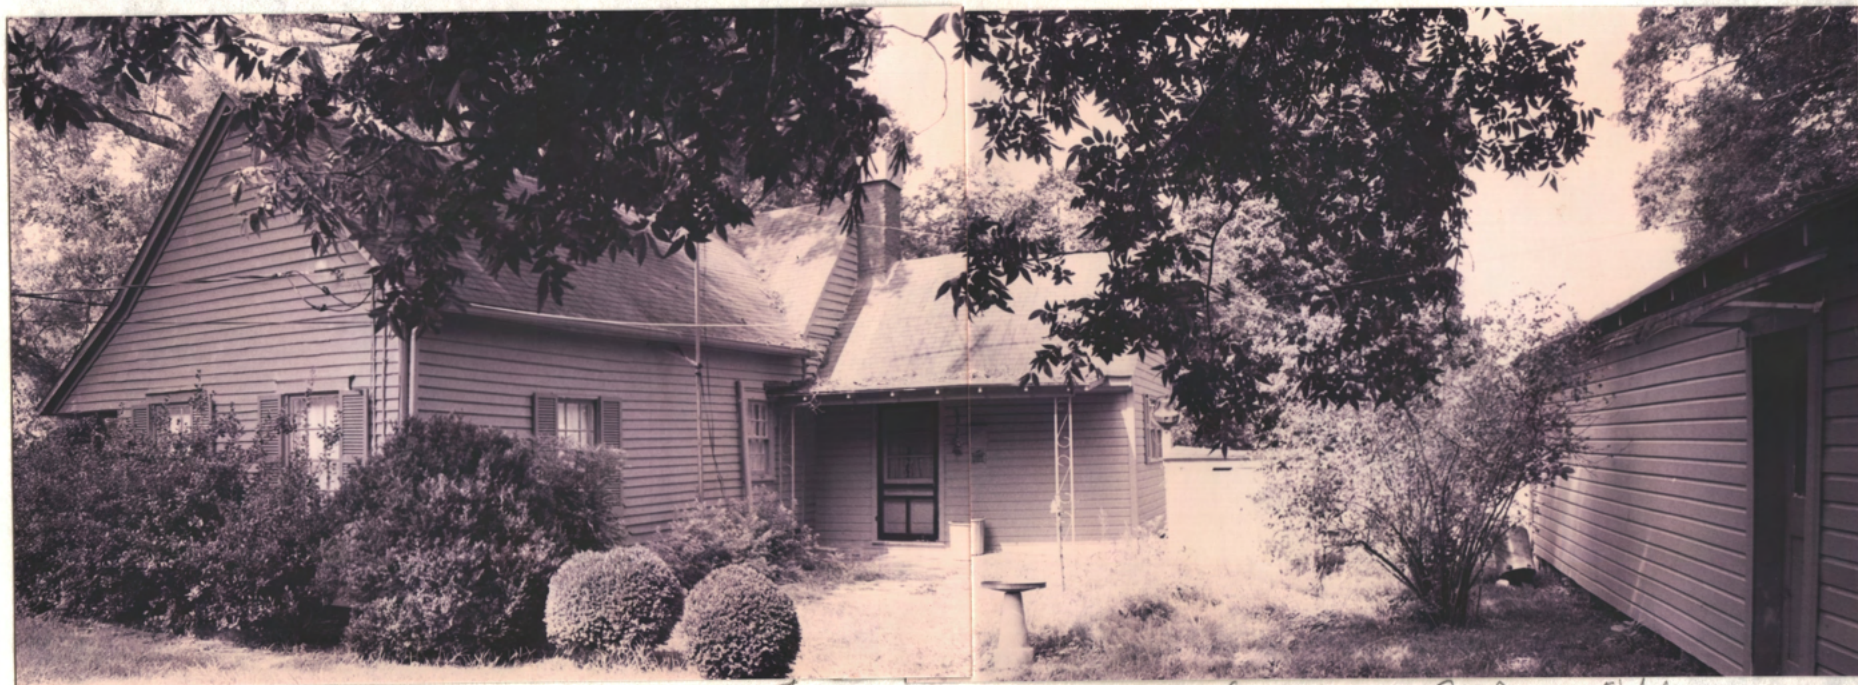
Vic. E. Wing

Ca. 1960 late mid

20th c. out. body.

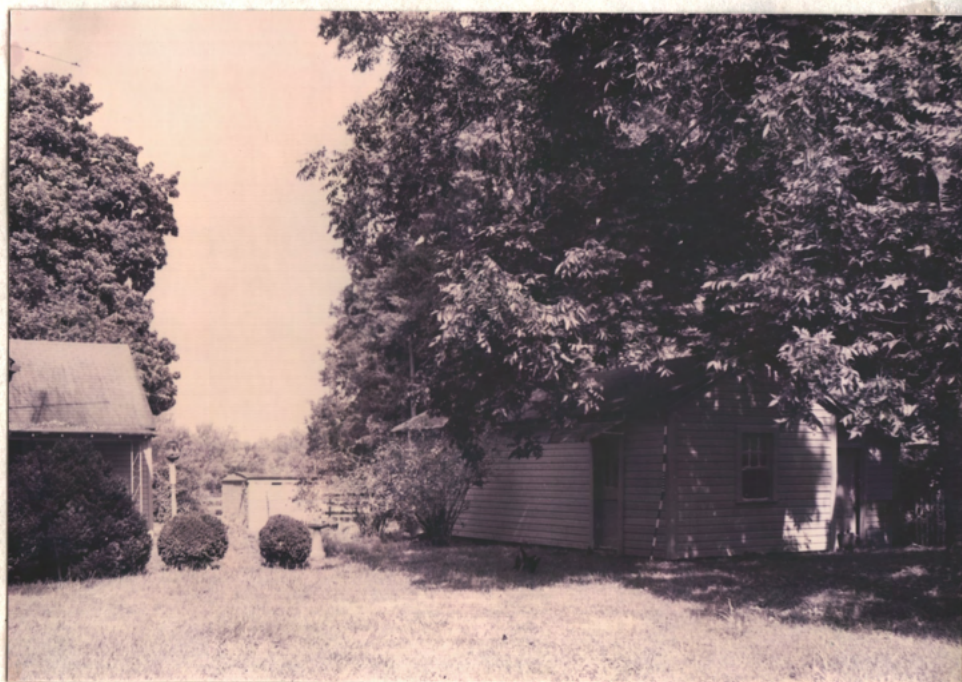
20th c. out. body

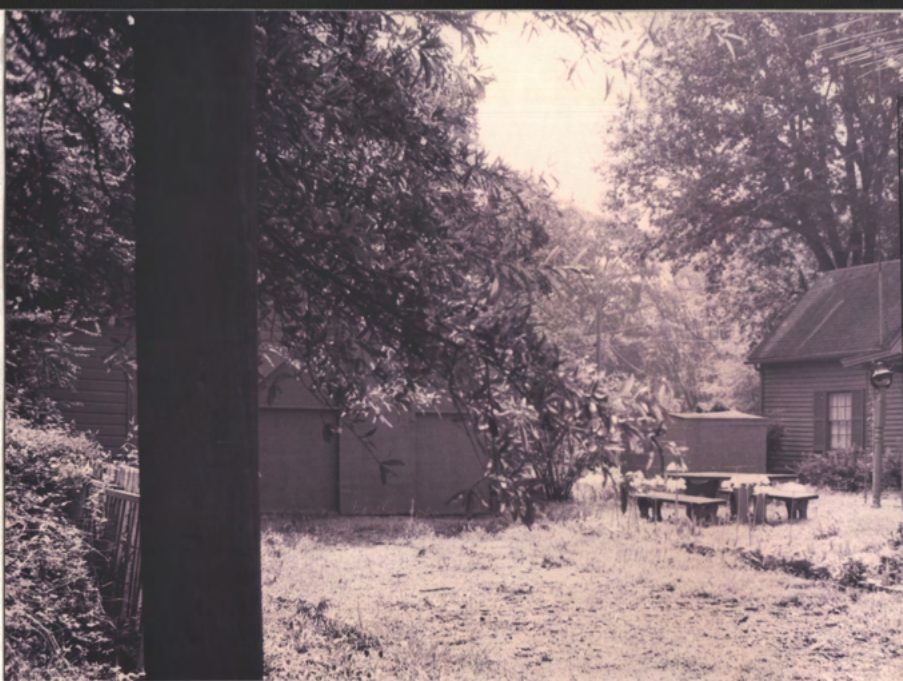
20th. c. on the side
(Cgnc)

Tapered & beveled
Fed. xtra fascia

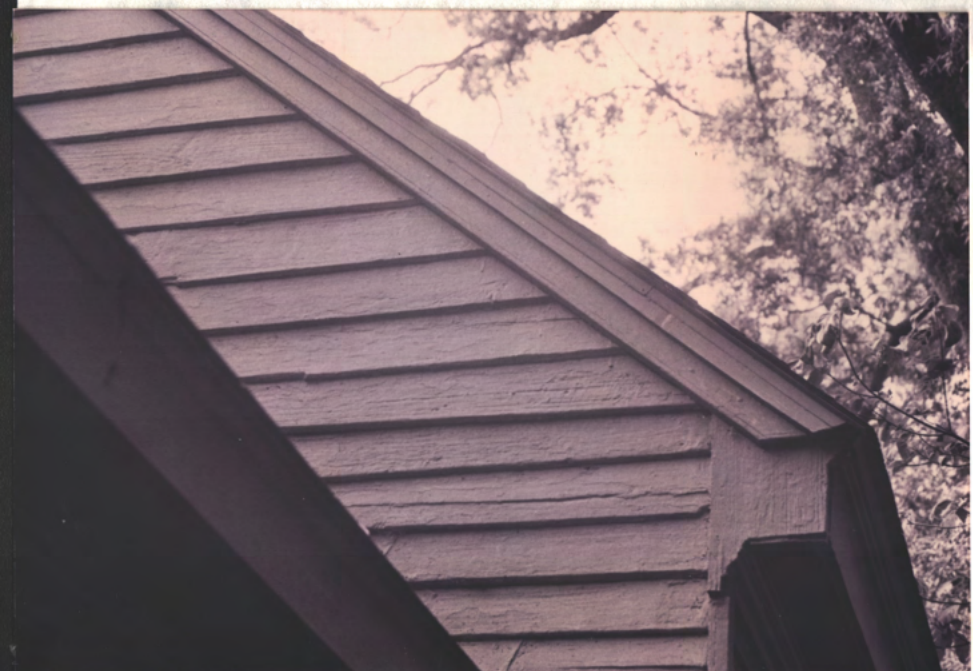
Fed.
end-
plate

Fed.
Clapb'd
only at
this
wall

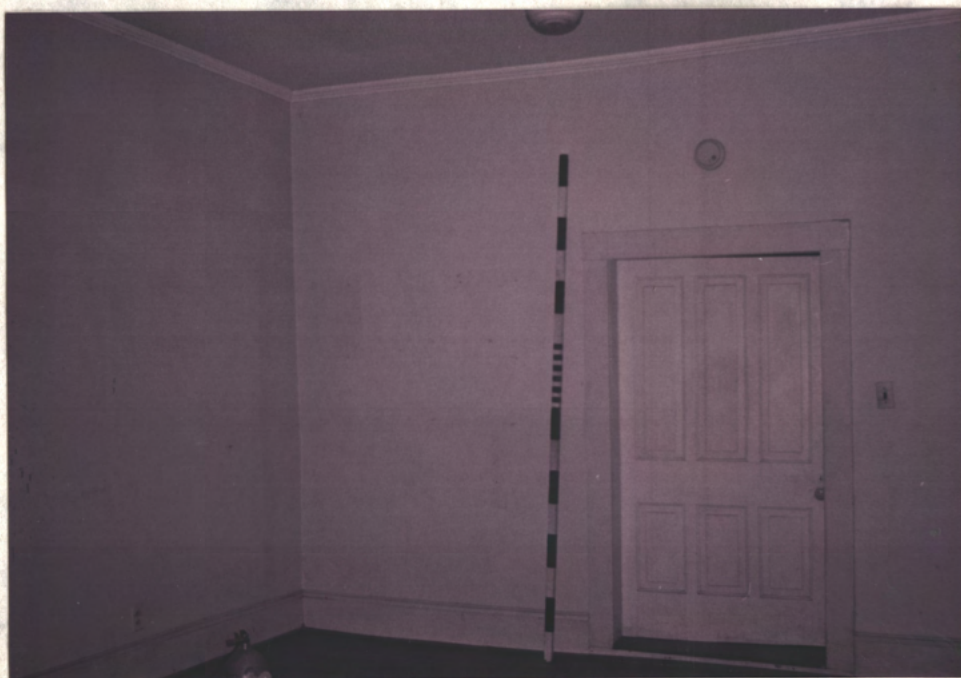
Mod. base of
gyp on wall
(c. 1960) at
Hall & Parlor

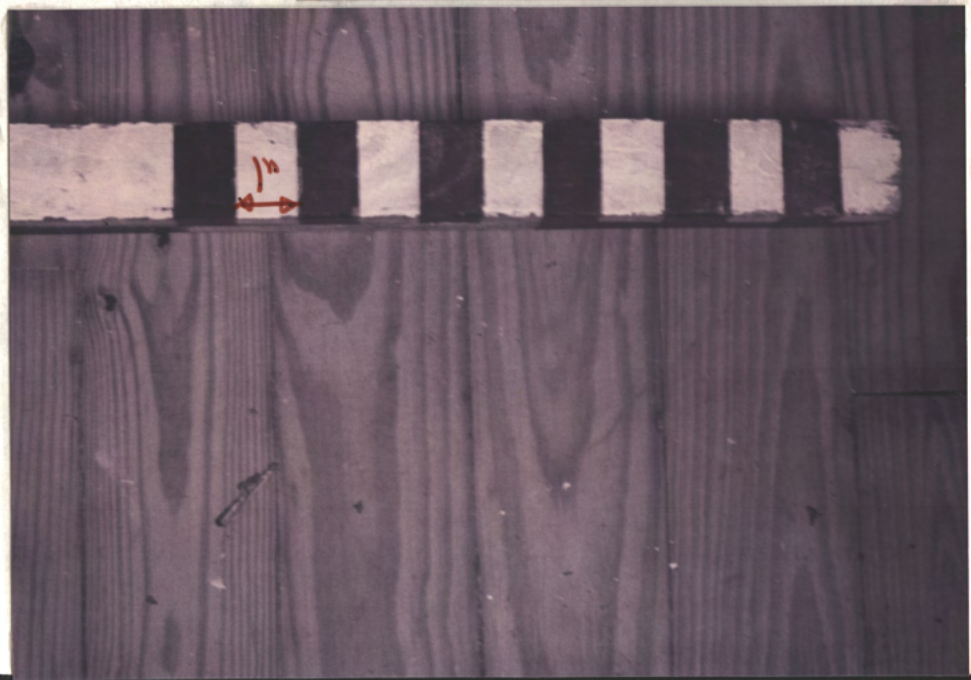
c. 1960
pine
fl. at
Hall &
Parlor

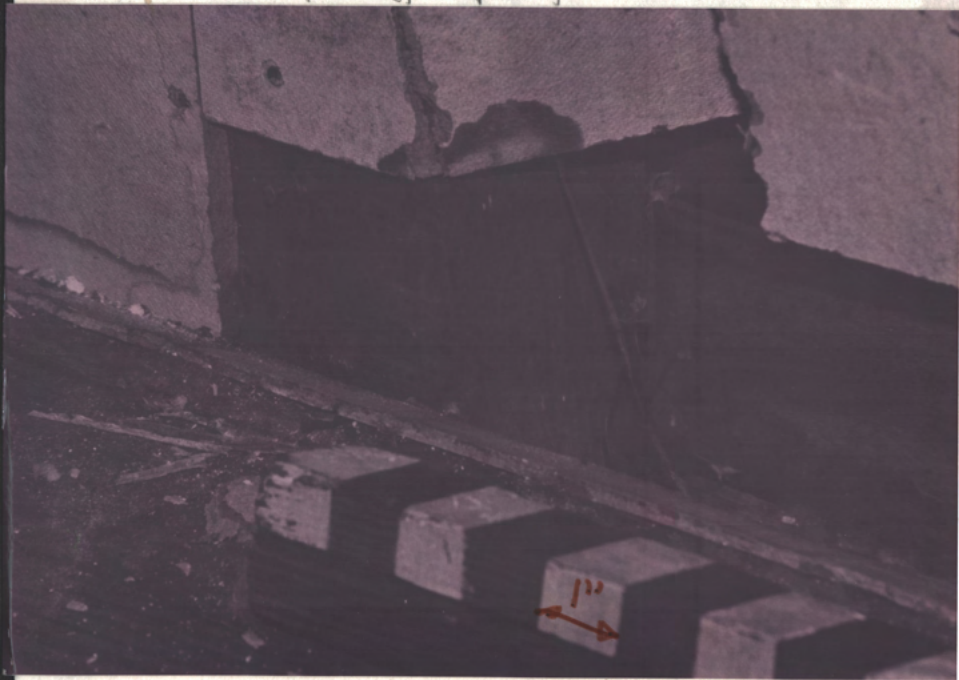
newly
 exposed
 studs at
 12M-Park
 orig. draw
 loc. at
 cent. west
 mod. window
 (at Fl.)

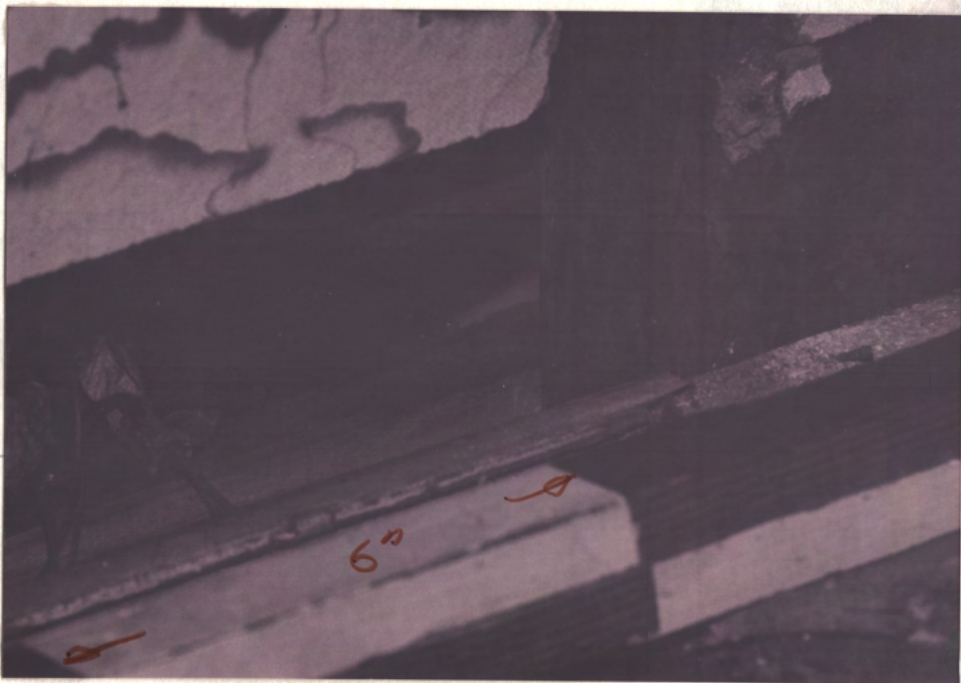
S. Side of N. jamb
 (was a brace, originally)

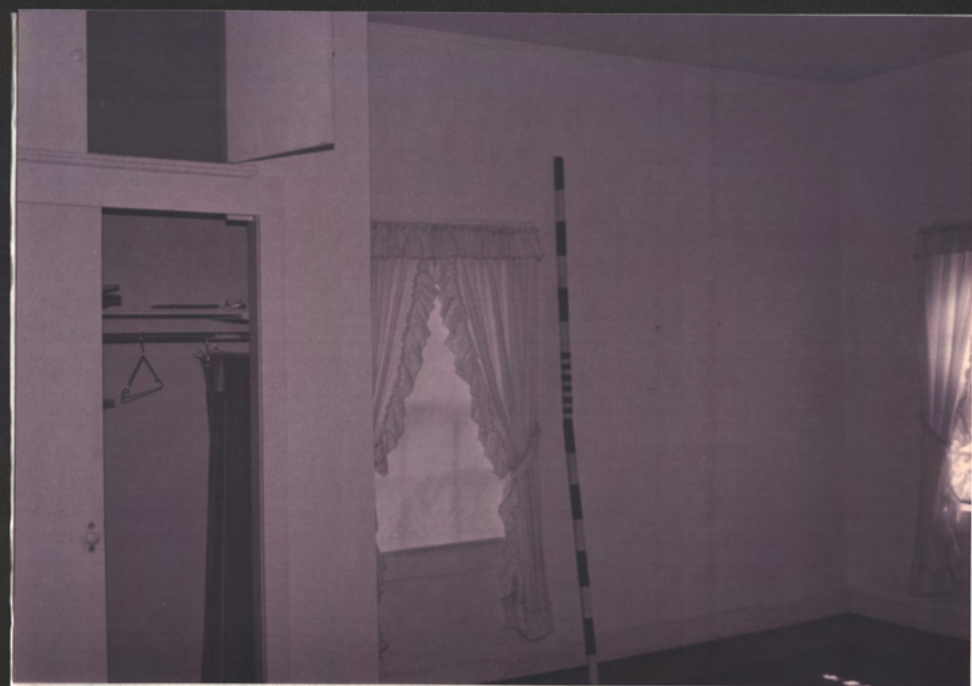
C. 1960
clo.

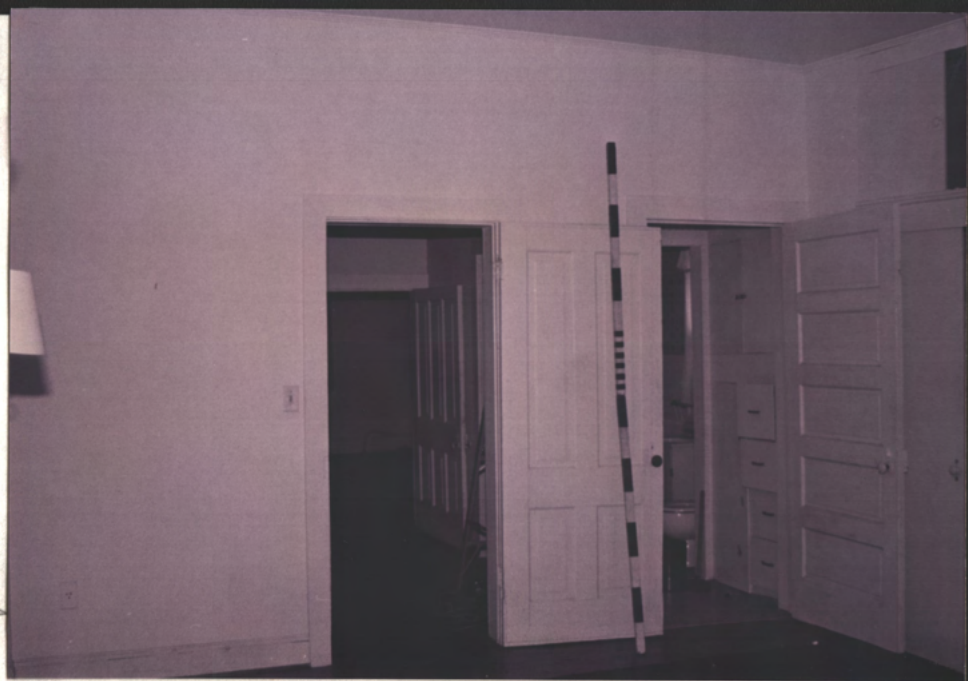
East View, BR
remodeled c. 1960

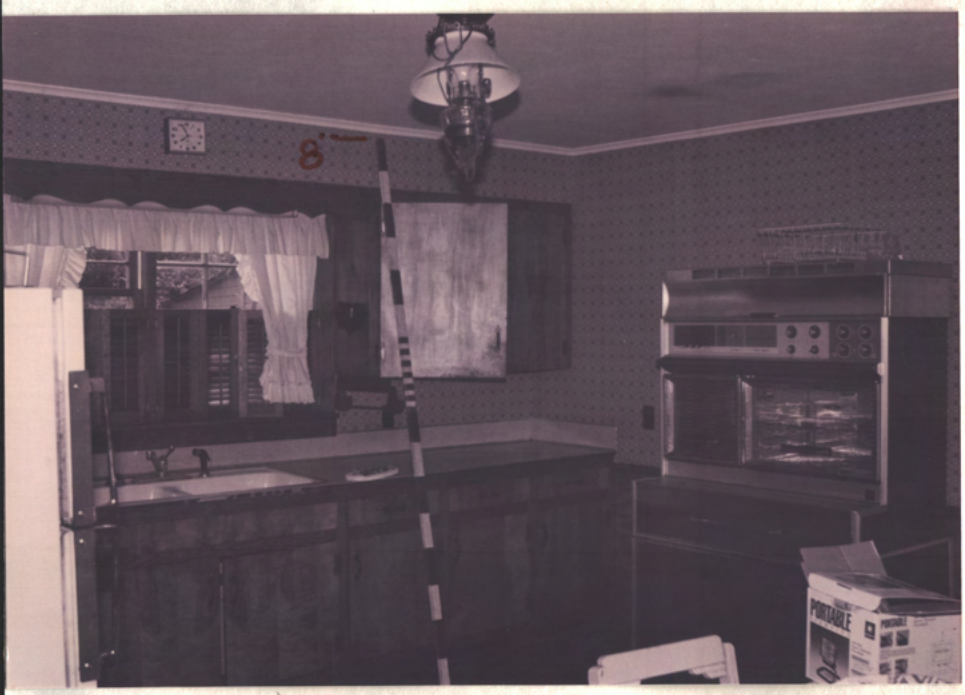
c. 1960 Kit. AMM.

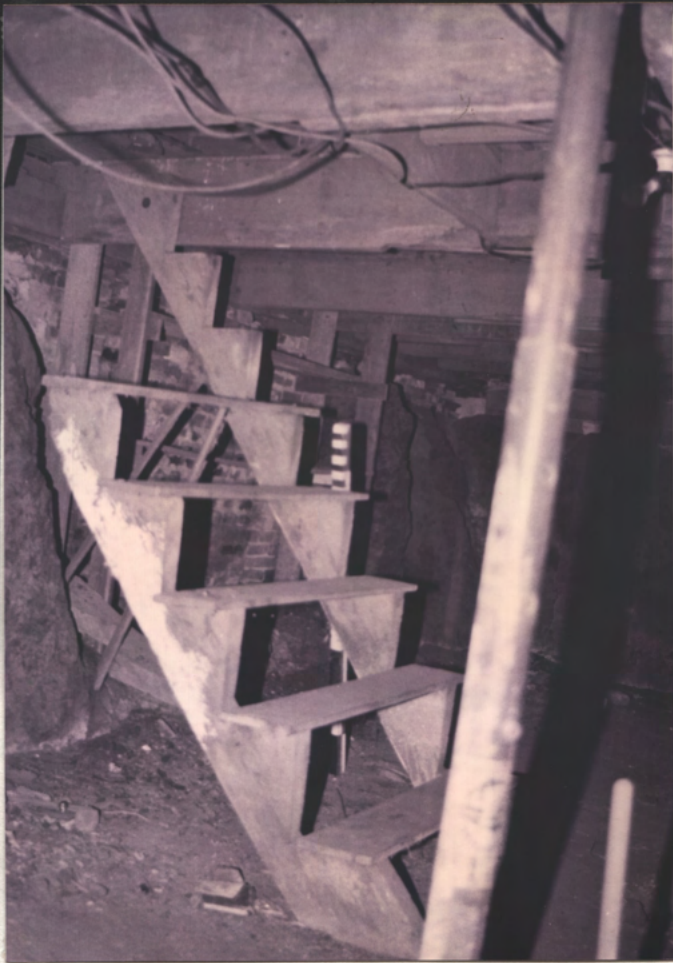
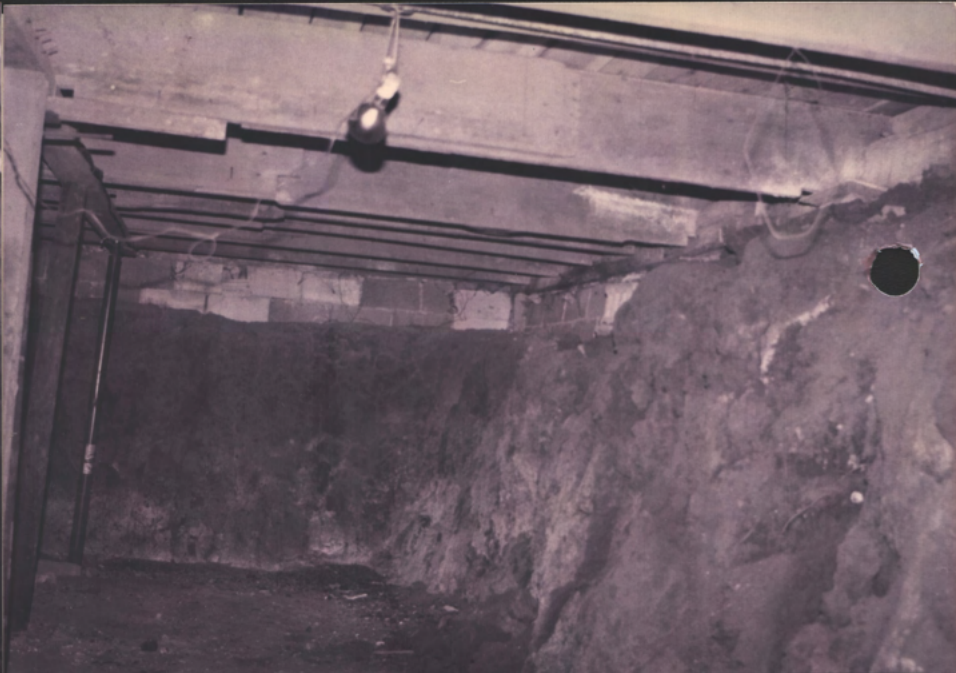
↑ corr. block (c. 1960)
under main SIM

Revised & inverted
Fed. painted stringers

Cellar (dry out apparently c. 1960)
is only under Fed. Hall & Patent

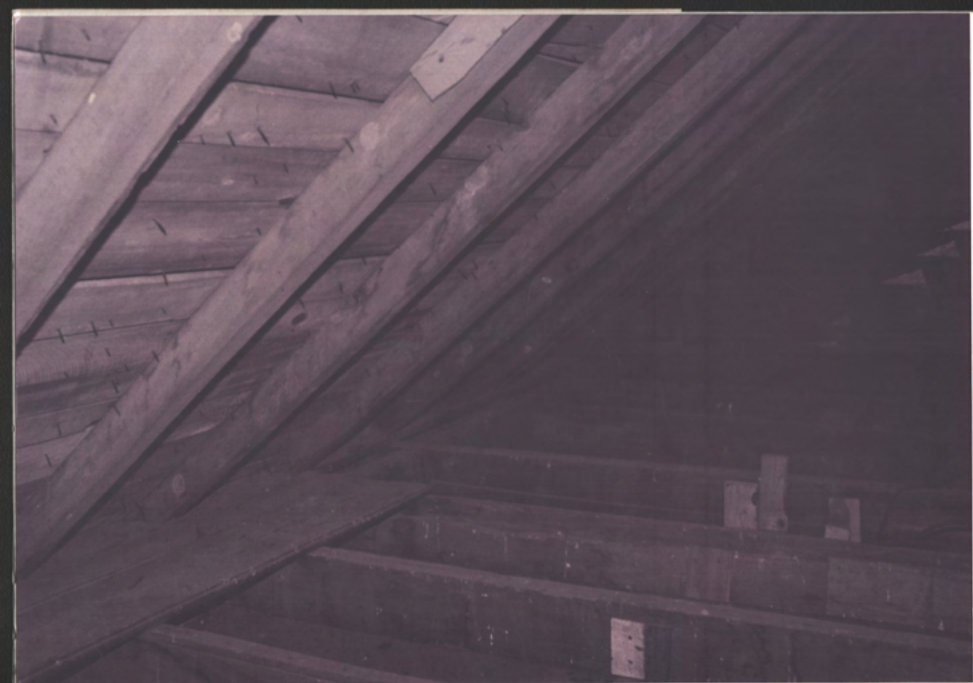
← Vic. rotting beams replaced →

FED. PERIOD ATTIC

← No ridge bt.,
half lap & peg jts (typical fed) →

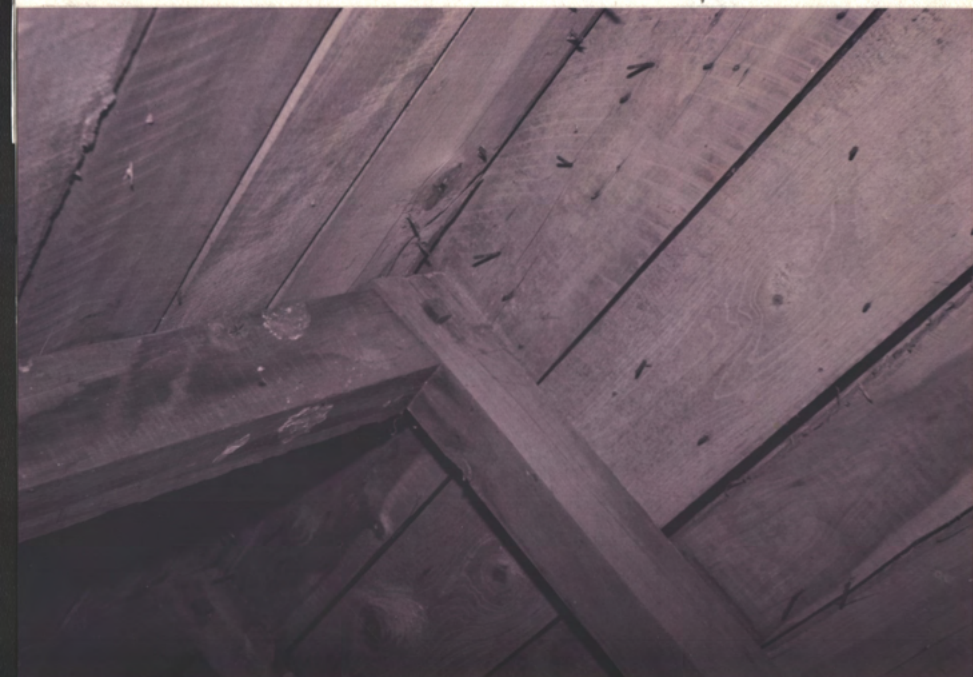
Some-sun
Fed.
rafters &
Joists
+ some
sun sun
Fed. deck,
some Vic.
rotting sun

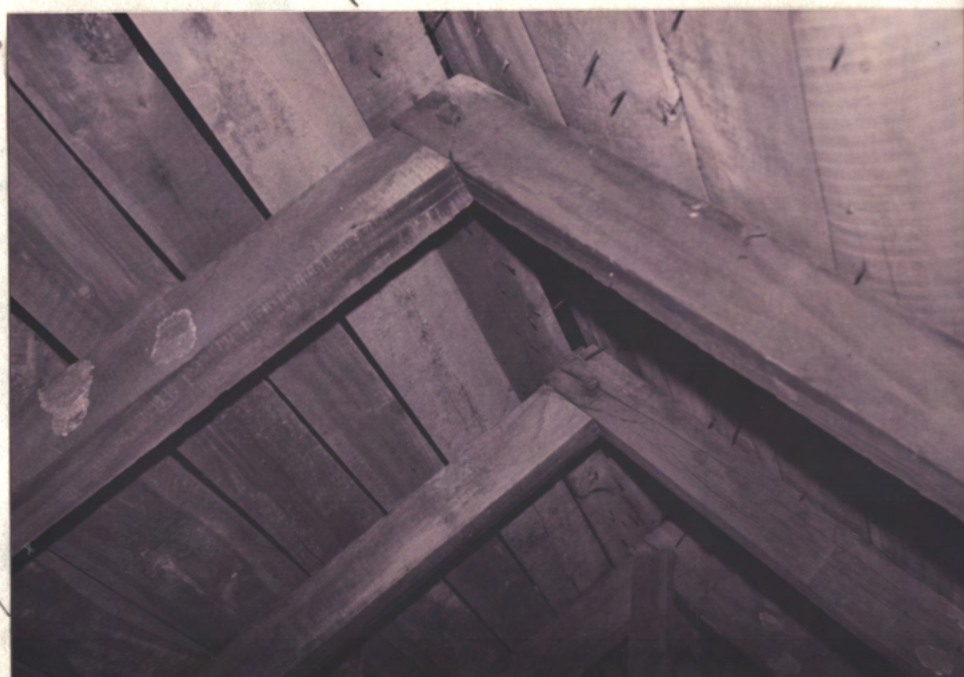
Fed
deck
(sash-sawn)

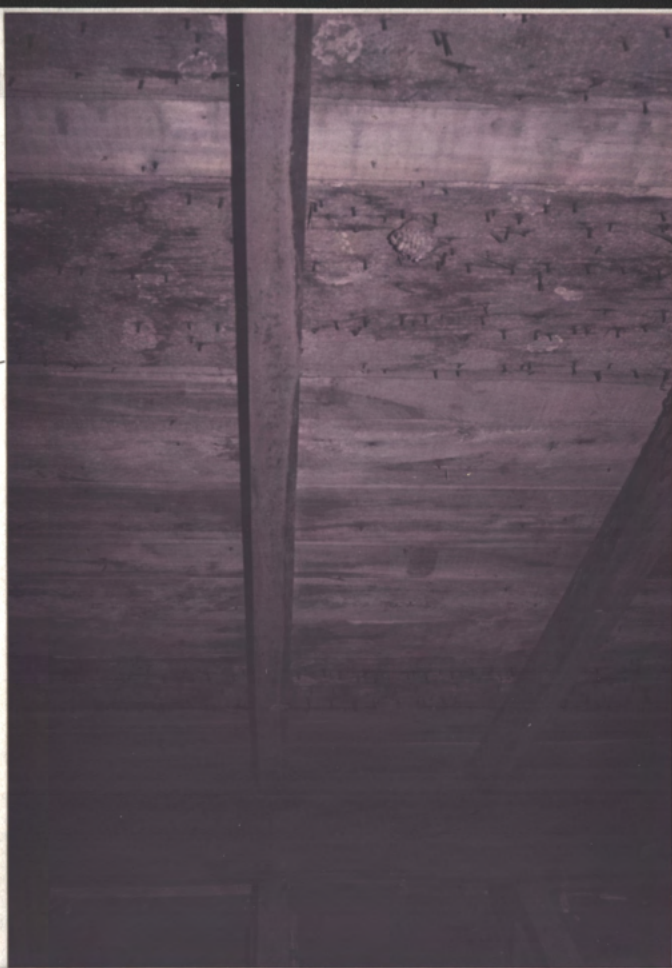
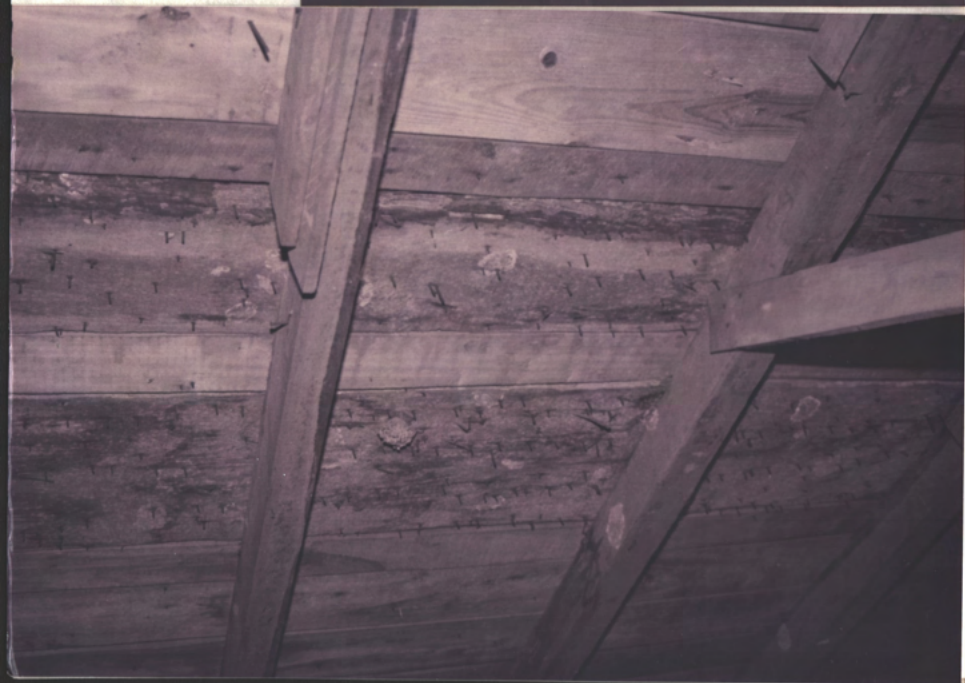
Fed. Rafters, sash-sawn, $\pm 3\frac{1}{2}'' \times 5''$, $\pm 2' 0''$

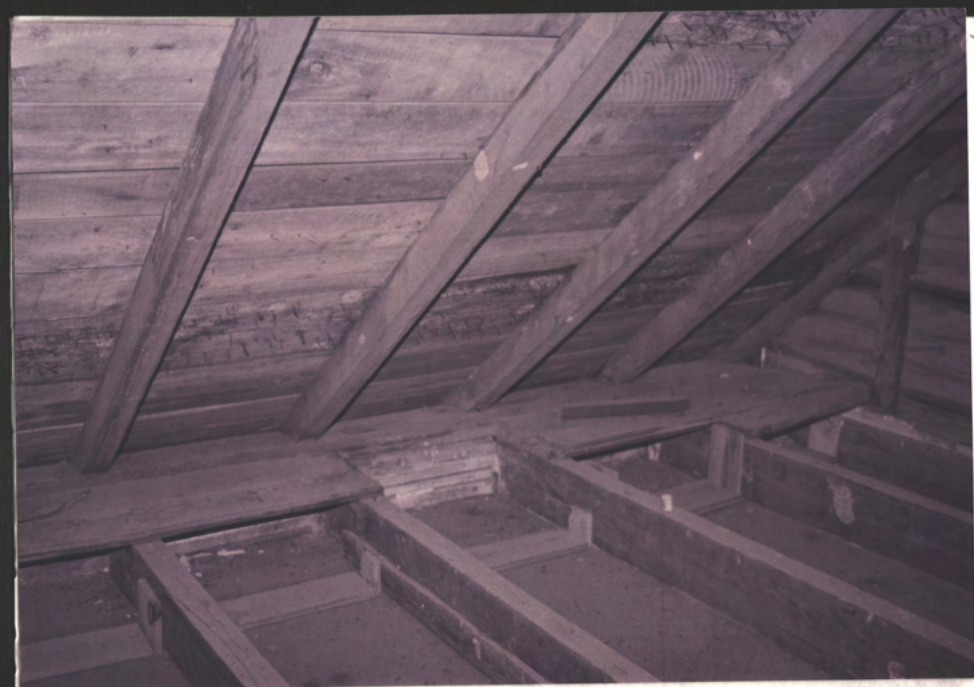
Fed.
deck-
bd.

Fed. →
5/4 x 6" x 8"
ceil. planks
for "Hall"
below

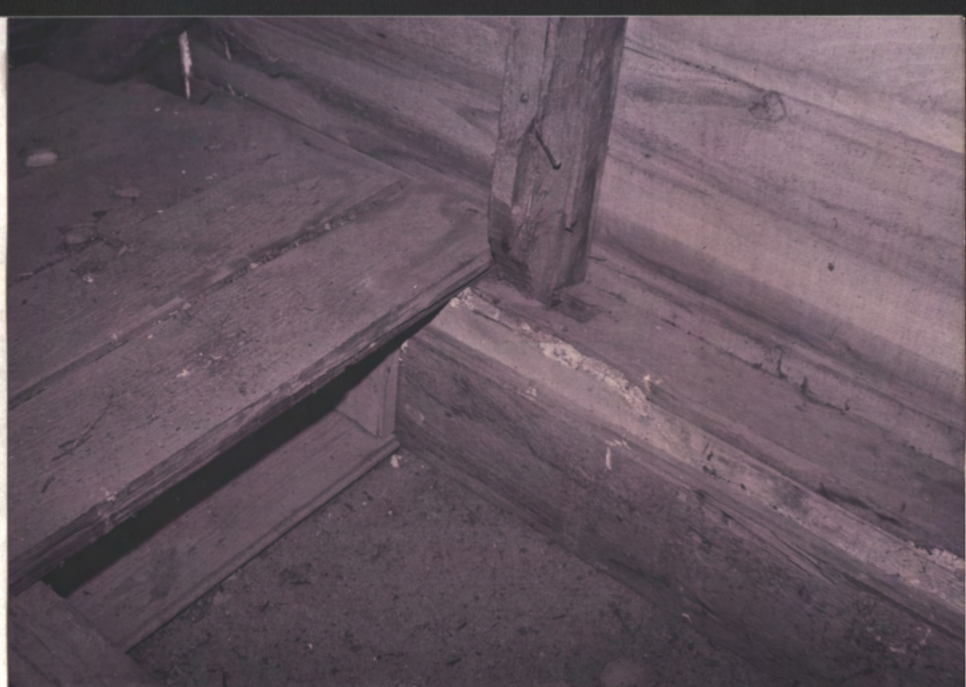
Struts = beam +
sash - sash

split lath +
hair plaster, area in
rms below

Fed. deck-bd (sash sash)

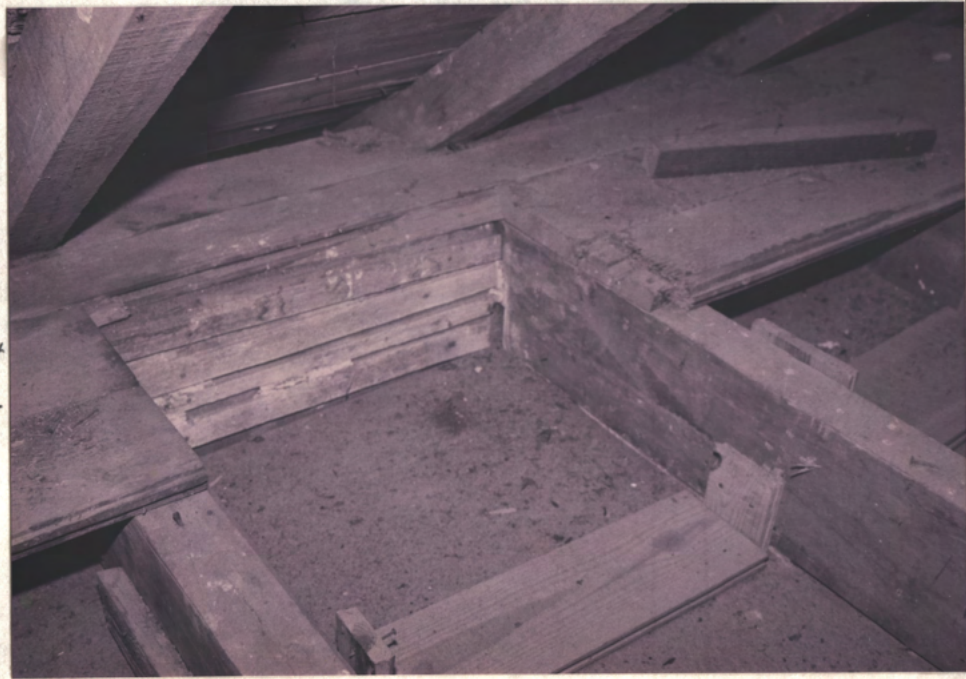
Joist = Fed. ± 3" x 10" x ± 2" o.s.

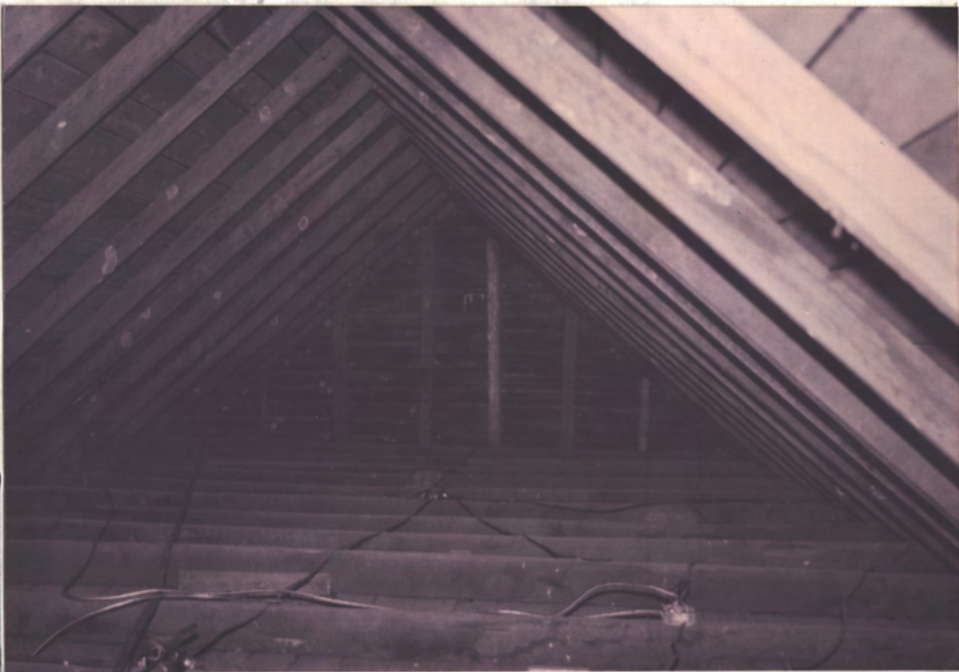
E. Wing Victorian Attic

6" depth
= Rotary Sawn

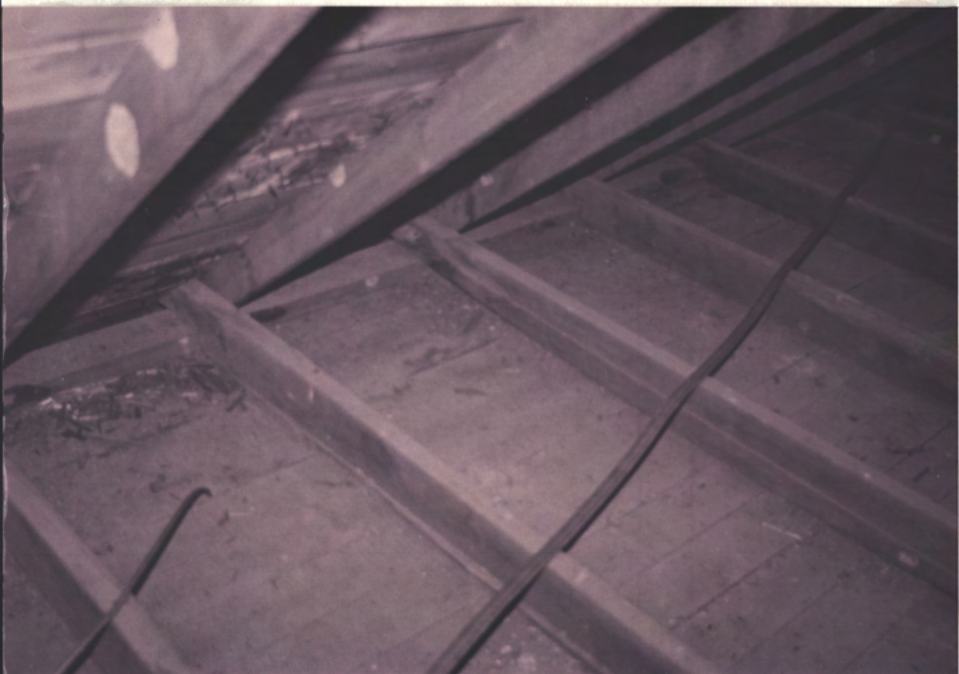
$\pm 1\frac{3}{4}'' \times 4''$
rafters
 $\pm 1\frac{3}{4}'' \times 6''$
joists
Rotary Sawn
