1850's Bledsoe - Kelly Hse (1993 owner = Charles Kelly) Al. 21, 1.5 miles N. of Snylaccuga, Al

Re: Kelly 1840's House Restoration
"Mountain Springs", H.A.B.S. Al. 428
Sylacauga, Alabama
Project No. 93027

Field Notes H Jones
 Mar. 1993 "Kelly Hse"
 c. 1840-50's "Htn. Spring" Hse

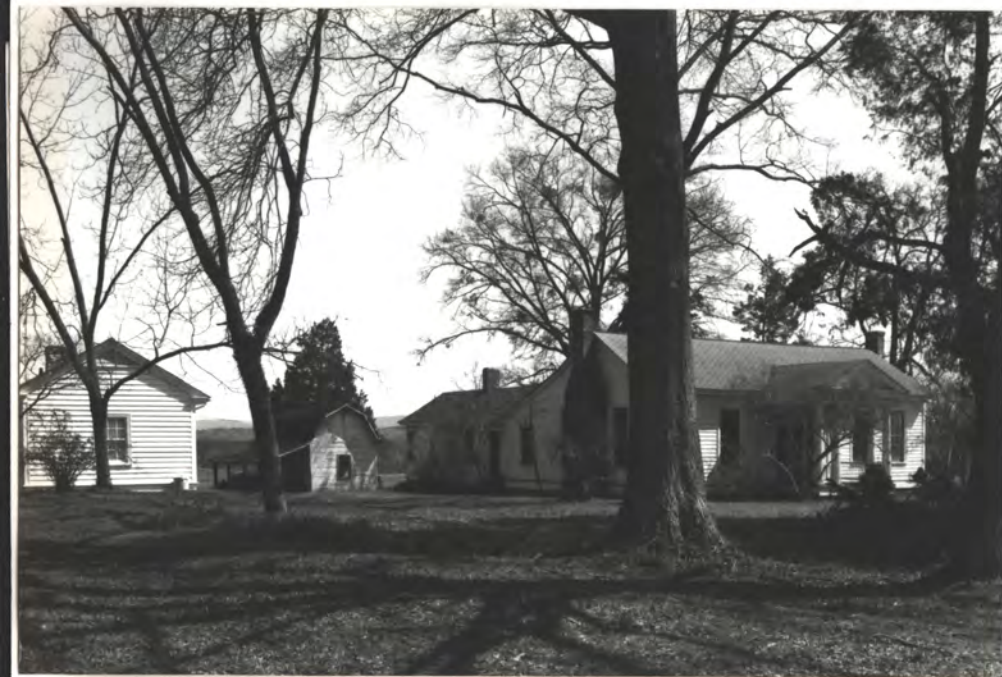
P
1940's
(rebuild on original site)

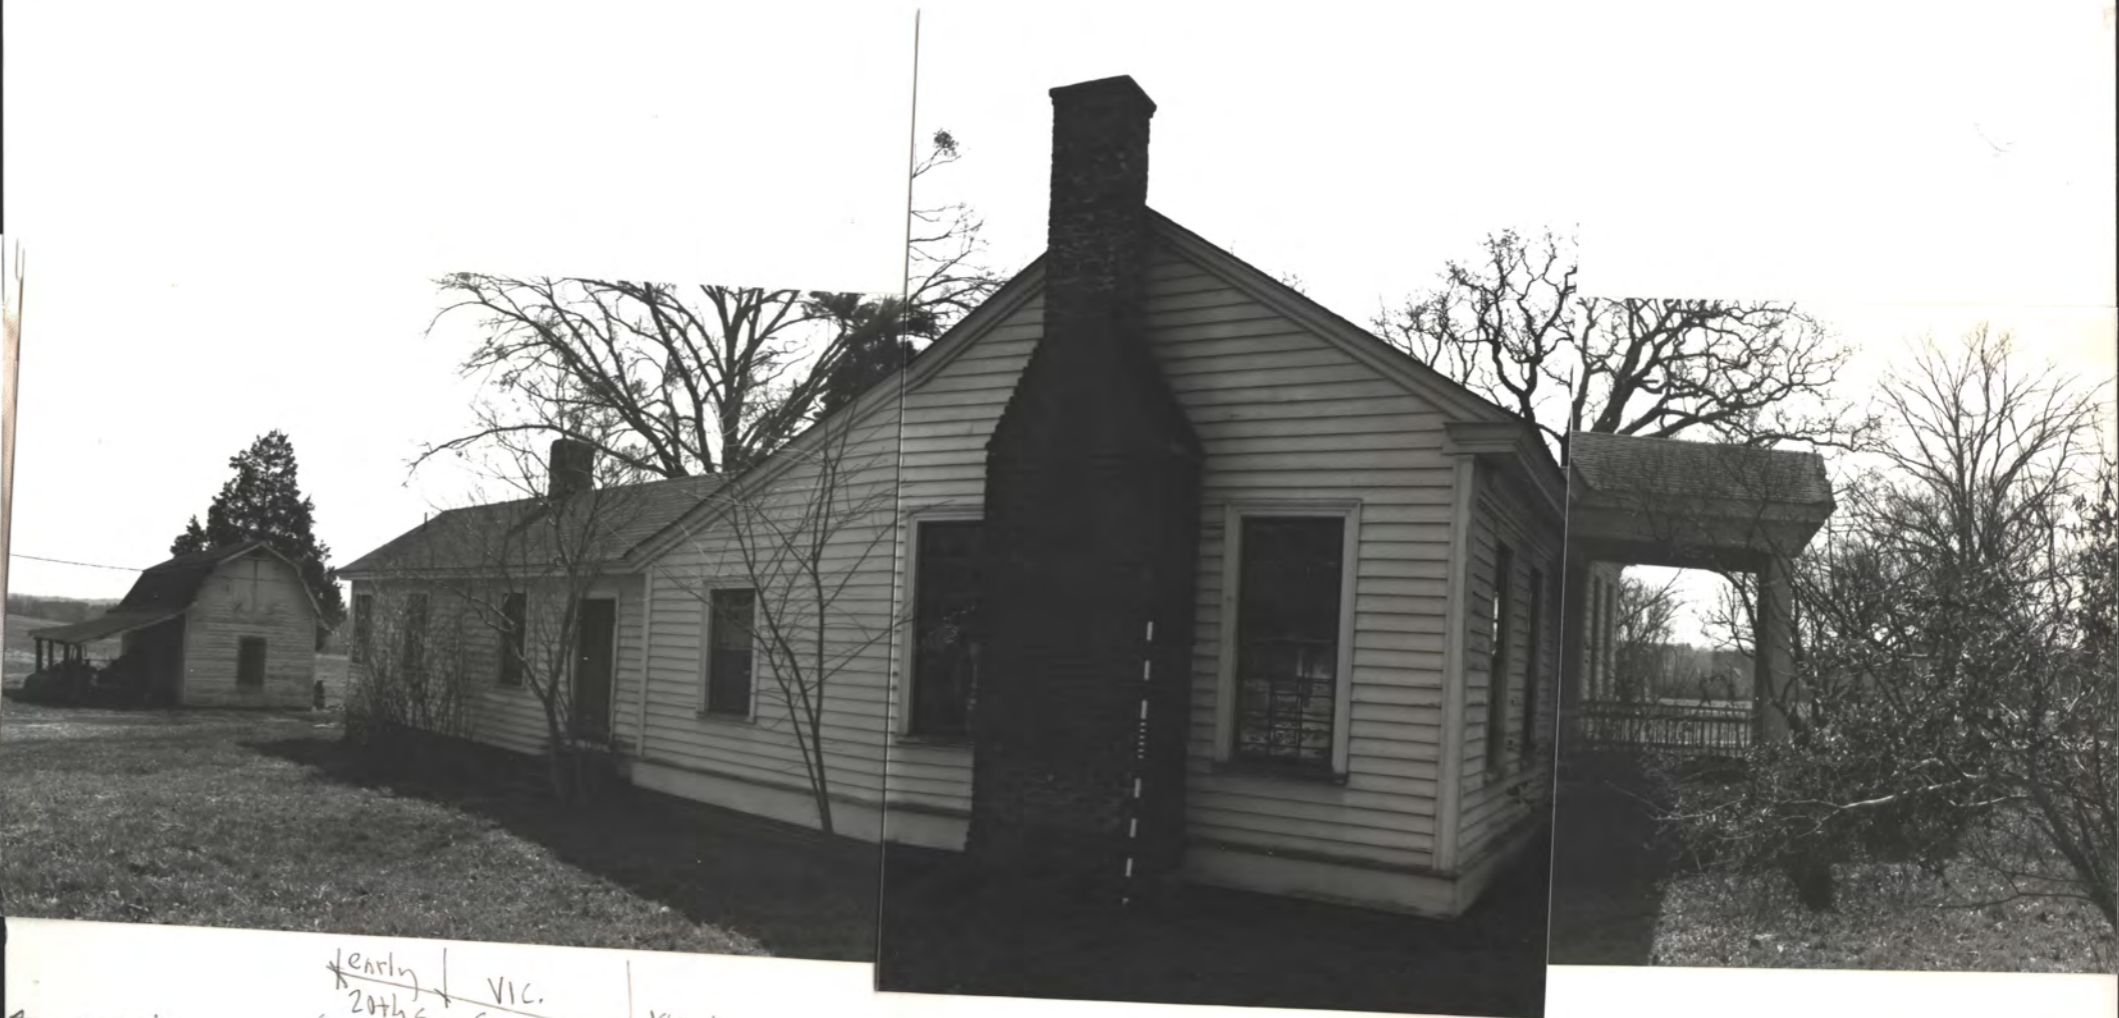
← 1940's
rebuilt
orig. kit
(burned)

← Early
20th c.
(c. 1912)

Vic.
(c. 1860)

← 1850's
(per hard.)

per elderly Mr. Kelly.
Arch. evidence supports

HBBS says "c. 1850" but the
C.I. looks w/ white ceramic knobs
look original & point to mid
or later 1850's - NJ

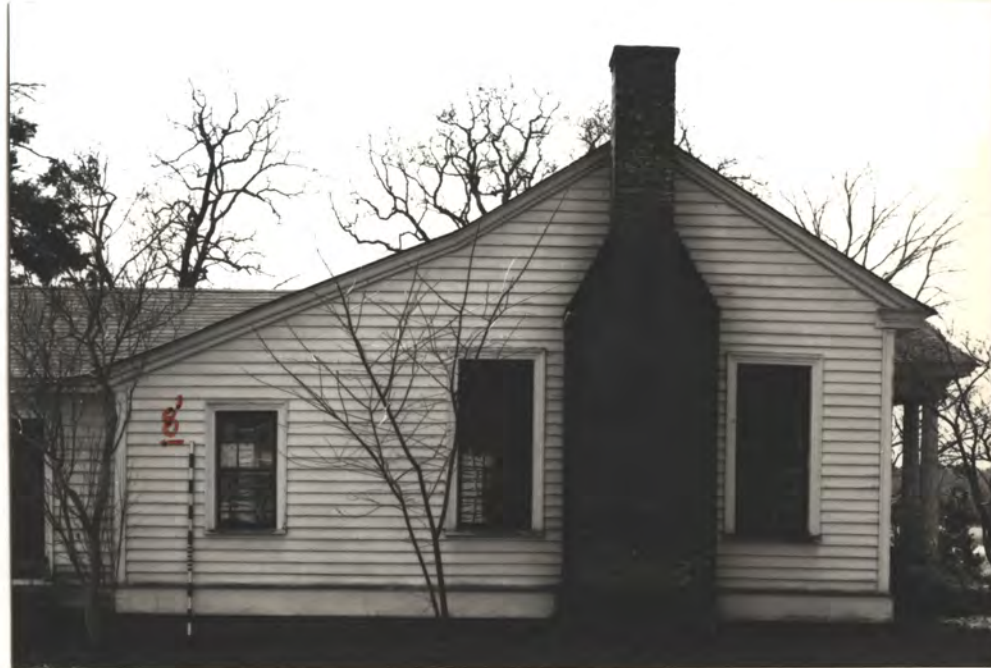
2

note typical 19th c
mortar joint profile

note white
paint
"penciling" on
jts., typical of
19th c.

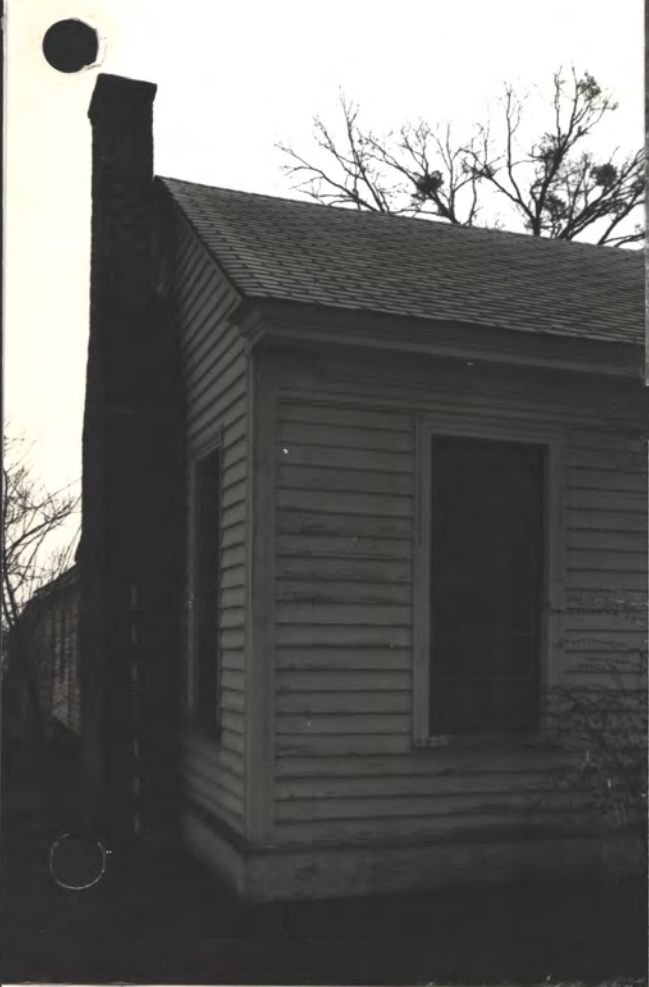
bottom 10" =
white Syracuse
marble

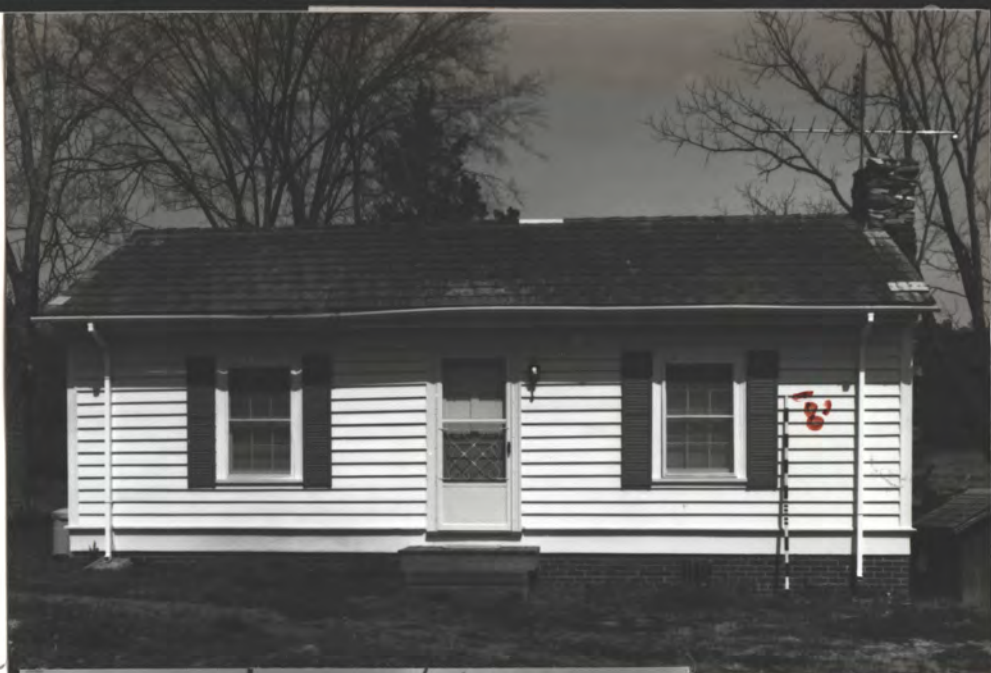
↖ 1940's bldg (2rm apt.)
= rebuilt orig. hse

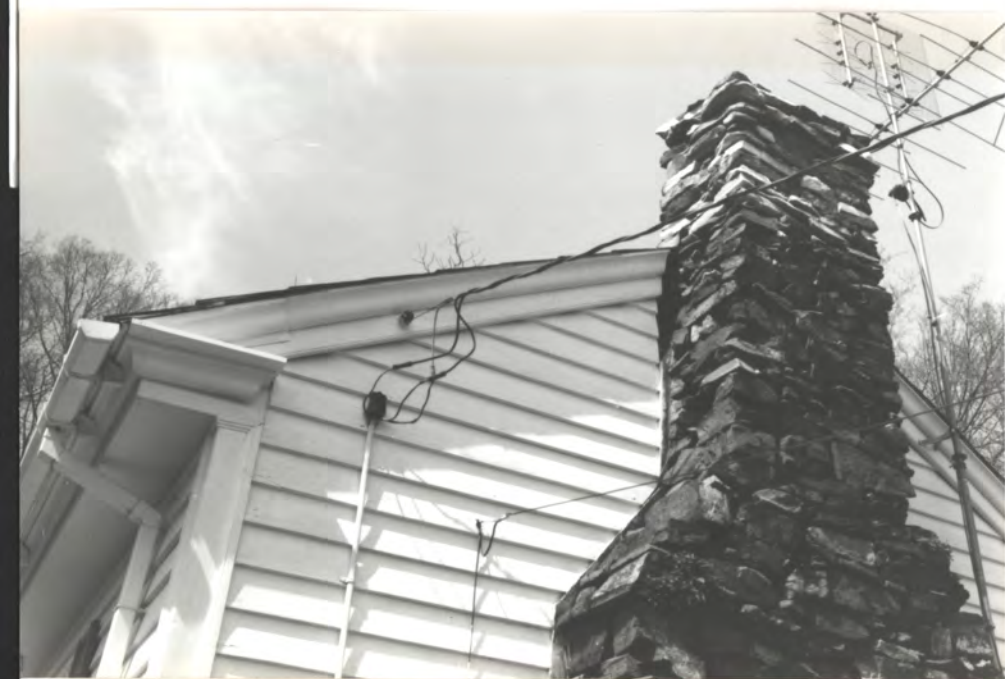
Chim. said to be from 1850's hse.
(looks st, per shoulder profile)

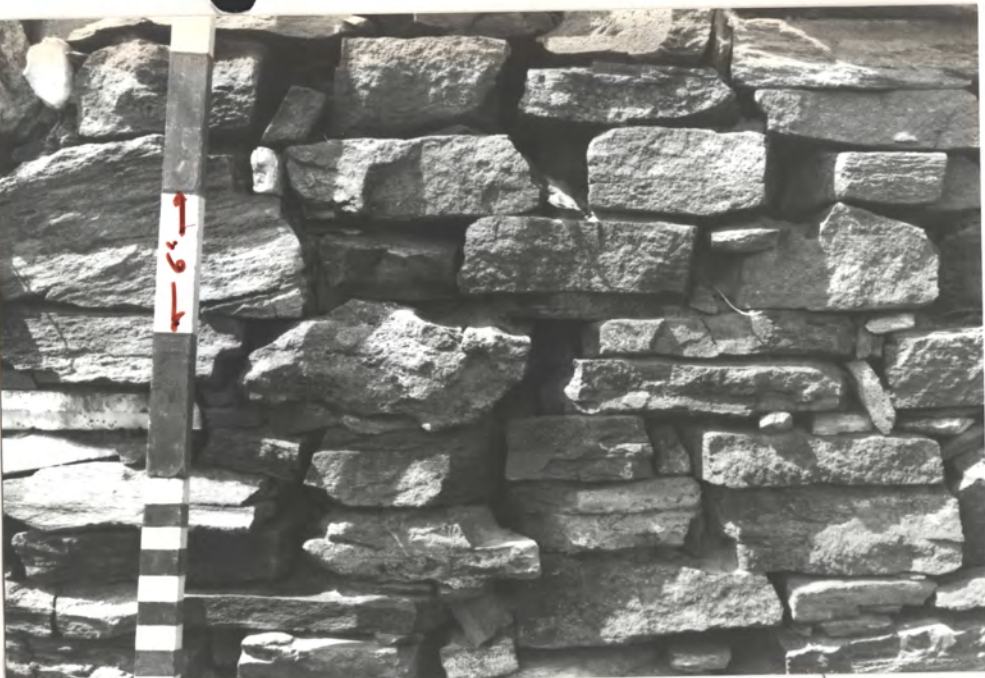
1950's chim. (sandstone) → N

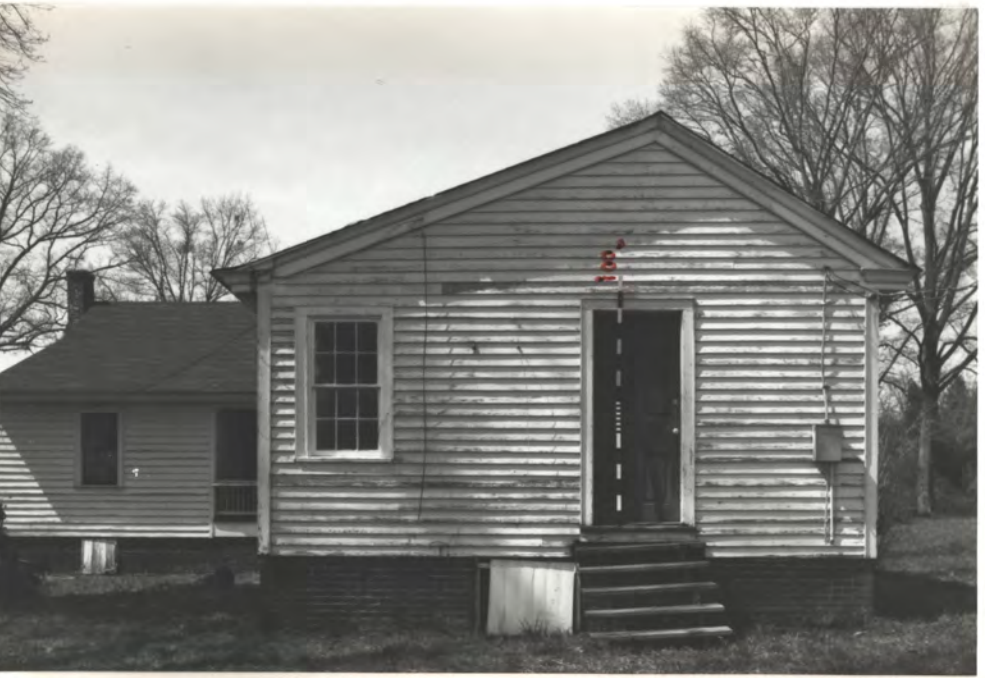
early 20th c. rear rm (kitchen) → N

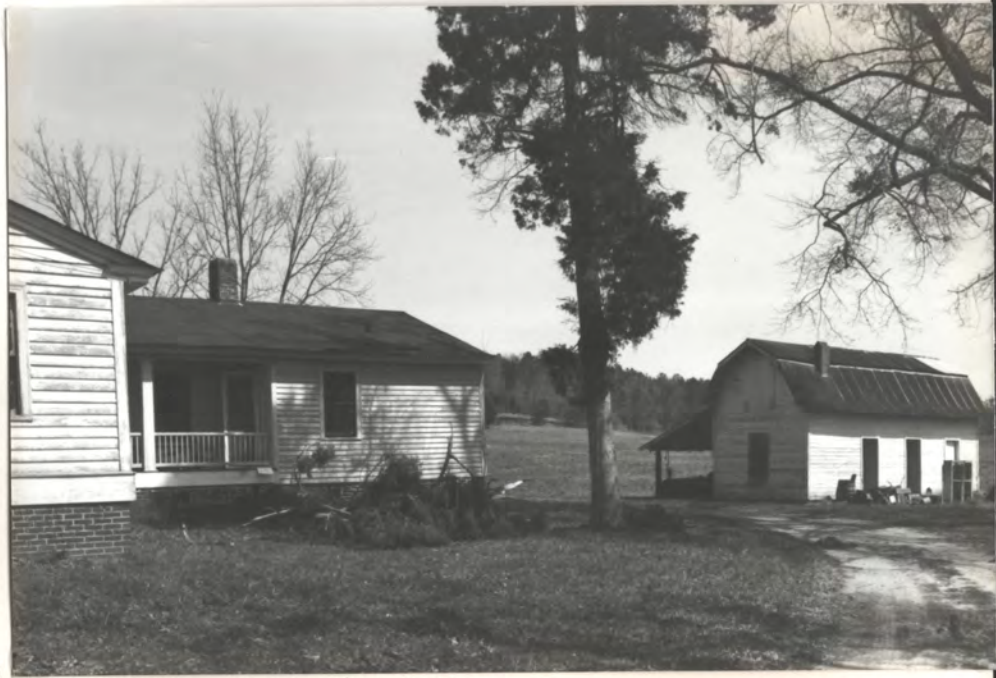
→ 20th c. kitchen

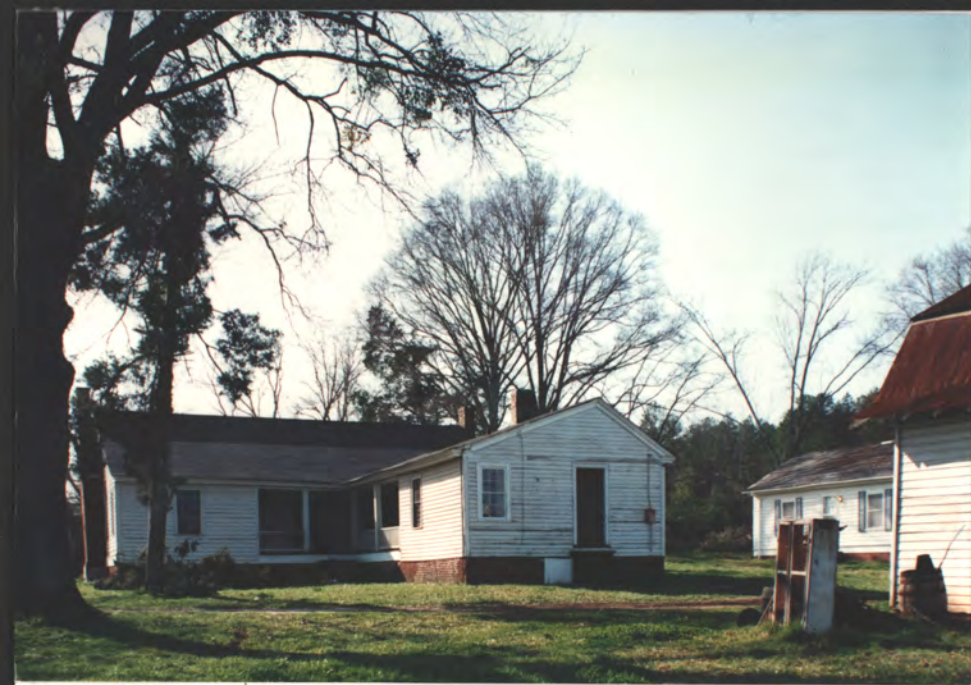
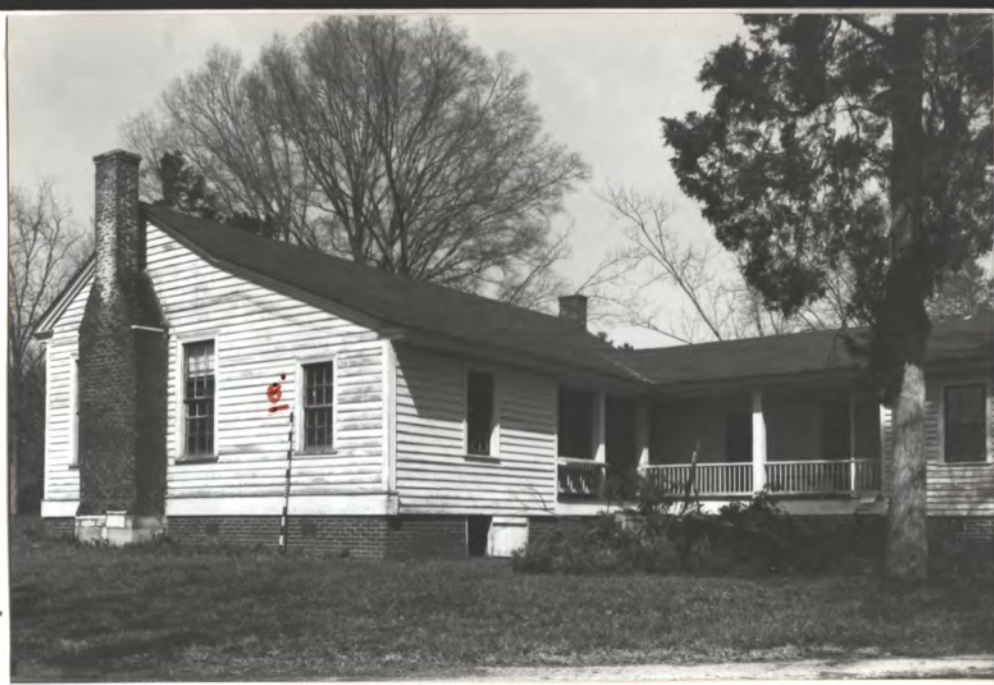
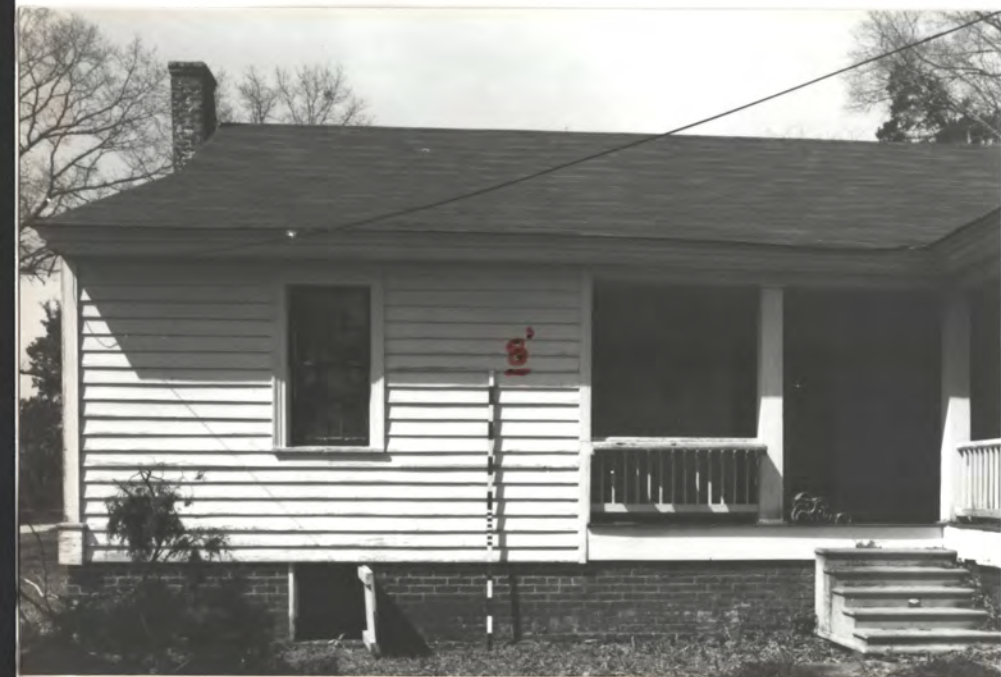
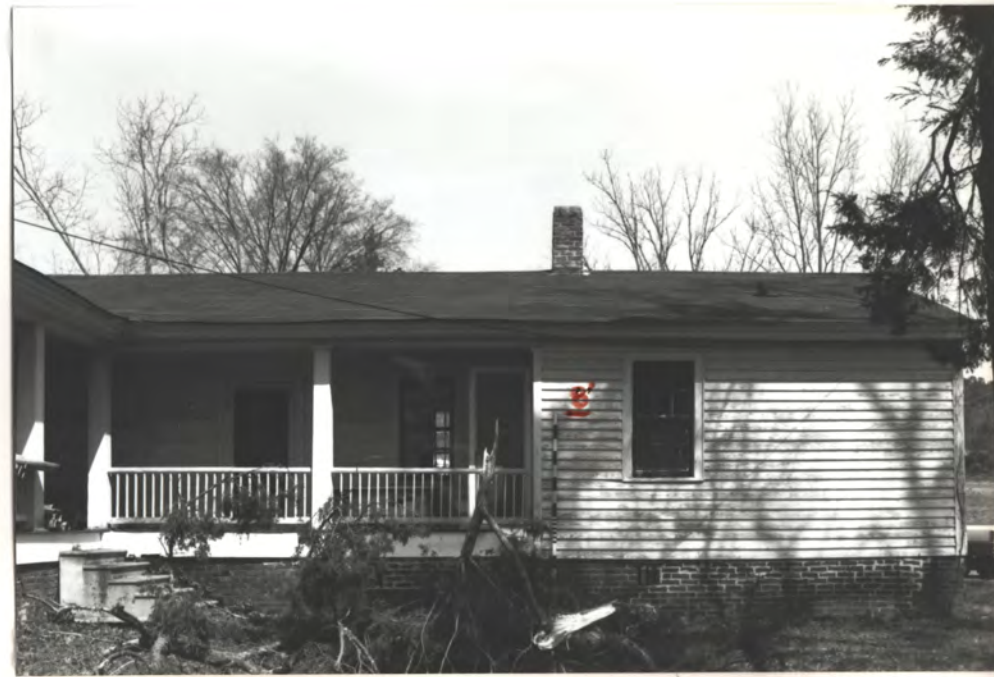
mod.
picket corr.
steps

20th c.
KIT

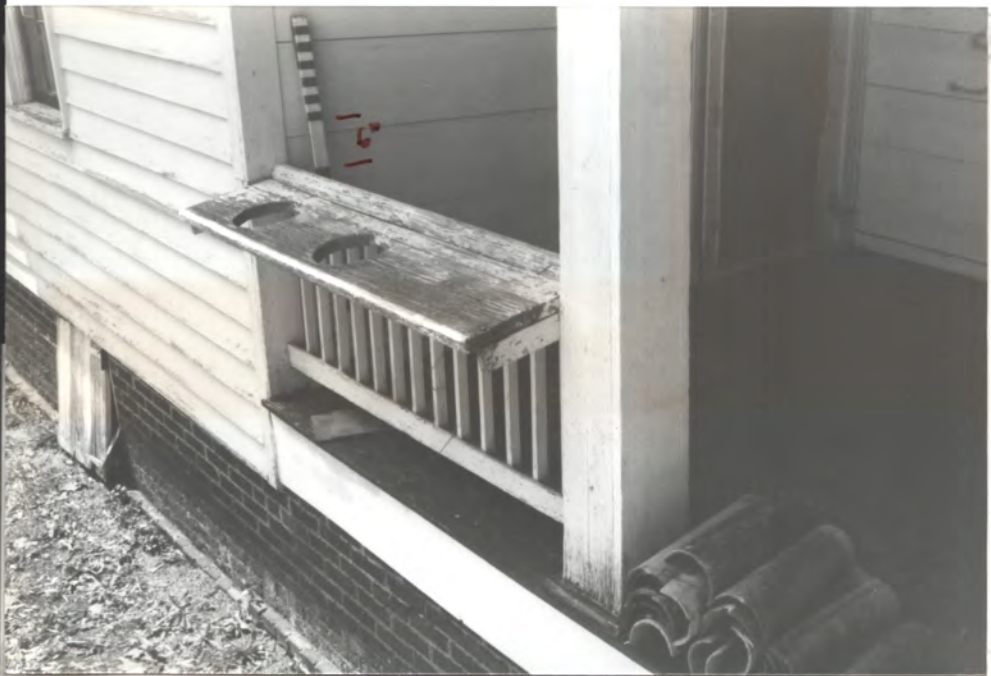
BACK (SE) PORCH
1850's

"Washboard holder" is unusual (holes for bowls)
(Usual is a shelf)

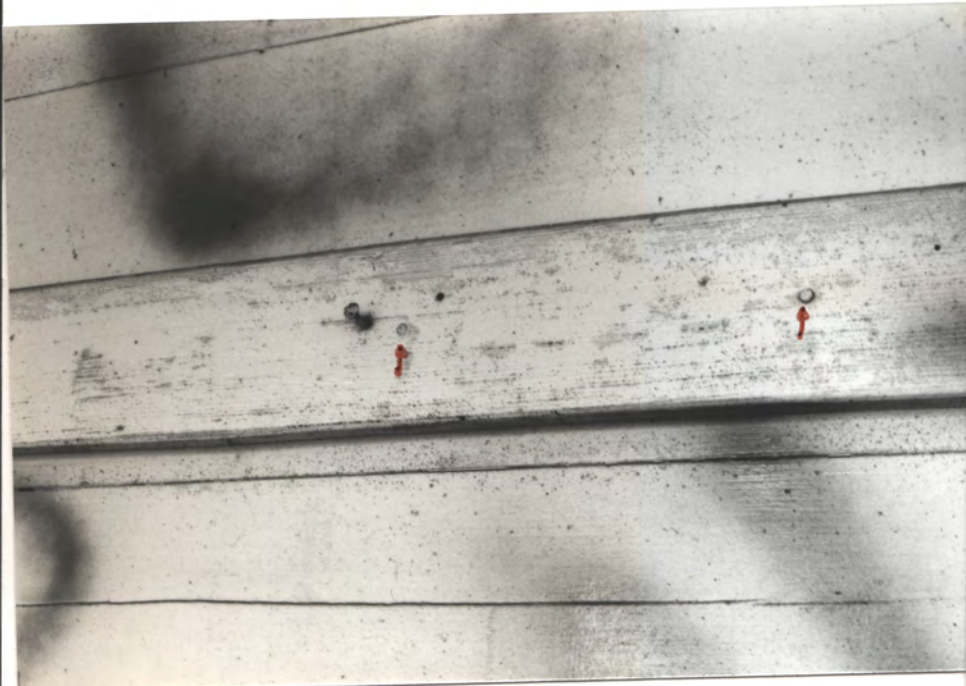
board mounted $\pm 6'$ h. on back porch,
to left of Rm doors.
Brown arrows show cut-off wood
dowels $\pm 1/4"$ ϕ for hanging bats
or coats

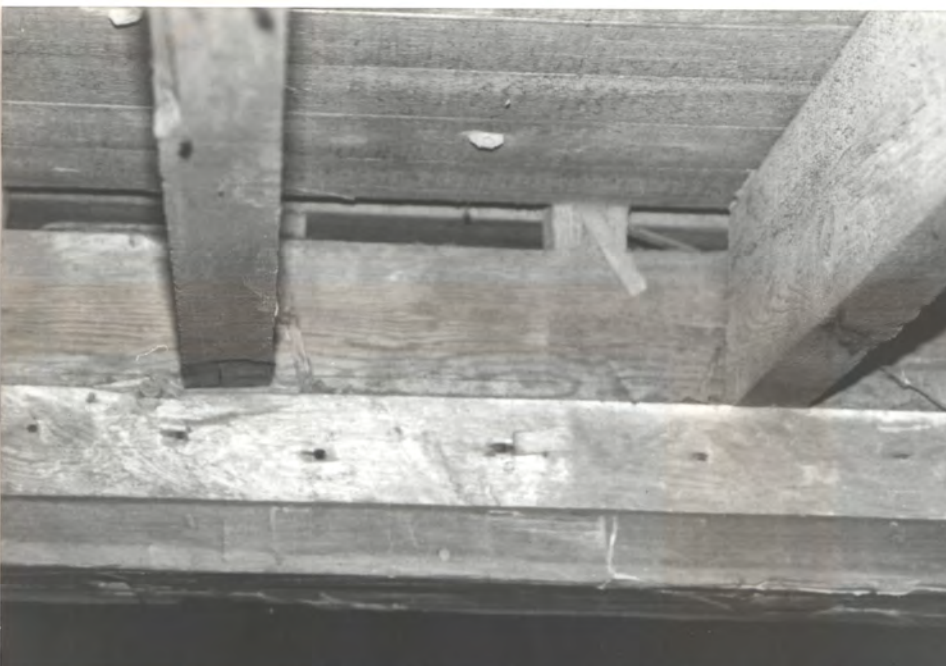
Ground space (1850s) under S. end of base, look W

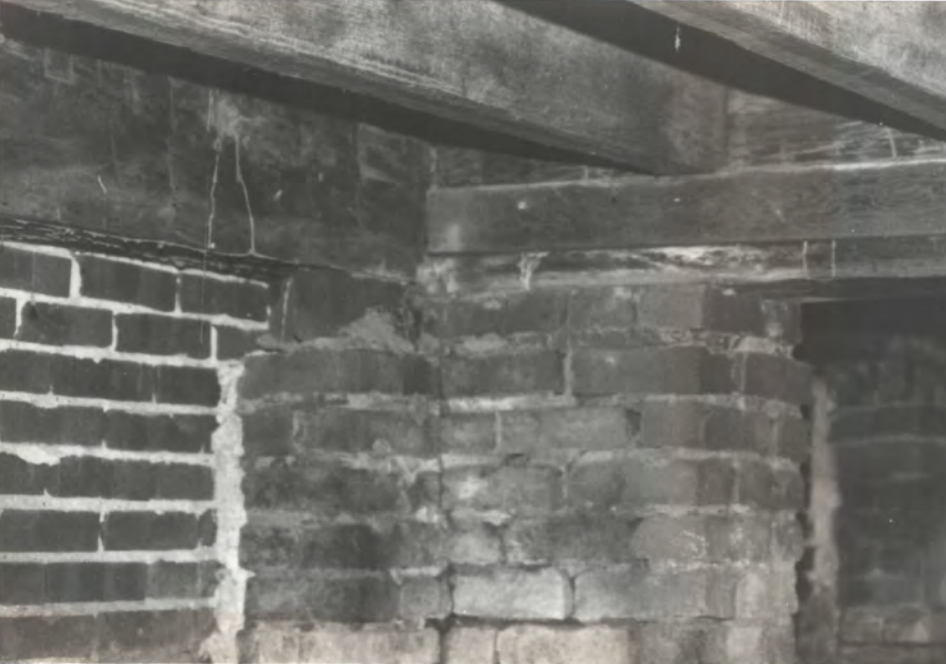
↘ Pt-sawn joists (hand)
 ↘ Sash-sawn 5/4 ft. (machine)
 = typical of 1800-1860
 Joists ± 4" x 12" nominal,
 ± 2' o.c.

↘ ON
 brick w/ lt. gr. =
 modern infill.
 Ground space open, originally.

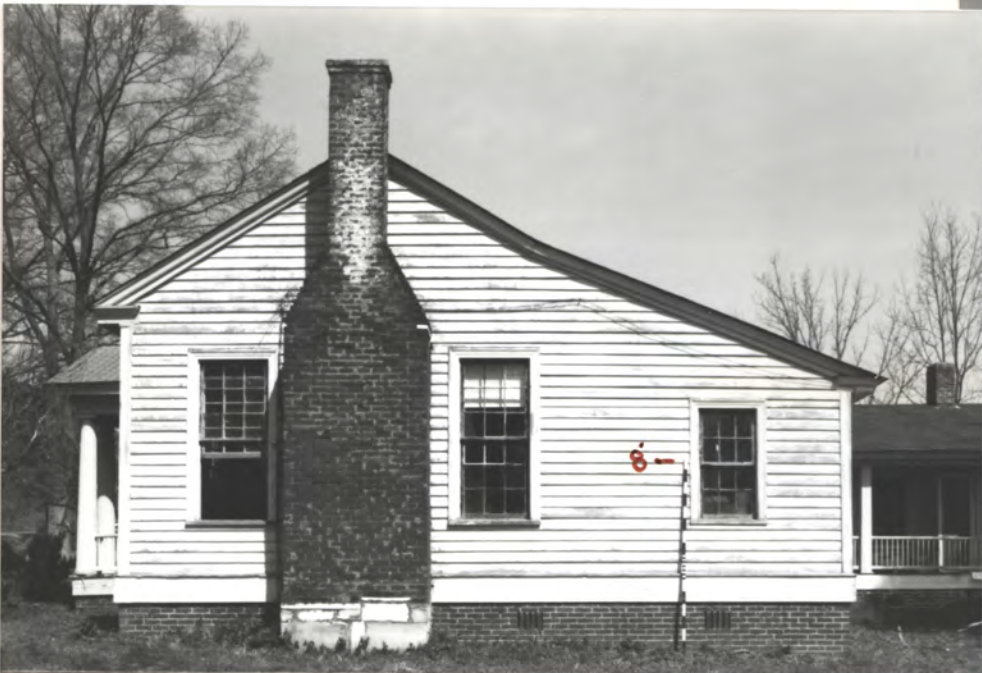
White = Synchrograph marble
Brick fndn. wall = modern

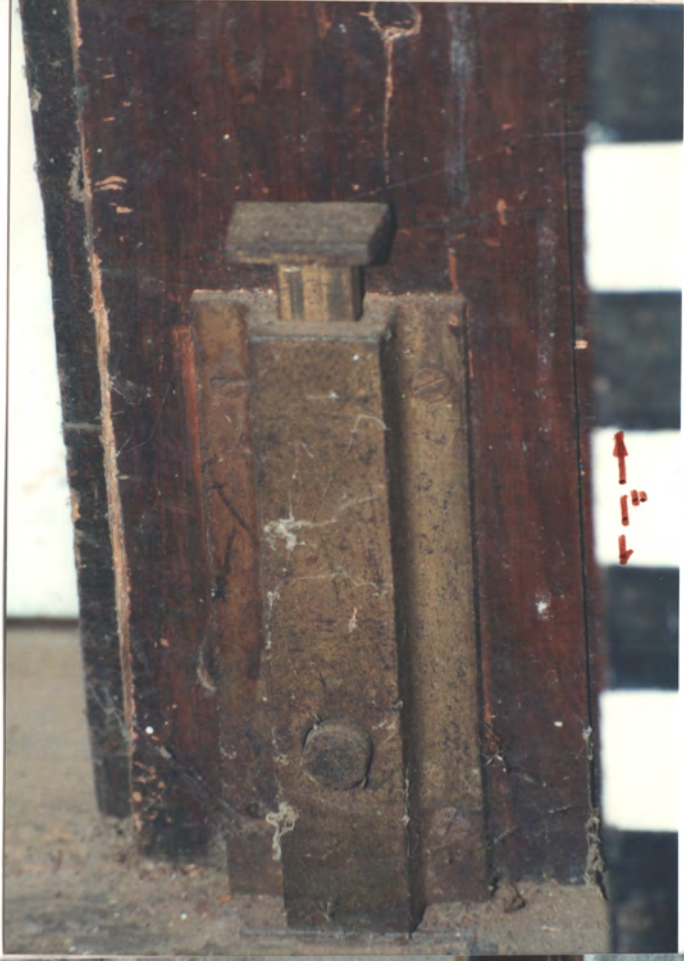
Rear (East) entry
fast bolt

C.I. "fast pin"
hinge at rear
entry (door is off)
Typical of
1800-1860

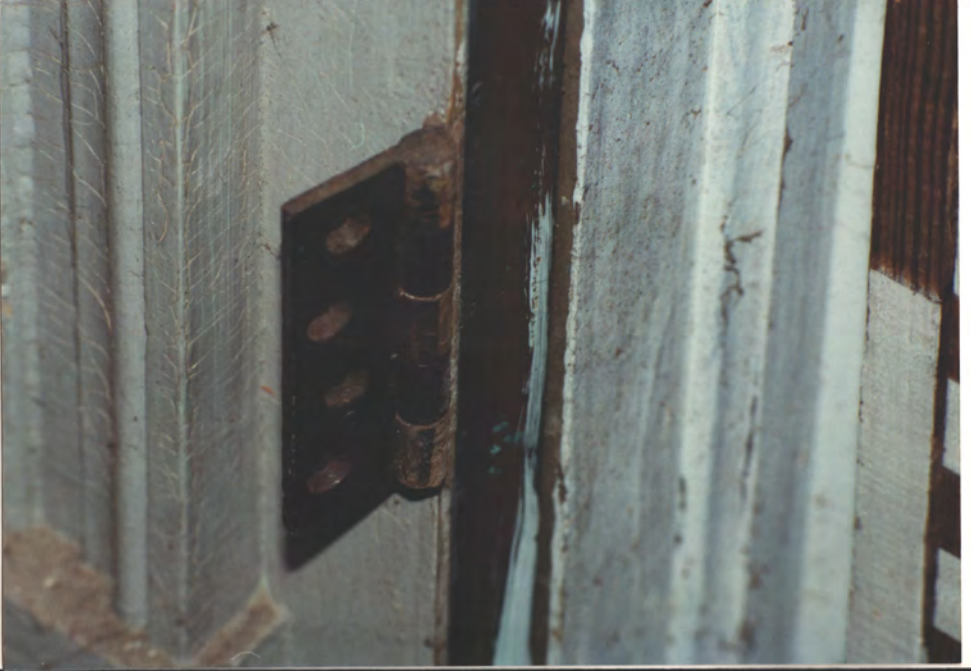
Handbolt at rear (east) entry
(See photo at rt.)

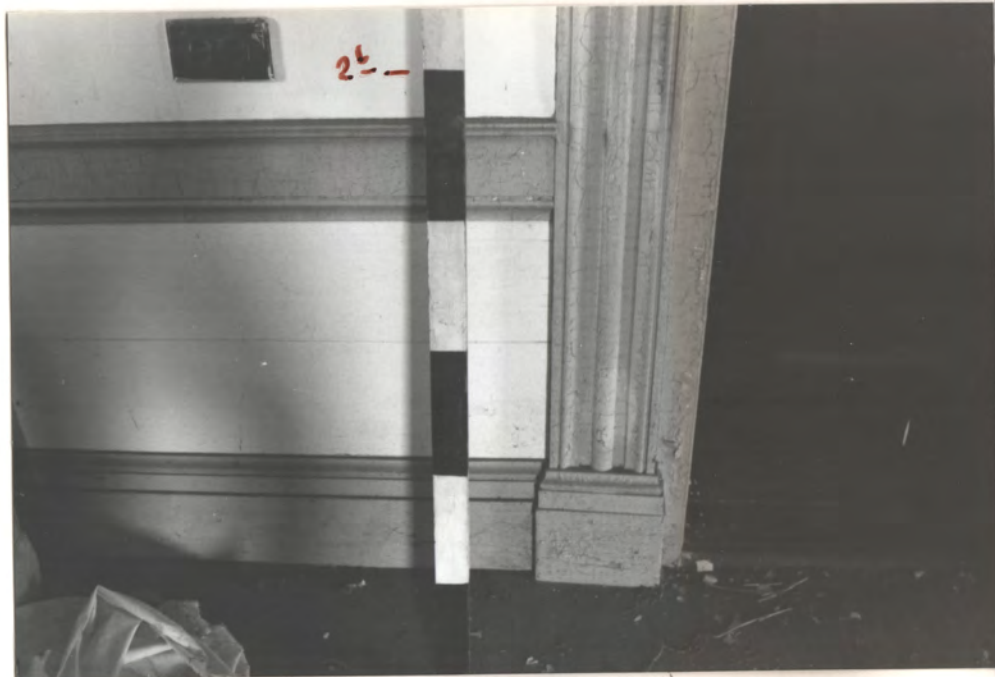
Ham door to NW room

Ham door to N.W. Room #1

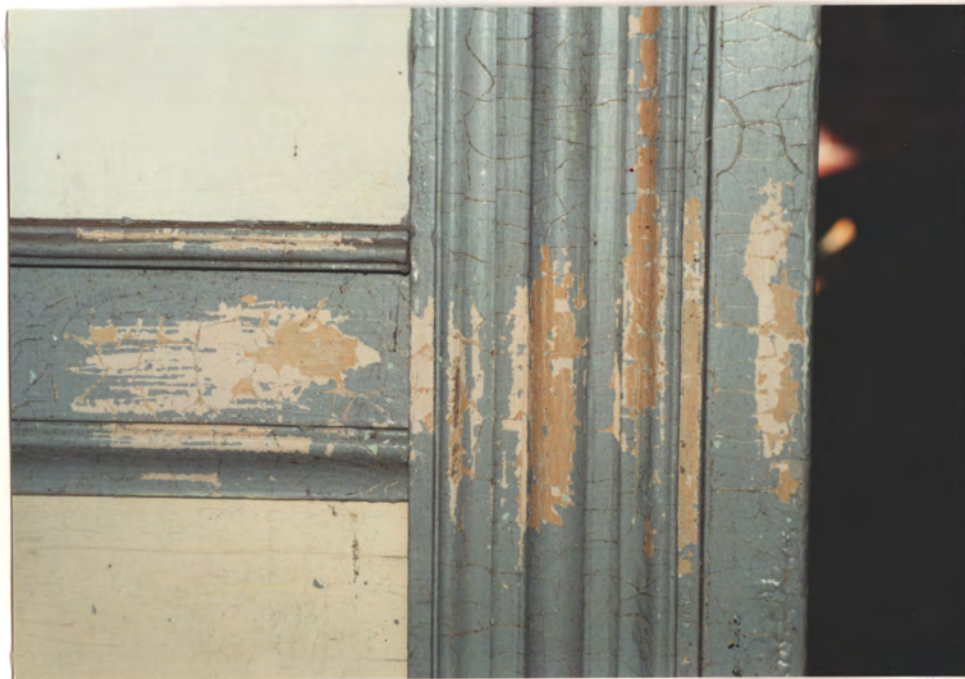
original color = caramel #1

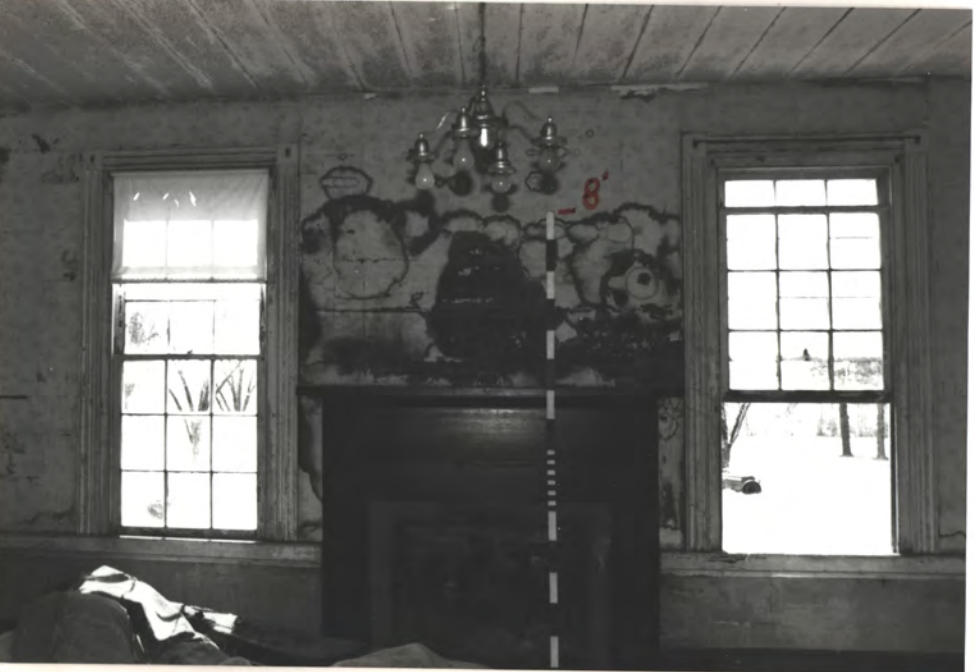
S.W. 1855's Rm

ceiling
with
wide
boards
(original)

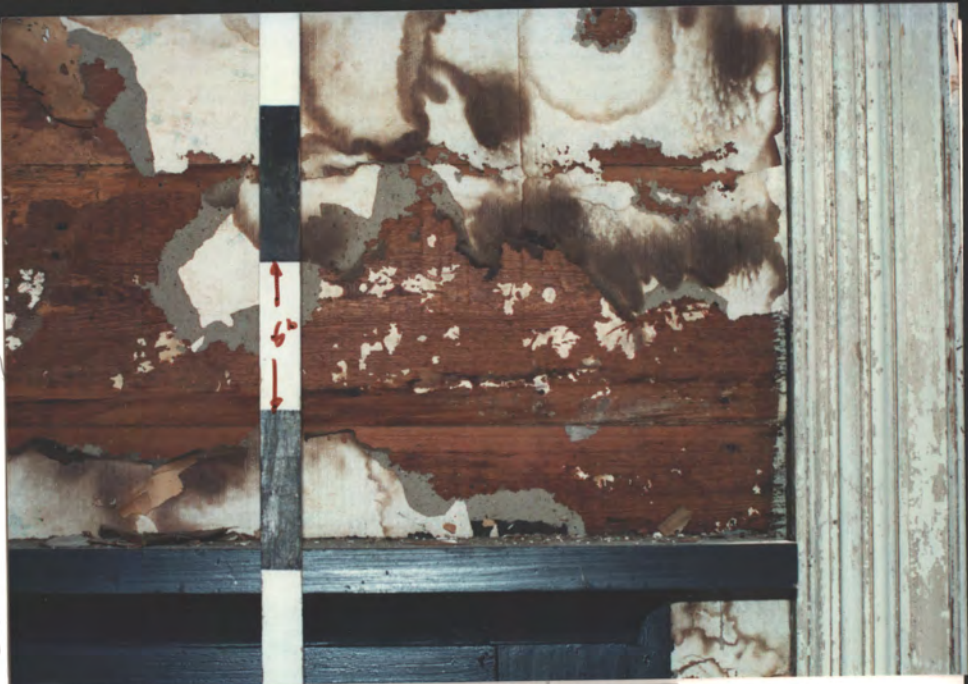
Note Sash plane
marks on mantel
= stl. 1800-1860

Black paint
= virtually
standard for
1800-1860
mantels.

AS has
checked
perhaps 75
of all but 2
were originally
shiny black
(some marked
probably)

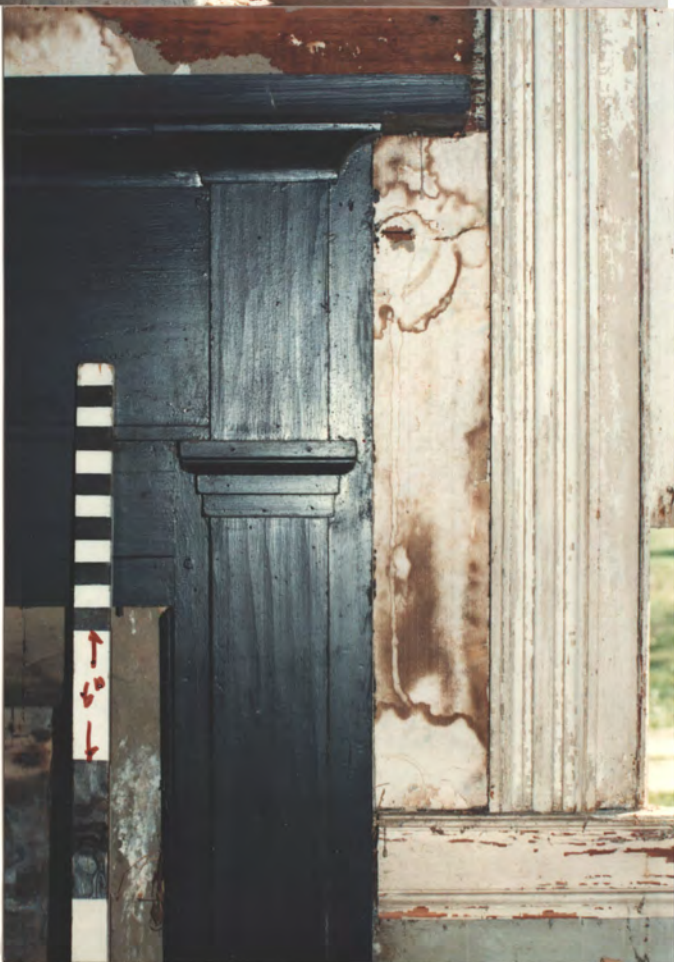
S.W.
Dm
S.W.
ORIGINAL
MATERIAL

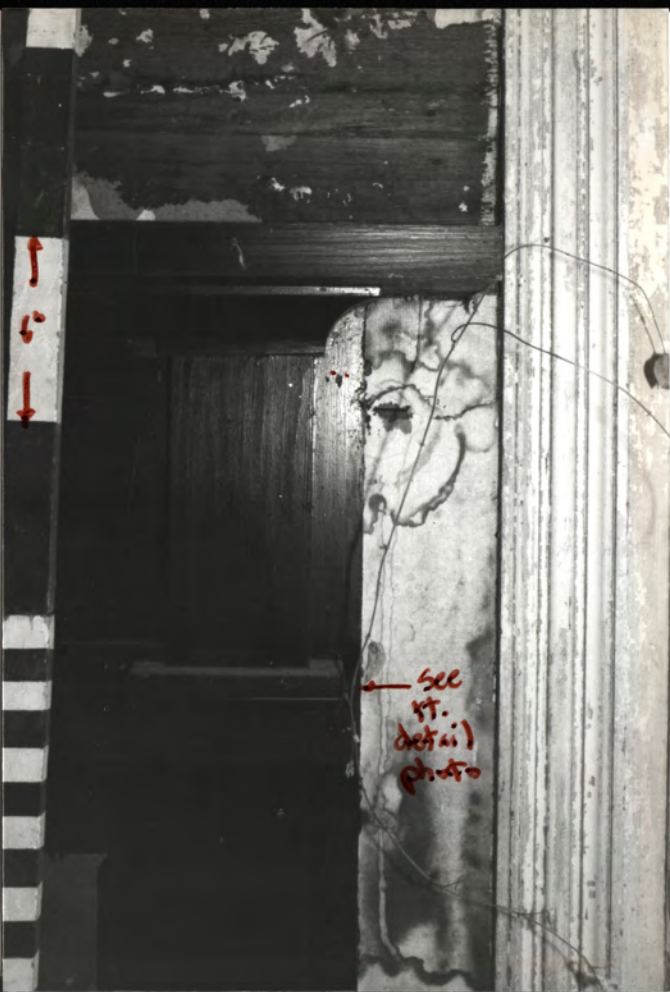
↓
Plaster surround =
stl. 1800-1860

S.W. BH - ORIG. MBH 76L ← pilaster →

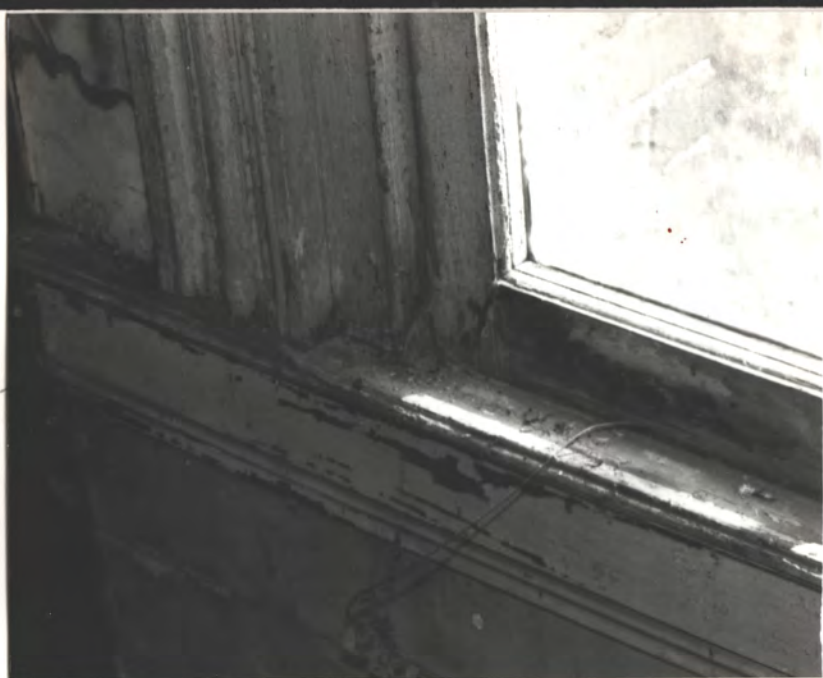
S.W. RM, S. WALL

walls = wallpaper over
w/fin. Sash & inner planks
(orig. cord)

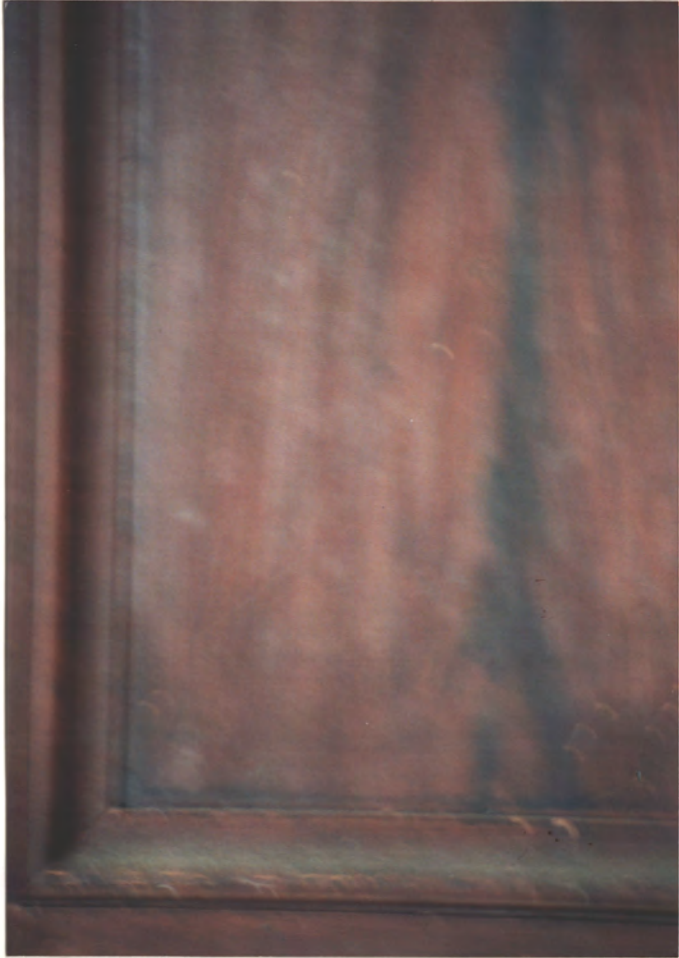
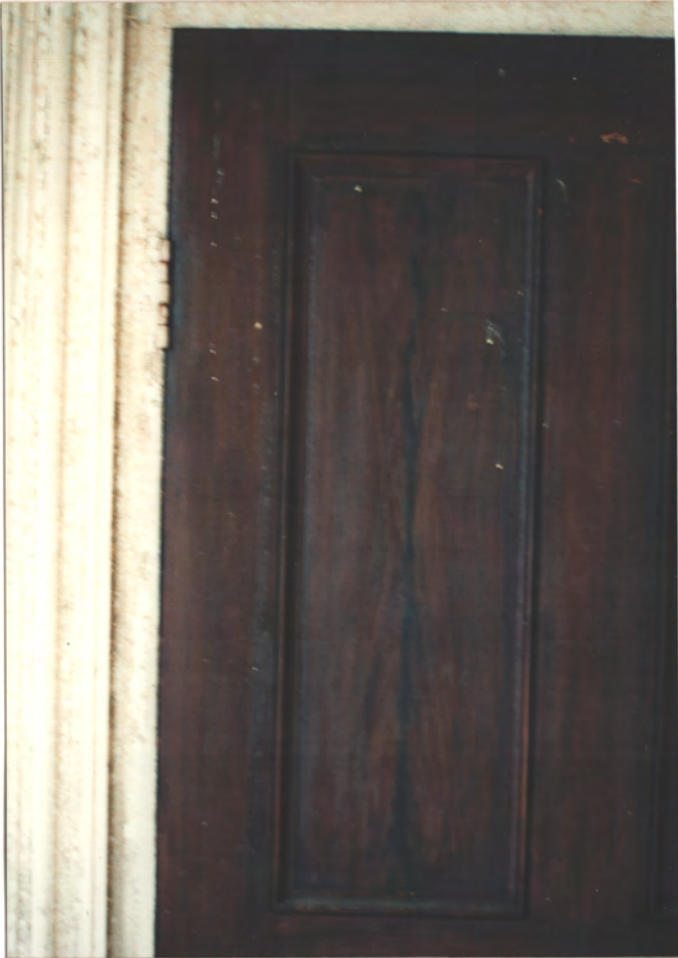
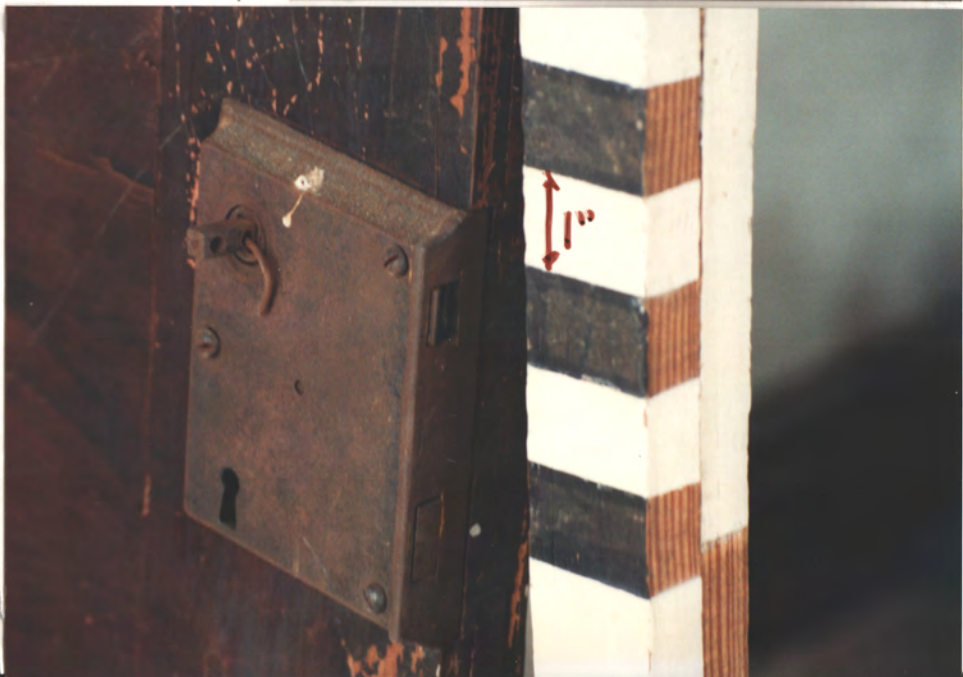
probably original
C.I. lock
(w/o cr. knob)
Shape is usual
for 1850's
(vert. dim. &
battered edges)

Probably
original
graining
on hall
door of
S.W. Rm.
↙ ↘

S.W.
Rm.
SIDE
↙
HALL
SIDE
↘
same
LOCK

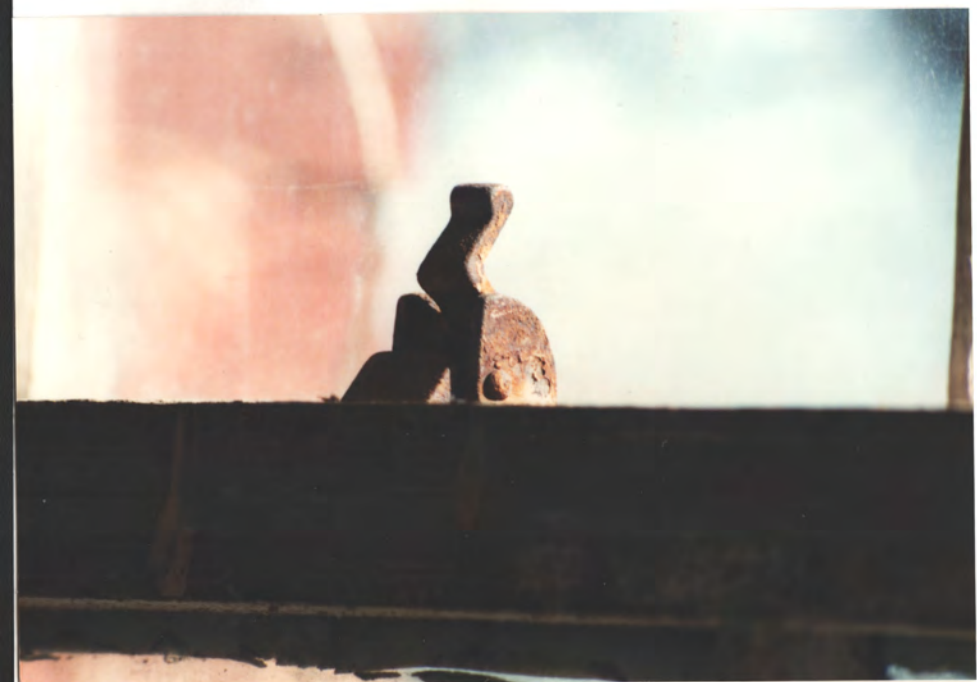
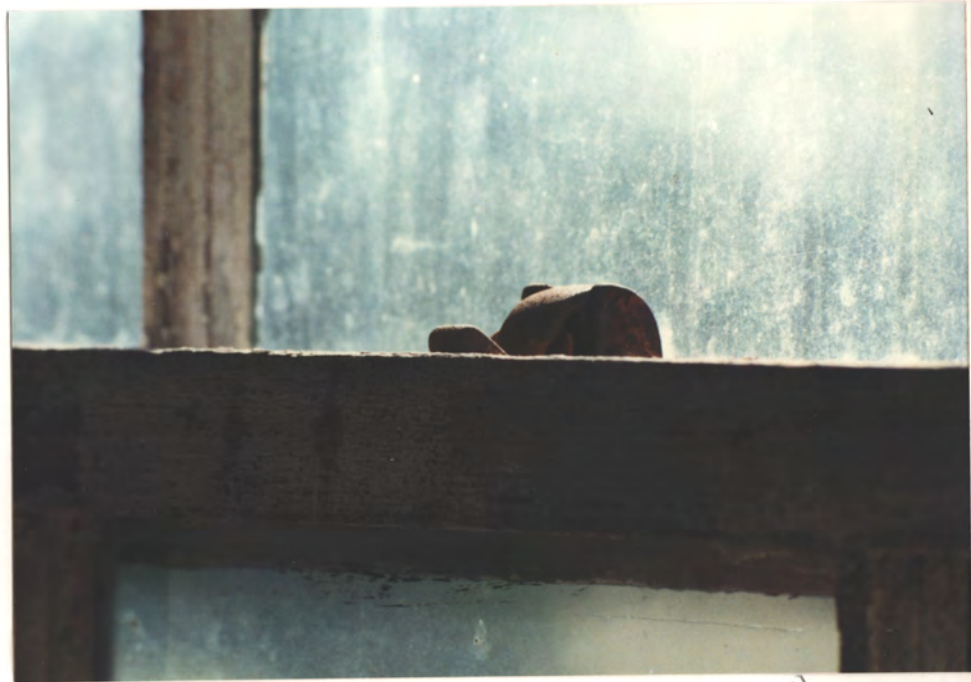
OPEN
(S. window)

C.F. Sash latch in S.W. Rm (is also in N.W. Rm)
probably is 1850's

CLOSED
(W. window)
