1850's Bledsoe - Kelly Hse (1993 owner = Charles Kelly) Al. 21, 1.5 miles N. of Snylaccuga, Al

Re: Kelly 1840's House Restoration
"Mountain Springs", H.A.B.S. Al. 428
Sylacauga, Alabama
Project No. 93027

Field Notes H Jones
 Mar. 1993 "Kelly Hse"
 c. 1840-50's "Htn. Spring" Hse

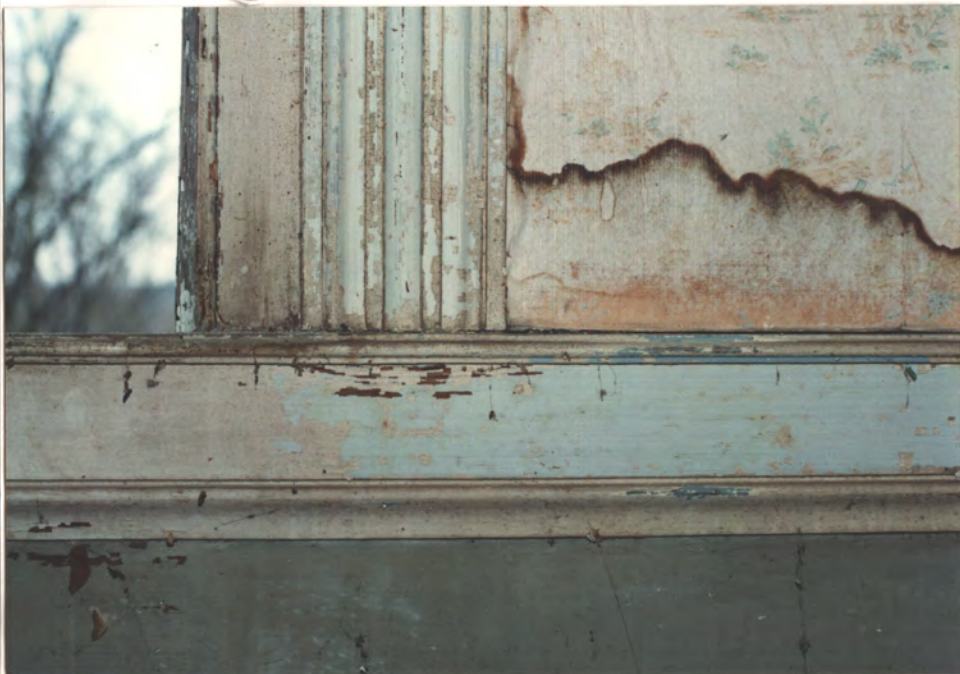
original
paint
exposed
S. W. L. L.

← robin's egg
blue =
original
→

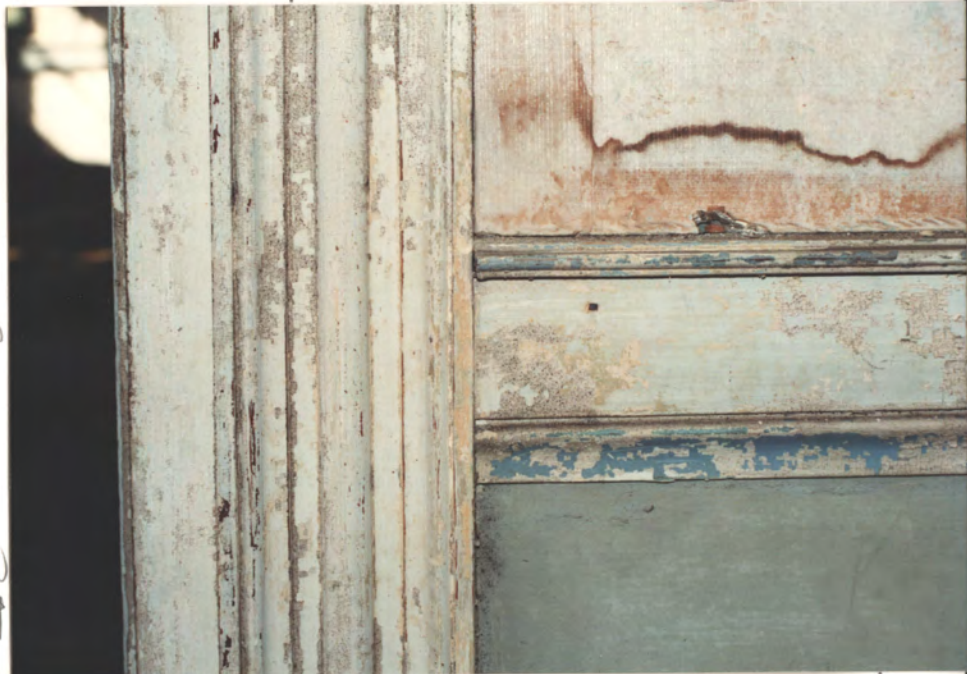
↑ blue = original fin. layer

1850's
S. E.
(small)
Room

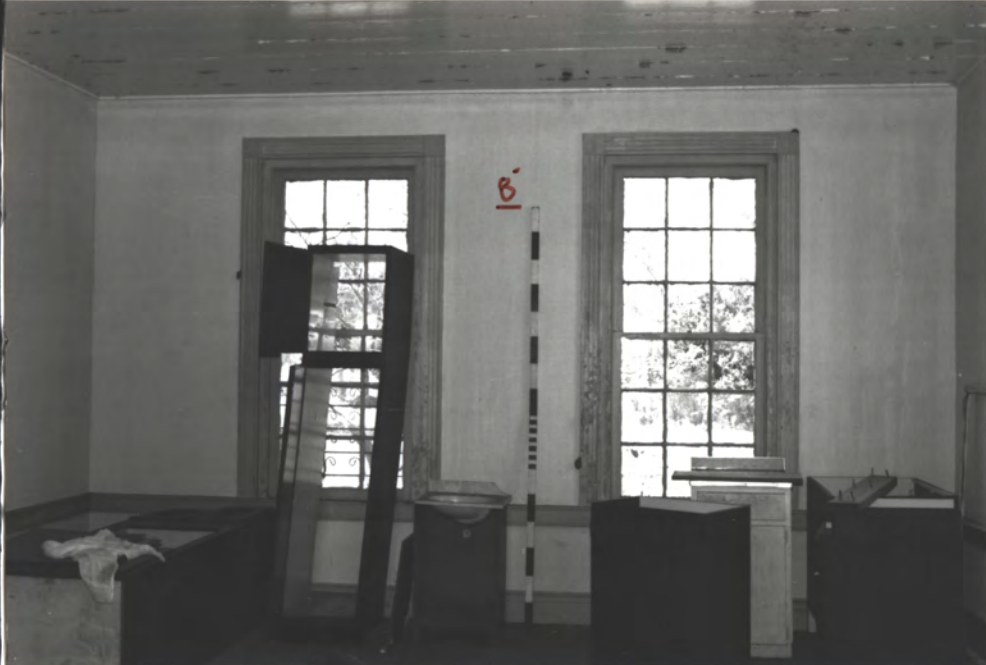
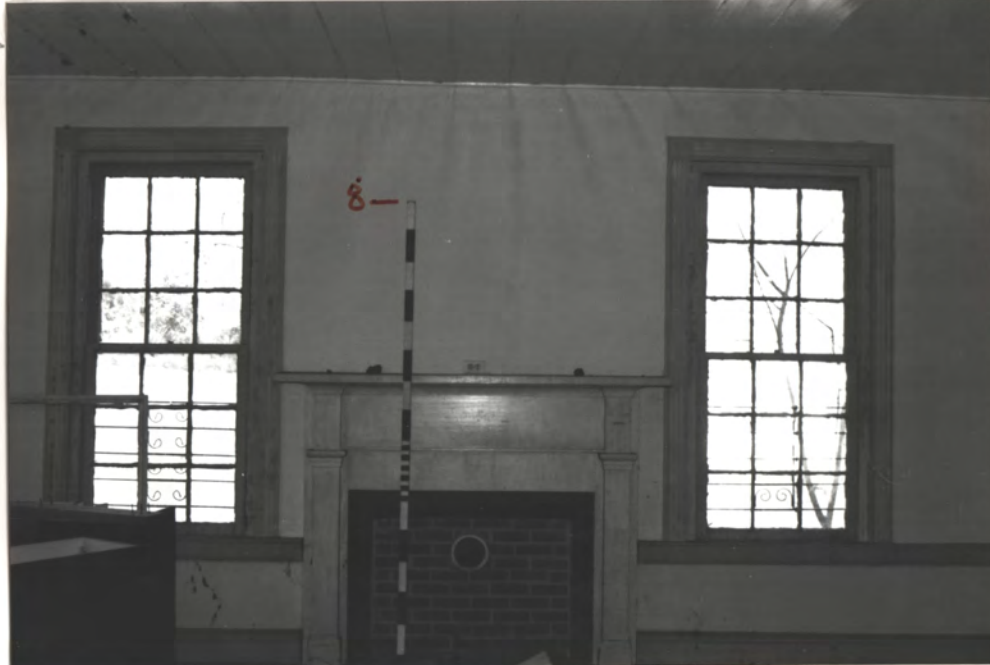
Ceil.
= wide
bld

→ N
Walls = modern "shetrock"
probably over orig. bldg like at SW Rm

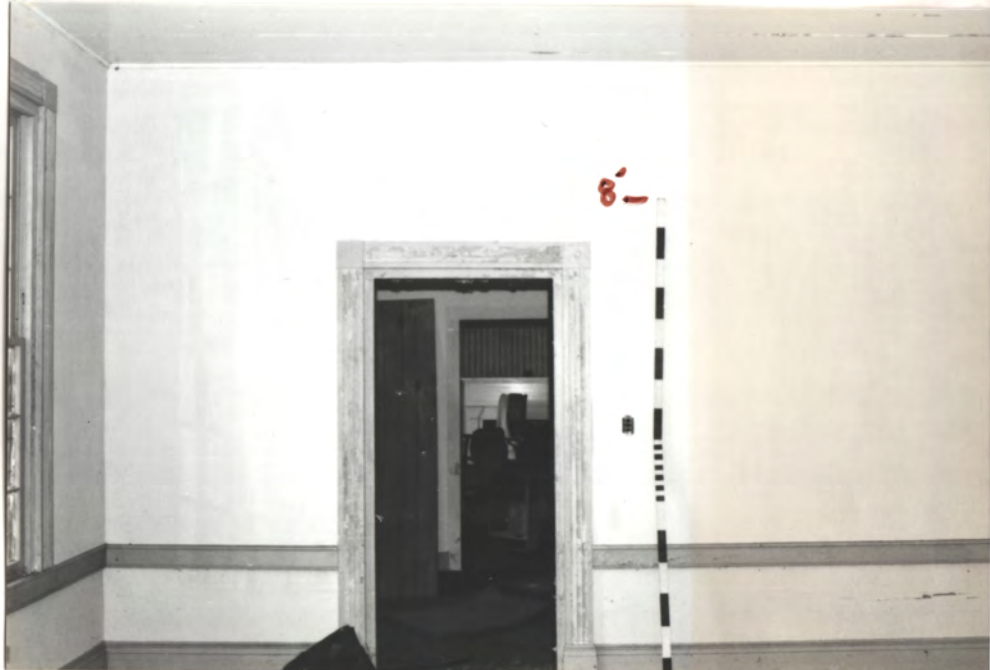
N.W. 1850's Rm
(orig. mantel, was black)

↑ to entry hall
→ N

→ N
↑ to all rooms

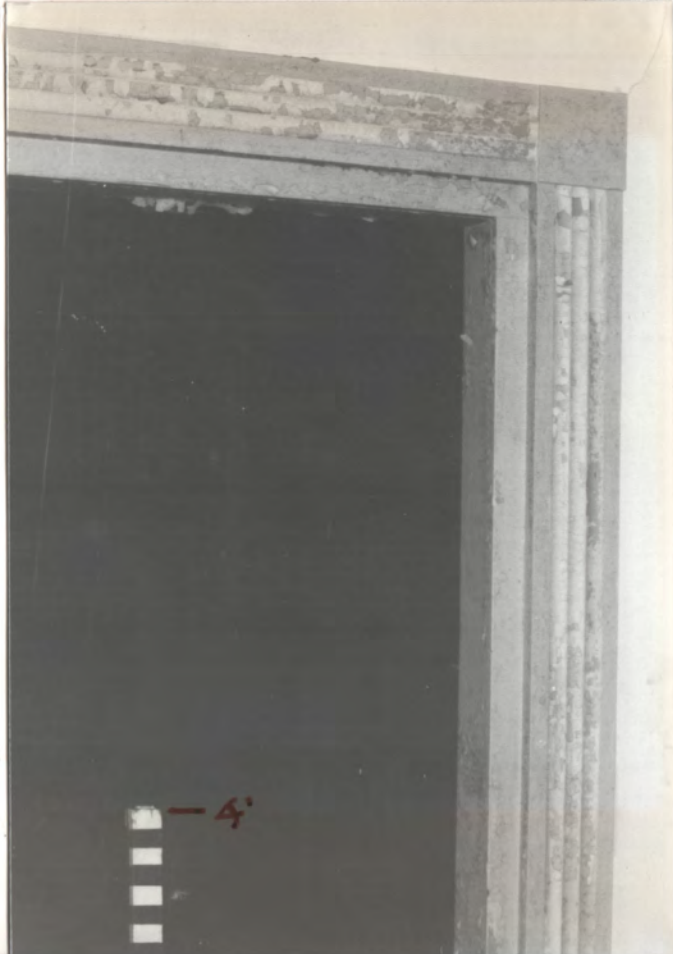
W. Fc.
N.W. Rm
S. door to
hall

N.Fc. of S. door
of N.W. Rm. to
entry hall

← W side of
S. door to
S.W. Rm

prob. the
original
grain
on N. side
of S. door
at NW corner

← orig.
CT
hinge

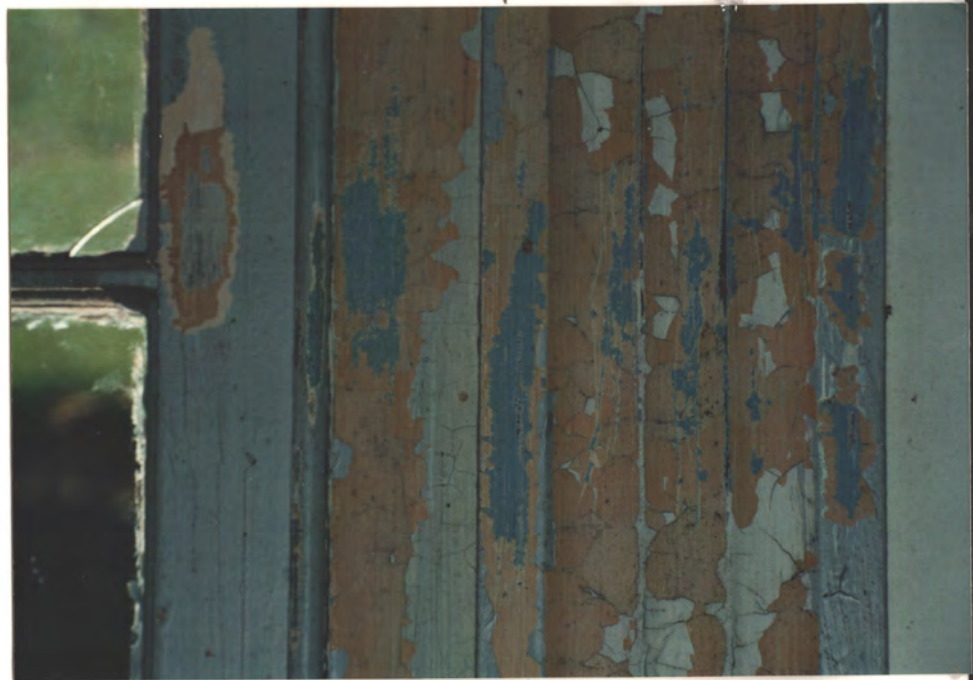
lt. blue on sash
Med. blue on trim

Medium Blue
= ORIG. color
←

←
E. Dow frame

Orig. paint colors of NW Rm trim (W. Sash W. Sash frame)

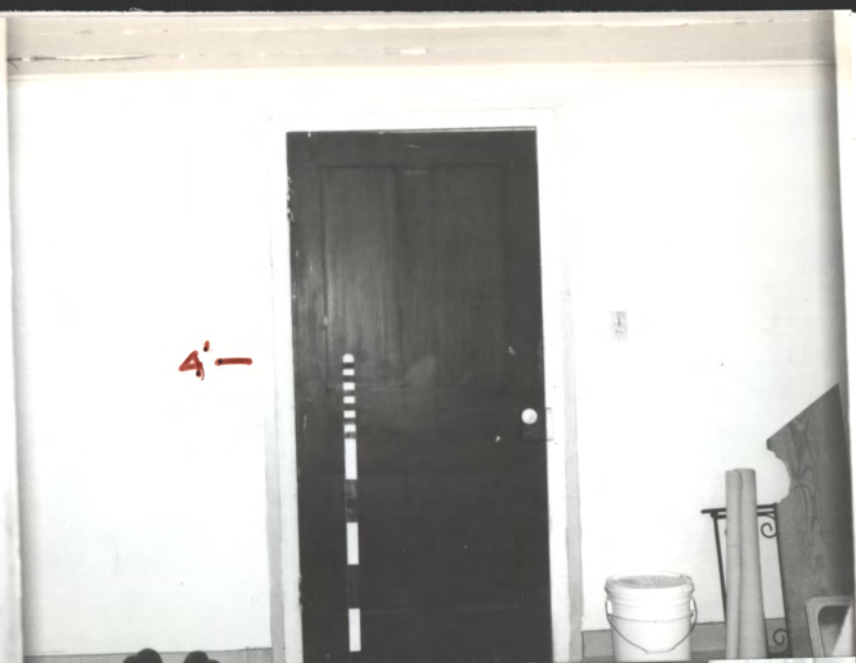
E. fac. of S. door
in N. Cont. Rm
(92 x 13 1/2 Rm)
(1950's Rm)

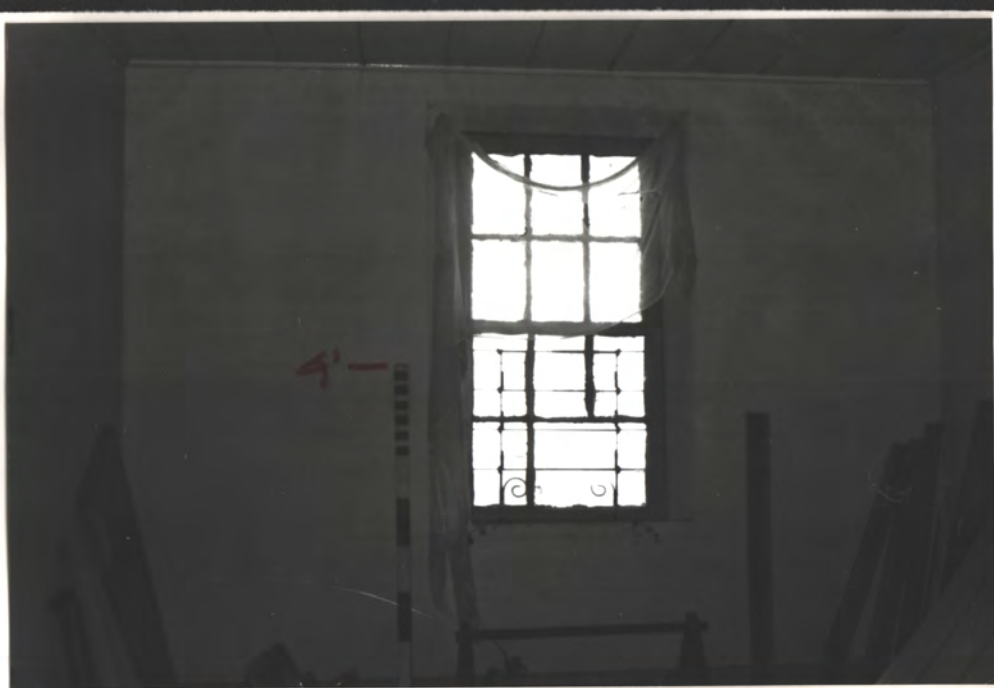
4N N. wall of narrow (92) N. C. Rm, (1950's)
