JONES & HERRIN

August 4, 1997

Re: 1829 Gorgas House Museum, The University of Alabama

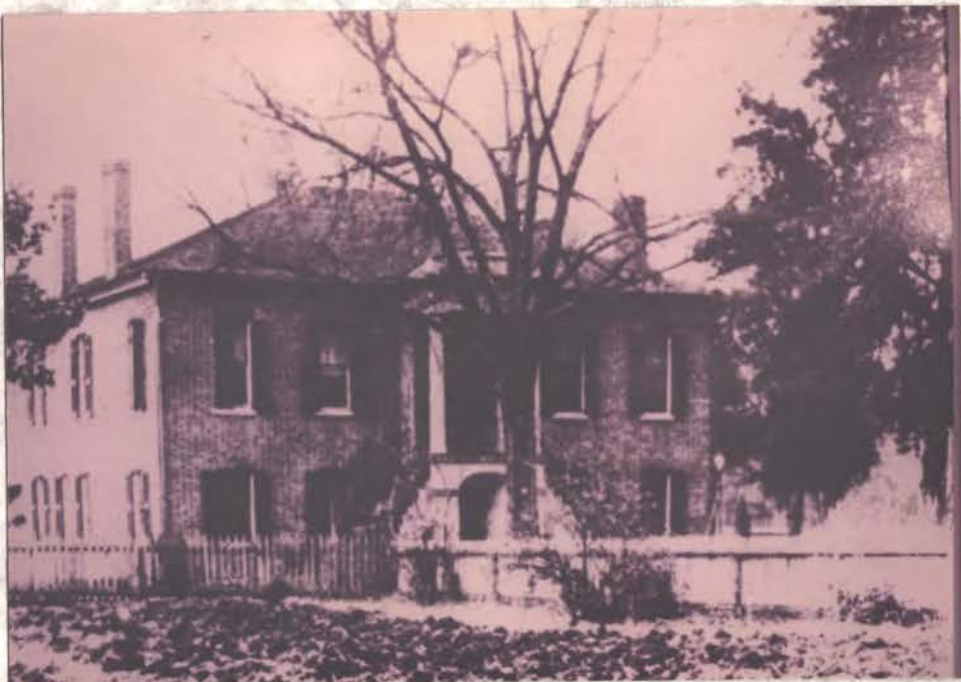
BRICK
WELL
c. 1970
(?)

PHOTO = POST-1853, PRE-1896 (1-BAY PORTICO = 1853 PER HABS
3-BAY PORTICO = 1896) - PER HABS

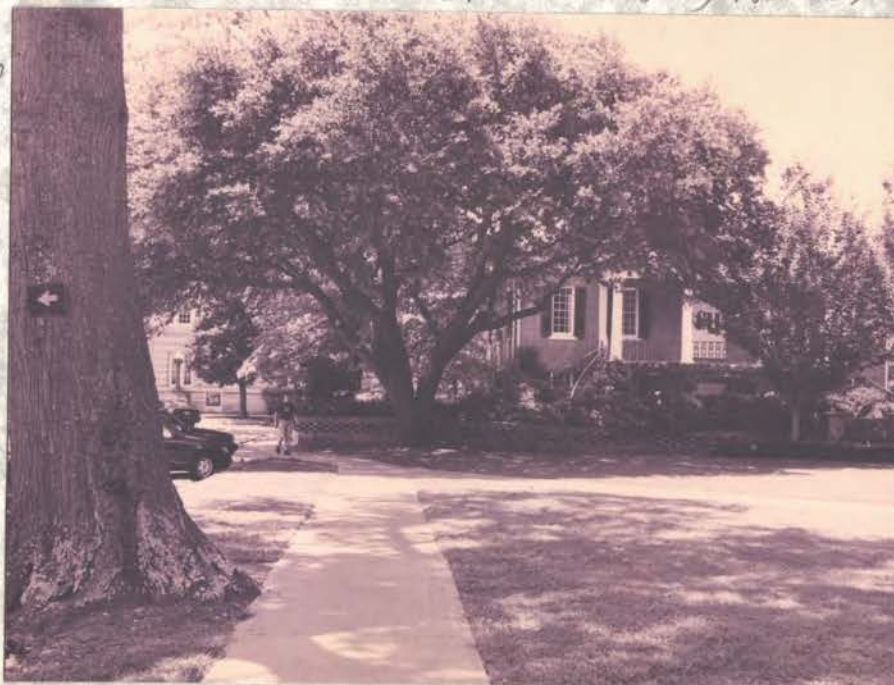
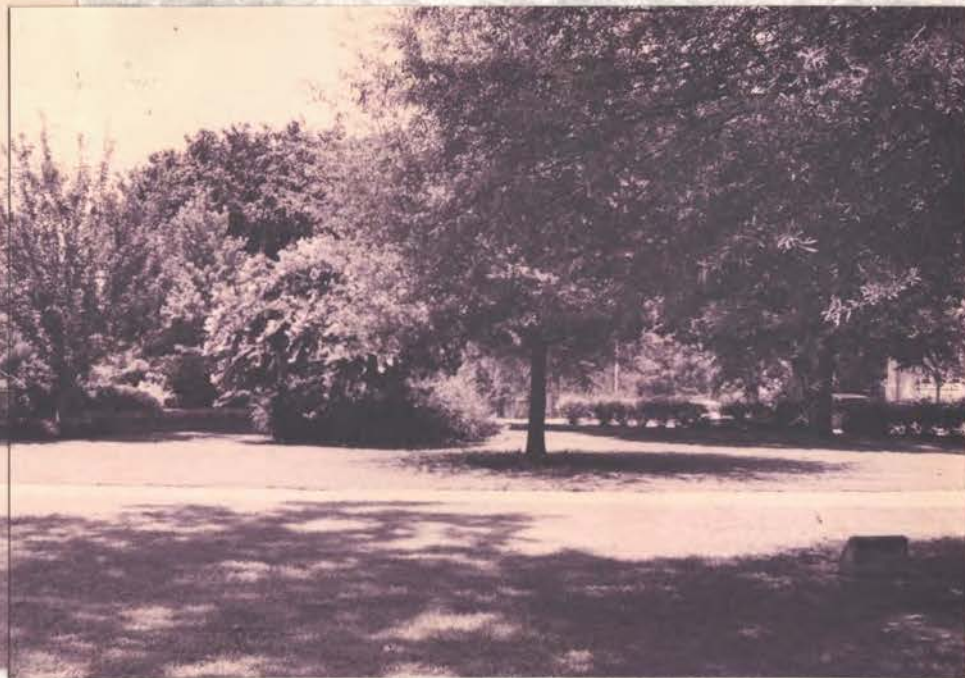
GORGAS LANE, UNIV. OF ALA. - TUSCALOOSA
1 AUG. 1997 PHOTOS, HARVEY P. JONES, F.A.I.A. - JONES & HERRIN, ARIZ. - HUNTSVILLE (FOR RESTOR. STUDIES)

1997 PHOTO - 3-BAY PORTICO = 1896 PER H.A.B.S. H15Z

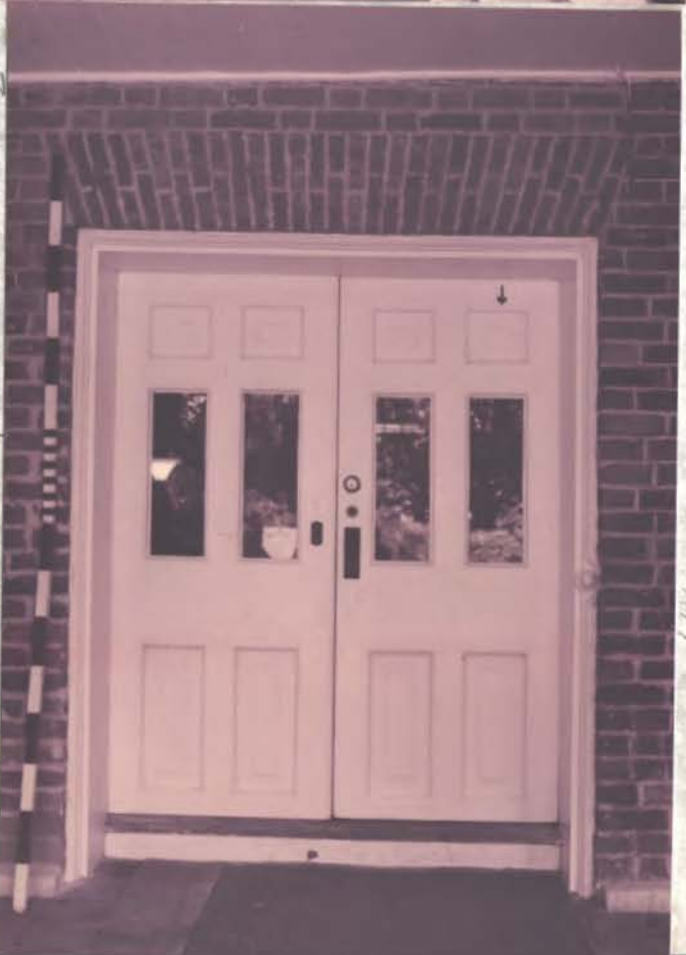
MOD. BRICK PAV.
INCORRECT PATTERN
SHOULD BE
(LIKE ORIG.
HEBERT
IN FL. 2
N.E. RM)
E MBW OTHER
AL. 1974. C.
EXAMPLES

GL. PNLs = LATER.
WERE WOOD
ORIGINALLY

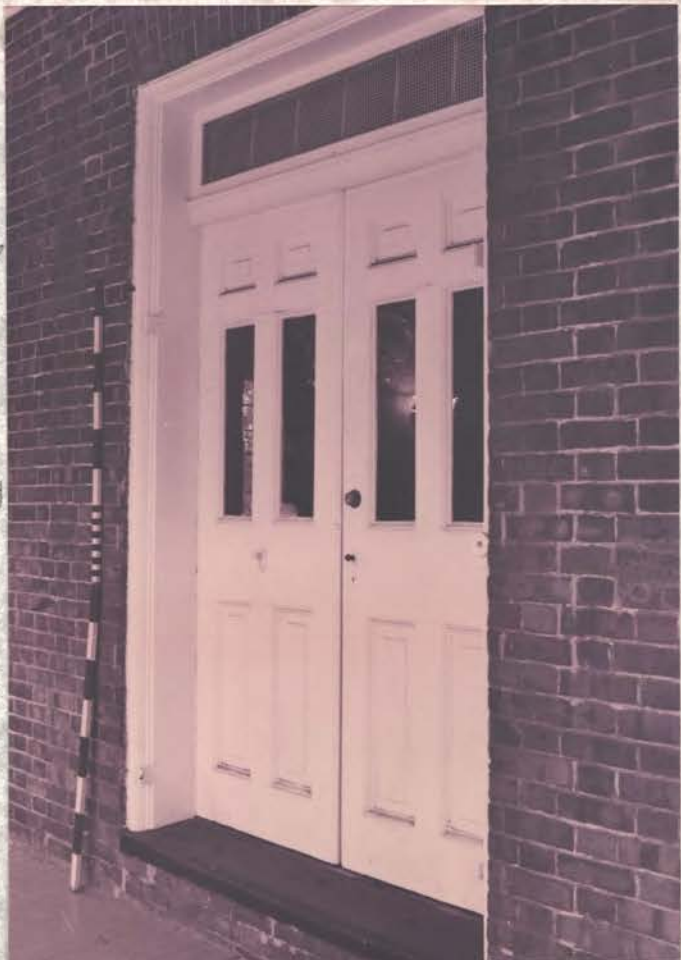
MOD.
HEAVY
GALV.
MESH
OVER
TRUSSOM
LEAD
PROTECT?

GLASS
PANELS
= LATER.
ORIGINALLY
WOOD
PANELS,
NO GL.
EXCEPT
BY
TRUSSOM

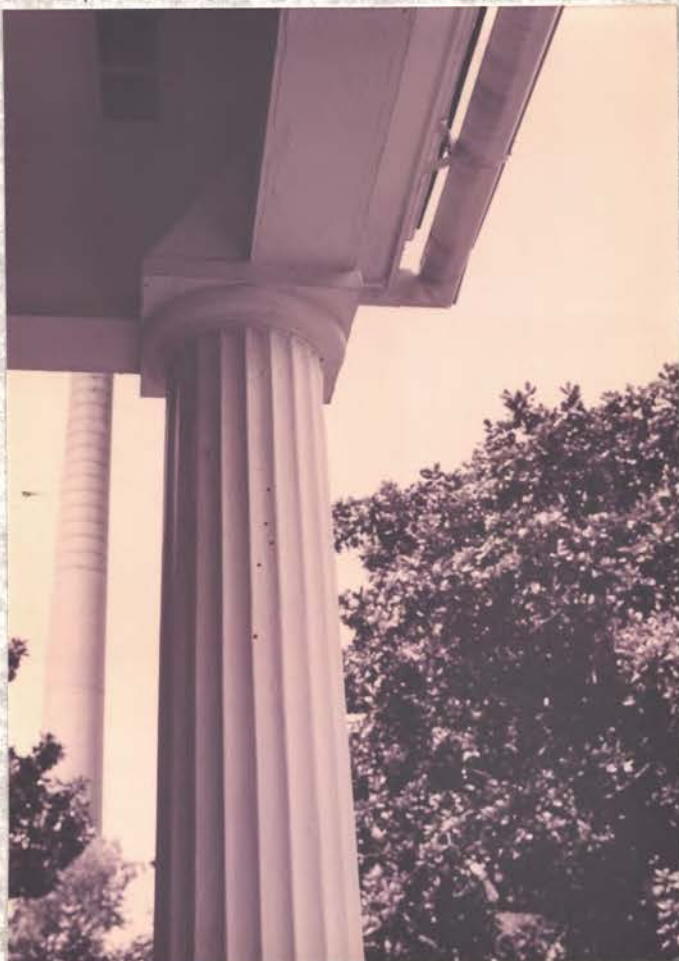
UPPER ENTRY AT PORTICO

MOD. BIRD
PROTECTION SLOPED CAP

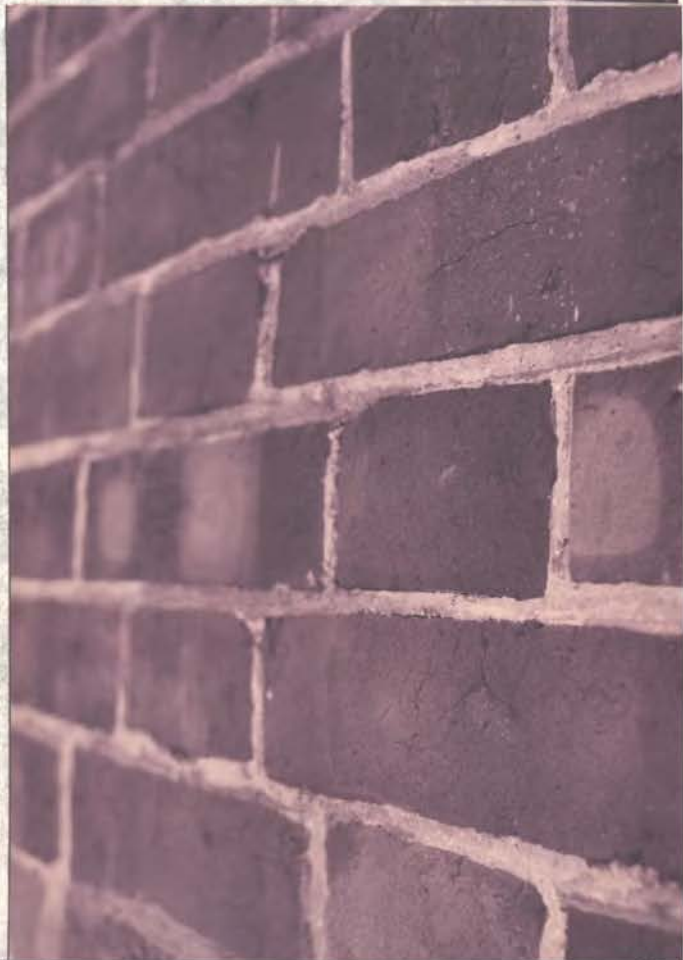
Harsh and harmful sandblasting has already occurred. It cannot be corrected for the faces of the bricks are blasted off and pocked as much as 1/4 inch deep, exposing the softer inner core of the bricks to moisture, freeze-thaw spalling and accelerated soiling.

Repointing in areas has been done, using hard modern Portland cement mortar, sloppily applied. At best this may be only partially reversed. Hard modern mortar subjects the soft 1829 bricks to temperature-stress cracking and spalling, and water entrapment and consequent freeze-thaw spalling. Hydrated-lime and sand mortar should be used, tooled like the unweathered neat 1829 joints.

ORIG. JS5,
 BADLY SANDBLASTED,
 SLOPPILY REPOINTED,
 HARD PORTLAND CEM.
 (c. 1996 work
 per Blkg. Supt.)

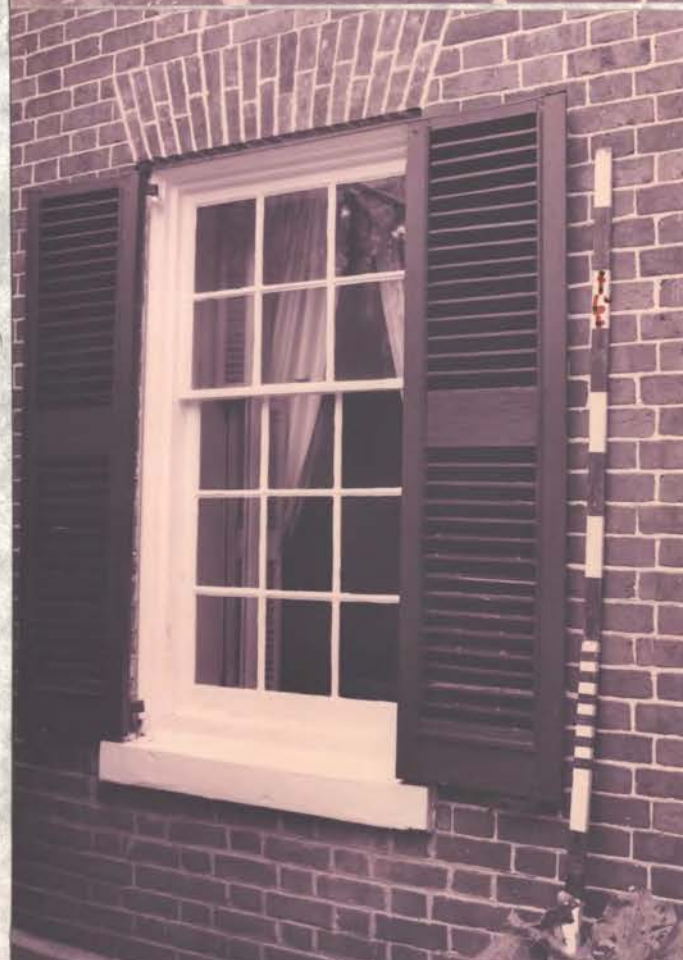
ORIG. JS5. (LINE SAND MORTAR)
 NEAT & SMALL (3/8")

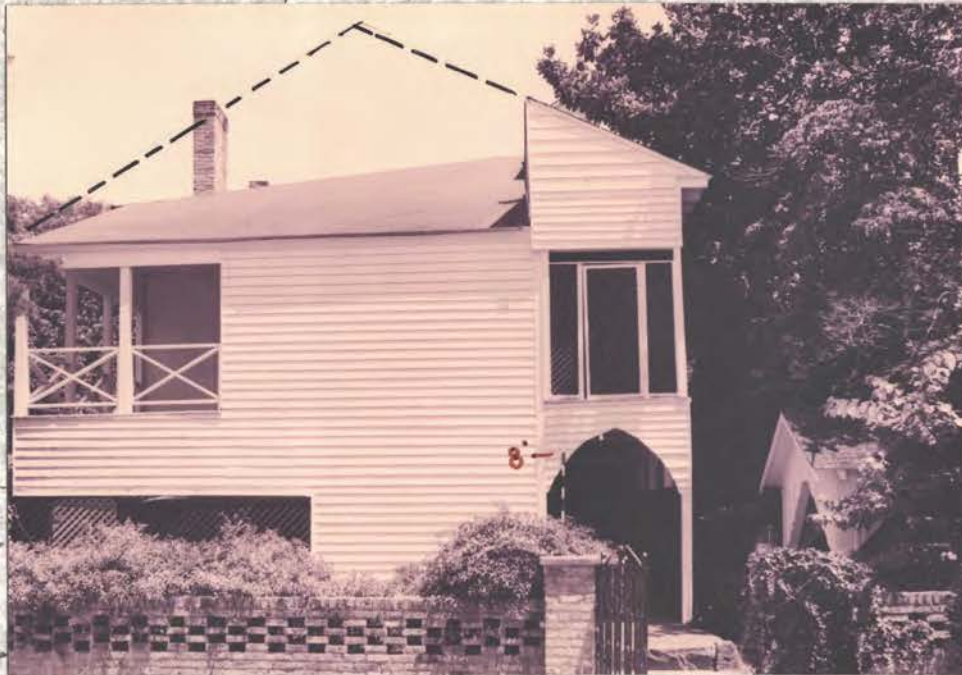
Roof modif. after 1987 (see 1887 perspective view)
Why? Makes no apparent sense
See 1887 View at left. ↓ Probably orig. clapped at gable remnant

N.W.
serv.
WING
perhaps
c. 1866-
70 +
gar. kit.
is hse.

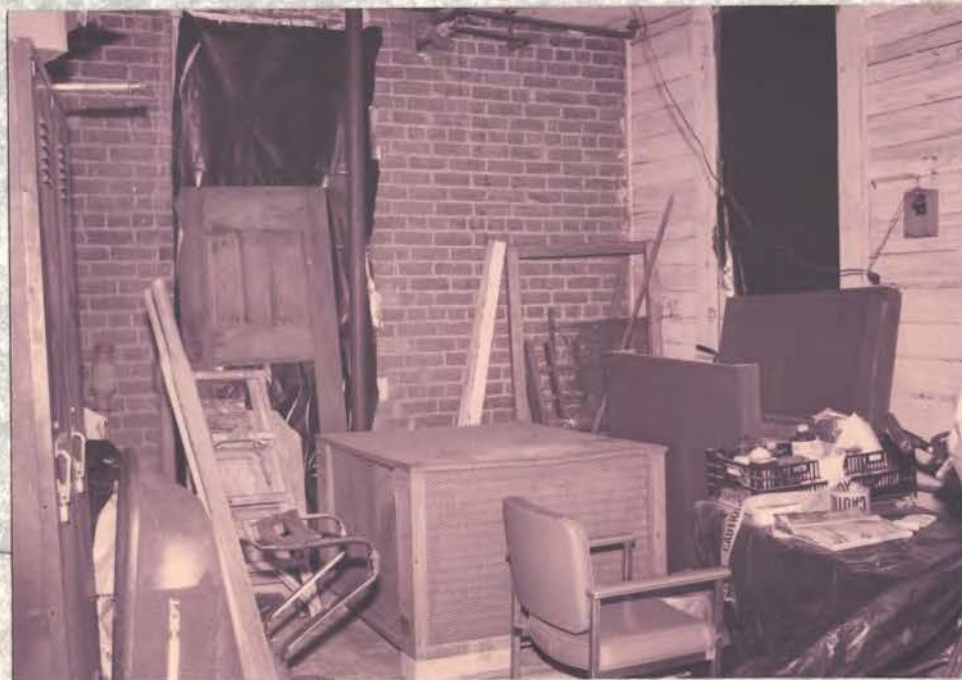
6. Grounds:
Poor drainage. Perhaps enlarge enclosed east lawn for receptions, etc. Planting to go along with the period of restoration (George Stritikus is most knowledgeable of this aspect). The brick walks are improperly laid (wide mortar joints, basket weave pattern, etc.) and would best be re-laid in the nineteenth century manner (tight joints, no mortar, pattern = herringbone or half-bond running bond etc.). Lighting (security and evening activities). One early nineteenth century carved sandstone splash block was seen discarded in the northwest corner of the yard. A proper use of this should be made.

Discarded 2/3 of orig. Sandstone
splash block, now in N.W. yard corner

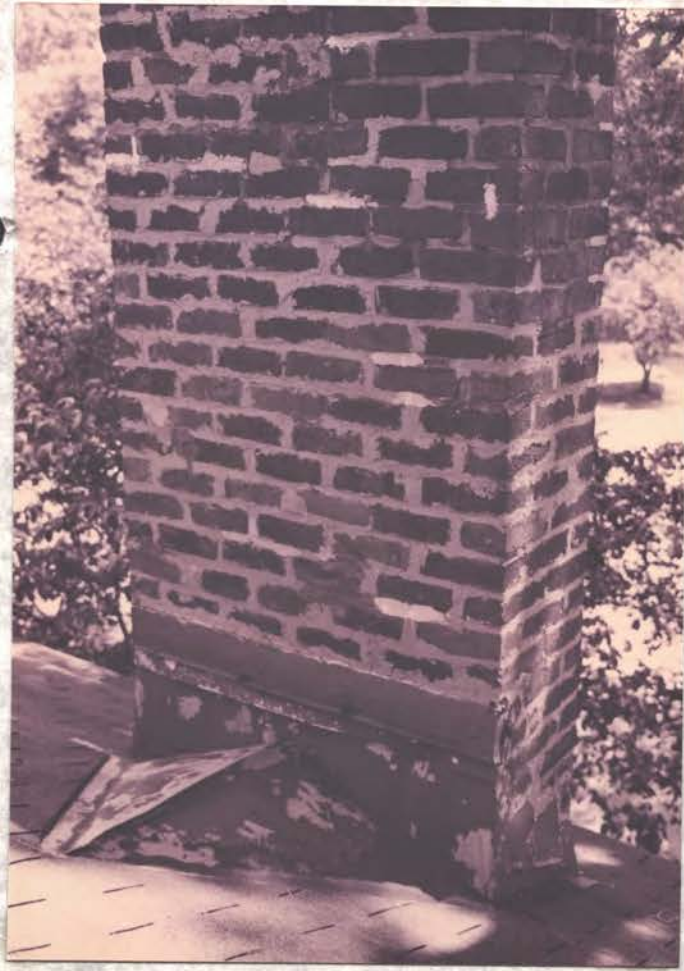
4. Catering Kitchen:
Improvements as needed. Consult with caterers. Meet Health Department specifications.
5. Roof and flashing: (1982):
Chimney leaks, better choice of shingles and flashings. Two north chimneys are rebuilt in porous "salmon" bricks and Portland cement mortar. 1982 shingles are near the end of their life. Galvanized flashings are rusty.

N ← N.W. CHIM.
rusty metal cap

N.W. CHIM. (rebuilt w/ salvaged salmon bricks
thru a portland cem. mortar)

N ← rusty galv. flash
ALL CHIMNEYS LEAK
DOWN INTO ATT.

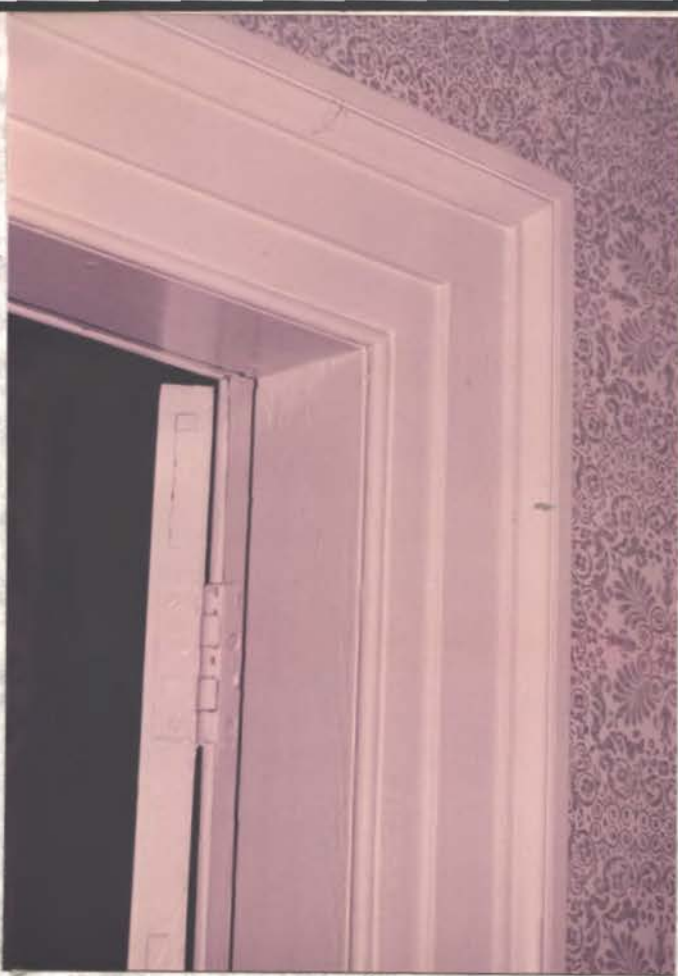
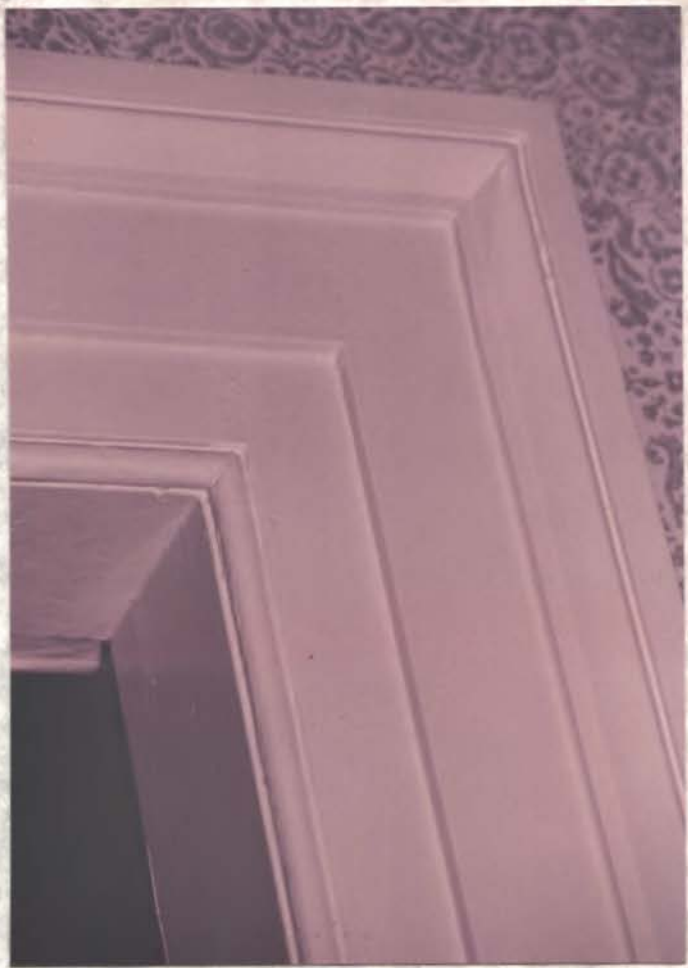
gl. panels were originally solid wood panels

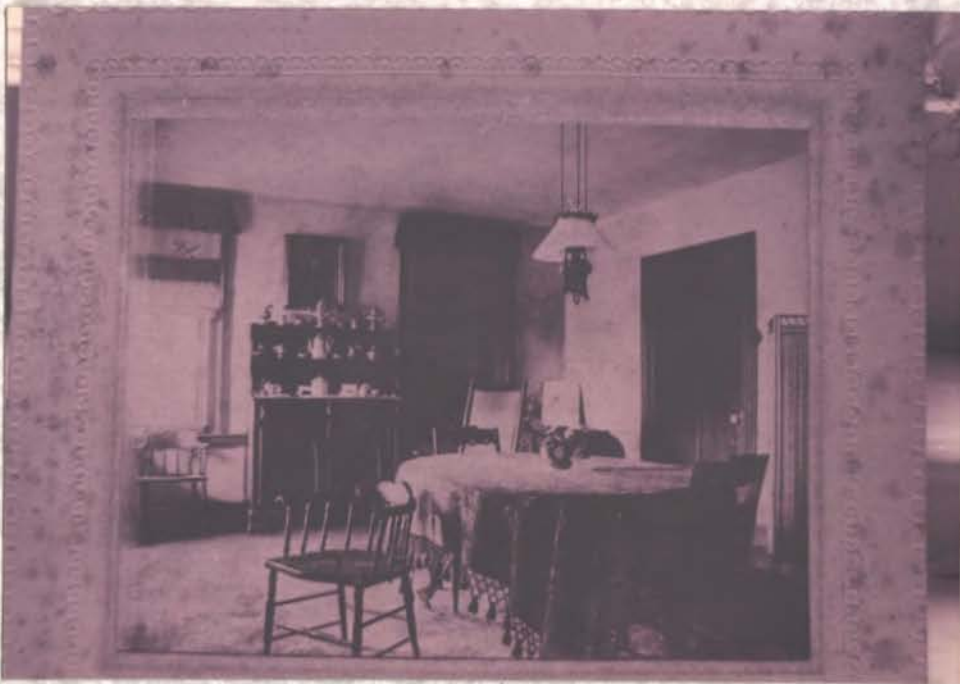
c.1970's duct

c.1970's closet for HVAC unit

1840's shimmied w/d fl. over original brick fl. when fl. was a dining hall

orig. fl. level

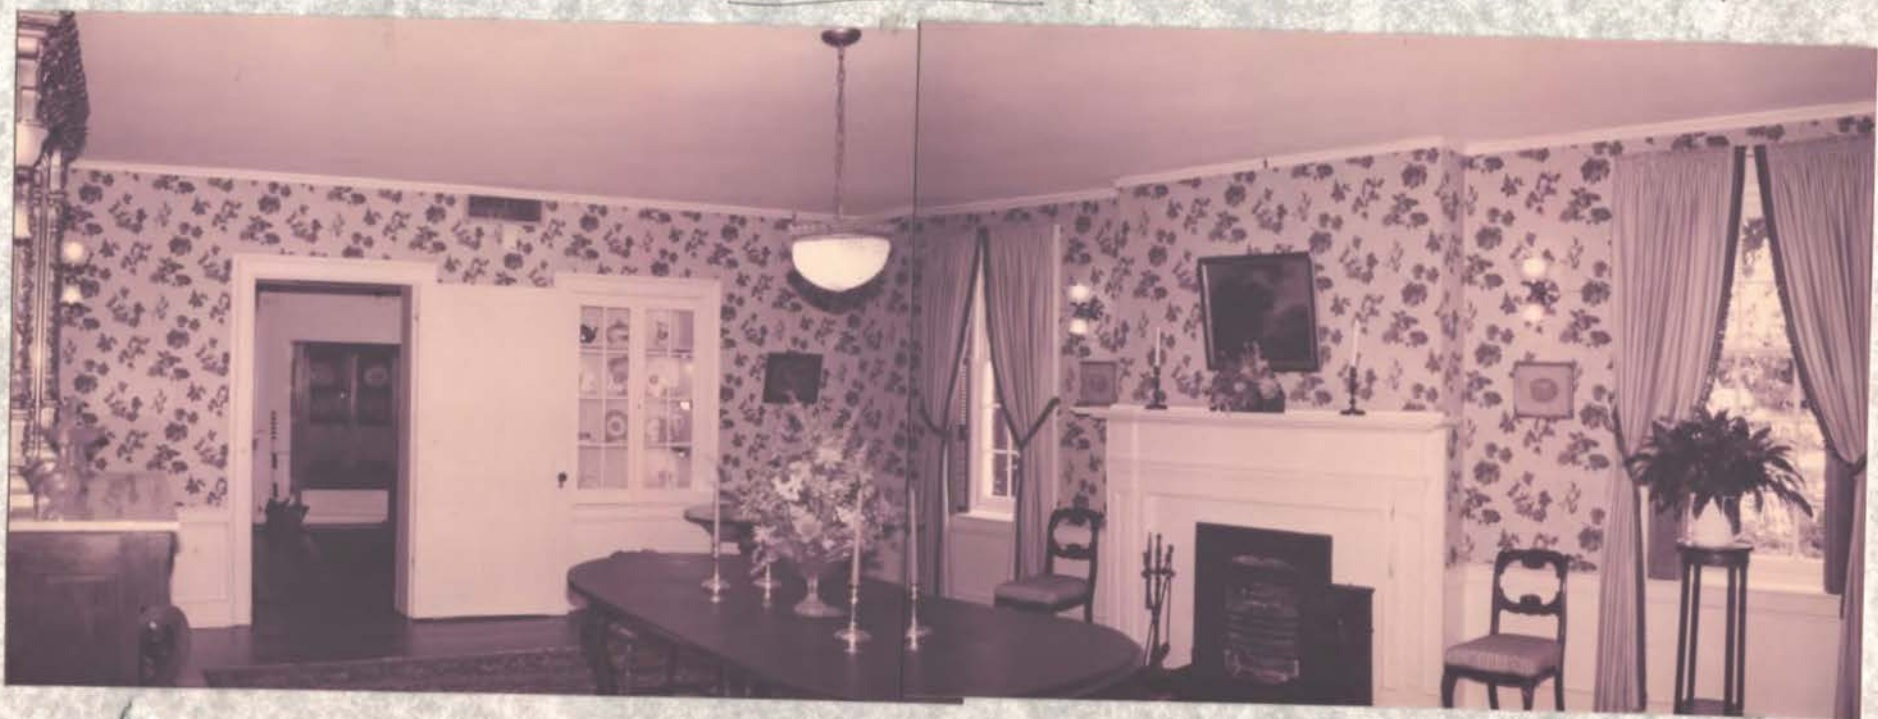
FL. & N.E. DIN. RM.

spike-heel dents (fl. was sanded in 1980's per the mus. mgr.) PN

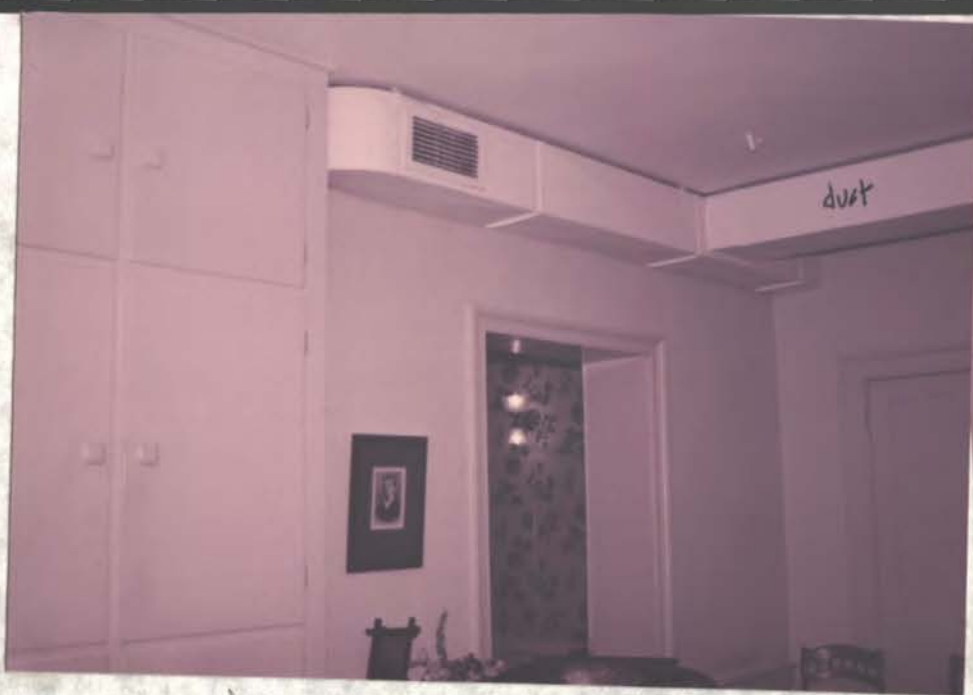
mod. chb. ↗

c. 1956 duct ↗
 1970s AC closet is behind door ↗

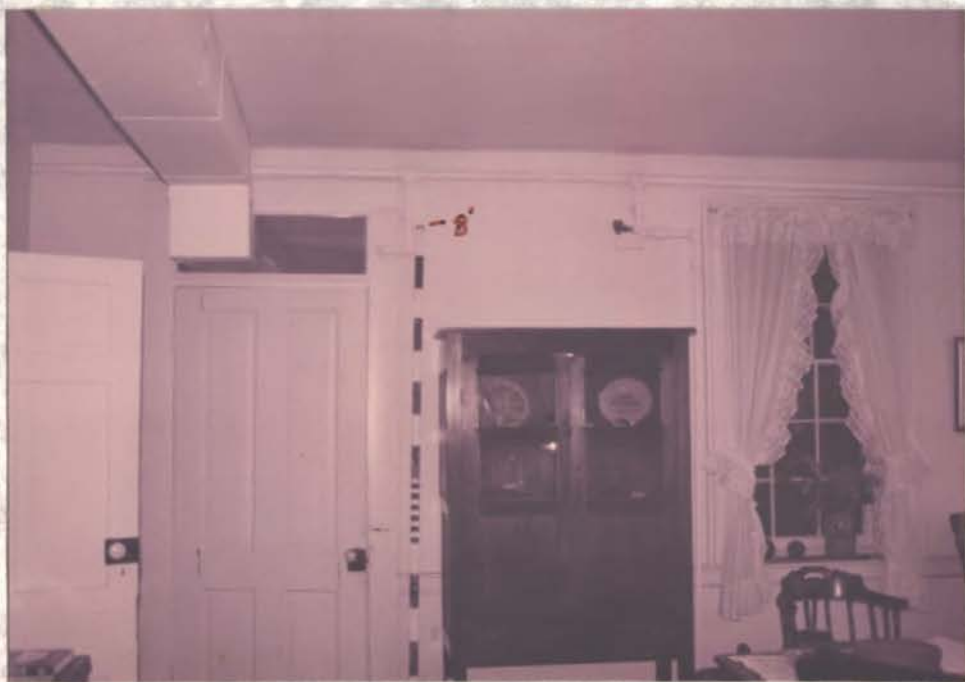
← radiator pipes
 (heats kit. only
 now)

↖ vic. door to
 N.W. wing
 (now kit)

↖ window opens
 to latticed
 porch

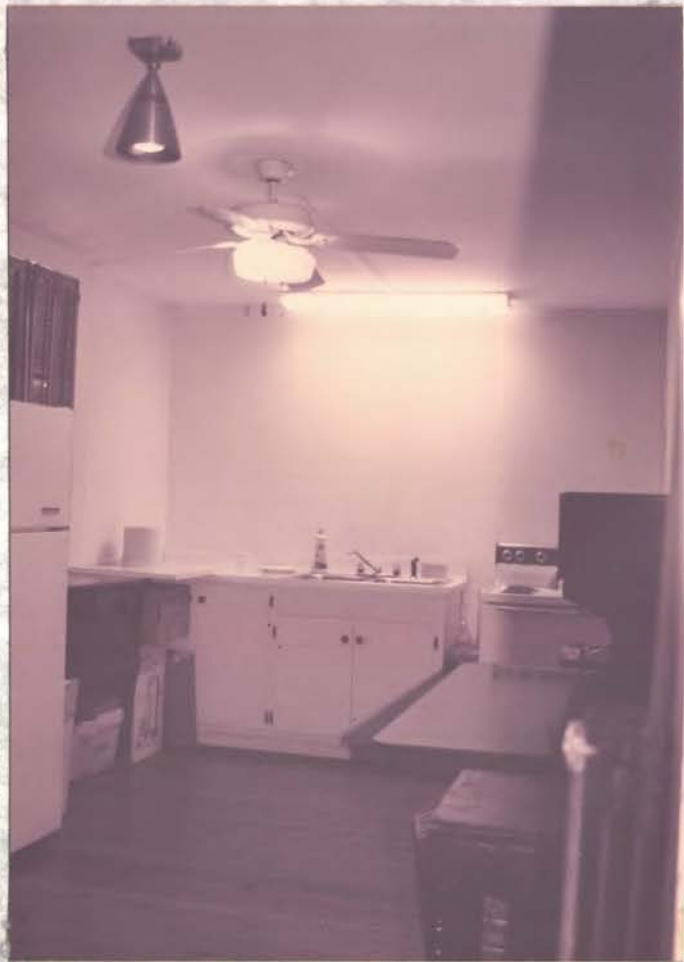
c.1970s Kit. in fl. 1 N.W. frame wing

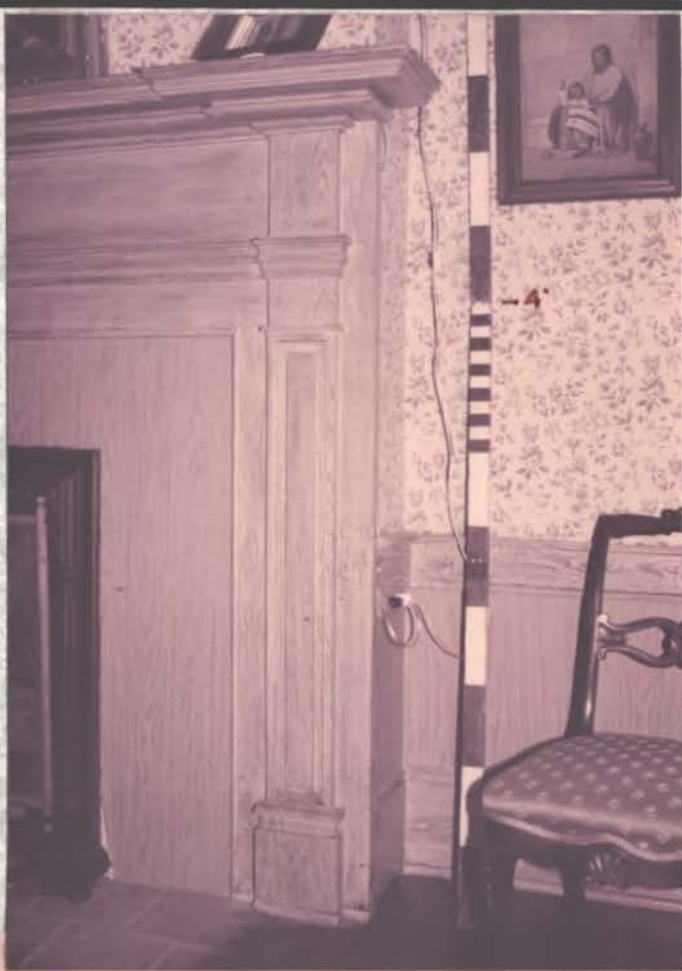
FL. 1
SE. RM.

This mantel has a circa 1953 stripped-and-pickled finish, popular in the mid twentieth century but not in the nineteenth century. Prior to the Civil War, mantels were painted, typically glossy black and sometimes marbled black.. Doors were usually grained, and sometimes trim was grained as well. Evidences of these early nineteenth century finishes were observed at several paint-nicks in the Gorgas House. Depending on the chosen period of restoration, modern finishes should be removed.

c. 1970's "pickled" fin. on wd.

1970's
Ando fin.

1970's
hearth

1970's
pickled
finish on
wood

1970's
finish

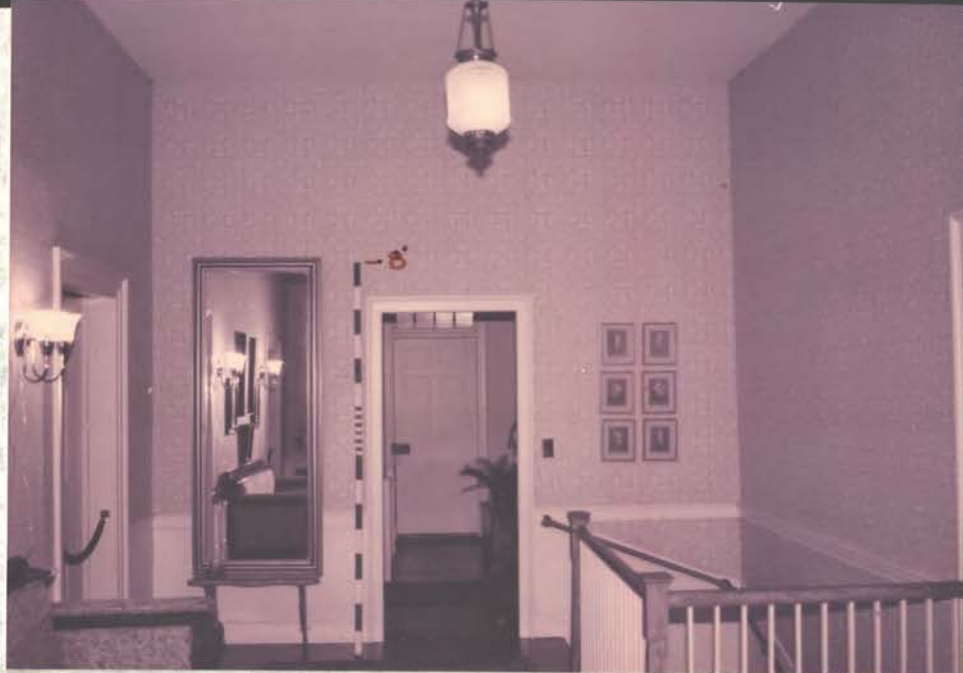
FL. 2
FRONT
HALL

Vic. look
Orig. head & foot bolts

mod. galv. mesh on ext.
(bird-guard?)
Transom was operable (note the chair)

st. panels = later.
Would be solid wd. original

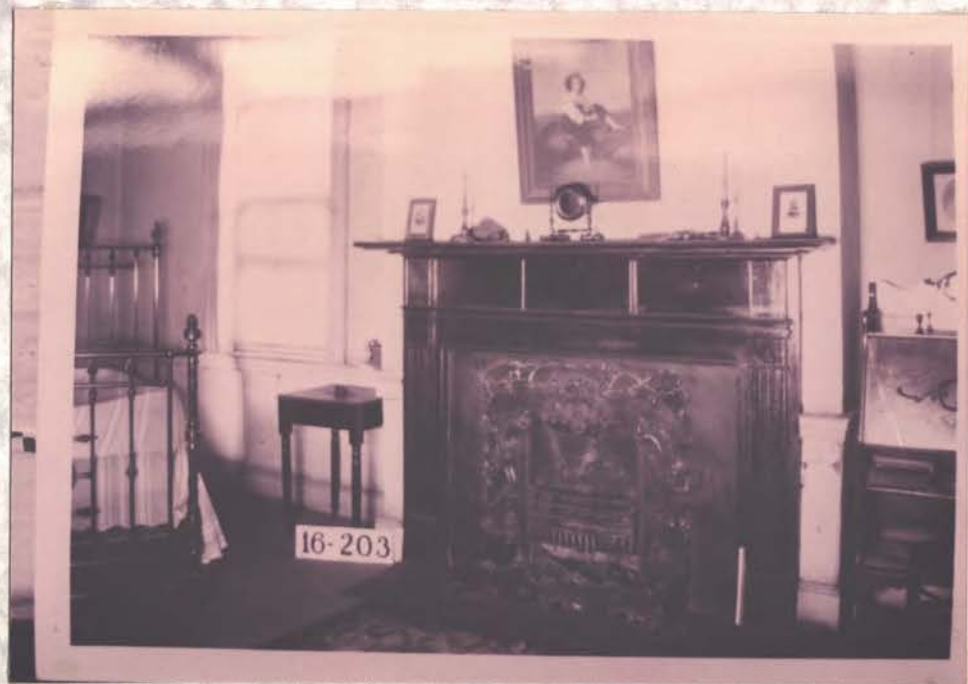
Fl. 2 N.E.

Fed. Mantel (1829)
 note glossy black fin. on
 mantel, typical of early 1800's.
 Shows in paint - chips in 1997

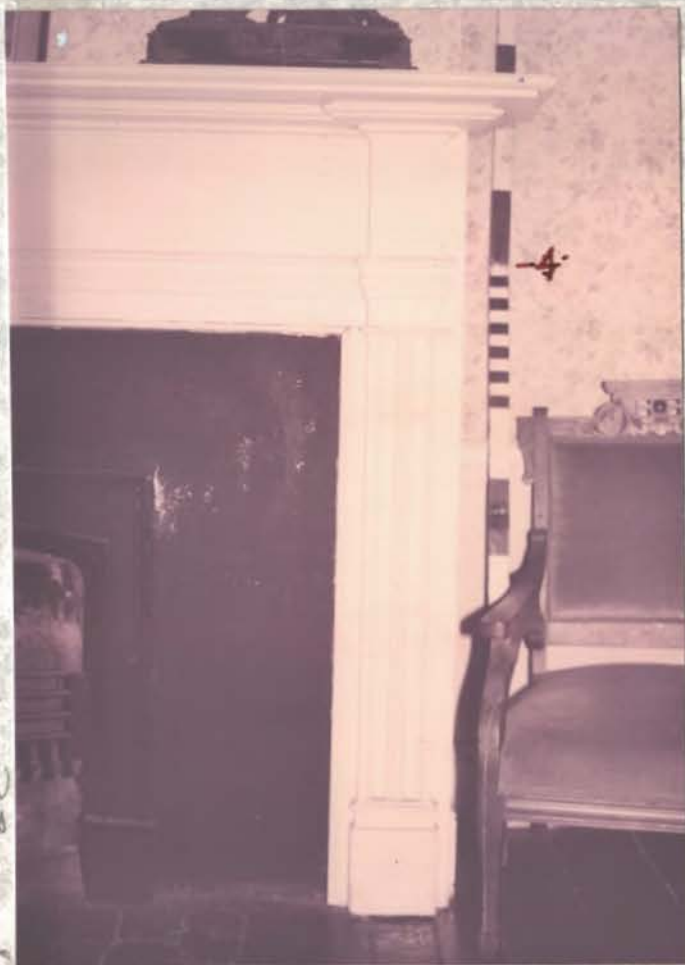
fire
mantel

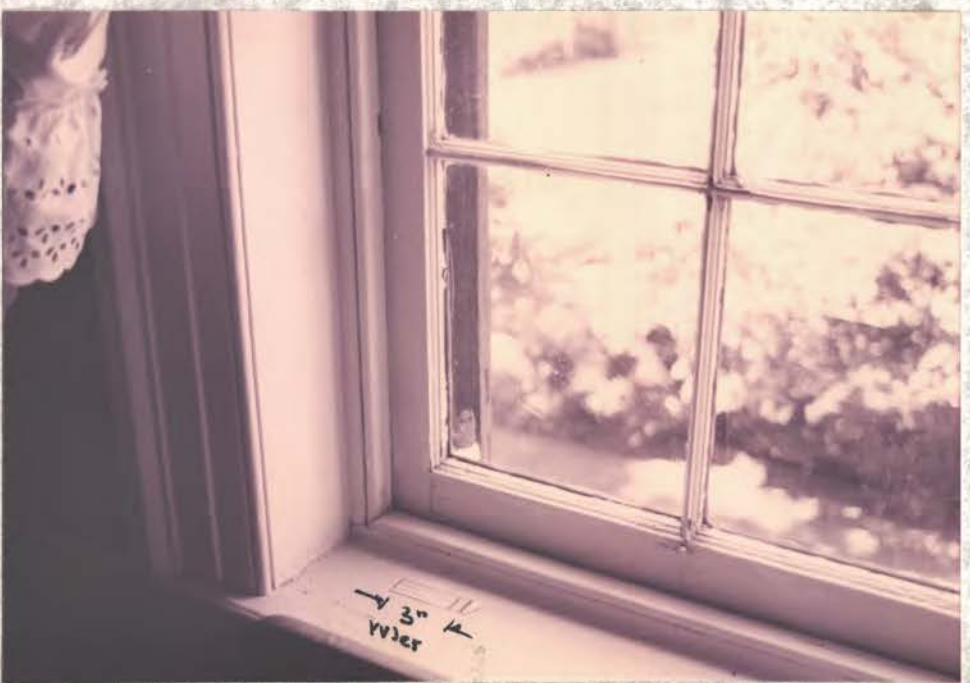
N.W. sash
in N.W. Rm
A.C.

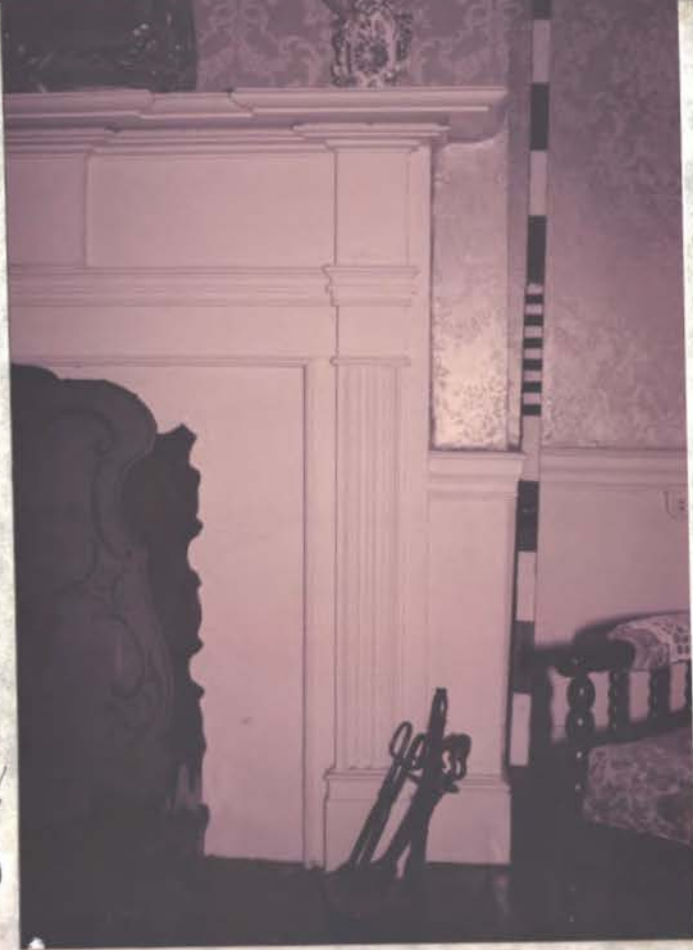
FL. 2
S.E.
RM.

Felt,
mantel &
chair

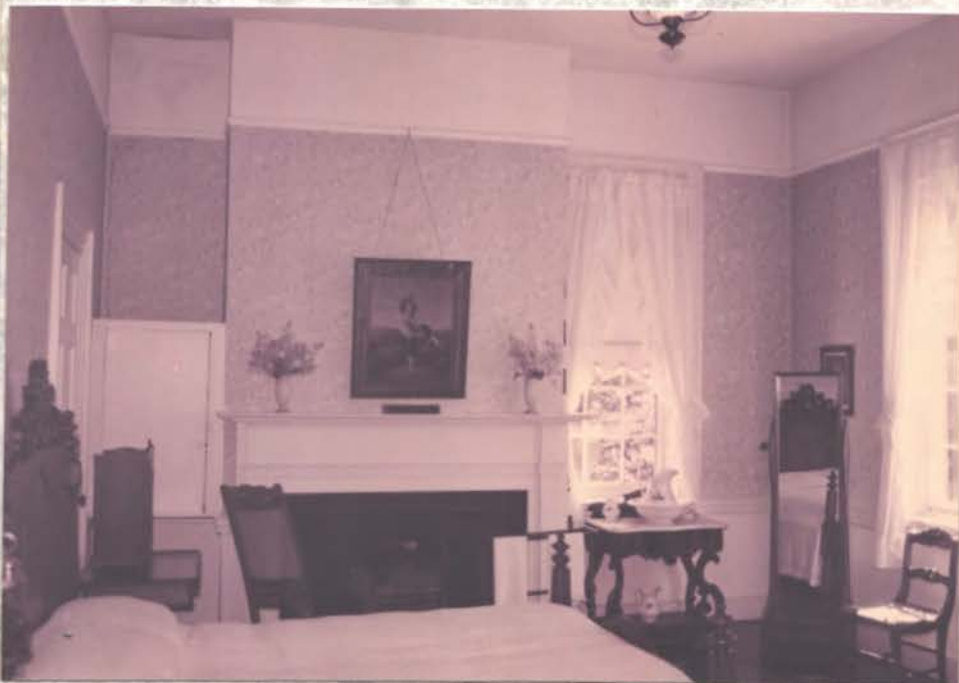
FL2 S.W. Rm

1970's dvt

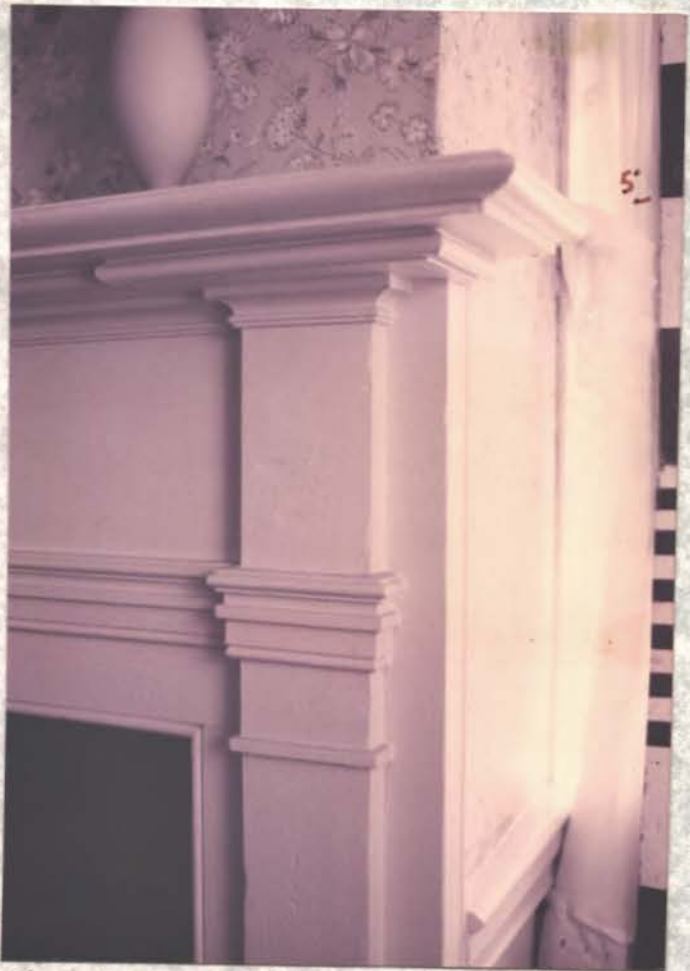
For mantel (plainer than others on this fl.)

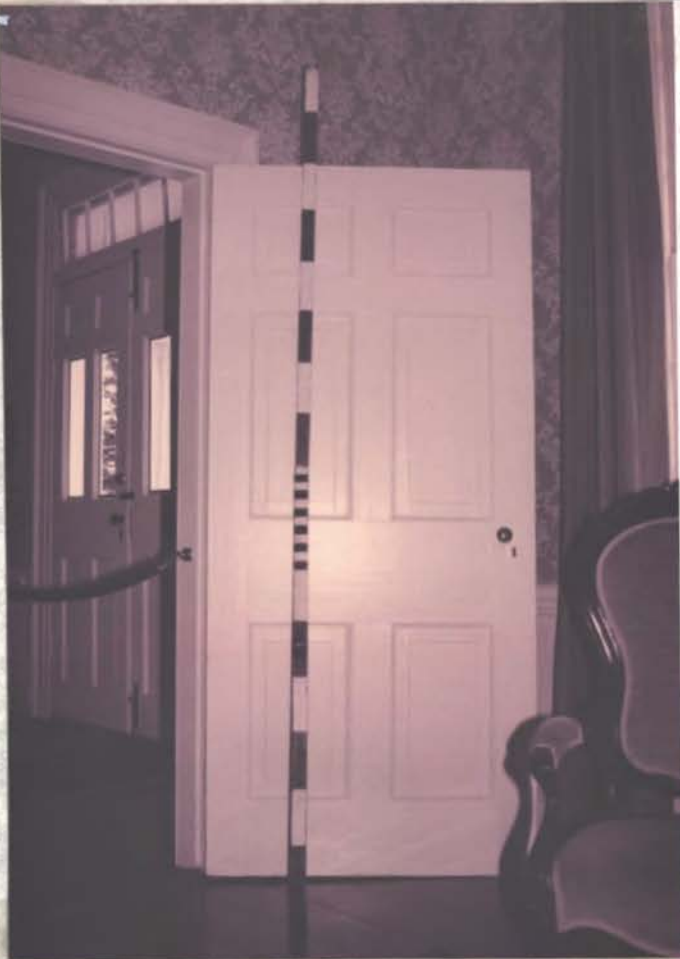
N.E.
Door
= bphl
fab
(also all
others
at fl.2)

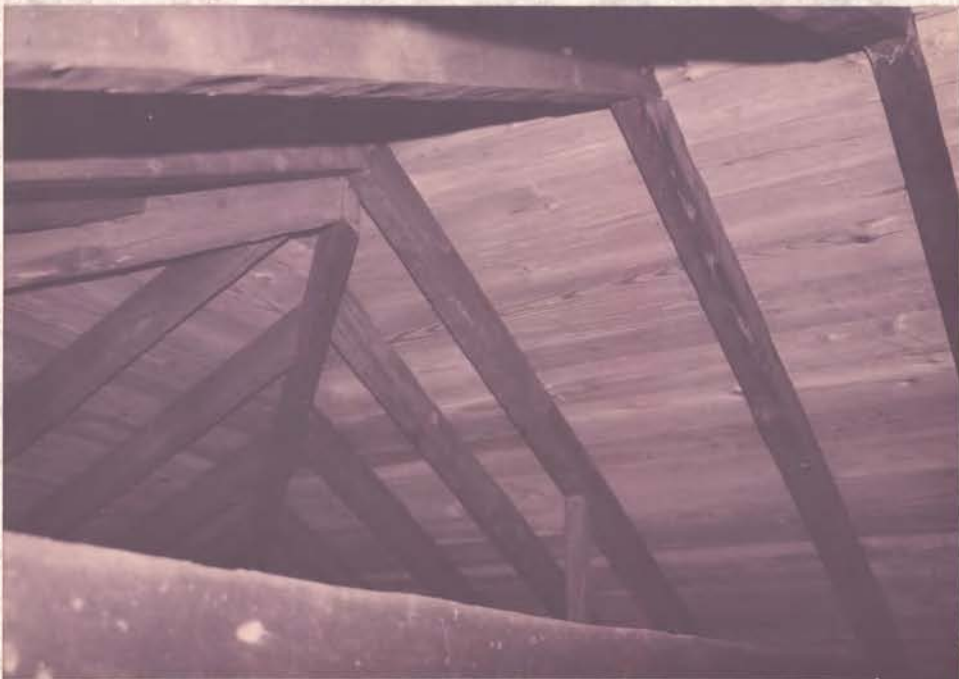
1829
rafters
& joists
±2" oc.

c.1970's
deck

"rock
wool"
insul.
±4"

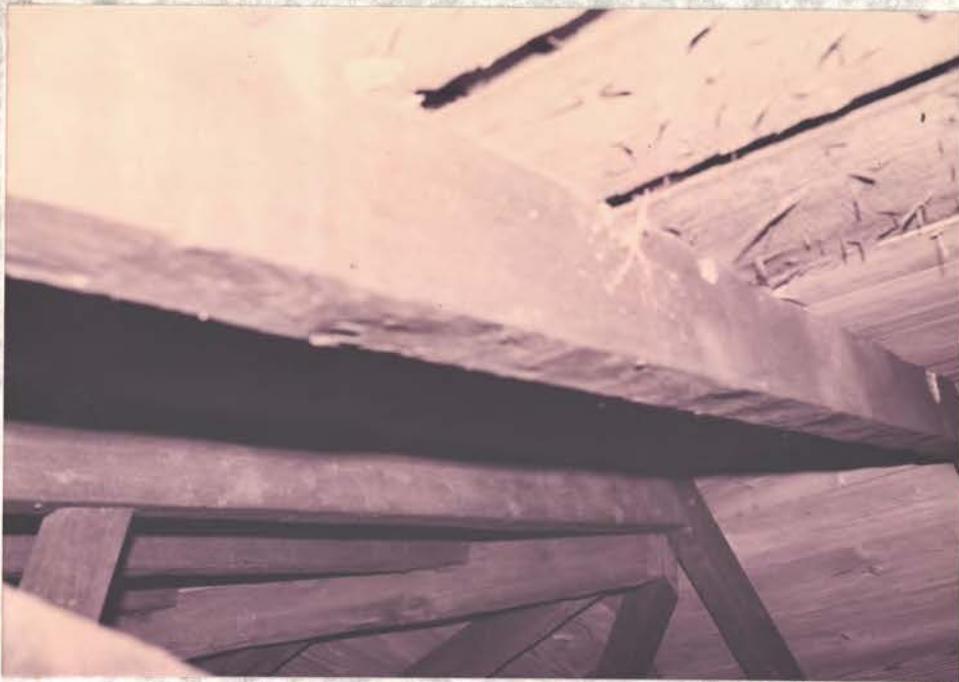
1829
deck

X
c.1970's
deck

sash-sawn
edges

hewn
bottom

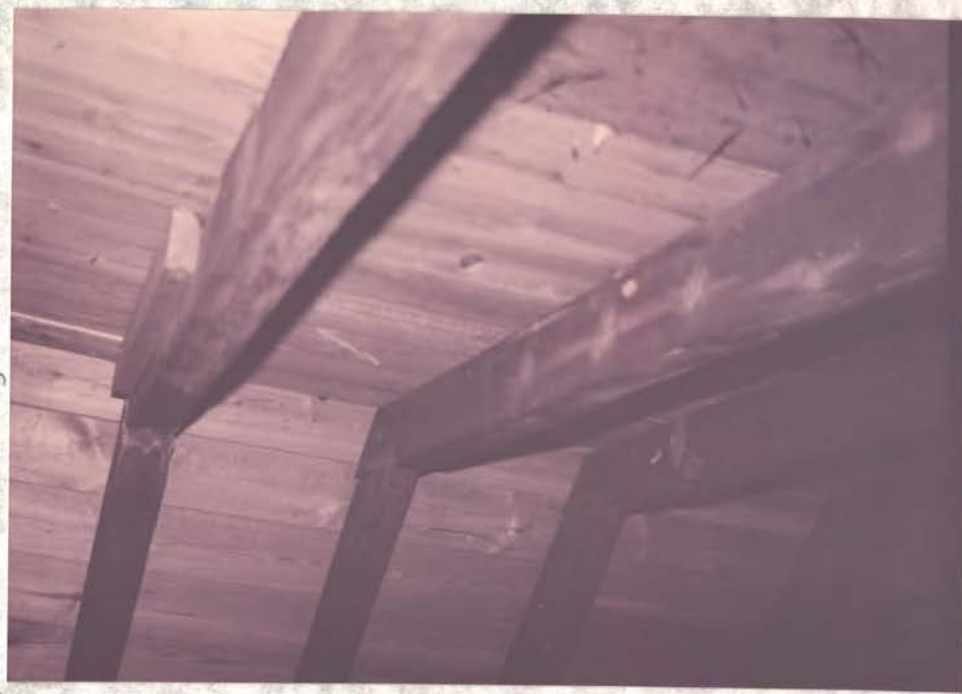
ridge = half-lapped & pegged
= most typical jt. in 1800-1860

1829
sash-sawn
deck here

wood shingles (orig roof)

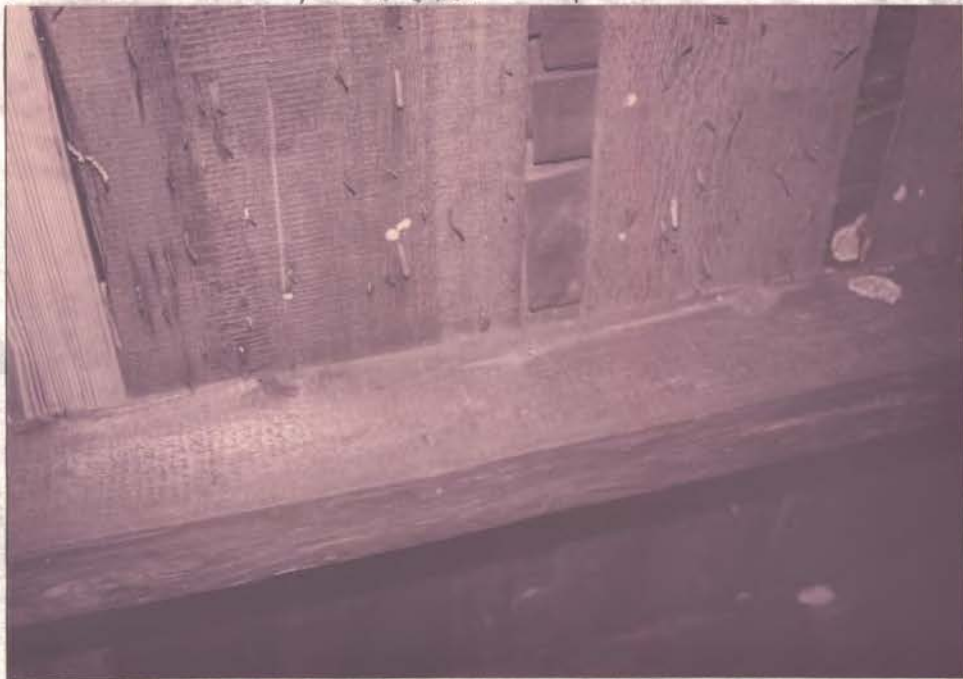
1829 rafters & joists

mod.
deck (mostly)

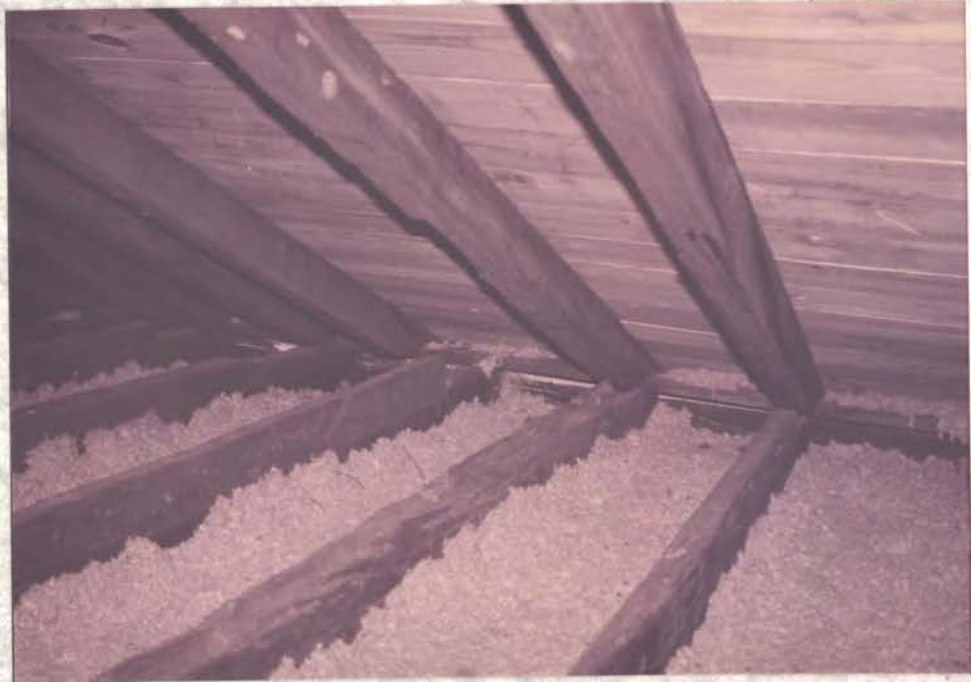
sash-sawn joists ± 2' o.c.
± 3x6
