JONES & HERRIN

August 4, 1997

Re: 1829 Gorgas House Museum, The University of Alabama

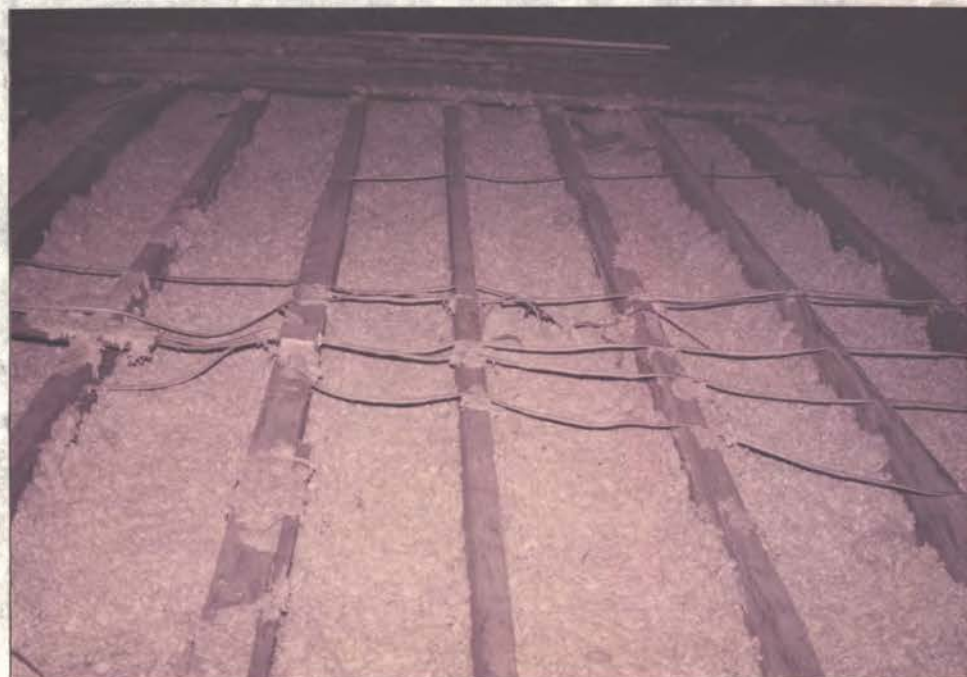
wiring probably 1970s or earlier
