**ARCHITECTURAL COLLECTION
OF
HARVIE P. JONES, F.A.I.A.**

**1859 Miller
Tuscaloosa,
Neville Res.**

1857 Miller Hse ("ALACK PLACE")

photos of renovation progress, Oct 1996 H P Jones FRK Huntsville
Restor. Consultant

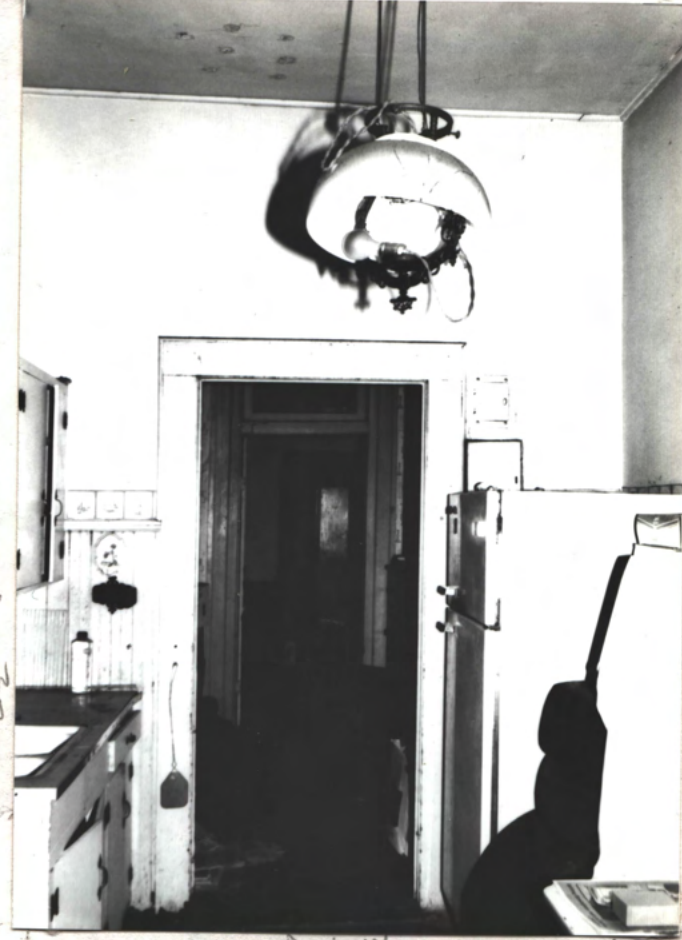
FL. 1 - WEST enclosed former porch (fl slopes) E to W. enclosed porch

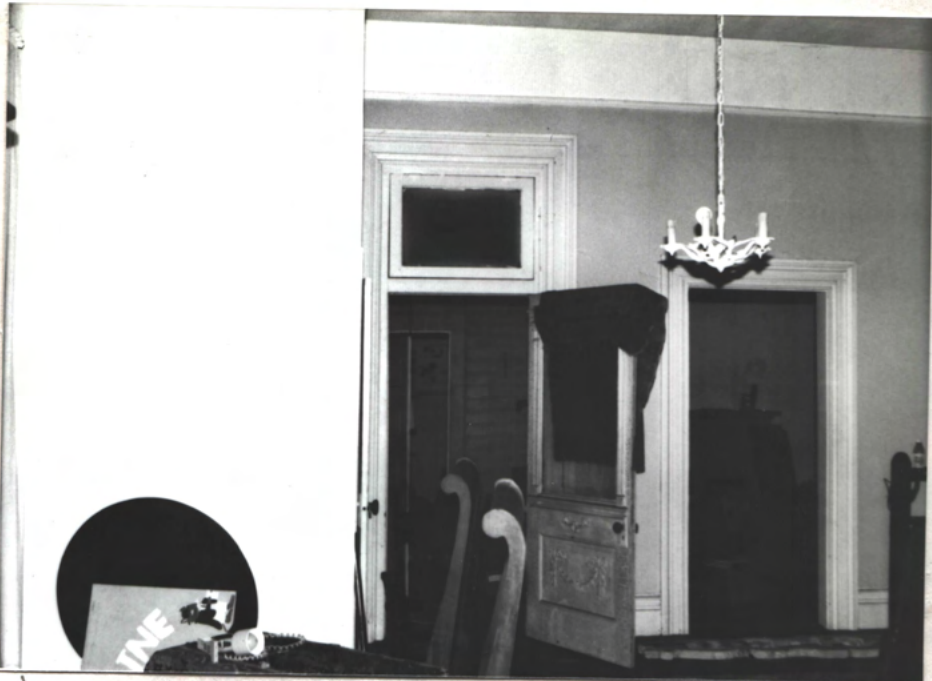
Fl. 1 East Cent. Rm

later bath

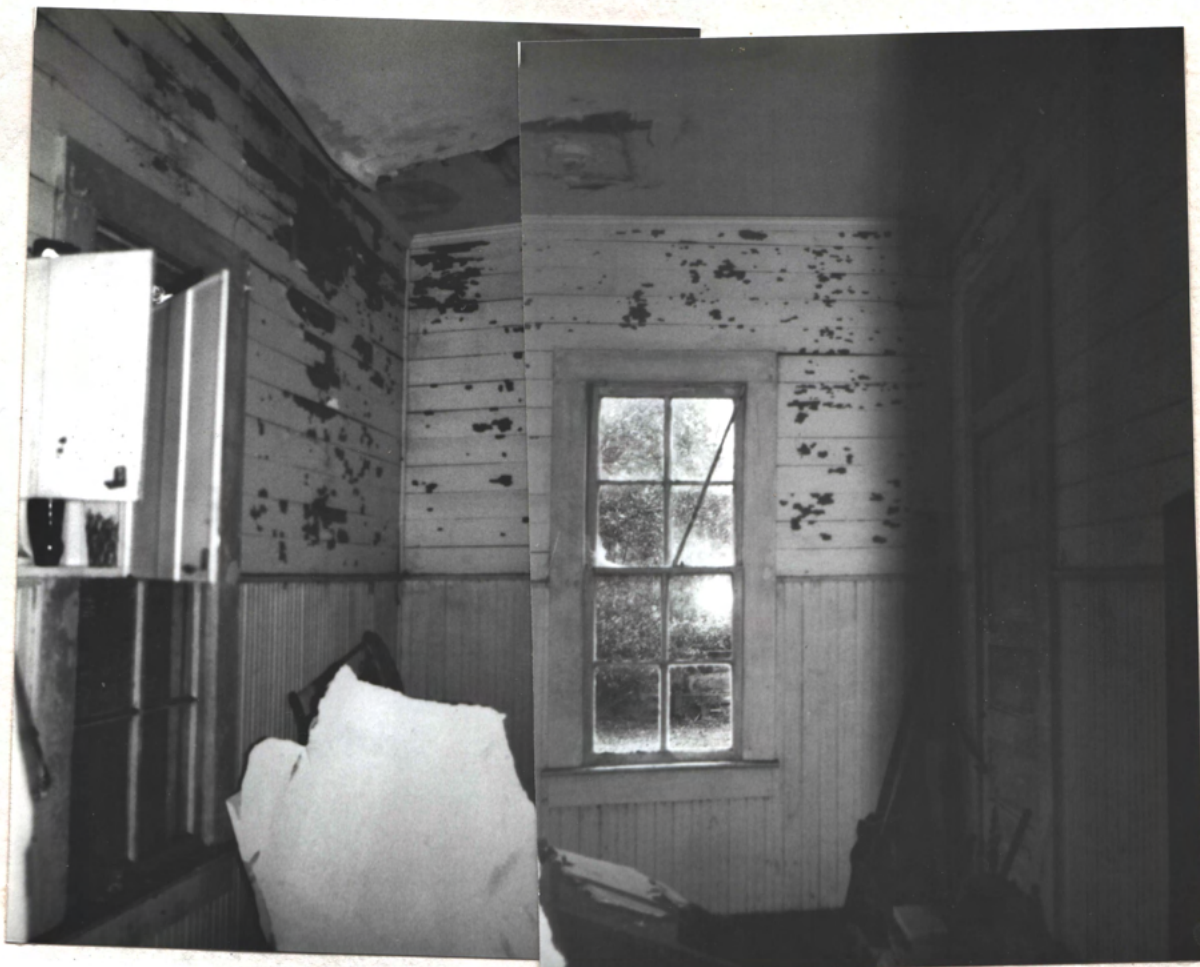
Fl. 1 - S.E. Stor Rm (20th cent?)
 Doors indicate c. 1900 - 1930

Fl. collapsed here →

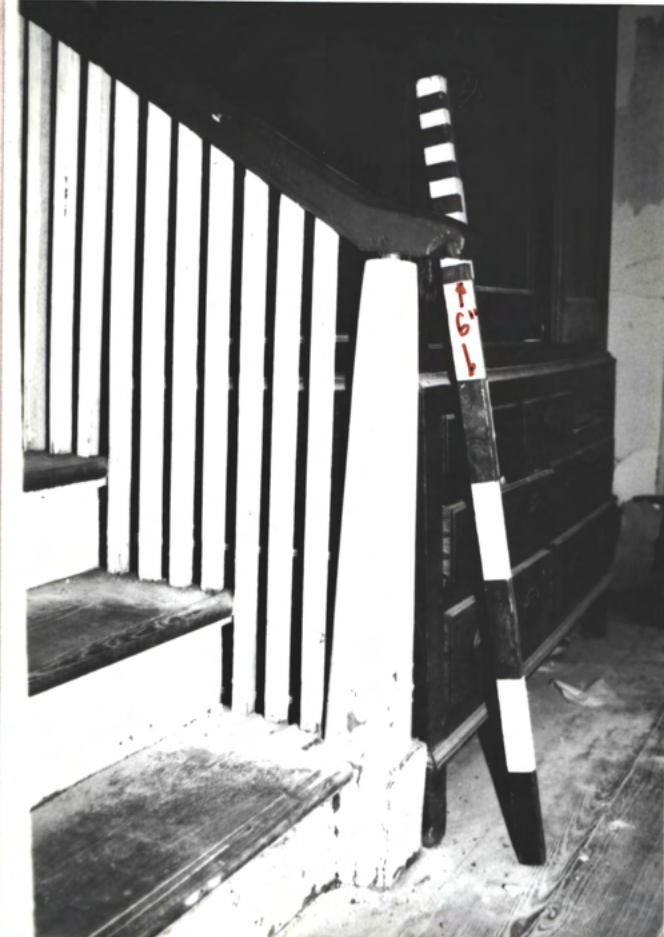
Ends of stair treads are same of landing.
 Truss (mother) of clerest. balustrade, 2 (tread)
 are in track

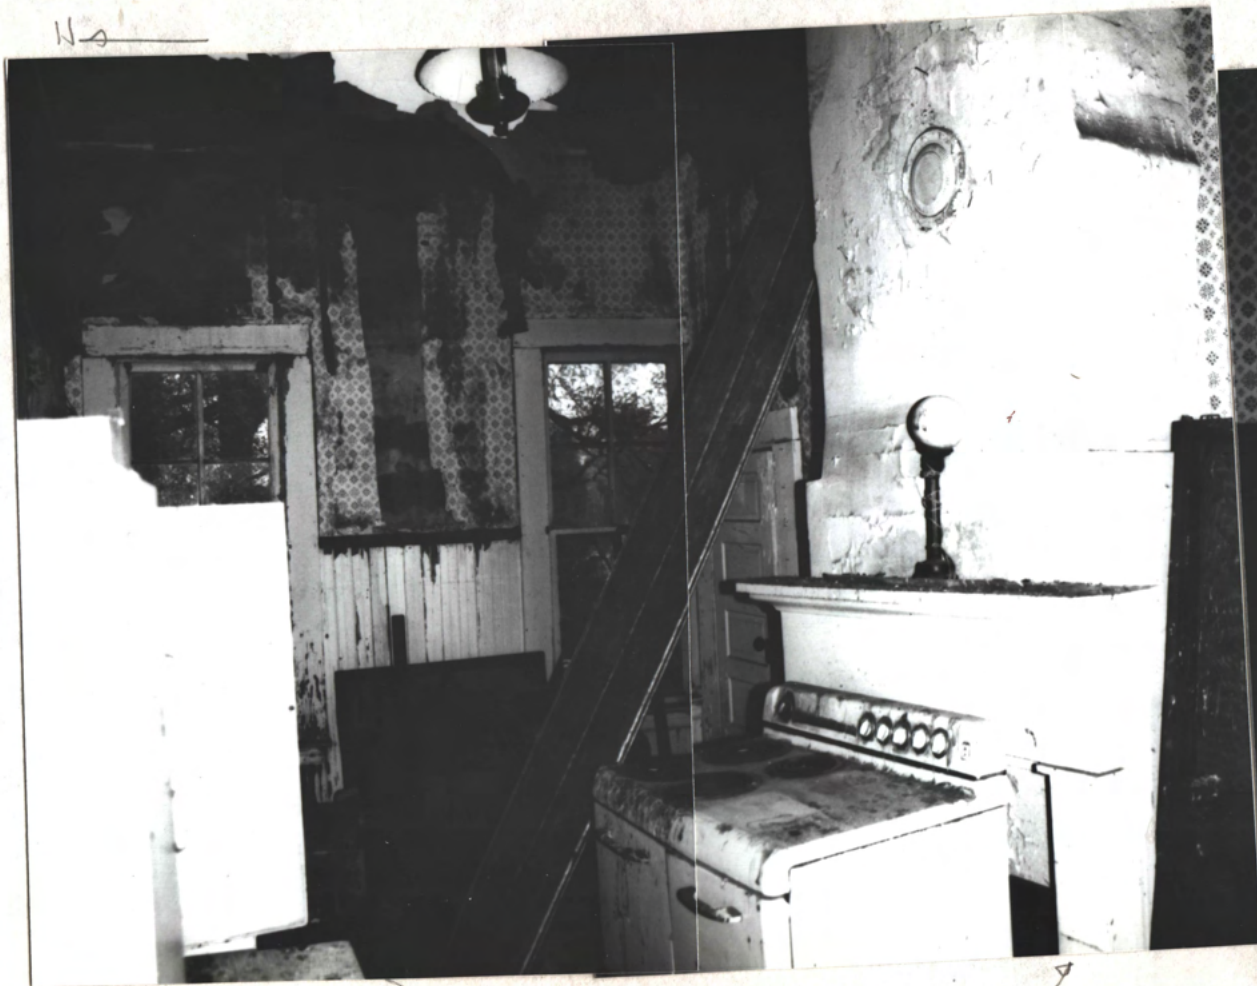
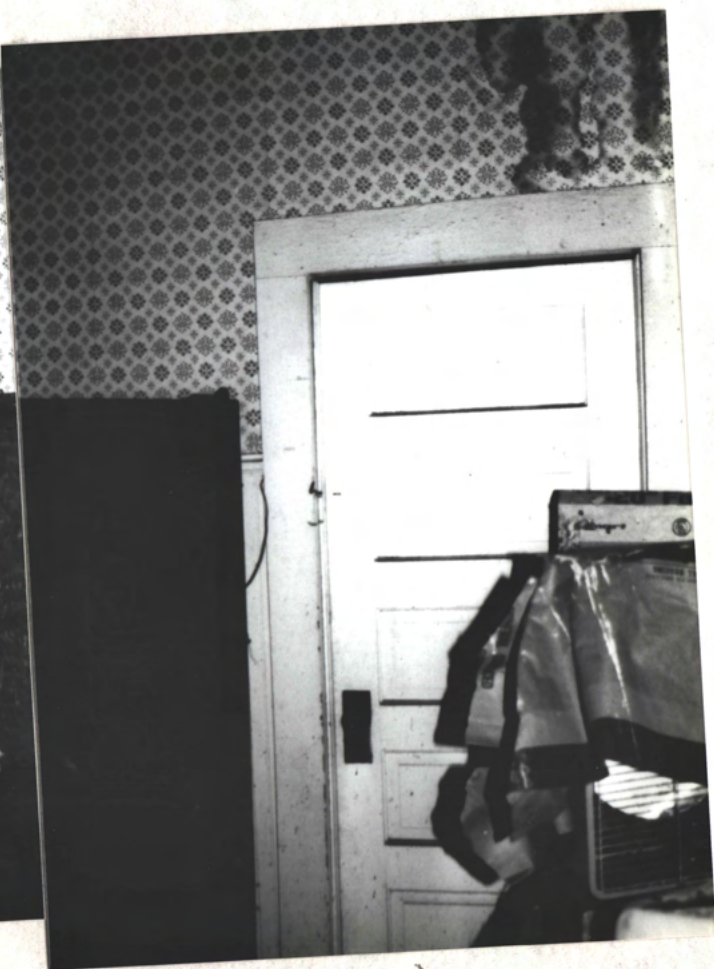
Fl. 2 S. Rm (apt. 121)

metal leaning on chin.
No fig. here!

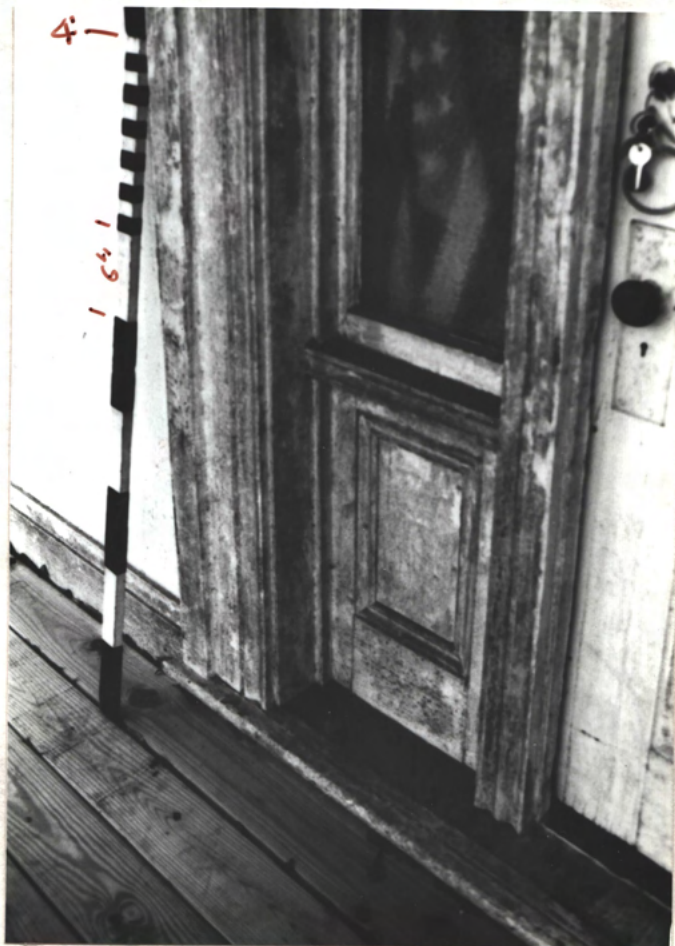
1994
treated pine
(incorrect
"deck")

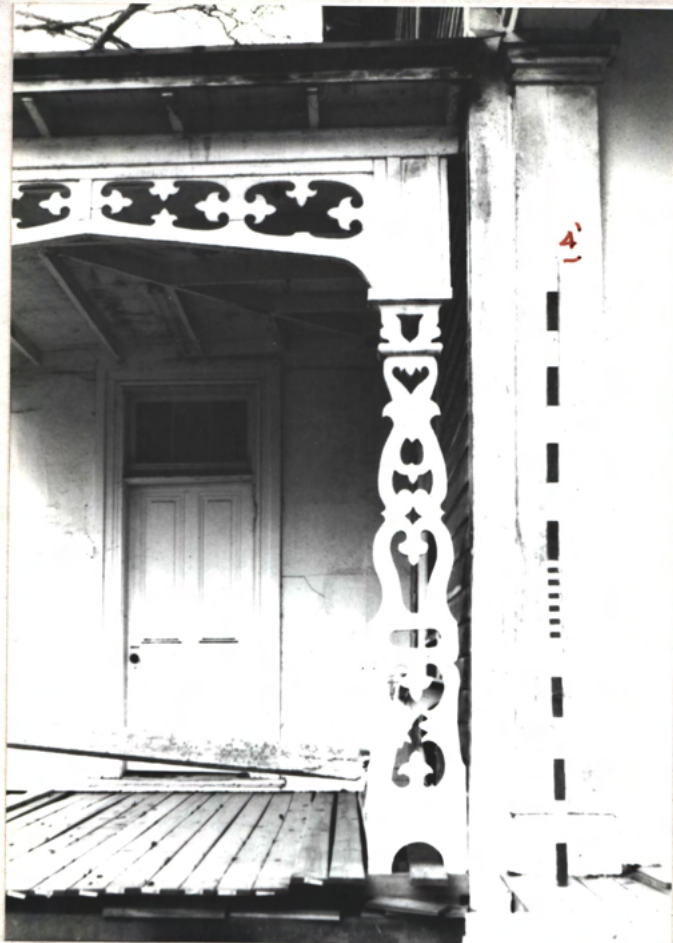
1994 incorrect photo (lower)

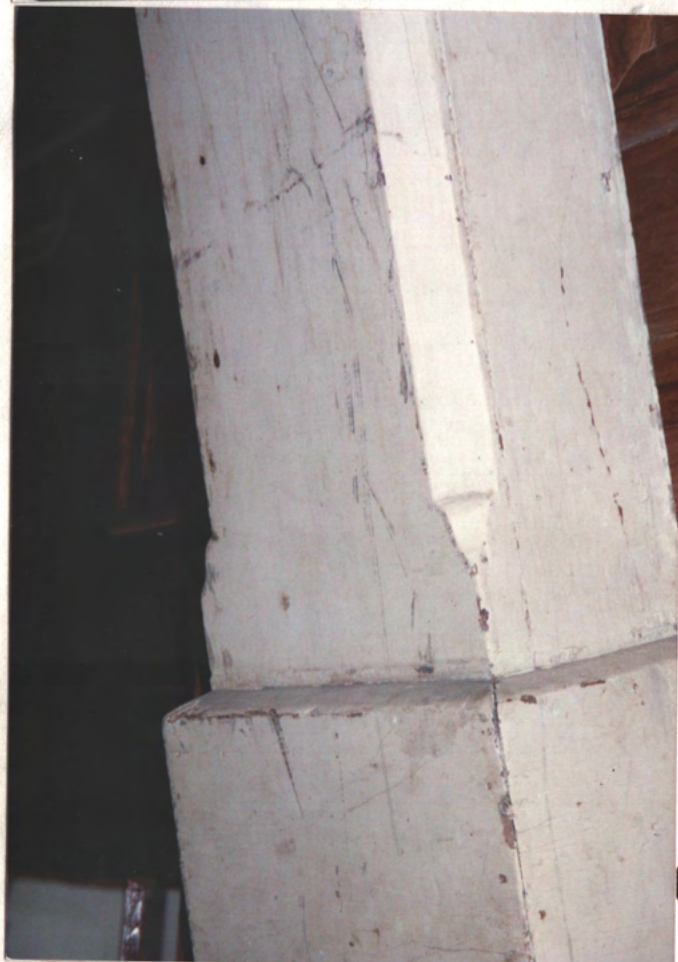
Col. at
Side
Porch
J

2 joints
torque
See p. 9.

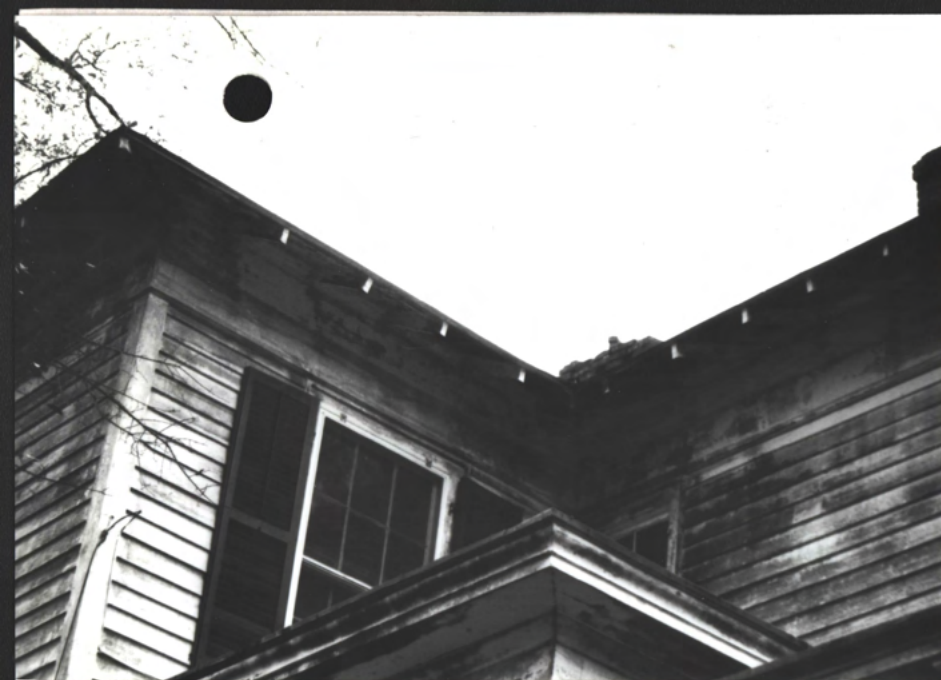
Roof dropped
 12" - 16"
 after fire
 probably in
 1920's
 See p. 1

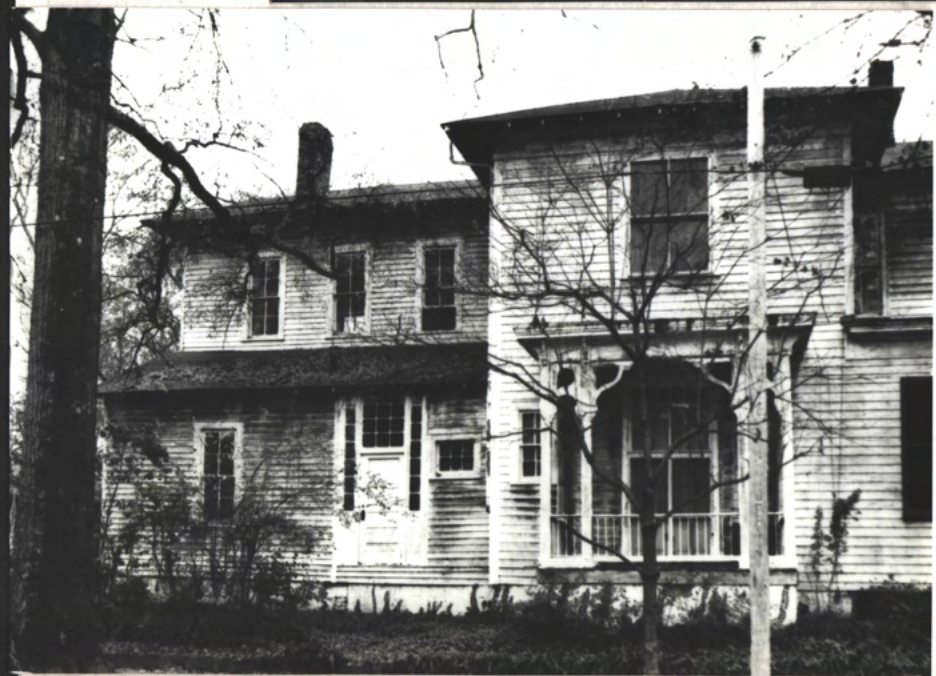
E SIDE

20th c.
← bungalow
roof
(dropped
12" - 1 1/2")

originally on
piers.
Later infill

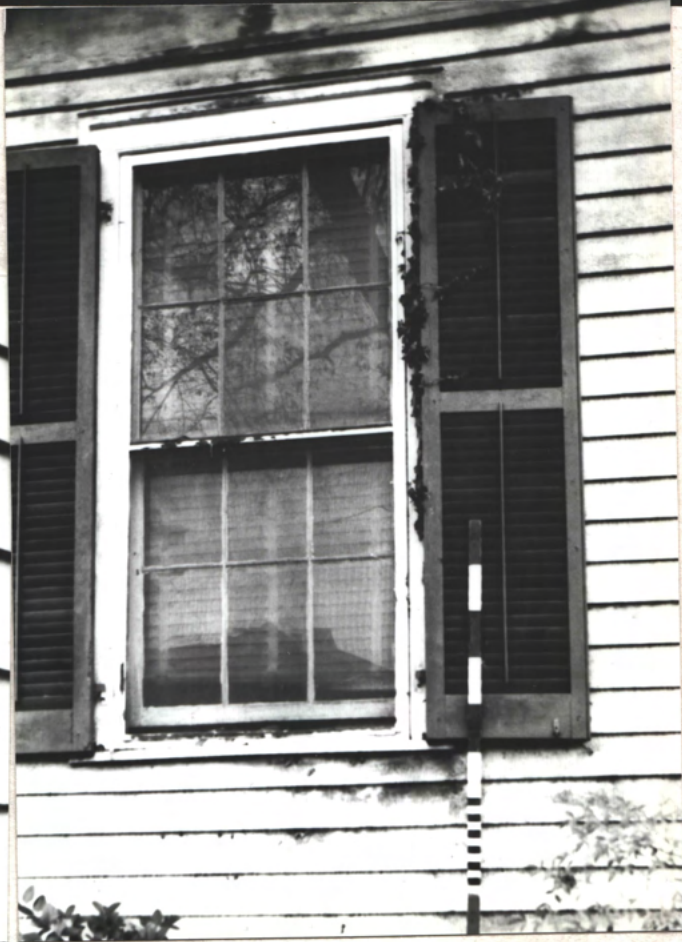
later sash for added bath mail ↓

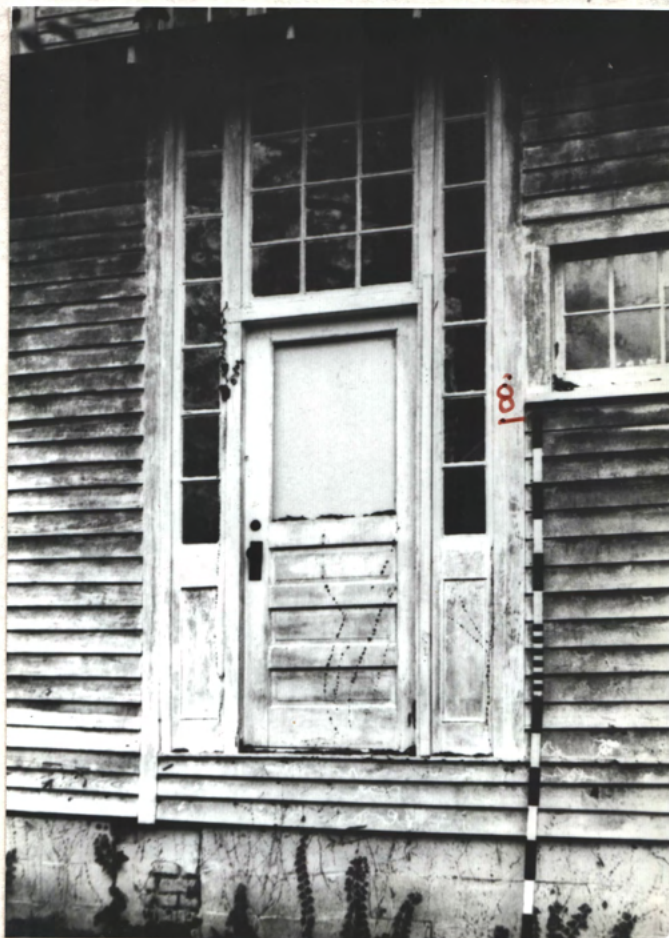
core block mfm brick pier

→ Was a porch, later enclosed
Note porch floor edge

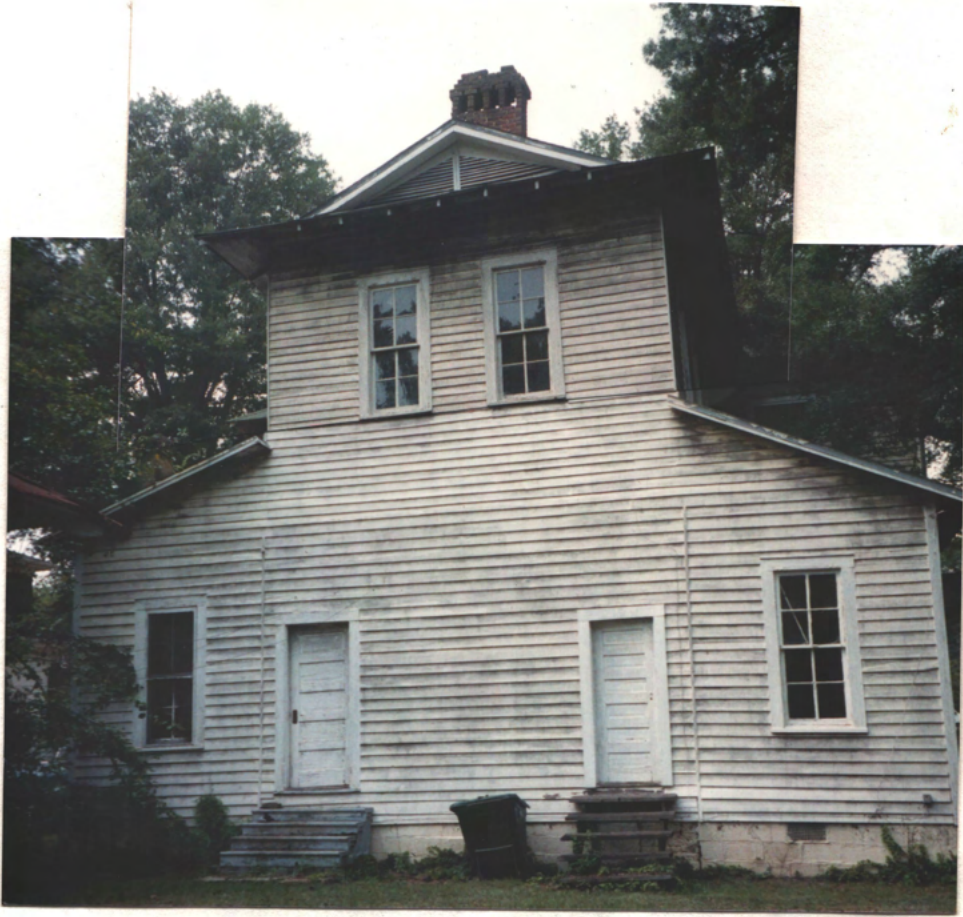
c. 1920's
Gw + Shed

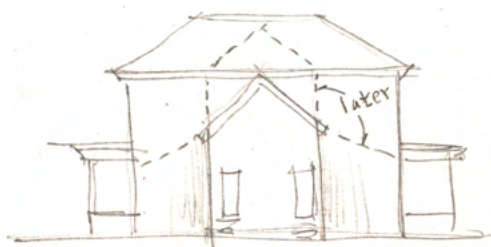
Apparent previous S. elev.

early 20th c.
type door

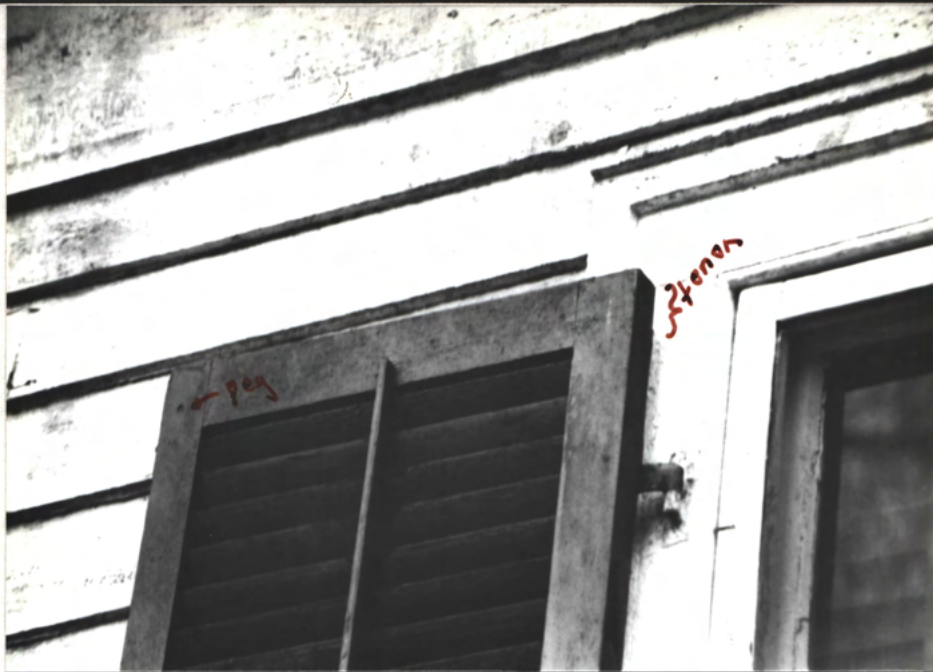
Notes through-mortises,
 tenons & pegs etc.

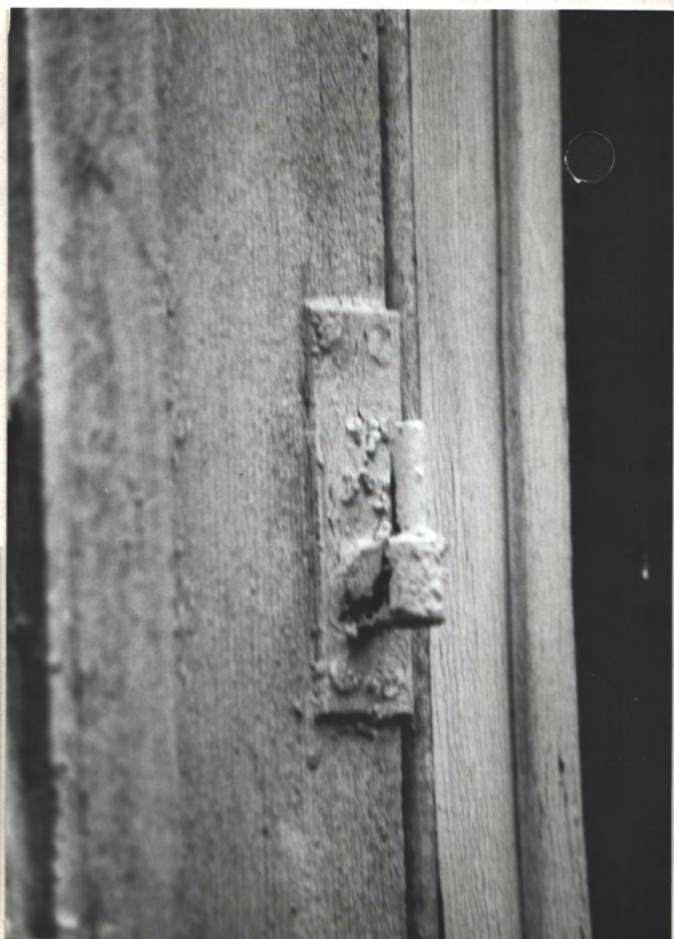
Blind-hook
 (at west wall)
 Typical blind
 (this at East stair hall rm.
 - see p. 11)

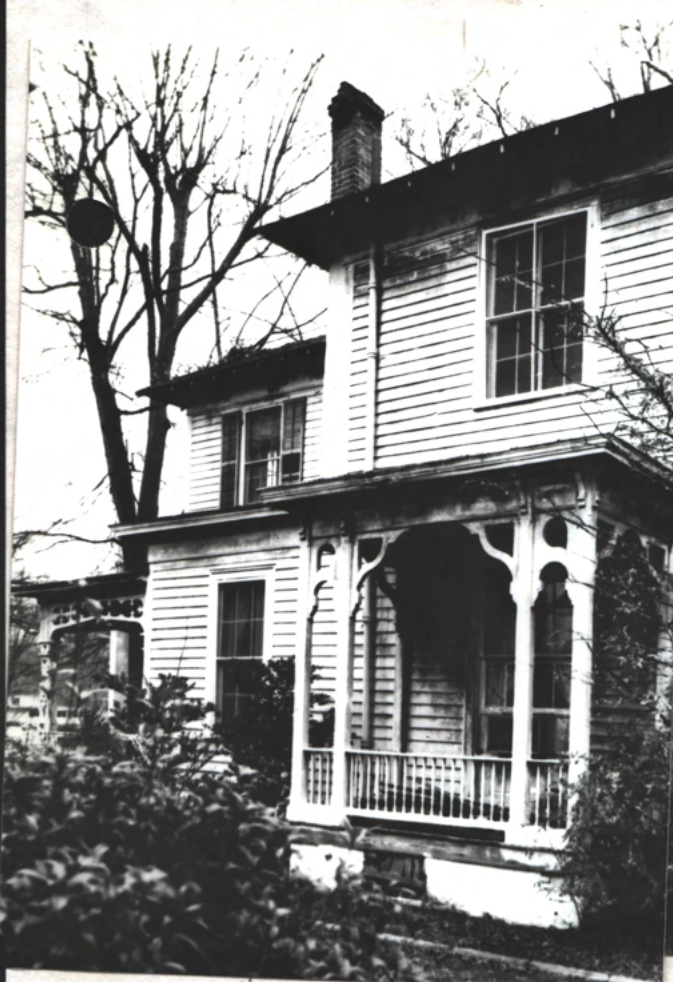
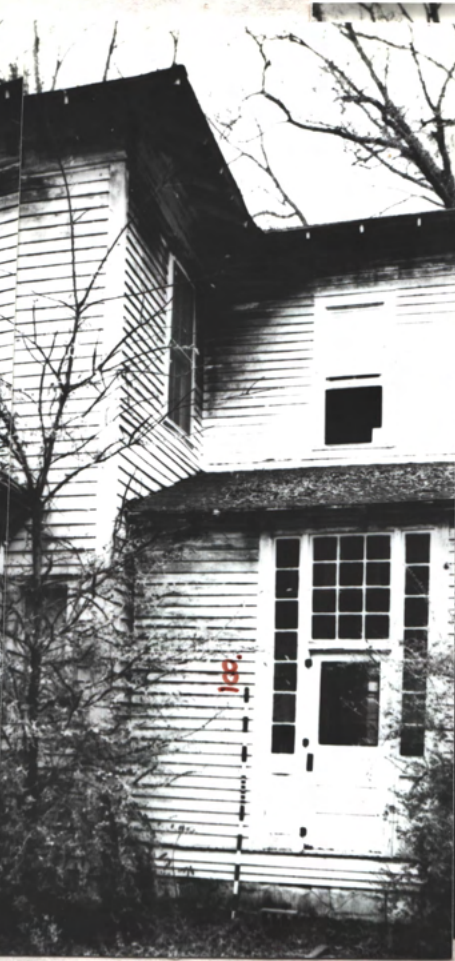
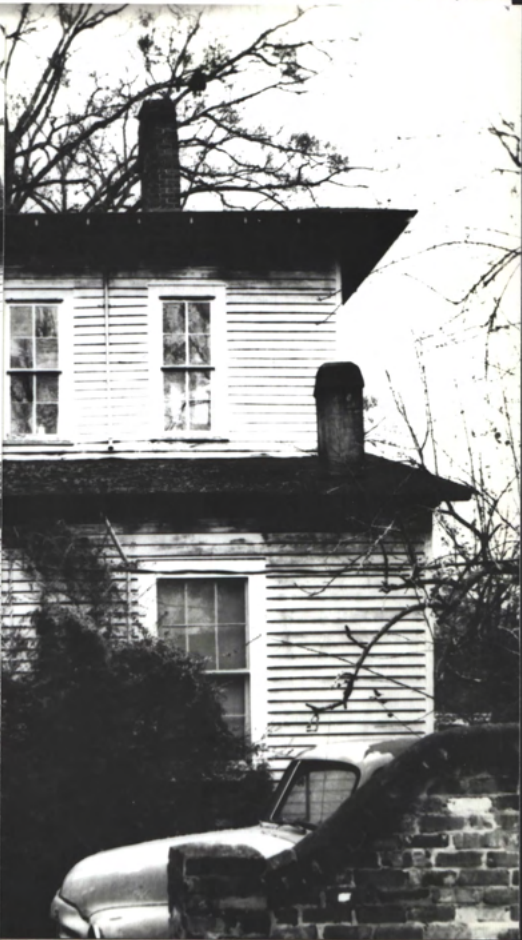
1857-4
West Wall

Later enclosure
of porch

Later
(both fls)

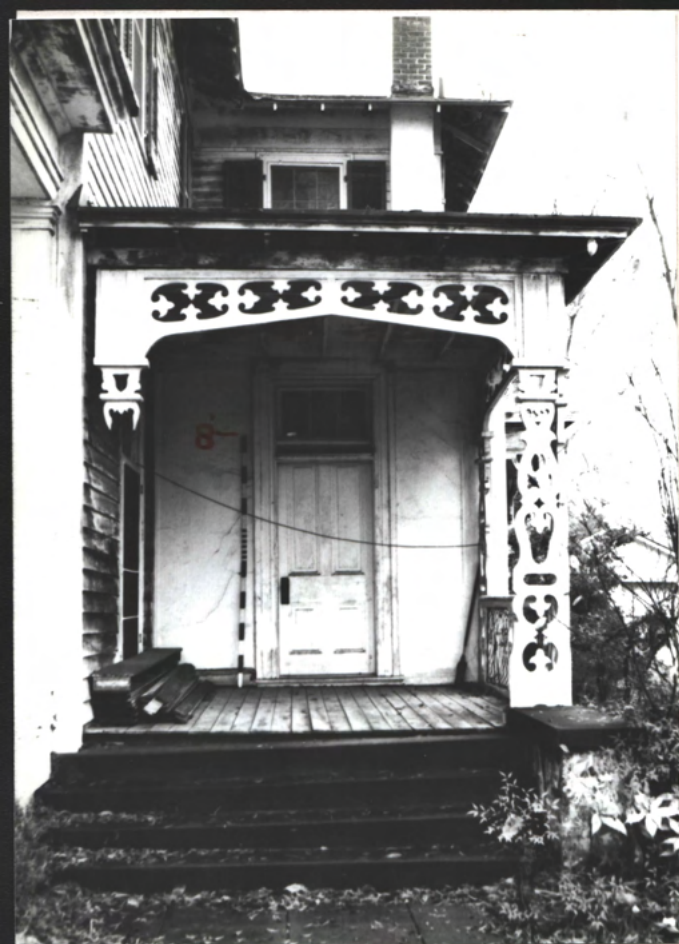
Metal rail
like on
hist. photo
on p. 1
porch roof

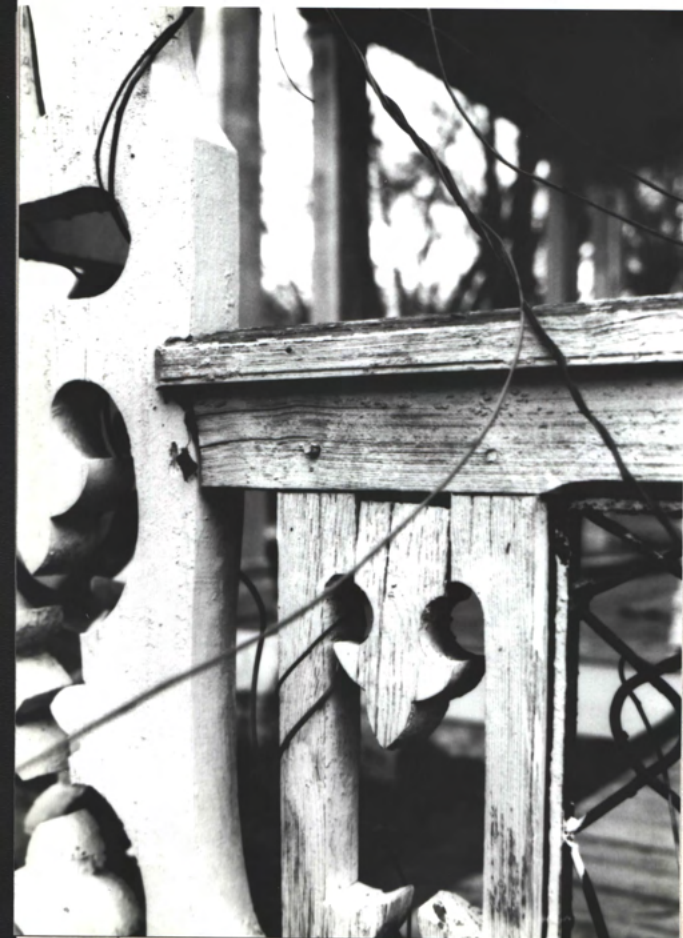
Mortise,
tenon
peg

Metal
Rail
in N.W.
porch

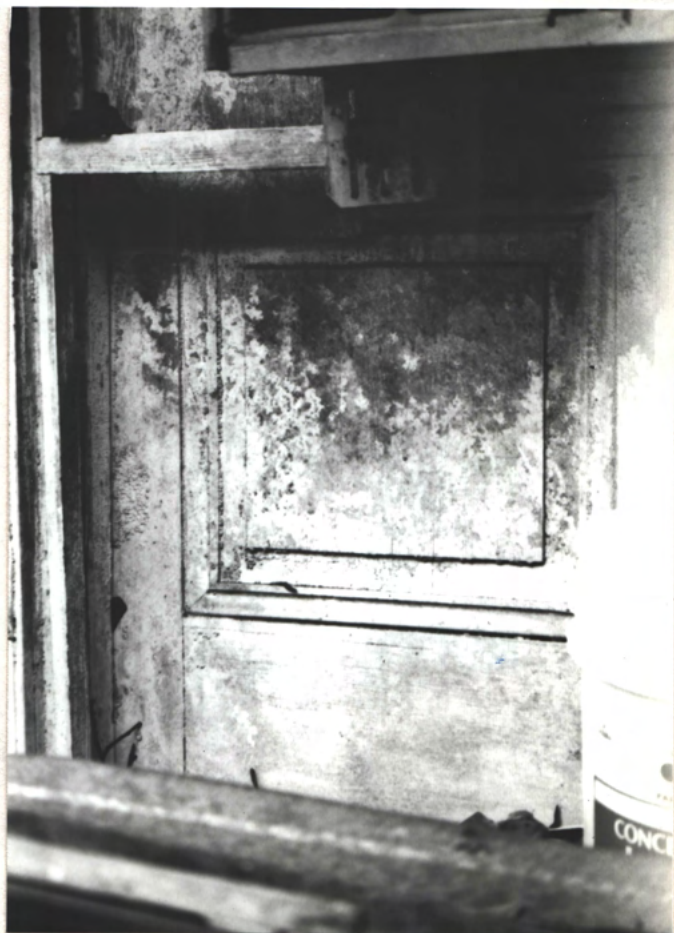
West Porch, Panel in Jib-Windings 20

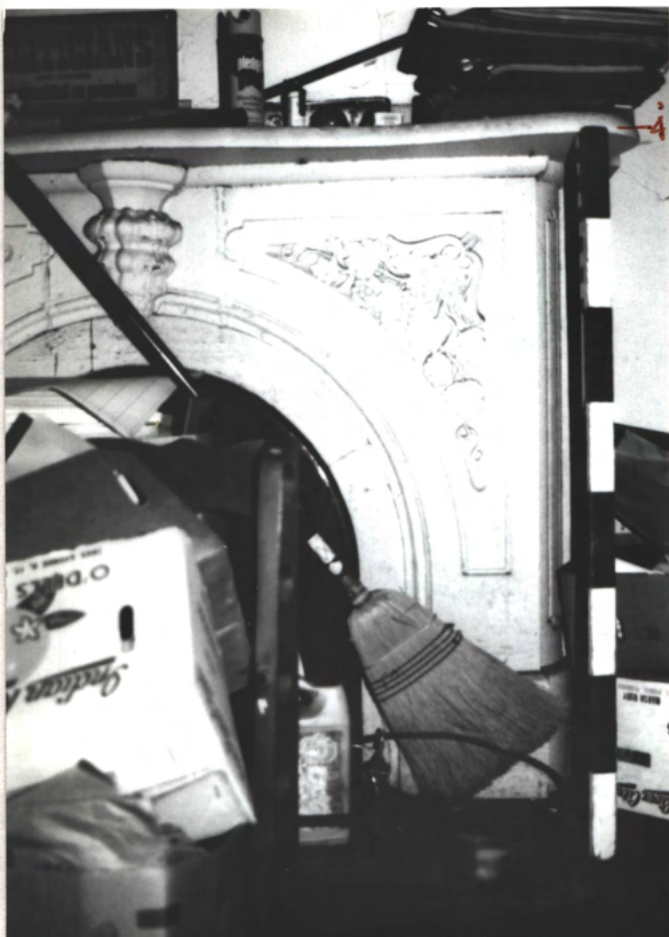
WOOD!
(not
marble)
mantel
carved in
imitation
of Italian
marble

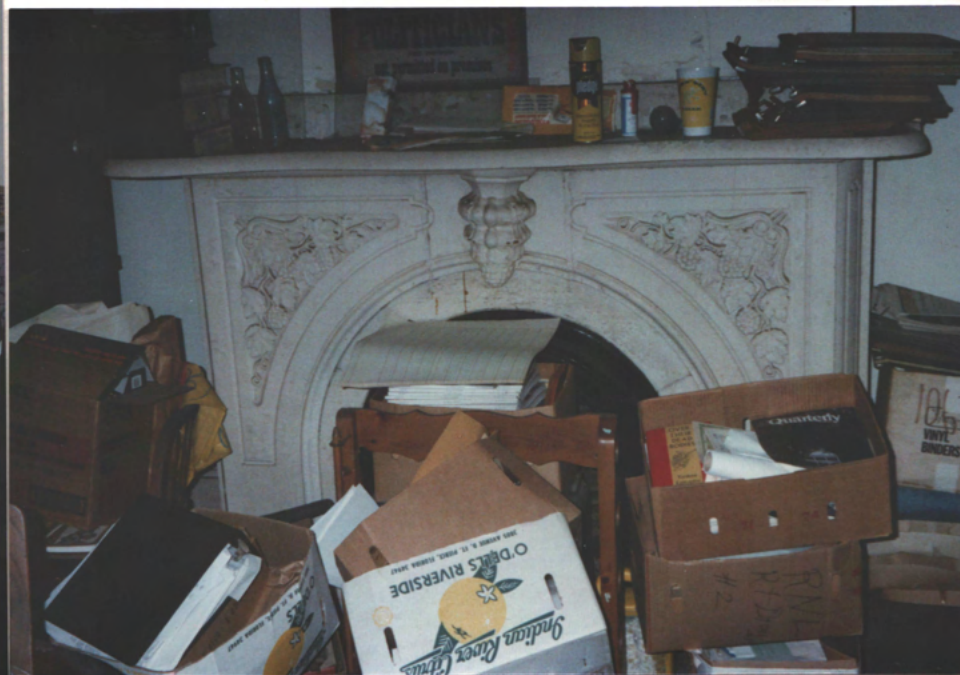
N. Cent. Parlor / Wood mantel (not marble)
 Fl. 1
